DEPARTMENT OF THE ARMY
UNITED STATES ARMY AVIATION TEST BOARD
Fort Rucker, Alabama 36360

28 DEC 1966

SUBJECT: Letter Report, (6) Product-Improvement Test of Component
TBO Extension, UH-1() Helicopter, RDT&E Project No.
(16) USATECOM Project No 4-5-0101-03

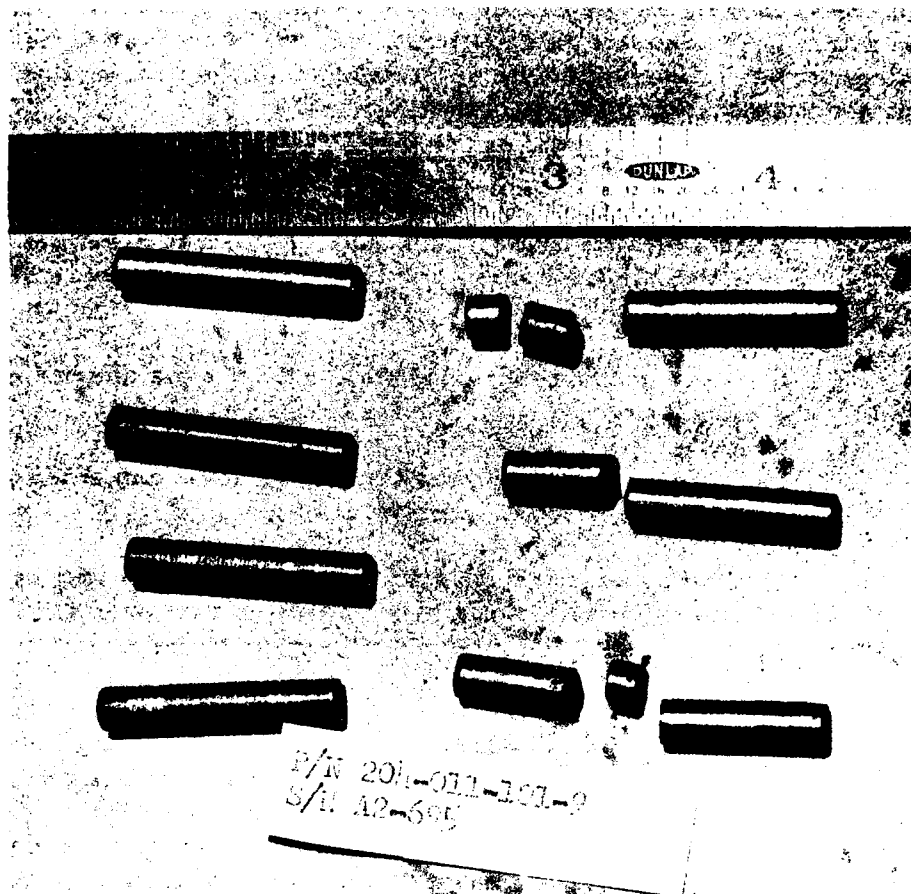
b. S/N A2-695. This hub had operated 1100.6 hours in RVN prior to receipt. Inspection revealed that the hub was unserviceable for testing because of damaged trunnion bearings. One of the bearings had three rollers missing and one had five missing. At disassembly, several of the cracked rollers came loose from their pockets (figure 1). The trunnion bearing inner race was badly galled (figure 2). The bearing cage was not pressed out for inspection of the outer race.

Figure 1. Dislodged and broken roller bearings (main-rotor hub, S/N A2-695, 1100.6 operating hours).

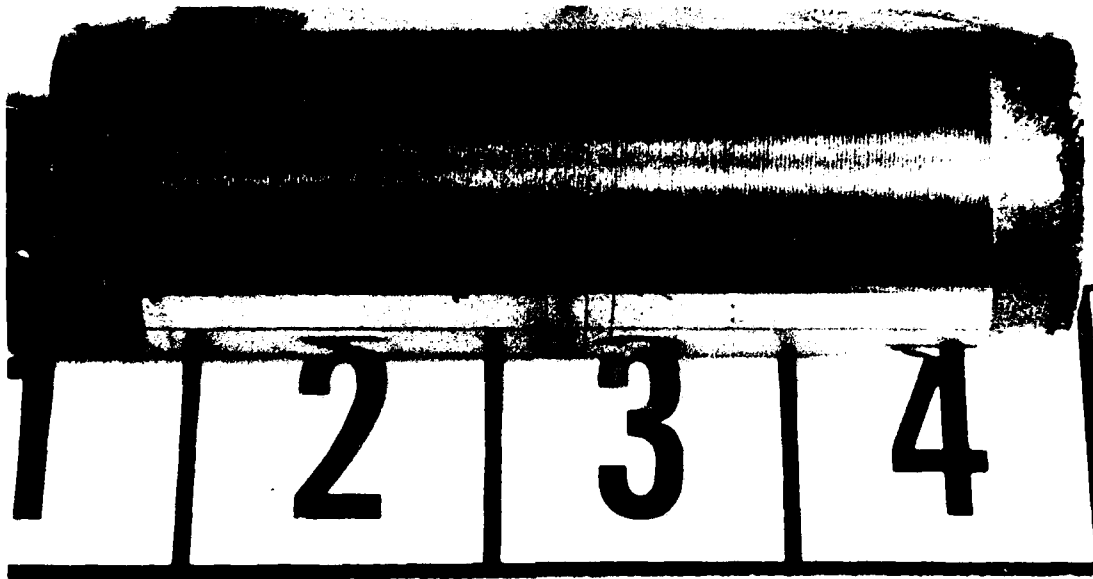
g. S/N H1-311. This hub had operated 993.0 hours in RVN. Inspection revealed the hub to be unserviceable because of cracked strap retention pins. The pins were the old type, P/N 204-011-168-1. One of the pins had cracked completely (figures 5 and 6), while two of the remaining three had circumferential cracks (figure 7).

Figure 7. Circumferential cracks in strap retention pin.
(Main-rotor hub, S/N H1-311, 993.0 operating hours.)

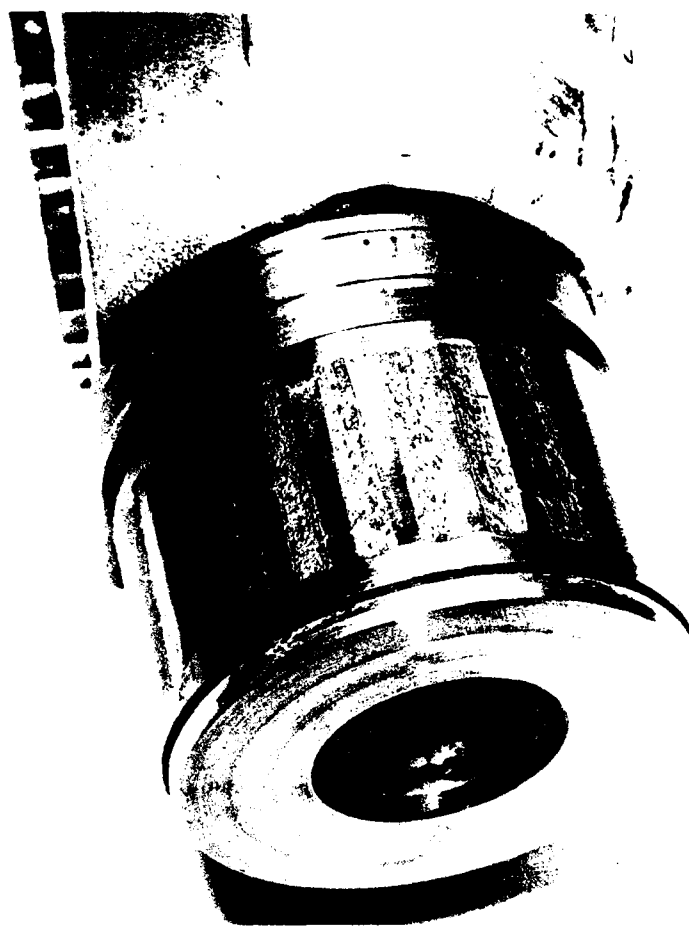
(2) The most probable cause of the trunnion bearing deterioration is inadequate lubrication; a contributing factor, however, may be a deficiency in the load capability of the inner race of the trunnion bearing.

h. S/N A2-361. This hub had operated 866.0 hours in RVN. Inspection revealed this hub to be unserviceable because of trunnion bearing deterioration. Both trunnion spindles were badly galled and scored (figures 8 and 9), and several roller bearings were broken in both bearing housings (figure 10).

Figure 8. Galled trunnion bearing inner race.
(Main-rotor hub, S/N A2-361, 866.0 operating
hours.)

Figure 9. Galled trunnion bearing inner race.
(Main-rotor hub, S/N A2-361, 866.0 operating
hours.)

(3) The manufacturer investigate the possibility of a materiel or design deficiency in the trunnion bearings.

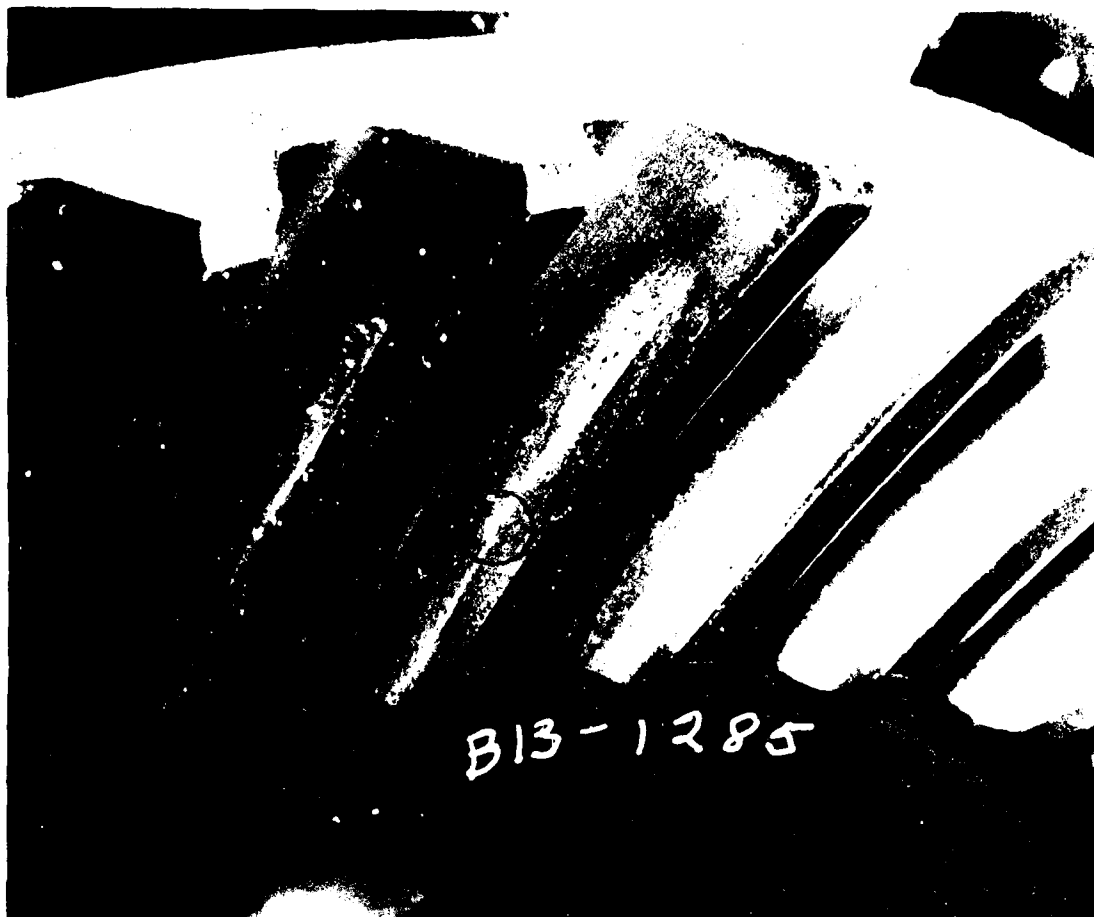
(1) The tail-rotor gearboxes were found to be unserviceable after various operating hours beyond the normal 1100-hour TBO due to pitting on the convex side of the output gear teeth. (See inclosure 1.)

Figure 59. Crack or pit on convex side of output gear tooth (90-degree gearbox, S/N B13-1285, 1300.8 operating hours).

(3) The output gears either be retired at overhaul or be
refurbished to blend out the wear-pattern overlap area until such time
that results of additional testing are available.
