DEPARTMENT OF THE ARMY  
UNITED STATES ARMY AVIATION TEST BOARD  
Fort Rucker, Alabama 36360

SUBJECT: Letter Report, "Product Improvement Test of T53-L-11  
Engine," RDT&E Project No. \_\_\_\_\_  
USATECOM Project No. 4-5-0101-01 and -06 ✓

## ENGINEERING ANALYSIS

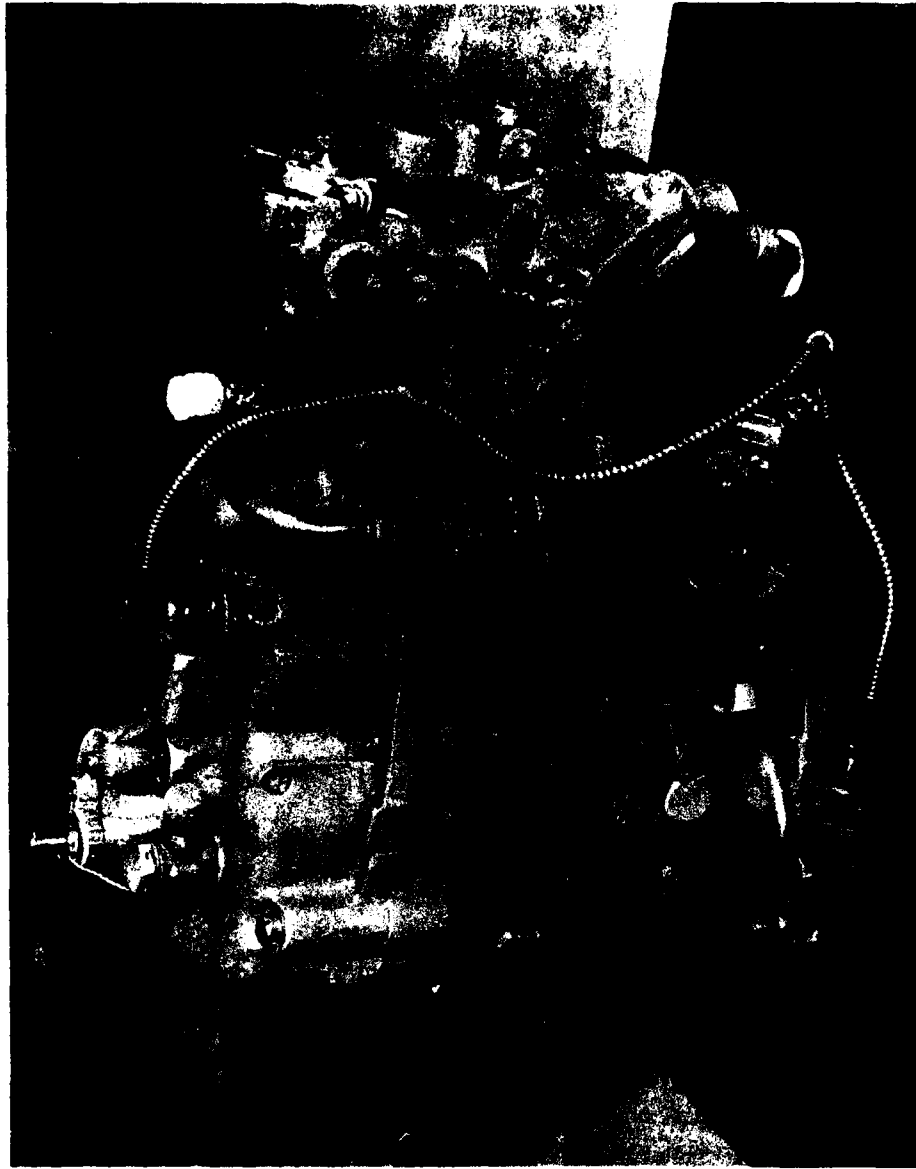
Figure 2. Modified manual fuel control

(1) The modified manual fuel control (figure 2) was originally installed on engine S/N LE-09753 and was later installed on engine S/N LE-10394. After 227.9 hours the control was removed and returned to the engine manufacturer because of fluctuations in the gas producer turbine speed, power turbine speed, and torque pressure. The engine manufacturer reported that bench and flight tests failed to duplicate the fluctuations, and the control was returned to the USAAVNTBD. The control was reinstalled, but no test time was acquired because the engine would not accelerate in the manual mode when helicopter cabin heat and anti-icing airbleeds were on. Bench test at the engine manufacturer's facility revealed that the control was still serviceable with all flow schedules the same as when initially shipped. Flight testing by the engine manufacturer, however, confirmed the malfunction. Subsequent investigation revealed that the problem was with the compressor discharge pressure input to the manual control actuator. This pressure was being tapped off at the point where the airbleed actuator takes its pressure from the airbleed manifold inside the air diffuser. When all bleeds were on, the compressor discharge pressure decreased enough to hamper operation of the manual control. To prevent recurrence of this problem, the air pressure tap was moved to one of the instrumentation ports on the air diffuser. This rerouting of the pressure tap solved the problem, and the fuel control was returned to the USAAVNTBD.

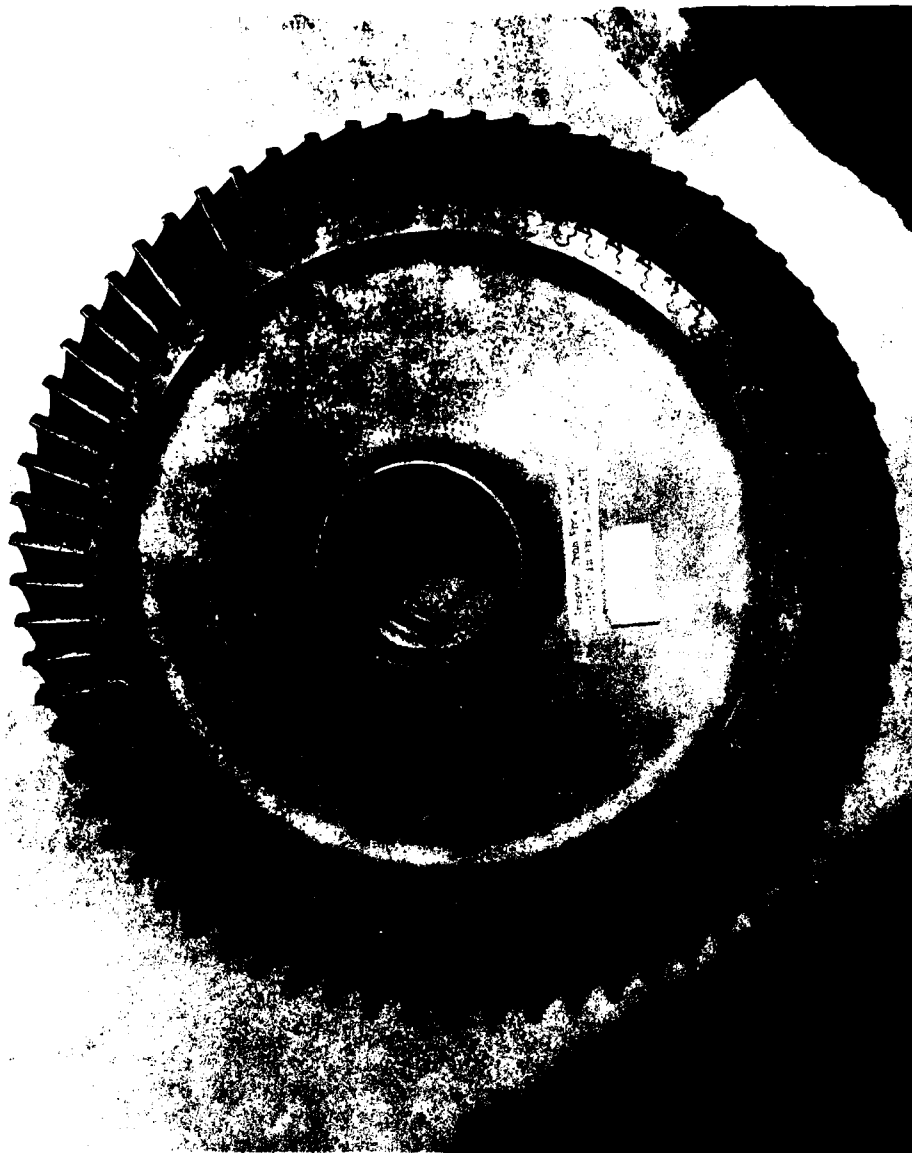
Figure 3. Gas producer turbine wheel, 192.7 operating hours.

b. Gas Producer Turbine Wheel (Thicker-Walled Blades), FSN 2840-022-7501, P/N 1-100-490-06. The gas producer turbine wheel (figure 3) accumulated 192.7 hours in engine S/N LE-09753. After the engine was removed due to FOD, the turbine wheel was fluorescent-penetrant inspected and no defects were found. The gas producer turbine tip clearances were:

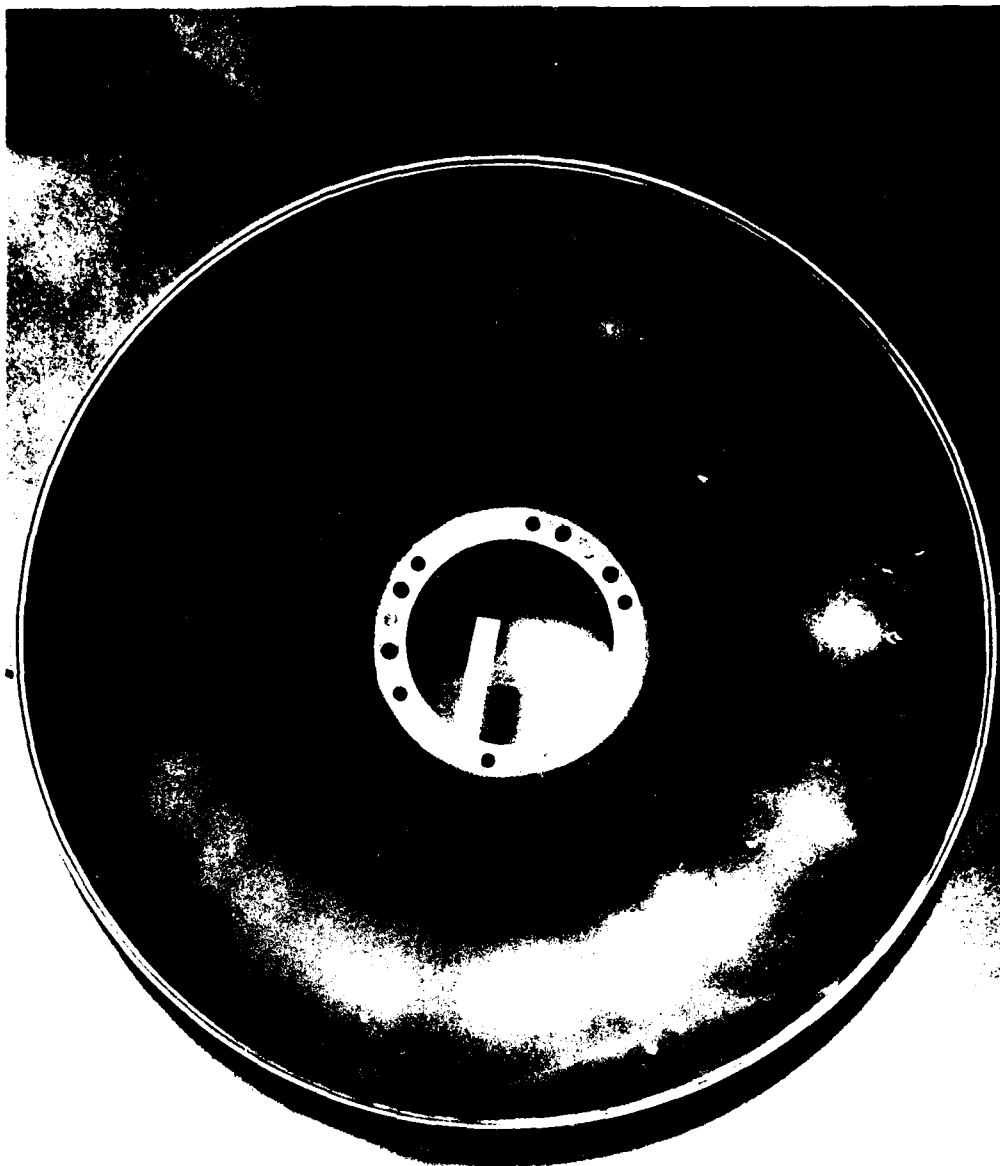
Figure 5. Combustor deflector,  
192.7 operating hours

c. Combustor Deflector (Flexible Support), FSN 2840-872-6126, P/N 1-110-440-02. The combustor deflector (figure 5) was removed after accumulating 192.7 hours in engine S/N LE-09753. Inspection revealed no defects. The deflector was installed in engine S/N LE-10394. After accumulating 600.4 hours, the deflector was again removed for inspection. No defects were evident and the deflector was installed in engine S/N LE-09109. After accumulating 1200.0 hours, inspection revealed no major defects. Only minor cracking was present in the inner flange spot welds (figure 6). Since the curl did not crack circumferentially at the seam weld, the new deflector appears to be a significant improvement over the previous assemblies, FSN's 2840-793-2065 and 2840-064-9425, P/N's 1-110-020-02 and -06, respectively.

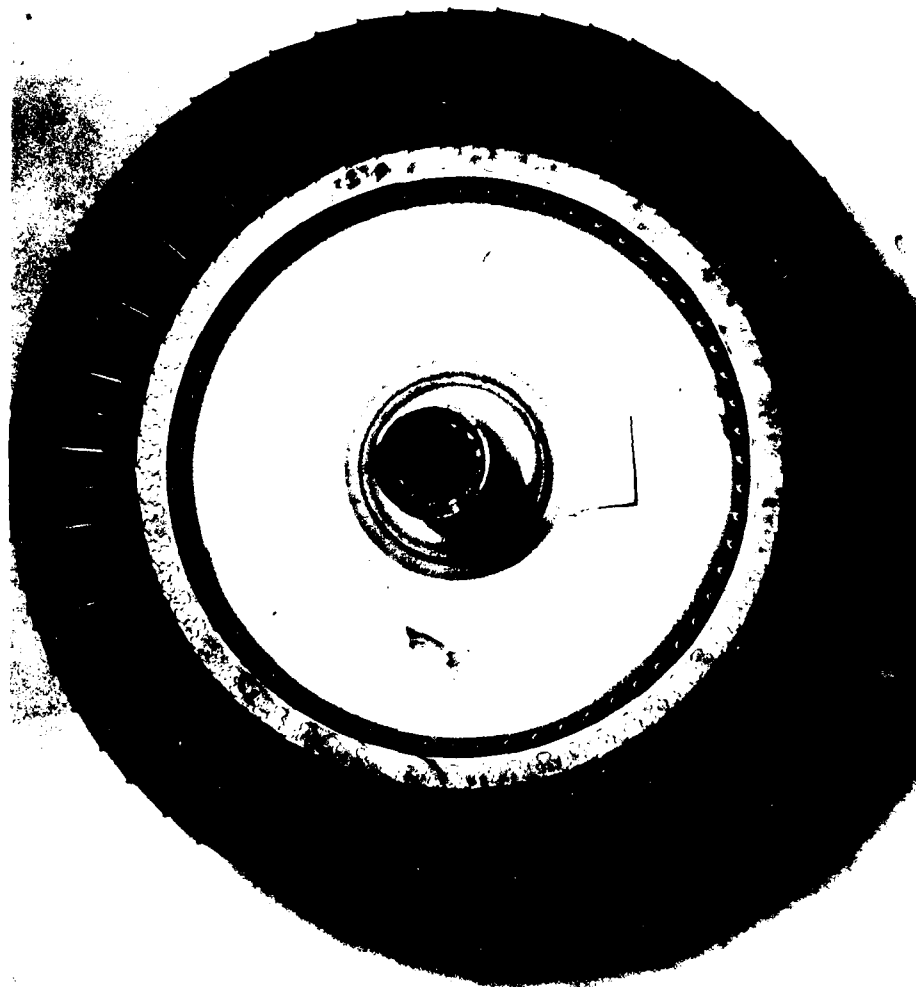
d. Power Turbine Wheel (N<sub>2</sub>), FSN 2840-475-6948, P/N 1-140-210-11. The power turbine wheel (figure 7) was removed from engine S/N LE-09753 after operating 192.7 hours. Fluorescent-penetrant inspection disclosed the wheel to be free of cracks. Power turbine wheel tip clearances were:

The wheel was installed in engine S/N LE-10394. After operating 600.4 hours, the wheel was removed for inspection. Inspection revealed no cracks or other discrepancies, and the wheel was then installed in engine S/N LE-09109. After operating 1200.0 hours, the wheel was again removed for inspection. Fluorescent-penetrant inspection disclosed no cracks; however, 22 of the 62 blades had FOD. Tip clearances were:

Inspection at the manufacturer's facility revealed the wheel diameter to be 0.006 inch over blueprint. The usual blade growth period occurs during "Green Run" at the factory. No tip clearance problems were observed during this test, and since blade growth was minimal and actually compensated for by normal power turbine cylinder wall erosion, the new power turbine wheel with the aged blades appears to offer an improvement over the turbine wheels with non-aged blades.

Figure 7. Power turbine wheel, 1200.0  
operating hours.

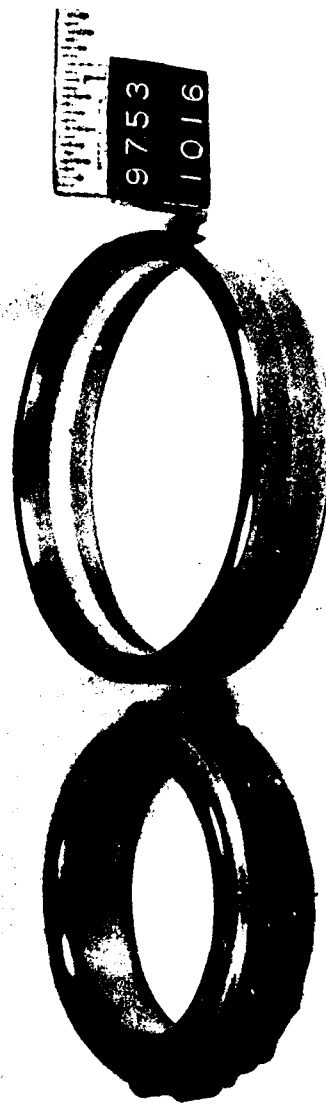
Figure 8. No. 2 mainshaft bearing,  
192.7 operating hours

e. Main Shaft Bearings (Number Two and Three Position), FSN 3110-869-7151, P/N 1-300-013-05 (SKF-457798). After accumulating 192.7 hours in engine S/N LE-09753, the No. 2 bearing (figure 8) was removed as a portion of the compressor section. Inspection revealed that the roller pockets had not developed cracks, and the rollers and races were in good condition. The No. 3 main shaft bearing was operated for a total of 1200 hours in engines S/N's LE-09753, LE-10394, and LE-09109. Magnetic particle inspection revealed no cracks, and the rollers and races were in good condition. The cage cracking phenomena has been associated more with the No. 2 bearing than with the No. 3. Because of the short operating time of this bearing in the No. 2 position, no conclusions can be drawn. The new bearing is acceptable for the No. 3 position in lieu of bearing, FSN 3110-863-1237, P/N 1-300-013-04.

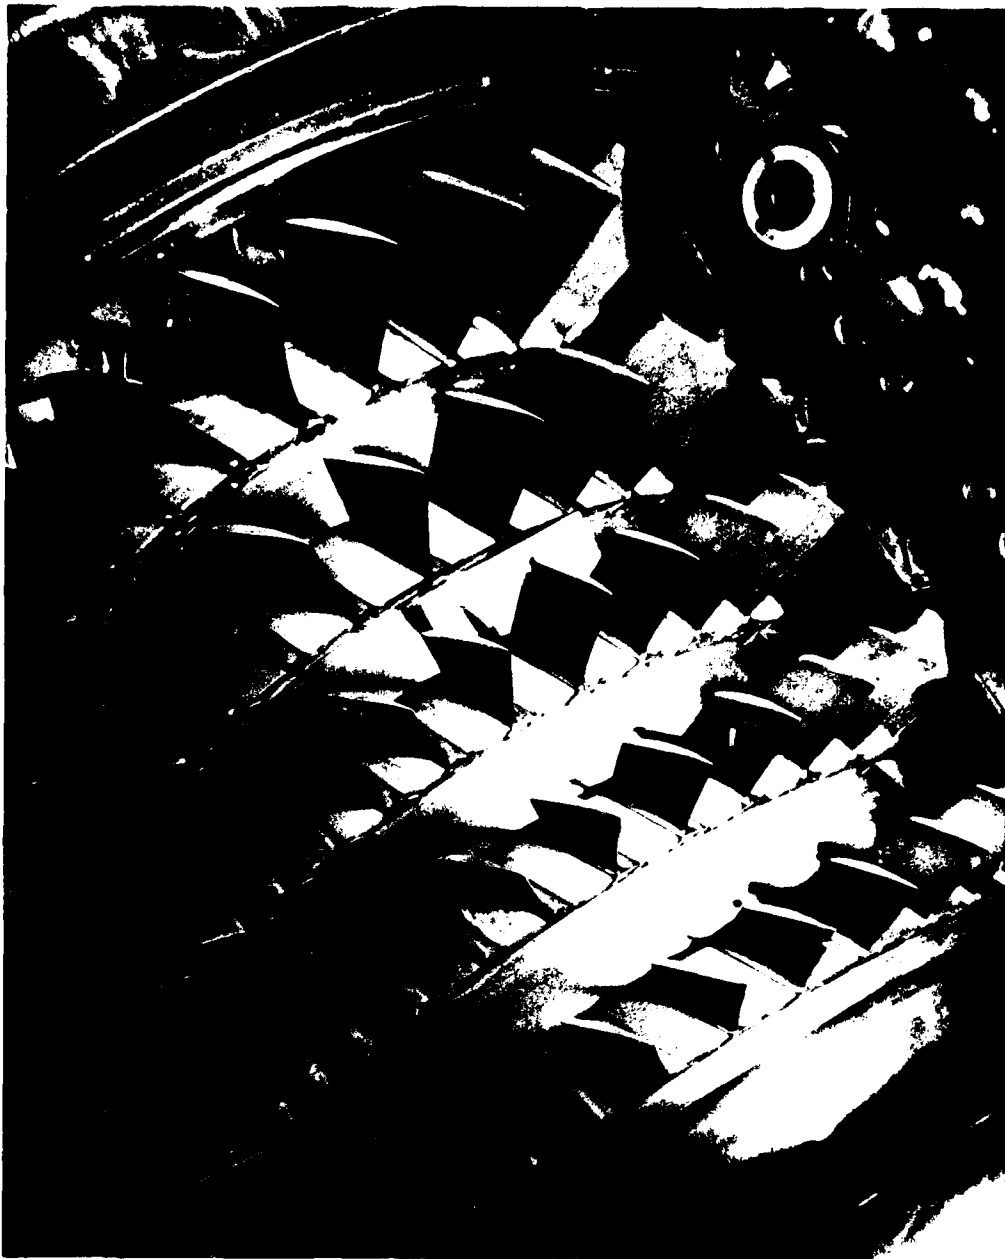
f. Compressor Rotor Assembly, FSN Not Available, P/N 1-100-560-07. After accumulating 172.0 hours, engine S/N LE-09753 was returned to the engine manufacturer for magnetic particle inspection of the AMS 350 stainless steel compressor blades, FSN not available, P/N 1-100-381-01 through -385-01. This inspection was dictated

by the appearance of cracks in similar blades at the manufacturer's plant. The inspection revealed one blade in the fifth stage to be cracked. The defective blade was replaced, the compressor rebalanced, and the engine returned to the USAAVNTBD. After accumulating 20.7 more hours for a total time of 192.7 hours, the engine experienced FOD (figures 9 and 10). The combustion section was removed and installed on engine S/N LE-10394. Inspection of the compressor revealed that, except for the FOD, the blades were in good condition. Insufficient time, however, had been accumulated to determine their susceptibility to erosion. Inspection of the titanium fifth-stage disc, FSN 2840-924-7362, P/N 1-100-417-03, revealed it to be in serviceable condition, with no cracking evident. Insufficient time was accumulated to determine its suitability.

Figure 9. FOD to compressor rotor assembly, 192.7 operating hours.

Figure 10. FOD to compressor  
rotor assembly, 192.7 operating  
hours.

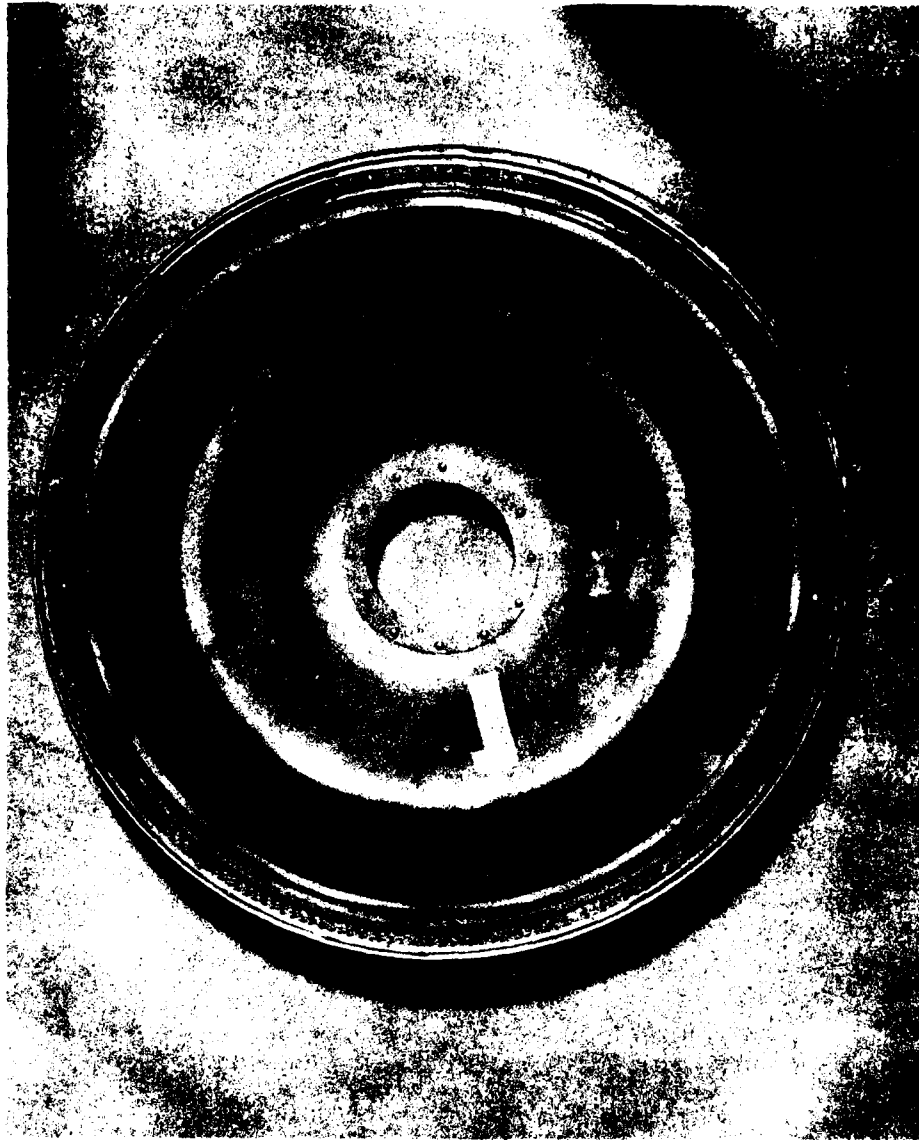
Figure 11. Power turbine nozzle,  
192.7 operating hours.

g. Power Turbine Nozzle (Depot Repairable), FSN Not Available, P/N 1-140-420-04-E (EXP-7710-02). The power turbine nozzle (figure 11) accumulated 192.7 hours in engine S/N LE-09753 prior to the first inspection. Fluorescent-penetrant inspection revealed that eleven of the vanes had cracks in the vane-to-outboard shroud joint at the trailing edge (figure 12). The cracks varied in length from 0.031 to 0.062 inch. The nozzle was installed in engine S/N LE-10394 and accumulated 600.4 hours prior to the next inspection. This inspection revealed no additional discrepancies and the nozzle was installed in engine S/N LE-09109. After operating for 1200 hours, the nozzle was again inspected. Dye-penetrant inspection revealed that 18 vanes had cracks in the vane-to-outboard shroud joint at the trailing edge (similar to those shown in figure 12); 4 vanes had cracks in the vane-to-inboard shroud joint at the trailing edge; 20 vanes had cracks in the vane-to-outboard shroud joint at the leading edge; and 1 vane had a crack in the vane-to-inboard shroud joint at the leading edge. All cracks were within the field limits specified in TB 55-2800-200-30/1 dated 28 June 1966. On the basis of these facts, the new nozzle appears acceptable for use in the T53-L-11 engine.

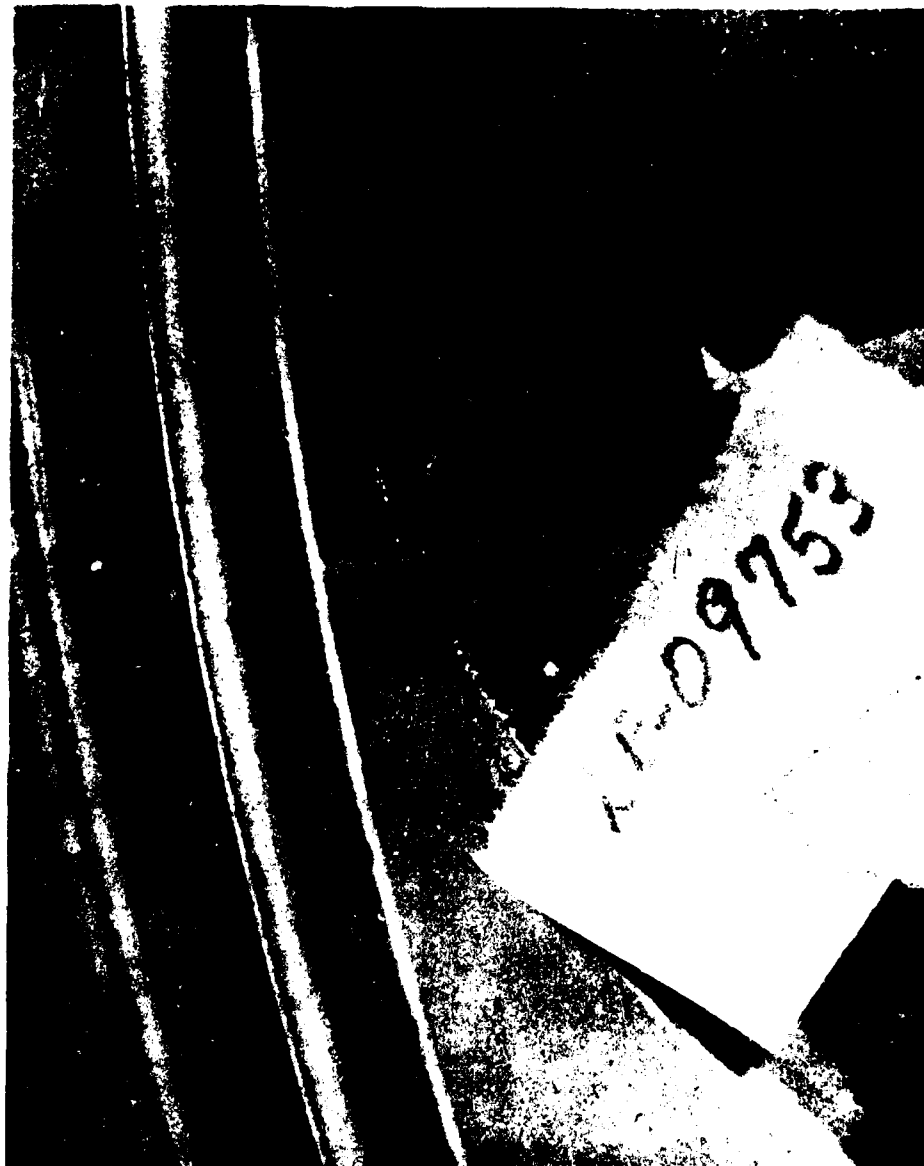
g. Power Turbine Nozzle (Depot Repairable). The power turbine nozzle accumulated 1200.0 hours. Some vane-to-shroud joint cracking occurred but it was within the limits specified in the Technical Manual (TM) (reference k).

Figure 12. Cracks in vane-to-outboard shroud joint at trailing edge of power turbine nozzle, 192.7 operating hours.

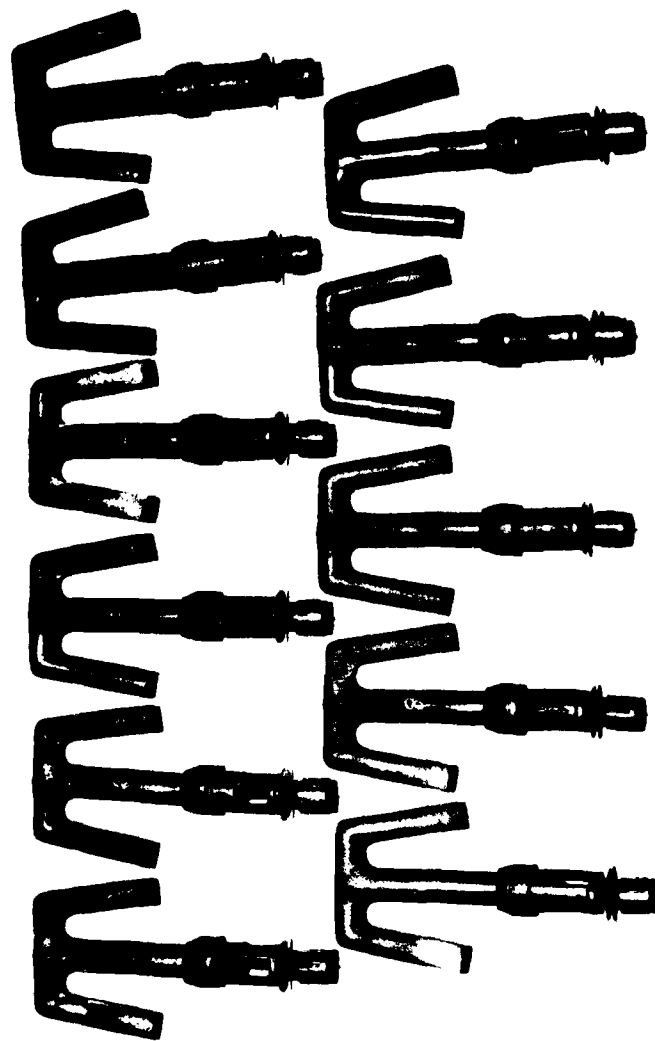
Figure 13. Fuel vaporizers,  
192.7 operating hours.

h. Fuel Vaporizers, FSN 2915-074-3369, P/N 1-130-590-02. The fuel vaporizers (figure 13) operated 192.7 hours in engine S/N LE-09753. Inspection revealed that one vaporizer had 1/16-inch cracks in two of the four welds that attach the cooling shroud to the vaporizer (figure 14), and another vaporizer had slightly damaged threads (figure 15). All vaporizers were considered serviceable and were installed in engine S/N LE-10394. After 600.4 hours of operation, the vaporizers were again inspected. Two vaporizers, numbers 2 and 4, were replaced

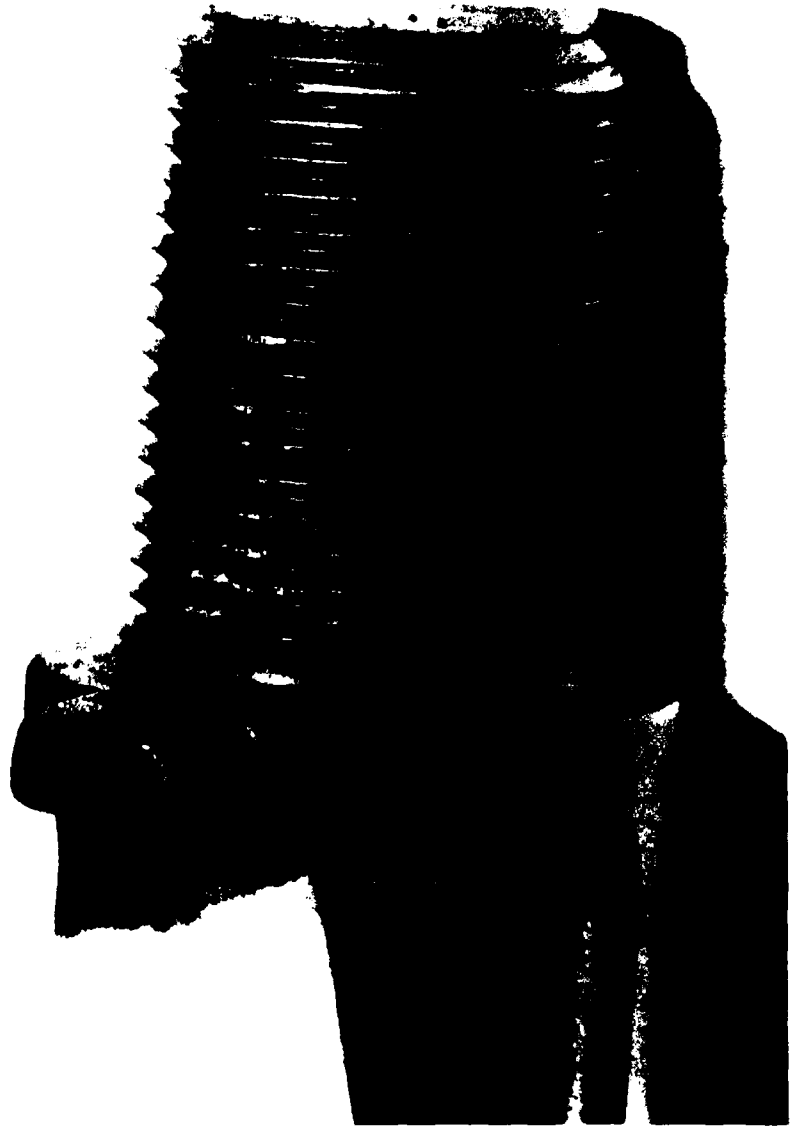
Figure 15. Damaged threads on vaporizer,  
192.7 operating hours.

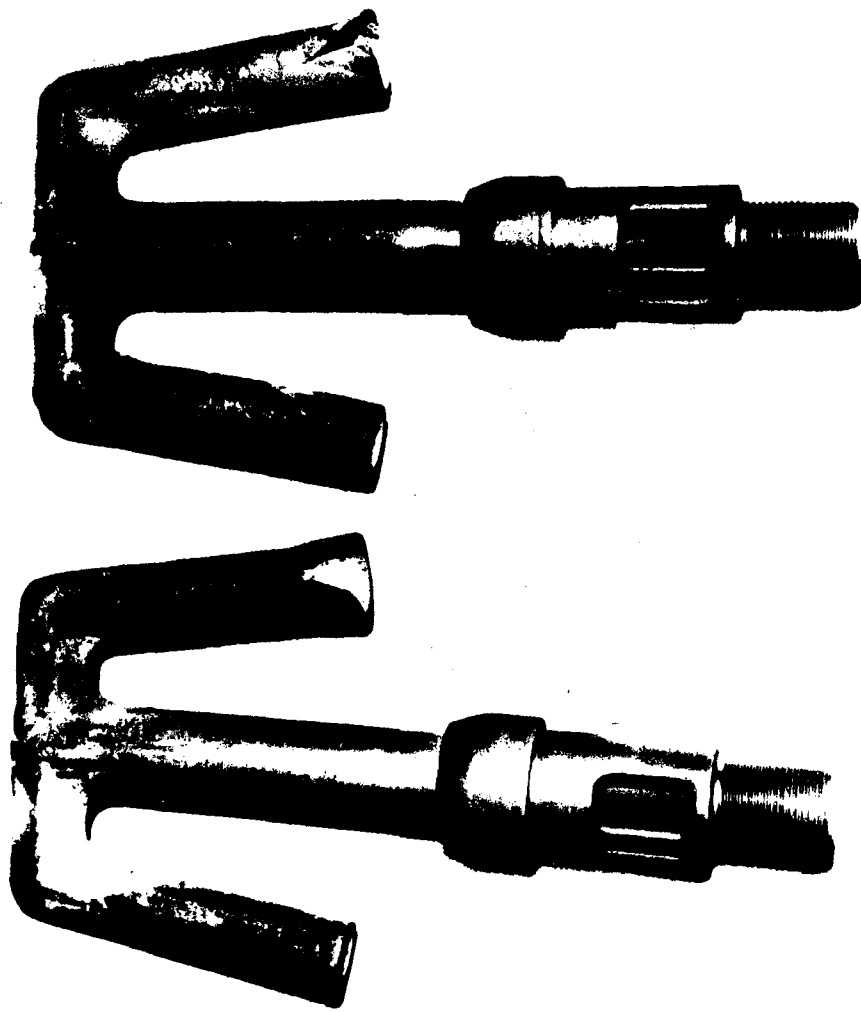
due to tip cracking and burning in excess of 0.75 inch (criteria per TB 55-2800-200-30/1) (figure 16). Because of the nonavailability of P/N 1-130-590-02 vaporizers, P/N 1-130-590-01 and -01"A" vaporizers were installed in lieu of the removed vaporizers. The original nine vaporizers and the two new vaporizers were installed in engine S/N LE-09109. After the original nine vaporizers had accumulated 1200 hours, they were again inspected. Inspection revealed that two of the nine vaporizers (positions 1 and 11) had exit leg burning in excess of field limits (figure 17), two had exit leg burning (within limits), one had exit leg cracking (within limits), one had exit leg warpage (within limits), and three had no defects. Figure 18 shows the condition of the nine 1200-hour vaporizers and the two non-test vaporizers (No. 2 and No. 4). Because of the excessive exit leg burning, the main fuel manifold was flow checked. The flow checks were performed at 25 p.s.i. for 30 seconds each at a flow rate of 80 lb./hr. All eleven manifold ports flowed 140cc of fuel under the above conditions, thus indicating no manifold blockage. The new vaporizers appear to offer an improvement over the previous standard vaporizers, FSN 2915-977-1044, P/N 1-130-370-01.

Figure 16. Burned and cracked tips on vaporizer No.'s 2 and 4, 600.4 operating hours.

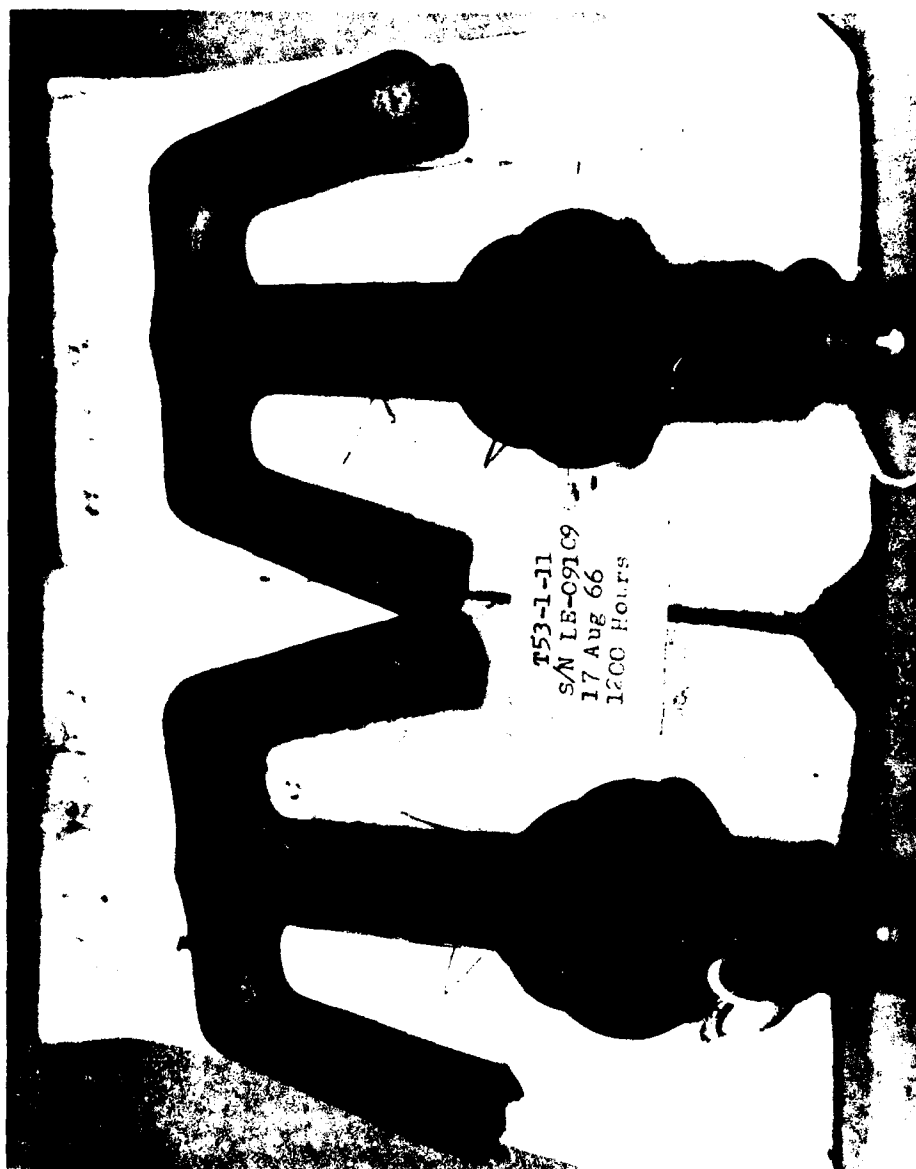
Figure 17. Exit leg burning on vaporizers,  
No.'s 1 and 11, 1200.0 operating hours.

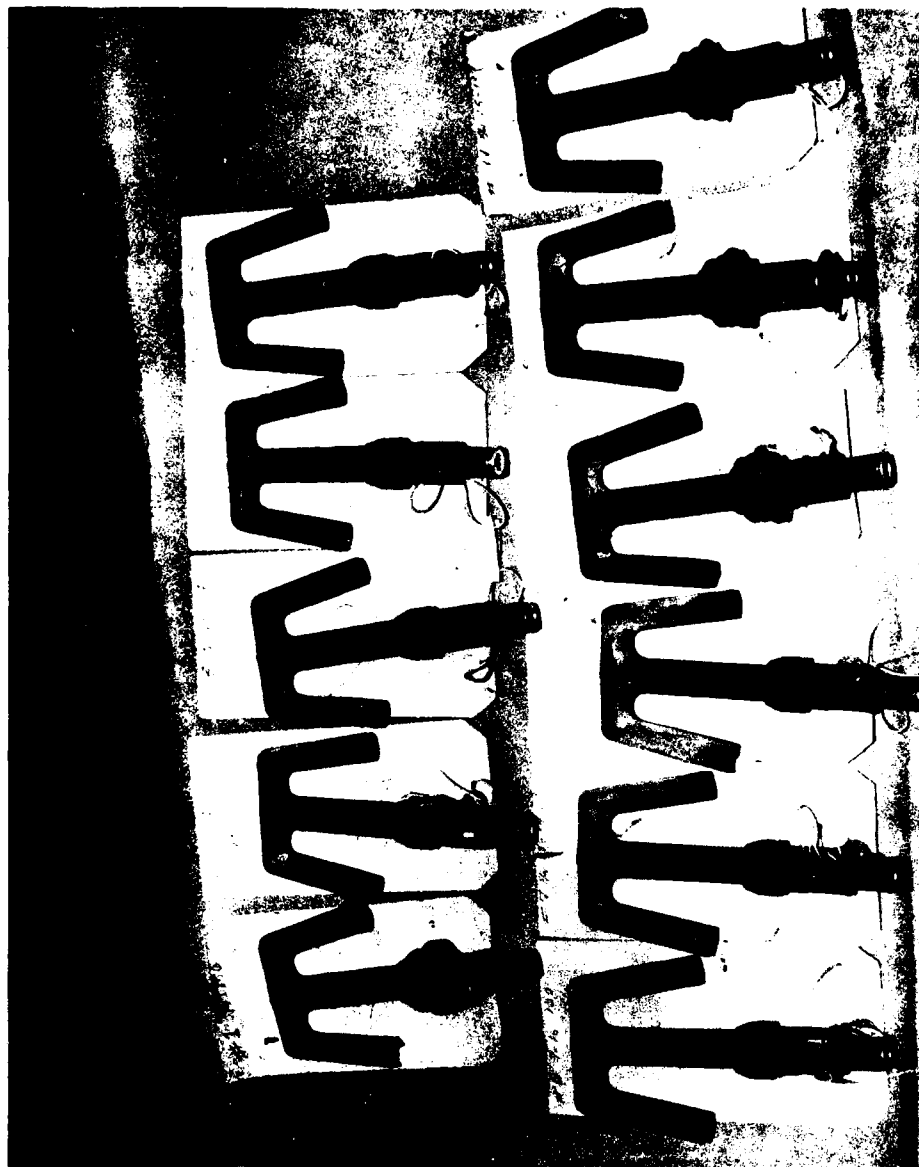
h. Fuel Vaporizer. Seven of the original eleven fuel vaporizers operated 1200.0 hours with damage still within TM limits. Two of the eleven operated 1200.0 hours with the damage at 1200.0 hours exceeding TM limits. The remaining two vaporizers operated 600.4 hours prior to being replaced for excessive tip cracking and burning. No cracking occurred in the base weld and the cooling shrouds remained intact on all eleven original vaporizers.

Figure 18. Condition of vaporizers, 1200.0 operating hours. (No.'s 2 and 4 are non-test and had 599.6 operating hours.)

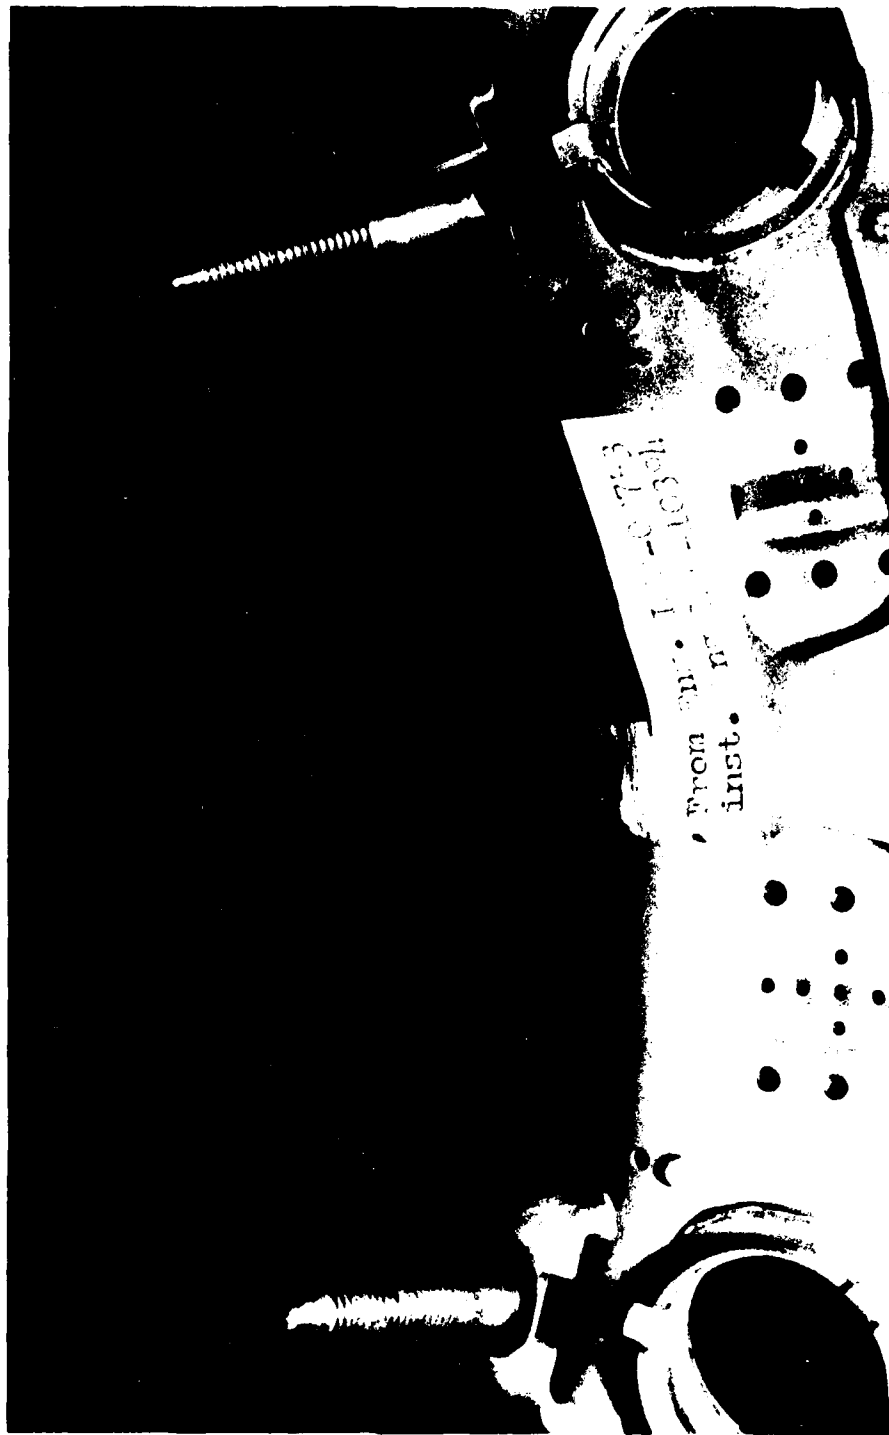
i. Combustor Liner Mounting Studs (Flexible and Three-Point-Solid Suspension System), FSN 5306-908-0373, P/N 1-130-096-02 and FSN 5306-908-0374, P/N 1-130-096-03. The combustor liner mounting studs (figure 19) were inspected after accumulating 192.7 hours in engine S/N LE-09753. No damage was evident and the studs were installed in engine S/N LE-10394. After accumulating 600.4 hours, the studs were again removed for inspection. The studs were in good condition and were installed in engine S/N LE-09109. After accumulating 1200 hours, the studs were removed for inspection. They were still in good condition, with no cracking or chafing present. The new eight-point flexible and three-point solid suspension system appears to be an improvement over the preceding system, FSN 2840-979-3740, P/N 1-130-096-01.

Figure 19. Combustor liner mounting studs, 1200.0 operating hours. (Left stud is flexible mount; right stud is solid mount.)

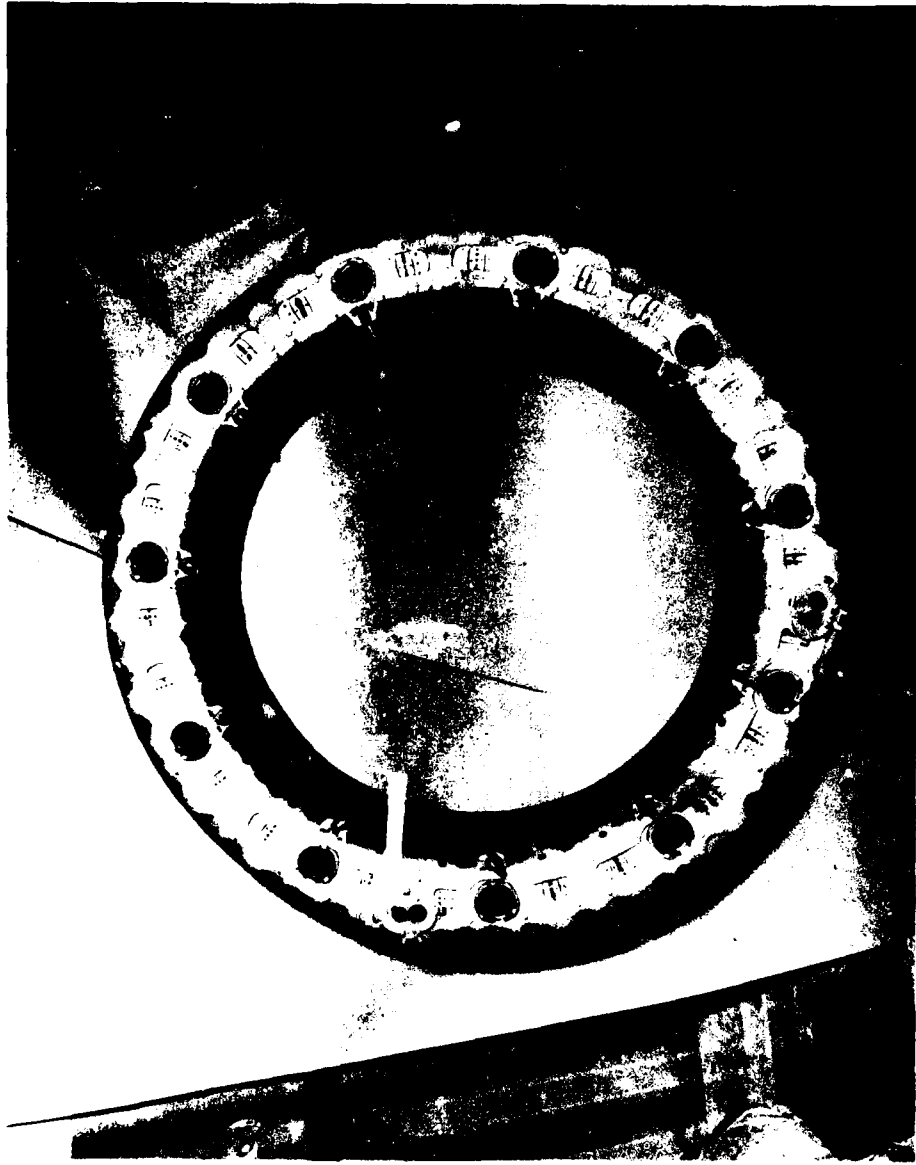
Figure 20. Combustor liner, 192.7  
operating hours.

j. Combustor Liner, FSN 2840-907-0853, P/N 1-130-600-02. The liner (figure 20) was inspected after accumulating 192.7 hours in engine S/N LE-09753. The only discrepancy found was a 0.093-inch crack in the igniter bracket weld at the 7 o'clock position (figure 21). The stud mounting brackets were in good condition, with no cracks evident. The liner was installed in engine S/N LE-10394. After accumulating 600.4 hours, the liner was again removed for inspection. No additional cracks were noted and the stud mounting brackets were in good condition. The liner was then installed in engine

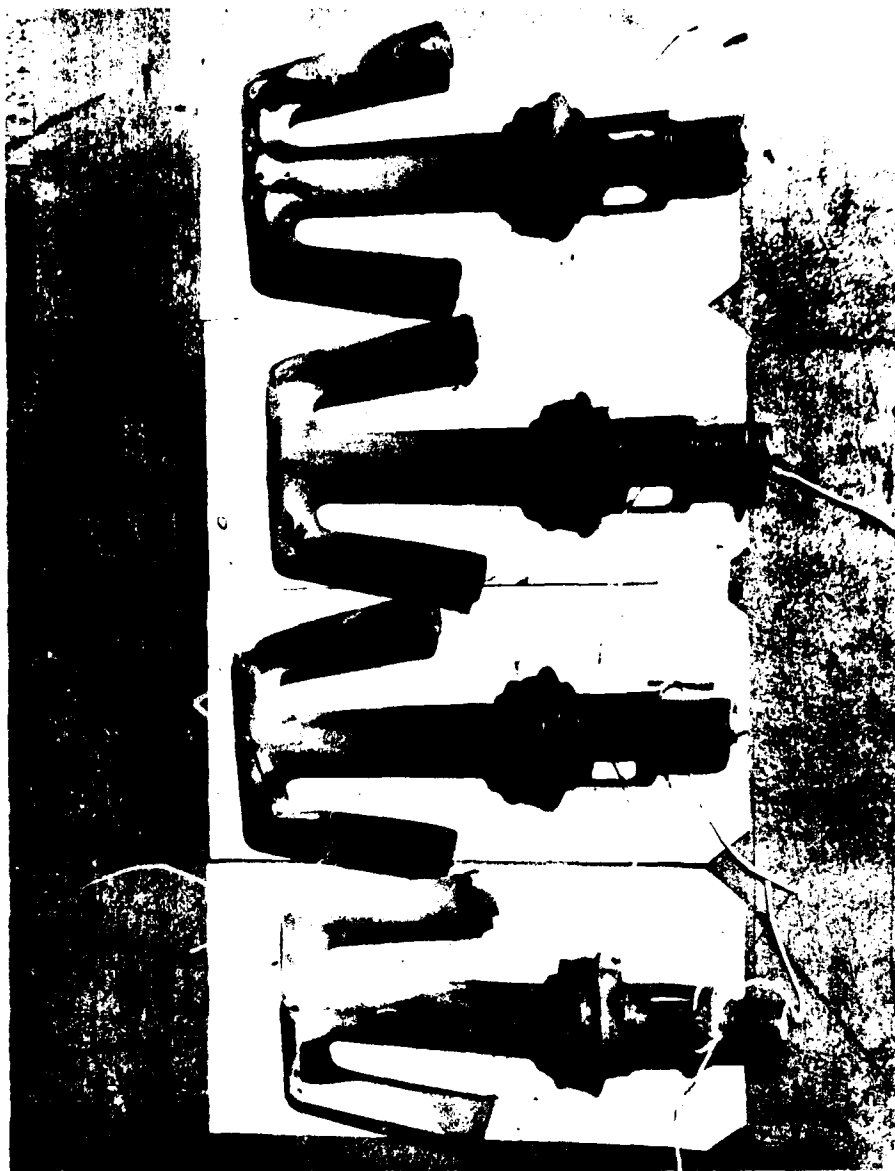
Figure 23. Four vaporizer seals broke loose from liner and jammed down on vaporizers, 1200.0 operating hours.

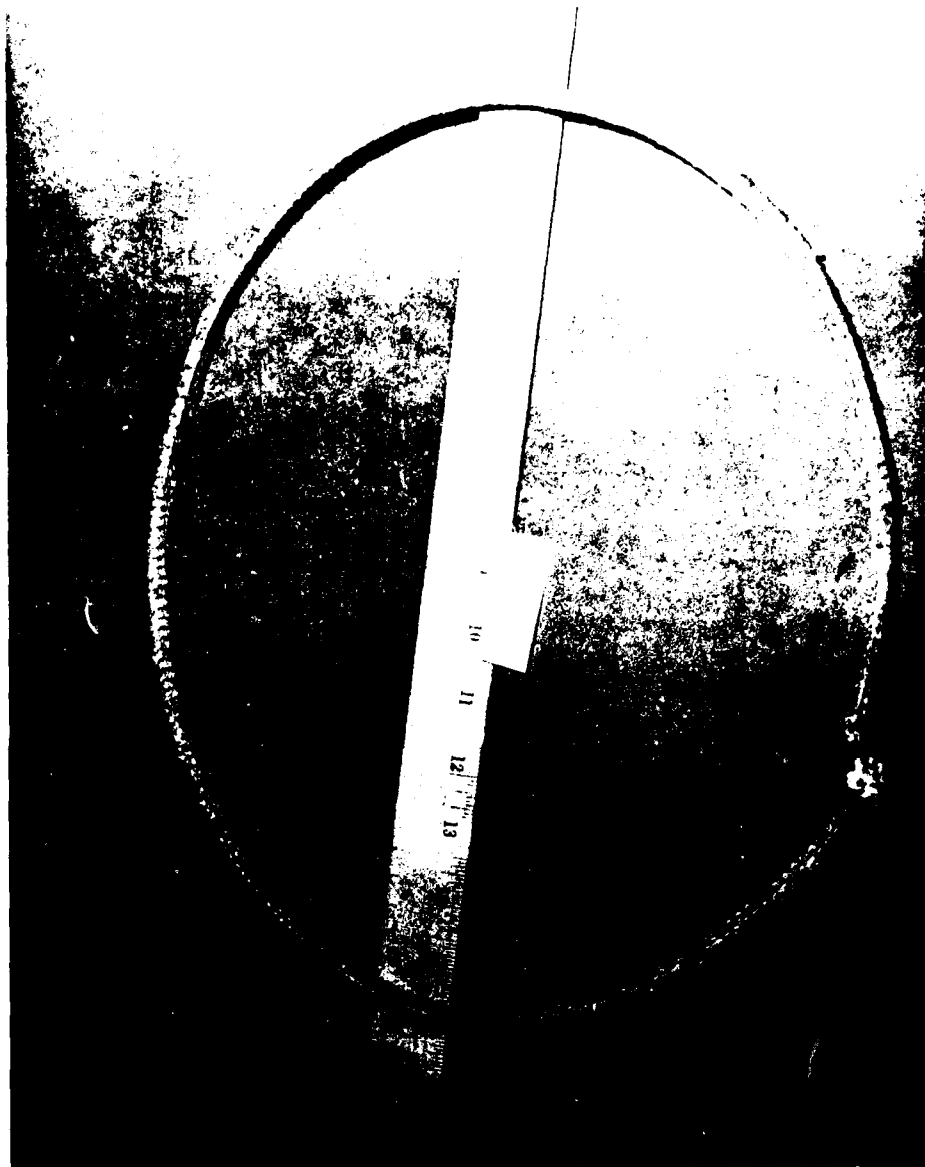
Figure 24. Interturbine air seal,  
1200.0 operating hours.

k. Air Seal Segments (Increased Length), FSN 2840-736-3996, P/N 1-140-222-01. The interturbine air seal segments were in good condition at each inspection and after 1200 hours of operation. The spring and seal were both in good condition after 600.4 hours of operation. They were changed as a normal maintenance practice at that time. The engine was cleaned once during the last 599.6 test hours, and there was no evidence of burning caused by walnut shell compound. At the end of the test, the spring tension on the seal was still tight and the seal was in good condition (figure 24). The butted segments appear to offer an improvement over the previous type segments which were wider spaced.
