PRODUCT IMPROVEMENT TEST OF T53-L-11 ENGINE  
IN THE UH-1D HELICOPTER.

Final Report of Test

5 Apr 1966

DEPARTMENT OF THE ARMY  
UNITED STATES ARMY AVIATION TEST BOARD  
Fort Rucker, Alabama 36360

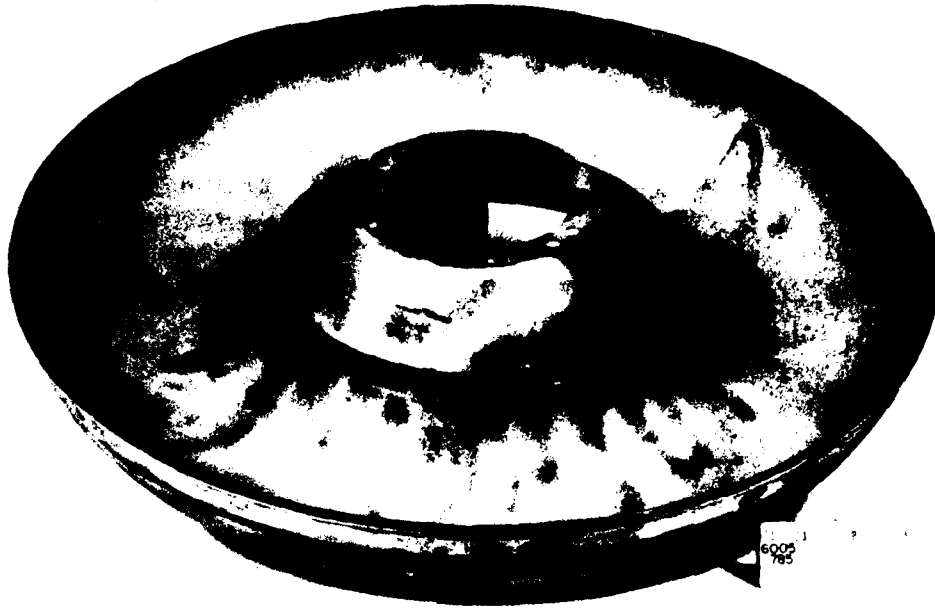
Figure 1. Combustor deflector at the end of test.

The combustor deflector was in serviceable condition at the termination of test (figure 1). No cracks were evident in the center seam weld. There were several small cracks in the spot weld area of the inner flange (figure 2).

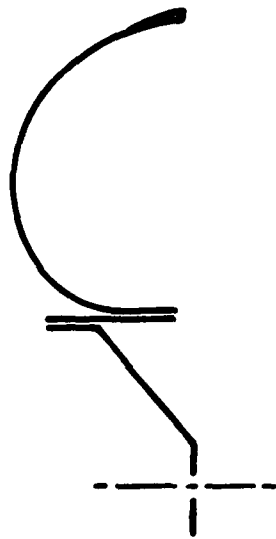
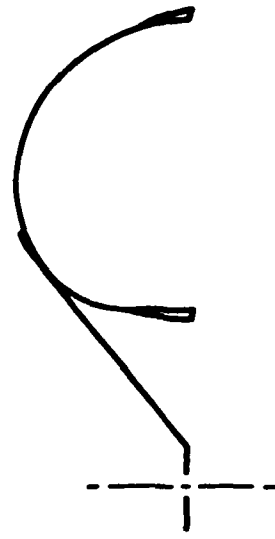
Figure 3. The design of the product-improvement combustor deflector (left) and of the standard combustor deflector (right).

2.2.3.2.1. The combustor deflector is suitable and offers a definite improvement over the standard part (figure 3).

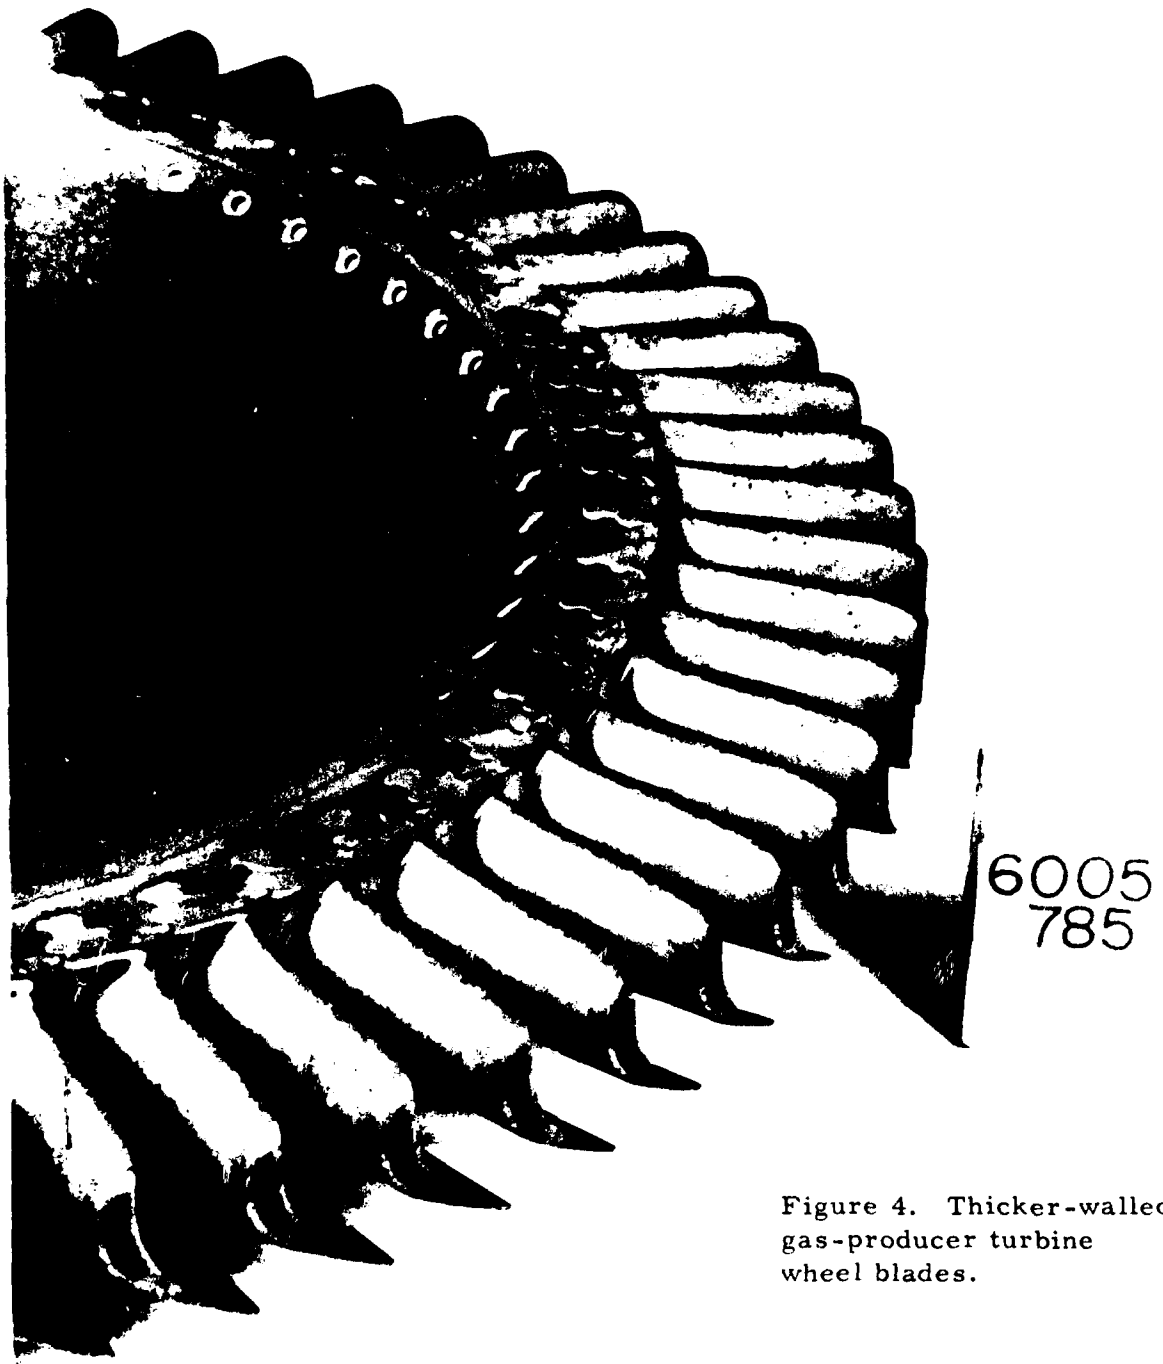
Figure 4. Thicker-walled  
gas-producer turbine  
wheel blades.

The gas-producer turbine wheel was in serviceable condition at the termination of test. Zyglo inspection revealed no cracks. The blades had experienced erosion (figure 4), but they met the serviceability criteria for erosion contained in Technical Manual 55-152-211-35 (reference 10, appendix I).

2.2.4.2.2. The thicker-walled blades have alleviated the cracking problem. The erosion was due to a combination of sand ingestion and combustion products.

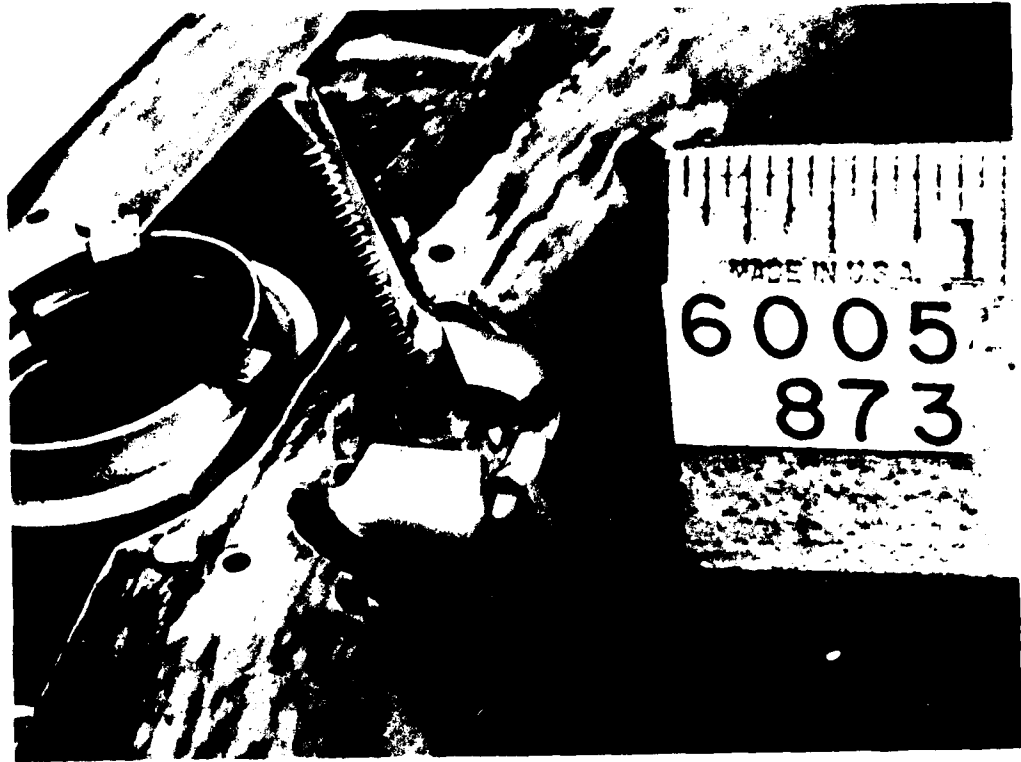
Figure 7. Solid suspension stud.

2.2.5.1.2. At disassembly, the solid suspension studs (without bushings) were in positions 2, 5, and 8. (The correct mounting positions are 1, 5, and 8.) A solid suspension stud is shown in figure 7 and a flexible mount stud in figure 8.

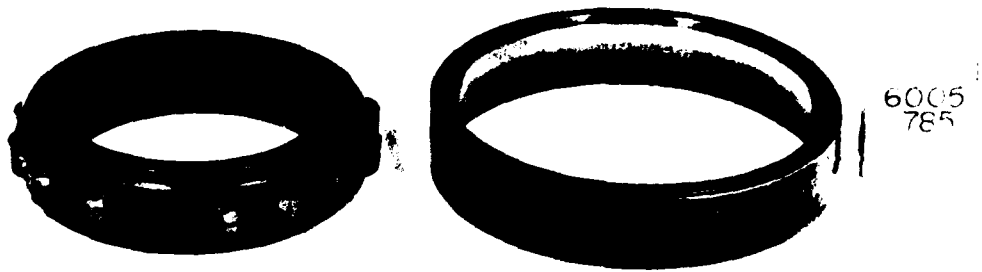
Figure 10. No. 2 bearing rolls and races.

2.2.7.1.1. The original No. 2 bearing was lost as a test item after 533 hours because of the replacement of the compressor section. The bearing installed as a portion of the new compressor attained 358 hours during the remainder of the test. No cage deterioration was evident, and the bearing rolls and races were in good condition (figure 10).

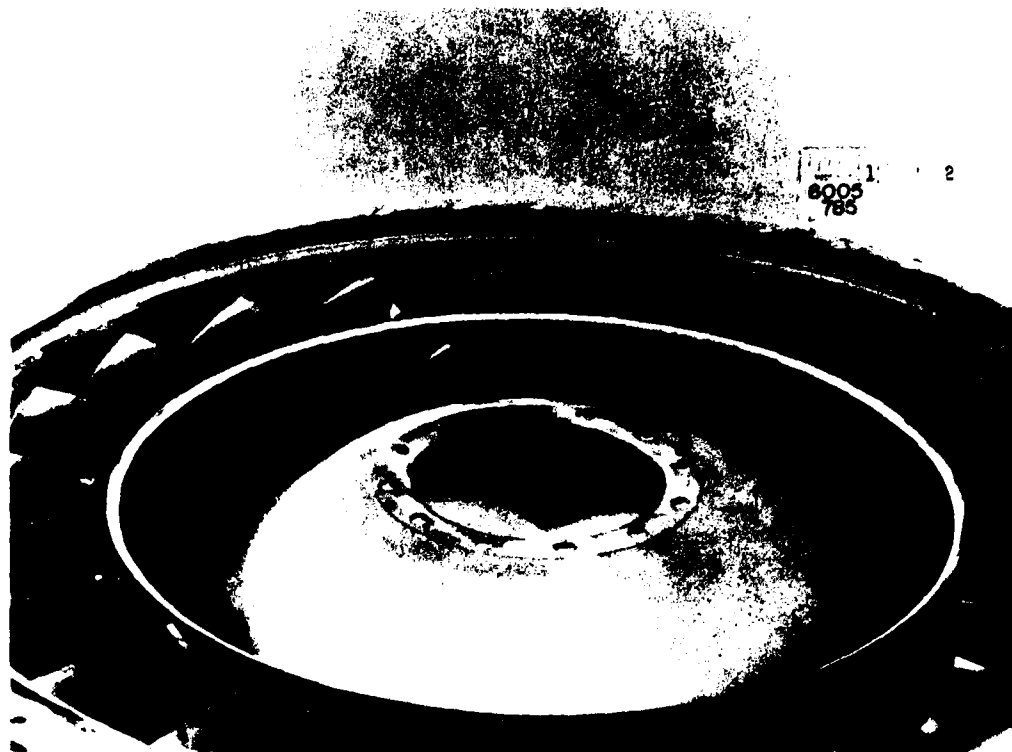
Figure 14. Damage sustained by the power turbine nozzle when the No. 4 bearing failed.

The nozzle was operated throughout the test. Because of the bearing failure, it was scuffed heavily by the power turbine (figure 14)

and was no longer serviceable. The nozzle was cracked in the outer-shroud vane brazements (figure 15). No cracks were evident on the inner shroud.

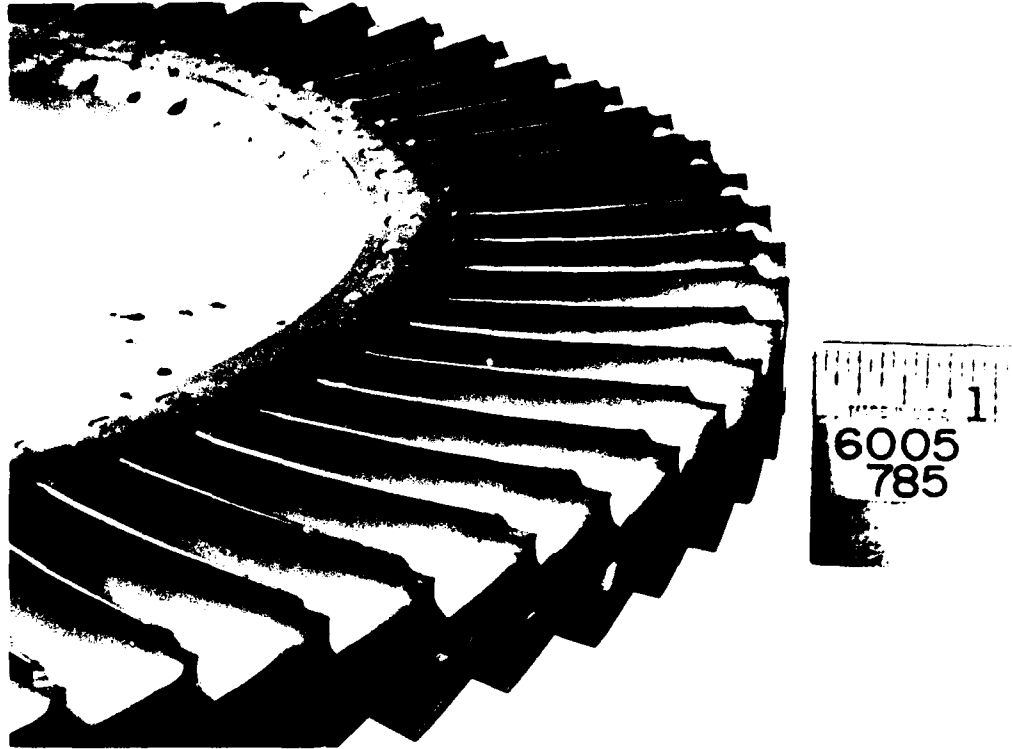
Figure 16. Damage sustained by the power turbine wheel when the No. 4 bearing failed.

The power turbine wheel was operated throughout the test. When the wheel moved forward during the bearing failure and contacted the power turbine nozzle, heavy scuffs were incurred at the disc face and the blade leading edges on the outer diameter (figure 16).

Tip clearance\* data were not valid because of the heavy scuffing incurred when the bearing failed. Therefore, suitability cannot be determined.

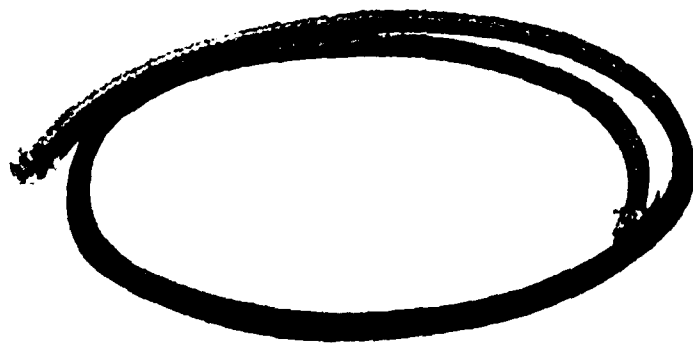
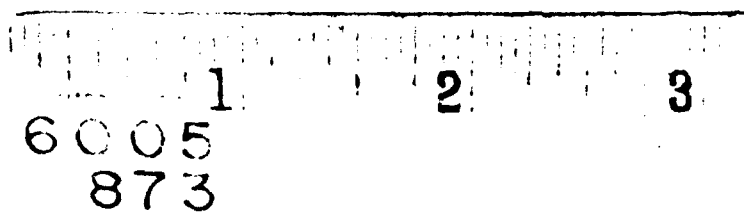
Figure 17. Asbestos air seal at the end of test.

The seal was in serviceable condition at the termination of the test (figure 17).

The air seal is suitable in that it did not require replacement during the test. The standard seal required replacement as often as each 300-hour hot-end inspection.
