NAVAL AIR ENGINEERING CENTER LAKEHURST N J ENGINEERIN--ETC F/G 1/5  
METALLURGICAL ANALYSIS OF ARRESTING GEAR DECK PENDANT FAILURES.(U)

NAEC-ENG 7910

METALLURGICAL ANALYSIS

ARRESTING GEAR DECK PENDANT FAILURES

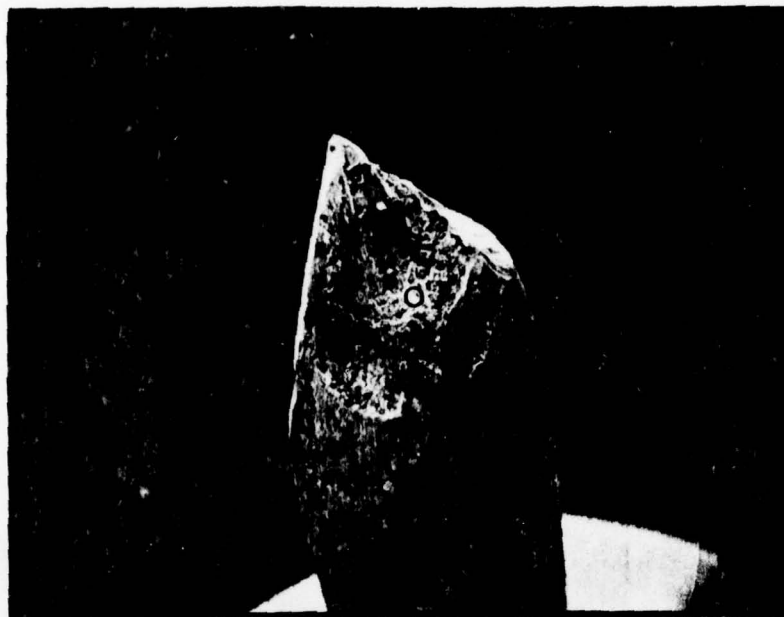
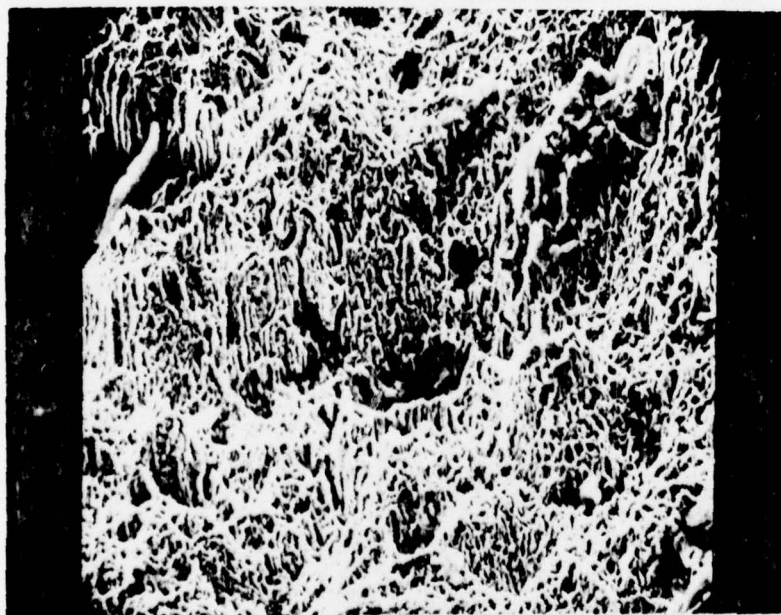
FIGURE 2

The fractures were of three basic types (four, if wires which show severe distortion as a result of damage after the cable fracture, are considered). These included, as the first two types, tensile cup-cone fractures and 45° shear failures, both of which are found in any severe tensile overload tests of wire rope. (see figures 2, 3). These failures are expected for the wires which break after other wires have failed first for any special reason (such as fatigue in the case of purchase cable.) As such, they are the last wires to break in typical service, but are the effects rather than the cause of the failure.

SEM photograph of  
tensile fracture.  
Area contained within  
"O" is shown below.

SEM photograph of  
transgranular fracture  
indicative of an over-  
load failure.

Typical Tensile Fracture

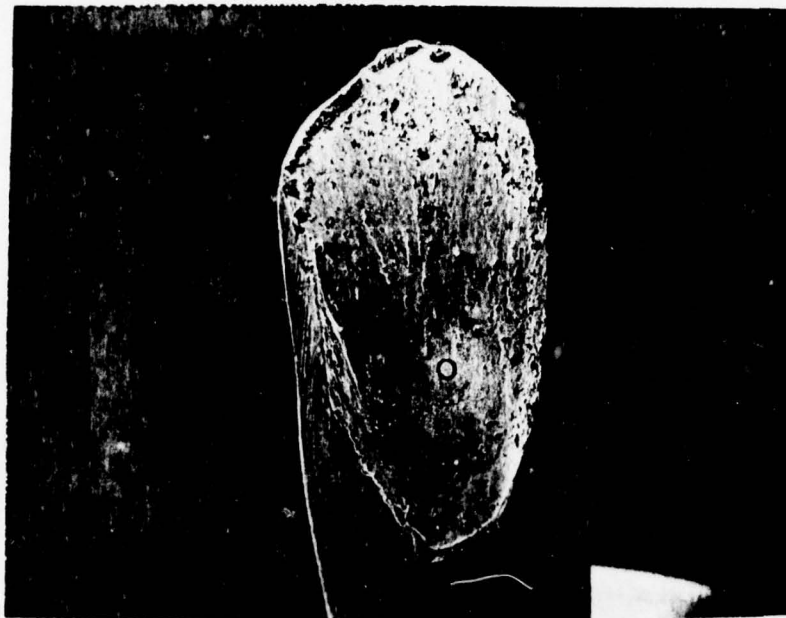
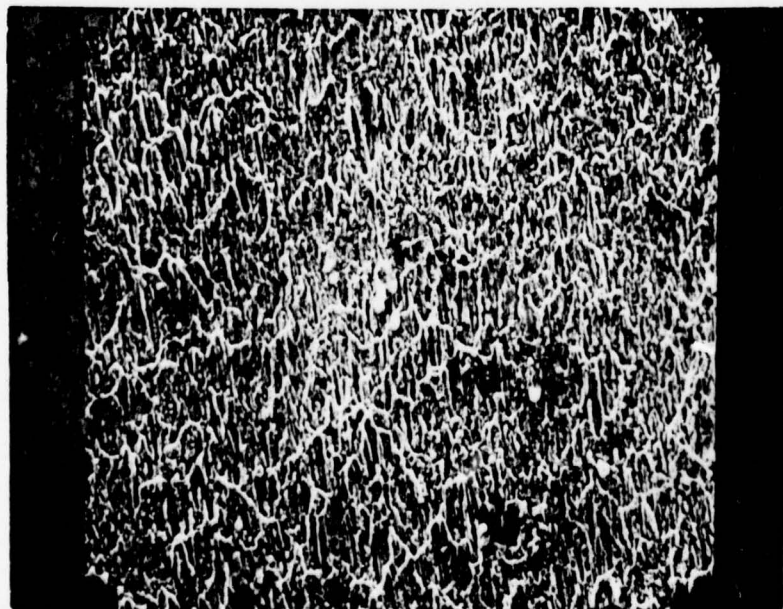
FIGURE 3

SEM photograph of  $45^{\circ}$  shear fracture. The area contained in "0" is shown below.

SEM photograph of transgranular fracture resulting from an overload failure.

Typical Shear Fracture

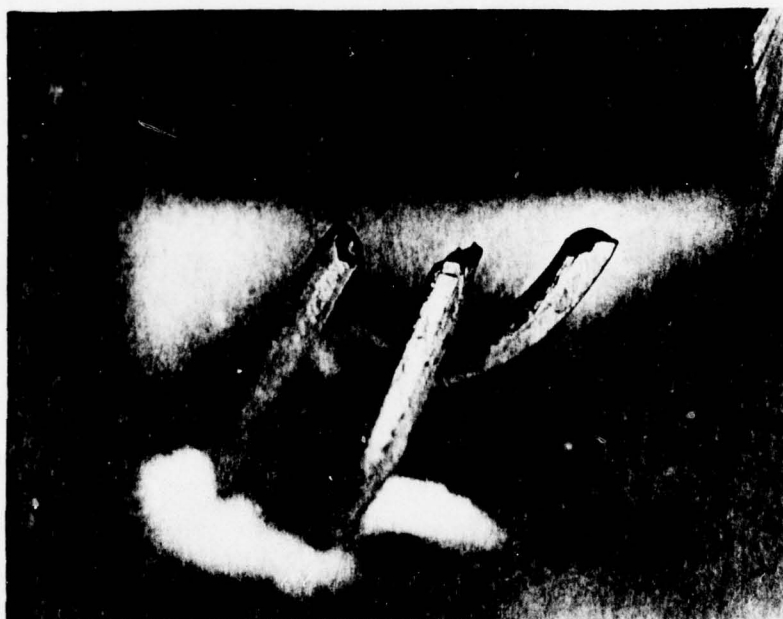
FIGURE 4

Samples from FDR failed cable showing heavy martensite layers and cracks.

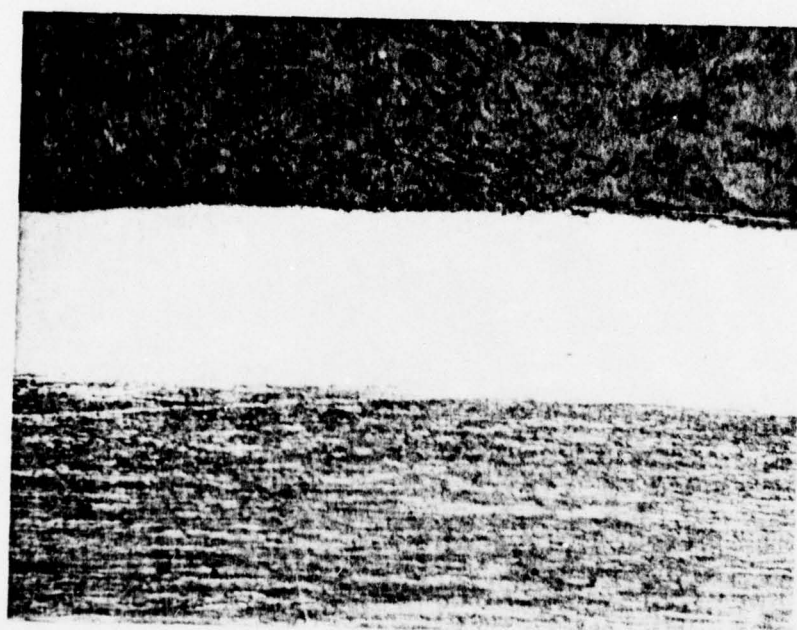
FIGURE 6

Typical layer of "white martensite"

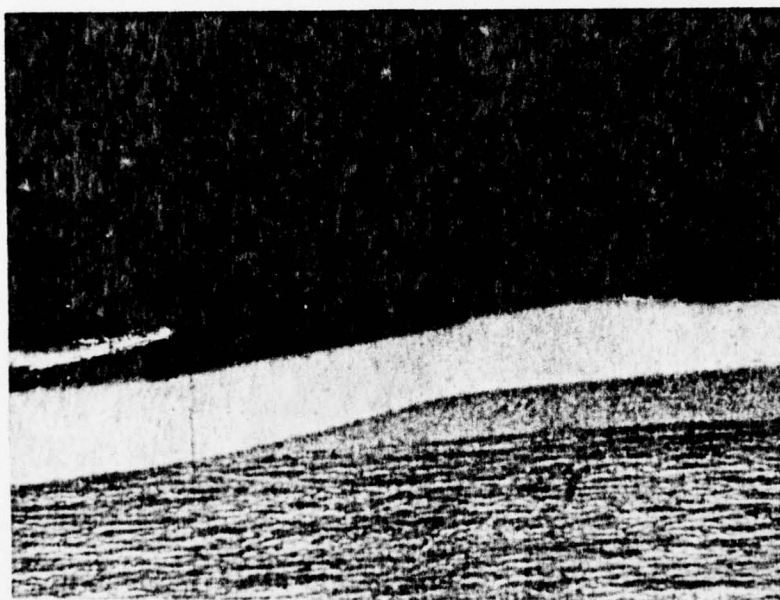
FIGURE 7

NOTE that maximum thickness has not been changed by second arrestment

Details of a multiple hit wire sample showing a freshly formed layer of "white martensite" on top of a tempered layer.

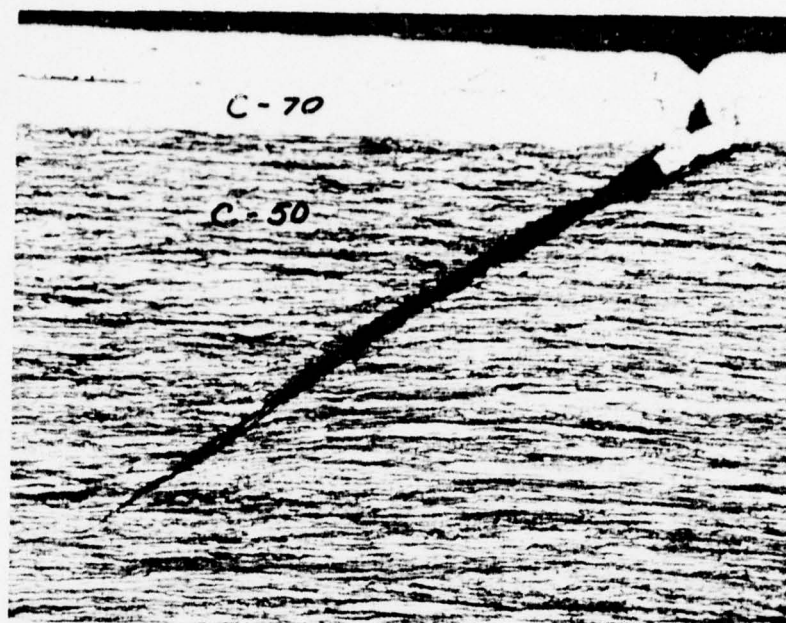
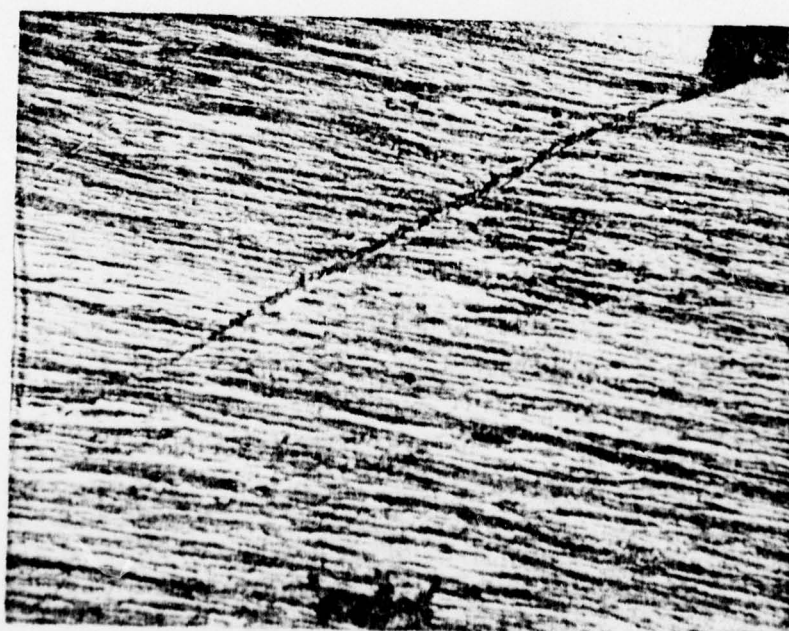
FIGURE 8

Details of martensite crack and resultant  $45^{\circ}$  shear in 2 FDR failed cable samples.

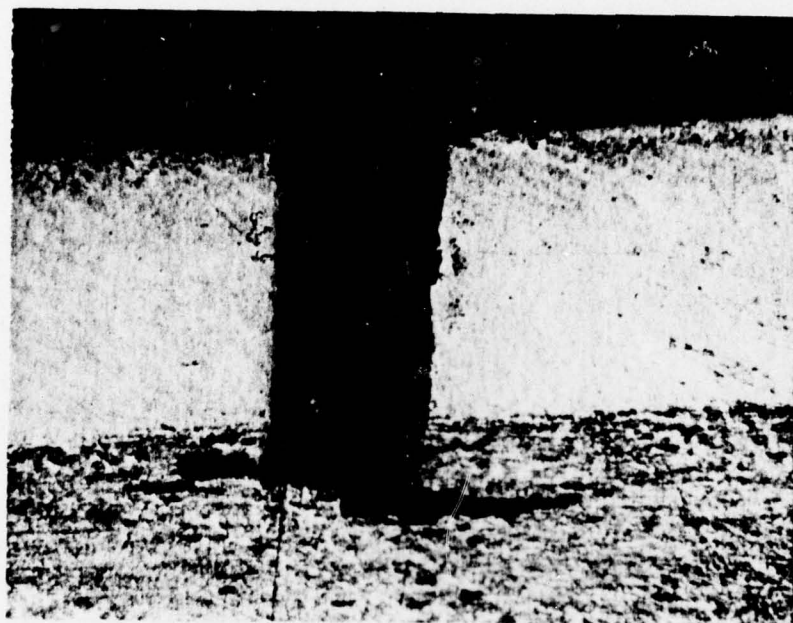
FIGURE 9

The preponderance of the irregular jagged fractures were found in three adjacent strands. It is believed that failure first occurred in these strands. In the opposite strands the wires exhibited mostly tensile and shear fractures. When martensitic-type surface layers were present in these strands, any perpendicular crack appeared to stop as it extended into the base metal. The cracks would tend to "blunt out" as they entered the base metal. (See figure 9).

NOTE how crack  
propagation stops after  
slightly penetrating  
base metal

Details of a Blunted Crack

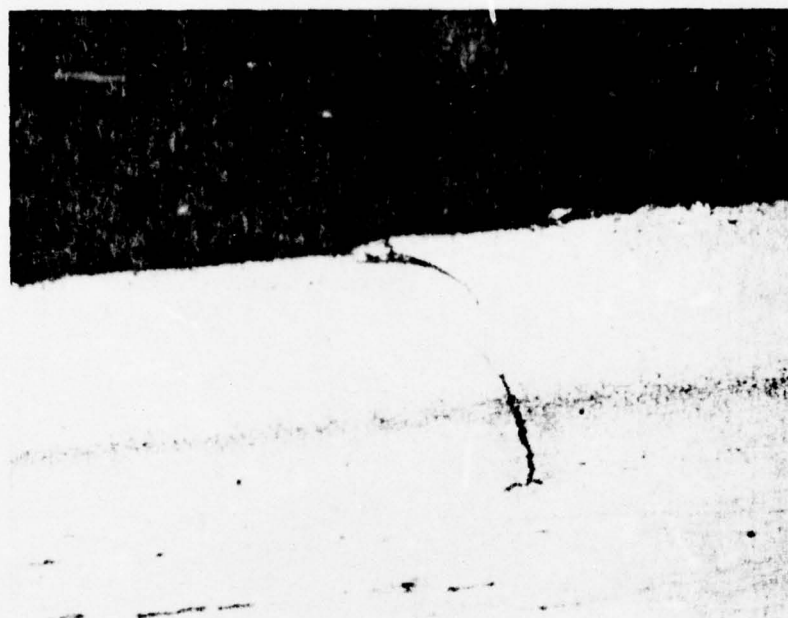
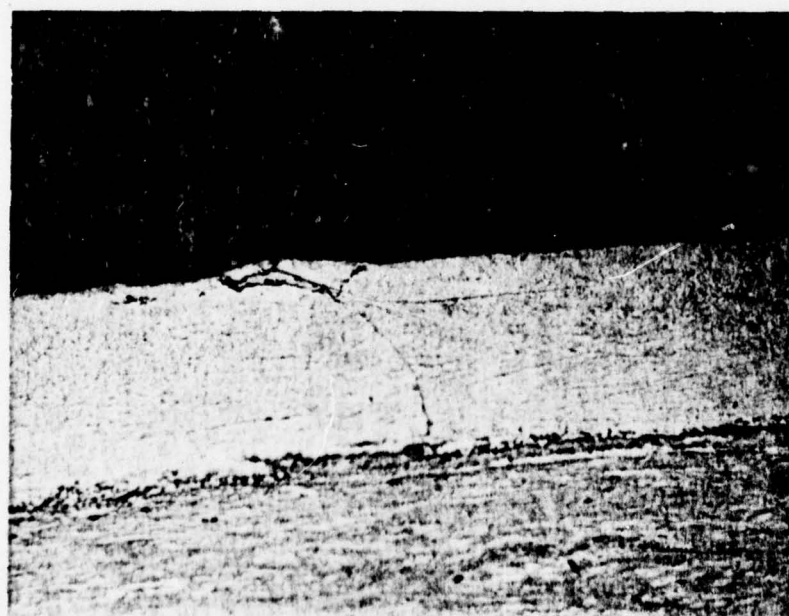
FIGURE 10

with a "bad" hook point; with 5 - 7 arrestments made with a "new" hook point, cracks found in samples taken from the RALS tests show a curved crack. (Figure 10).

Details of the spalling type crack found in NATF (RALS Site) wire specimens.

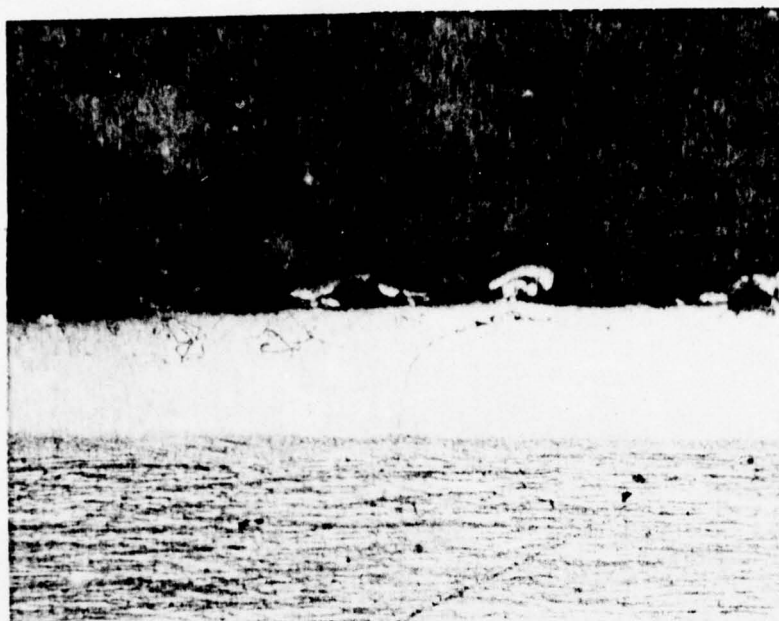
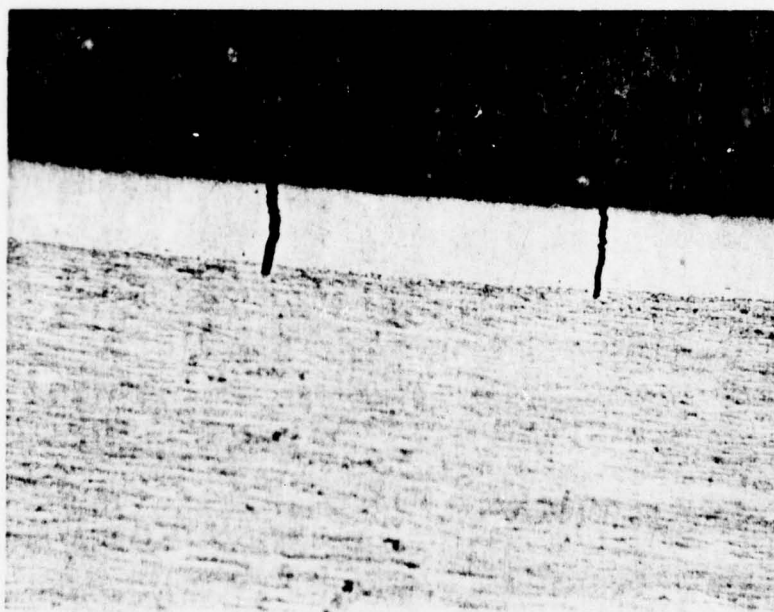
FIGURE 11

Cable exposed to 22 arrestments with a "good" hook point exhibited both straight and curved cracks (See figure 11). It can not be stated whether or not the earlier appearance of the straight horizontal cracks were a result of the use of the sharp edged hook point, or merely the result of material containing martensitic-type surface layers having been bent in tension earlier in this one cable than in others. Note that in the single arrestment in which the sharp edged hook broke 11 wires, a heavy martensitic-type layer was found, but no cracks were observed (See figure 12).

Details of both straight and curved type cracks found in RALS test cable with 22 hits and good hookpoint.

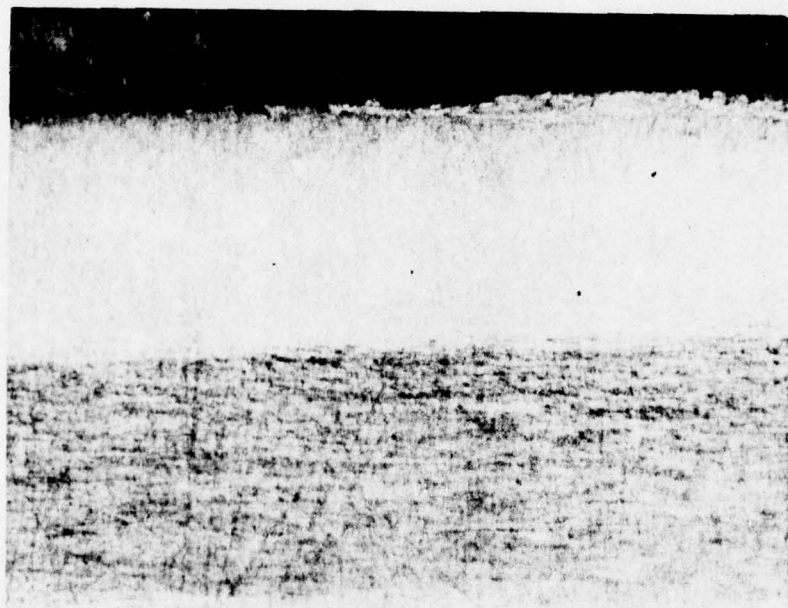
FIGURE 12

NOTE thickness of  
"martensite" layer.

Details of wire sample from the FDR cable with only one arrestment which sustained heavy damage (11 broken wires)

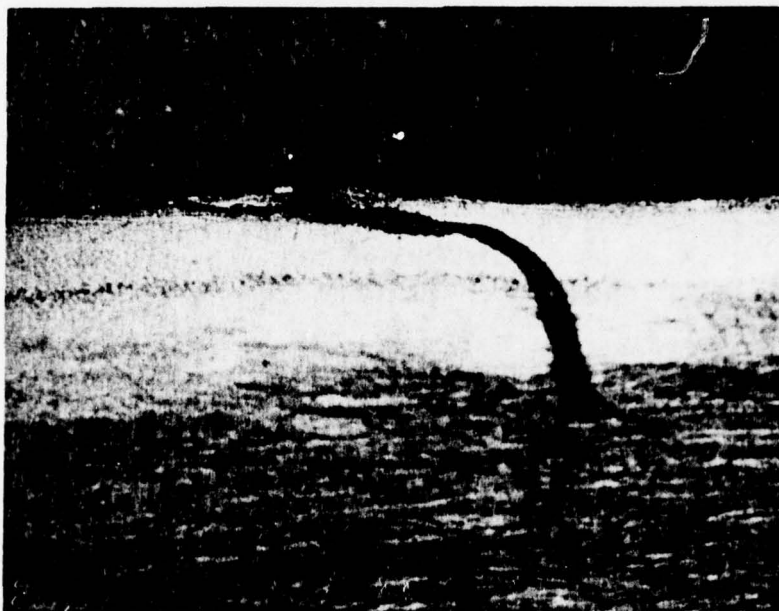
FIGURE 13

Here, one of the two major significant differences between the FDR failed cables and the individual broken wires from the simulation tests were observed. Except for the fractured wires in the last test cable (discussed later) all the individual broken wires in the simulated RALS tests showed the curved type cracks in the martensitic-like layers (See figure 13).

Typical spalling crack found in NATF (RALS Site) test cables.

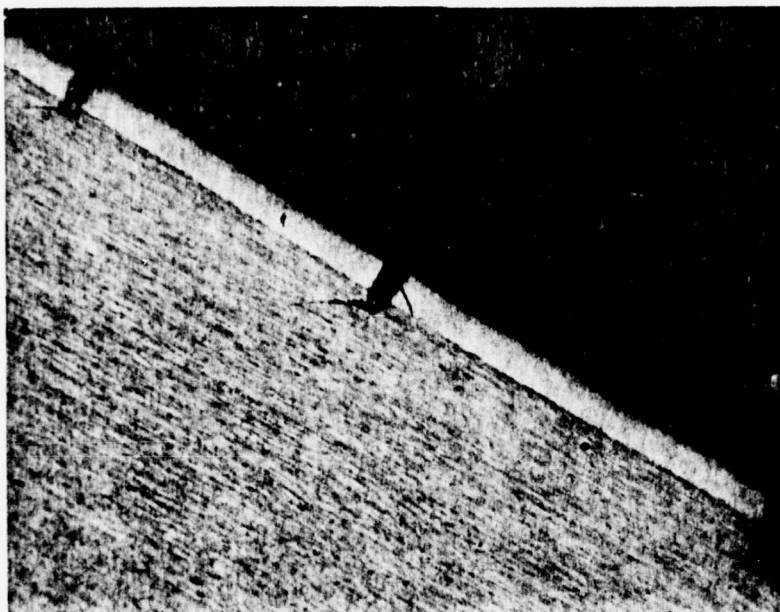
FIGURE 14

Wires opposite direct  
hook slide.

Cracks formed in wires rubbed by hook point vs. cracks in wires opposite  
hook slide.

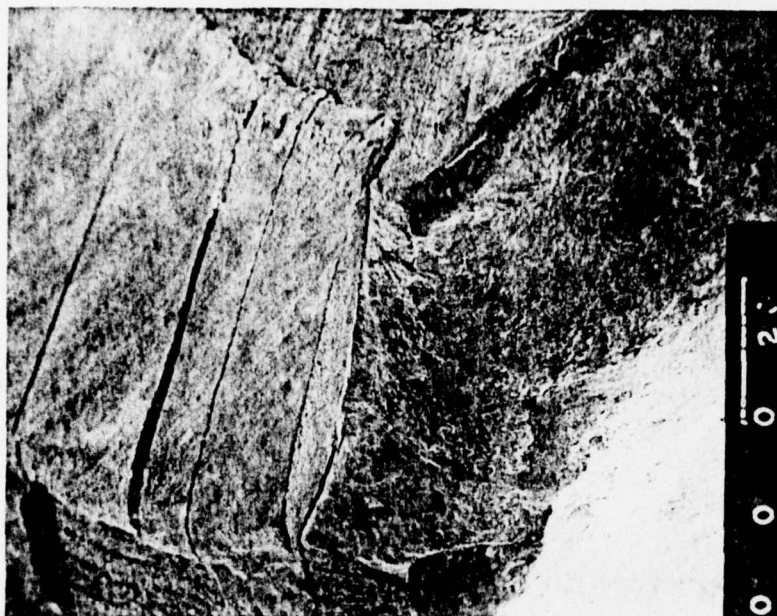
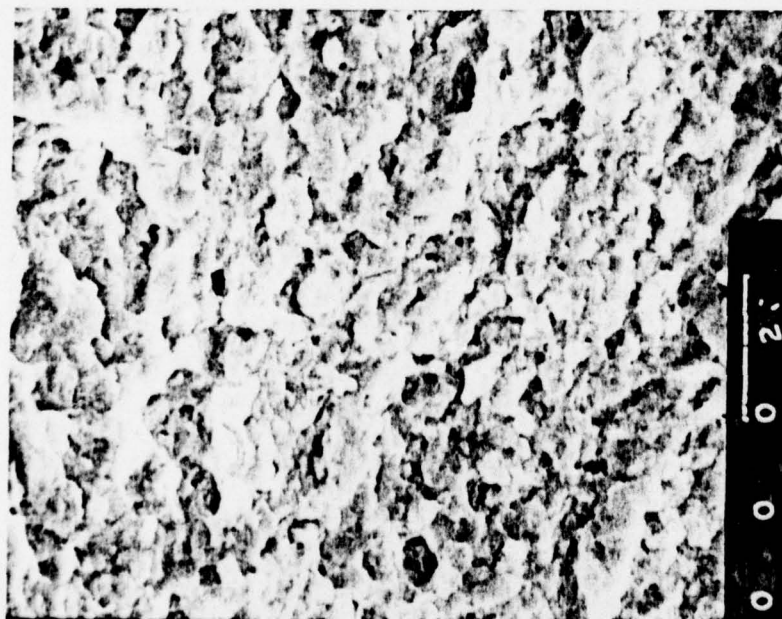
FIGURE 15

NOTE Transverse cracks

NOTE Fine celled structure

Details of cracks in "martensite" layer

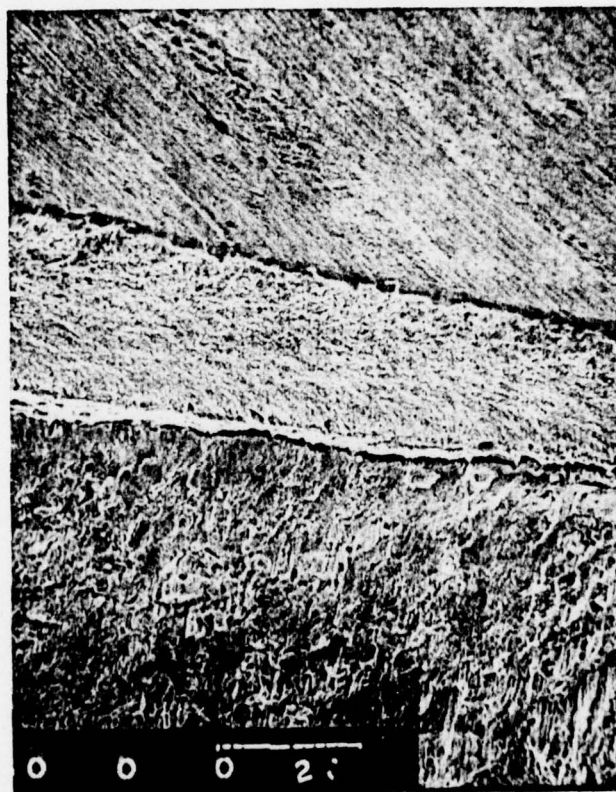
NOTE Martensite layer  
at top and center, and  
ductile shearing  
below.

"White martensite" induced fracture.

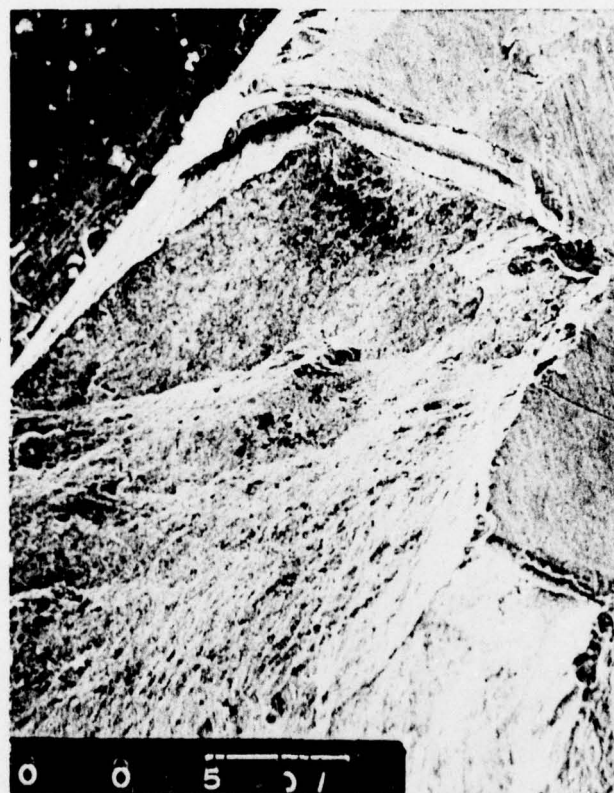
FIGURE 17

NOTE smear at upper  
right hand corner

Typical individual wire fracture (type which occurs at a rate of one or two per arrestment).

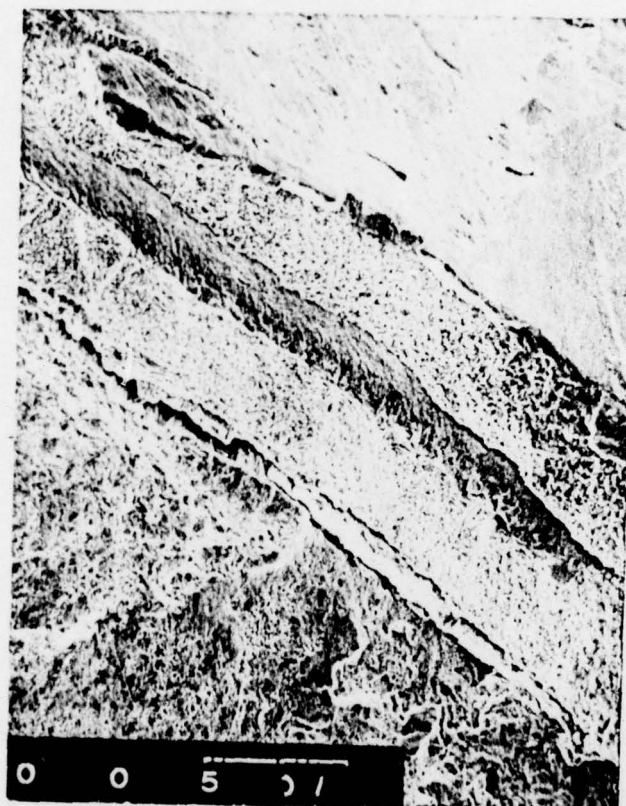
FIGURE 18

NOTE double layer of  
"white martensite" caused  
by additional hook  
abrasion

Enlargement of Figure 17

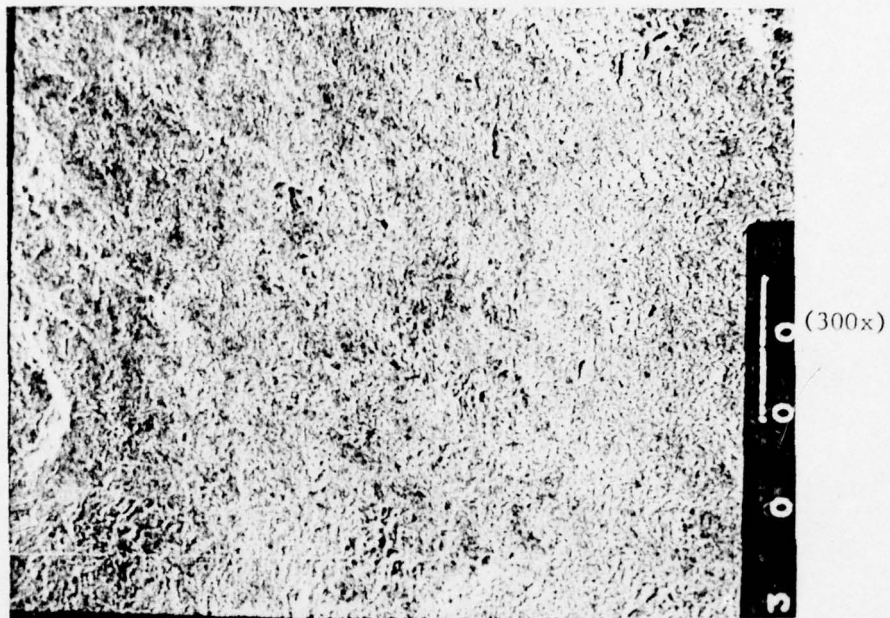
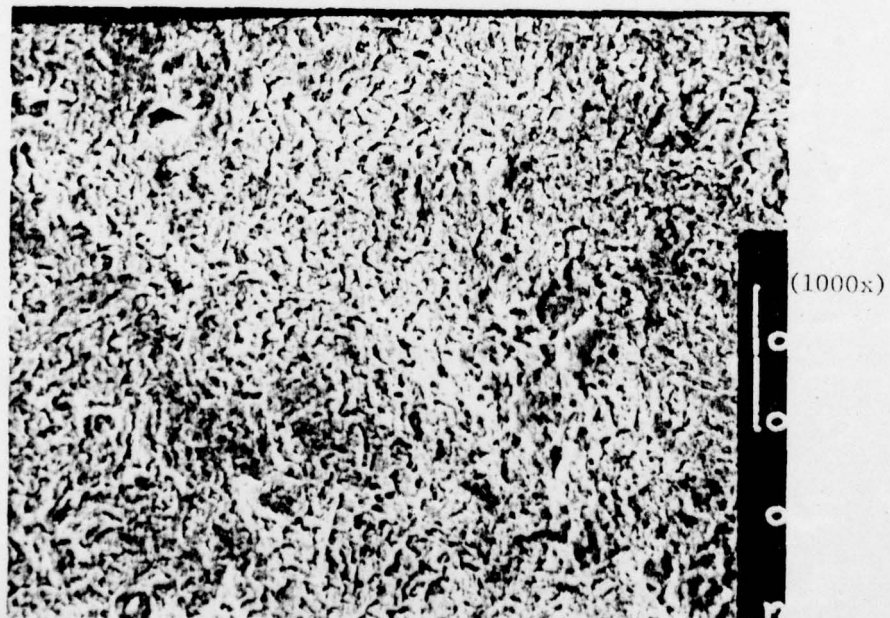
FIGURE 19

Individual wire fracture illustrating apparent fatigue structure.

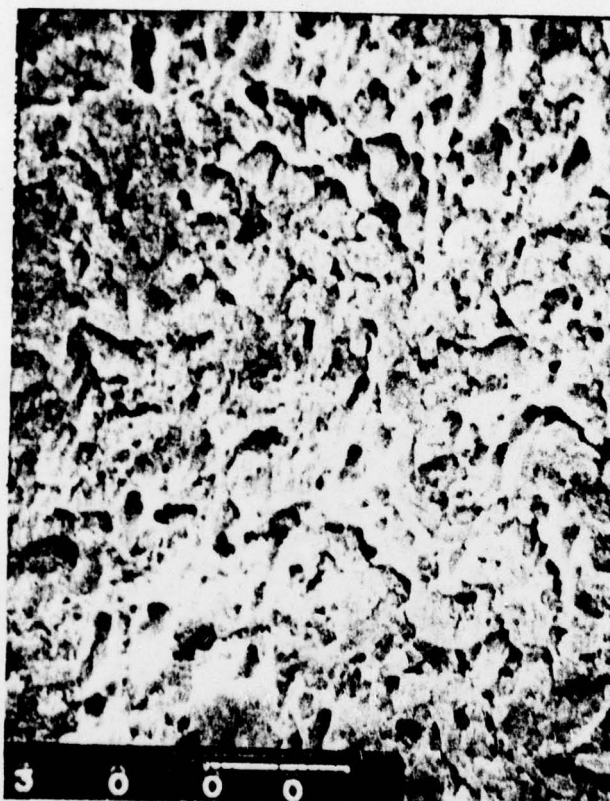
FIGURE 20

NOTE that higher magnification reveals fatigue appearing structure is actually ductile.

Same as Figure 19 except at higher magnification.

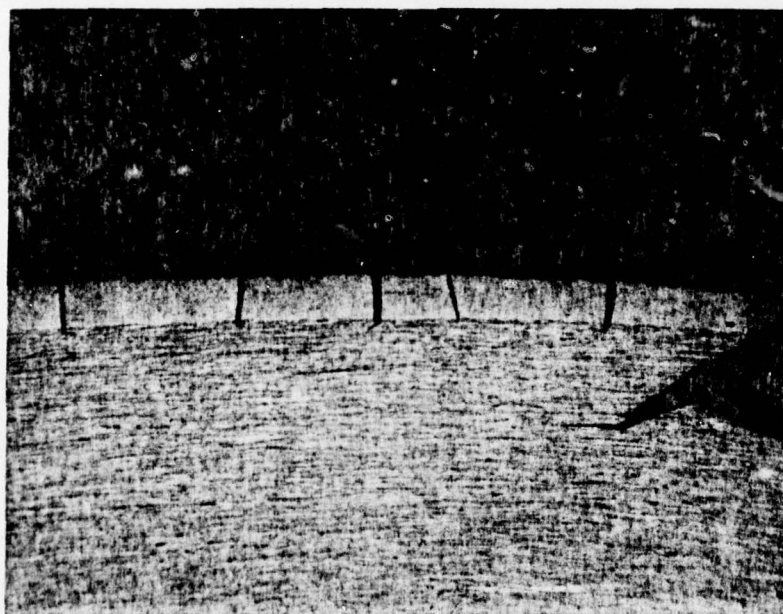
FIGURE 21

Horizontal cracks found in FDR failed cable wire fractures when "white martensite" was involved.

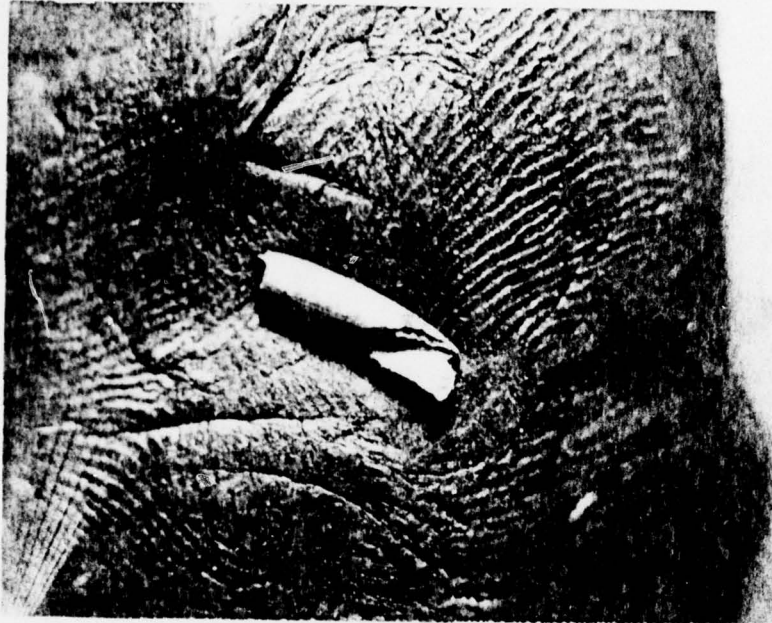
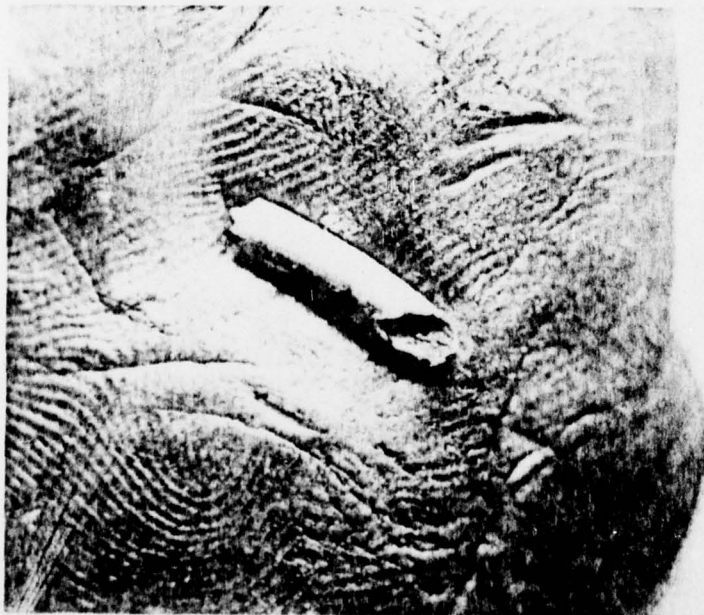
FIGURE 22

Severe notching found on TK #1 test cable which failed on first arrestment.

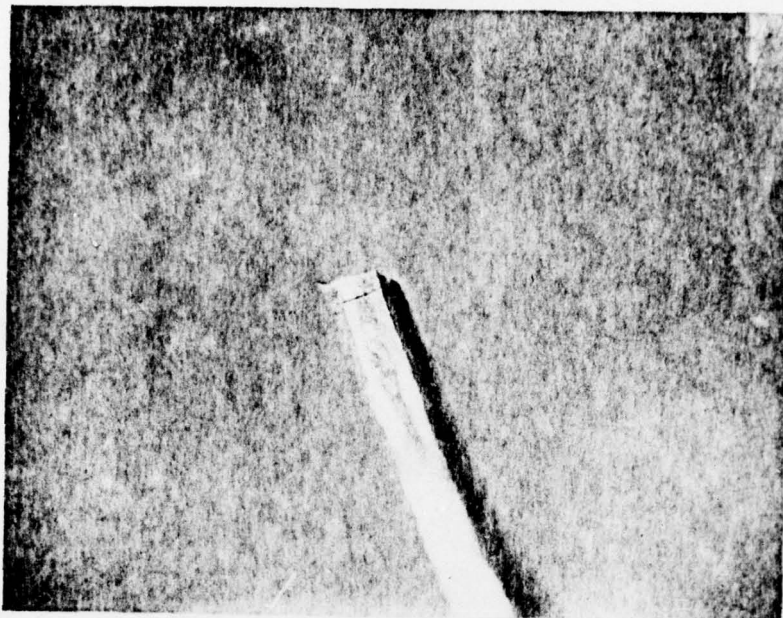
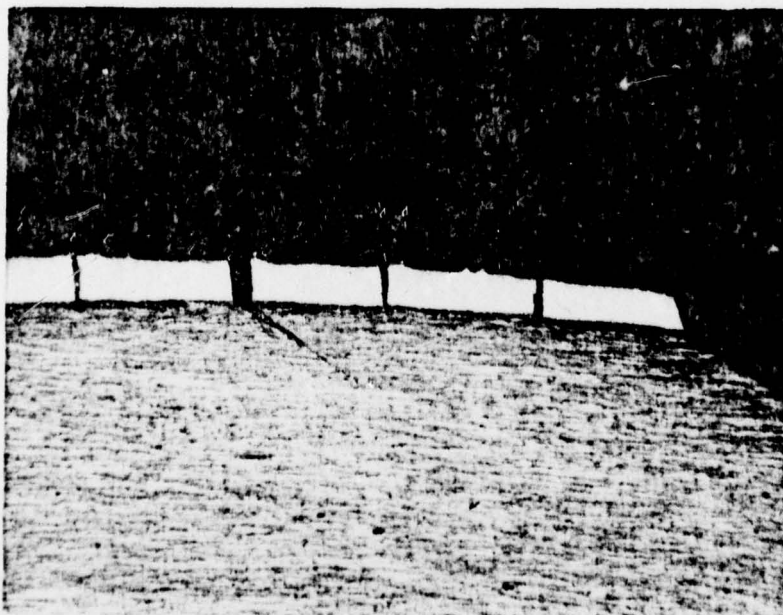
FIGURE 23

Martensitic-type smear induced fractures found on some RALS site test cables.

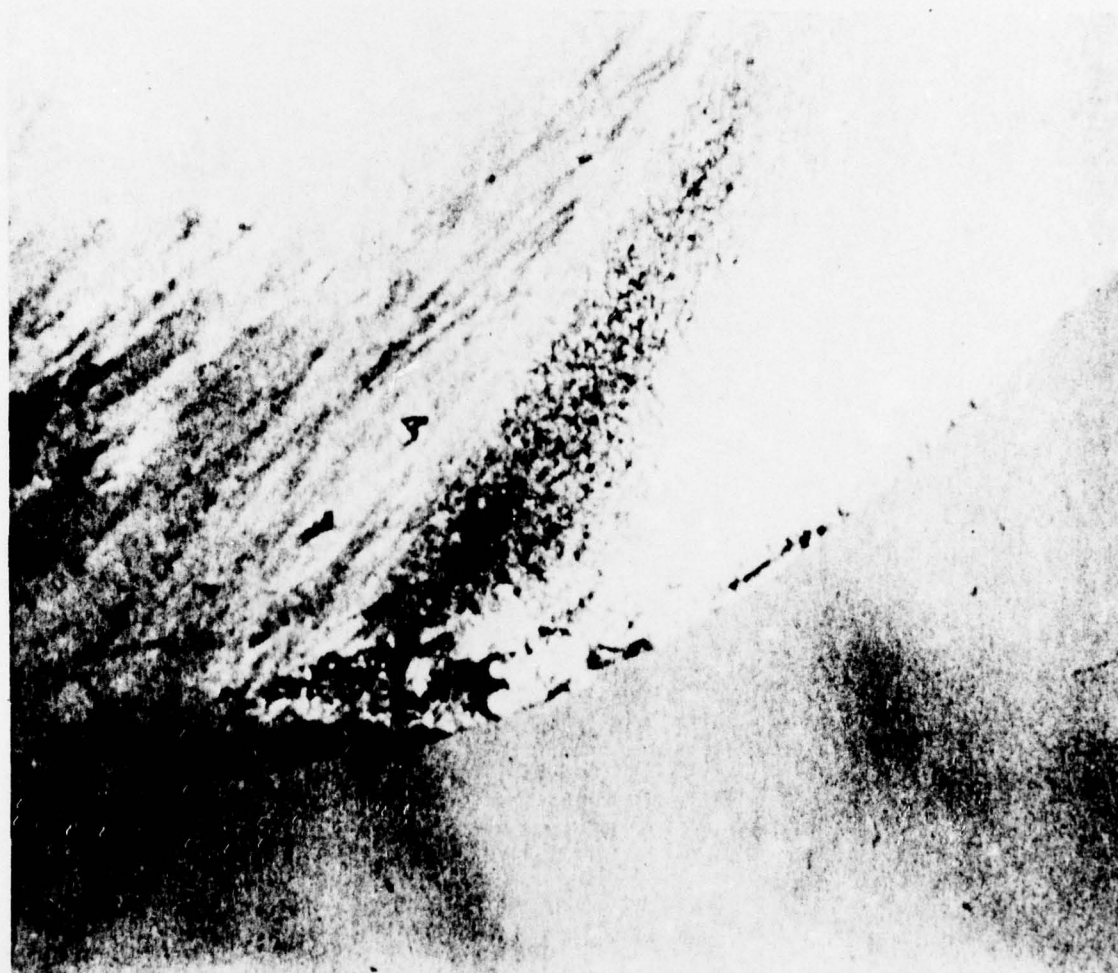
FIGURE 24

View of damaged area along the toe of the hookpoint involved with the FDR Cross Deck Pendant failure.

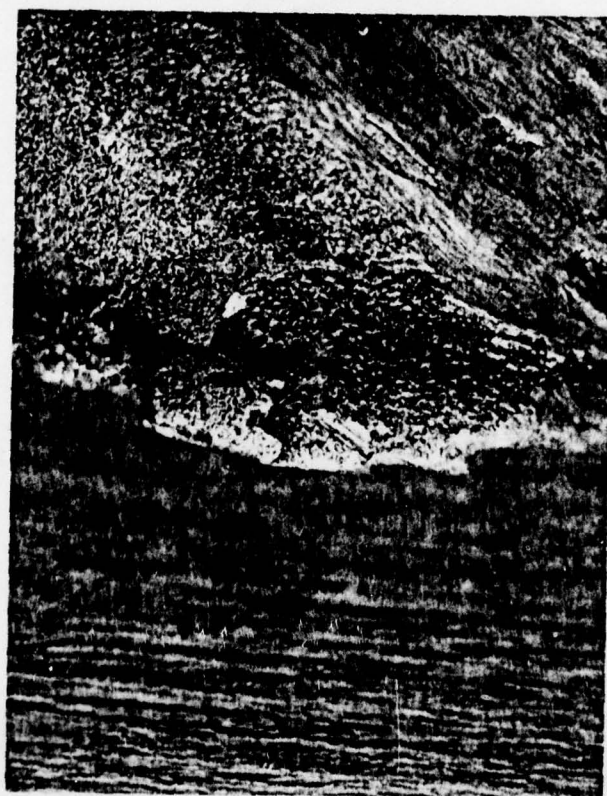
FIGURE 25

NOTE wire mark on  
base metal.

Close-up view of damaged area in Figure 24.

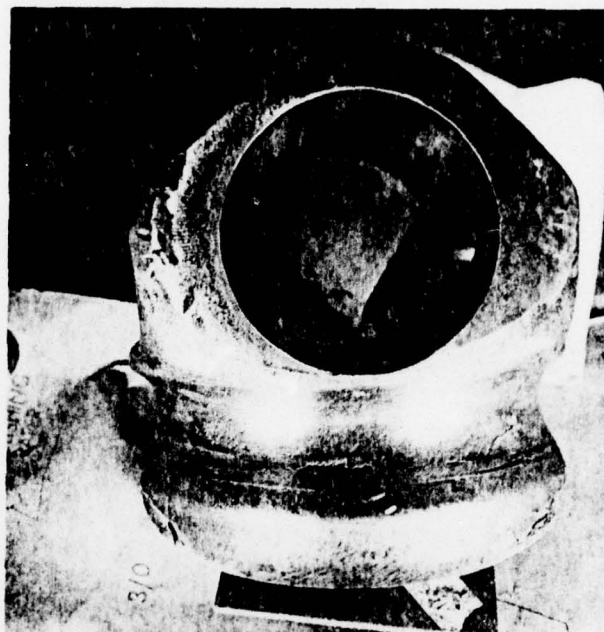
FIGURE 26

Overall view (above) and closeup of Damage sustained by hook point  
(Serial #9550)
