ICE BUOY DEMONSTRATION PROGRAM

Kenneth R. Bitting

June 1975

Final Report

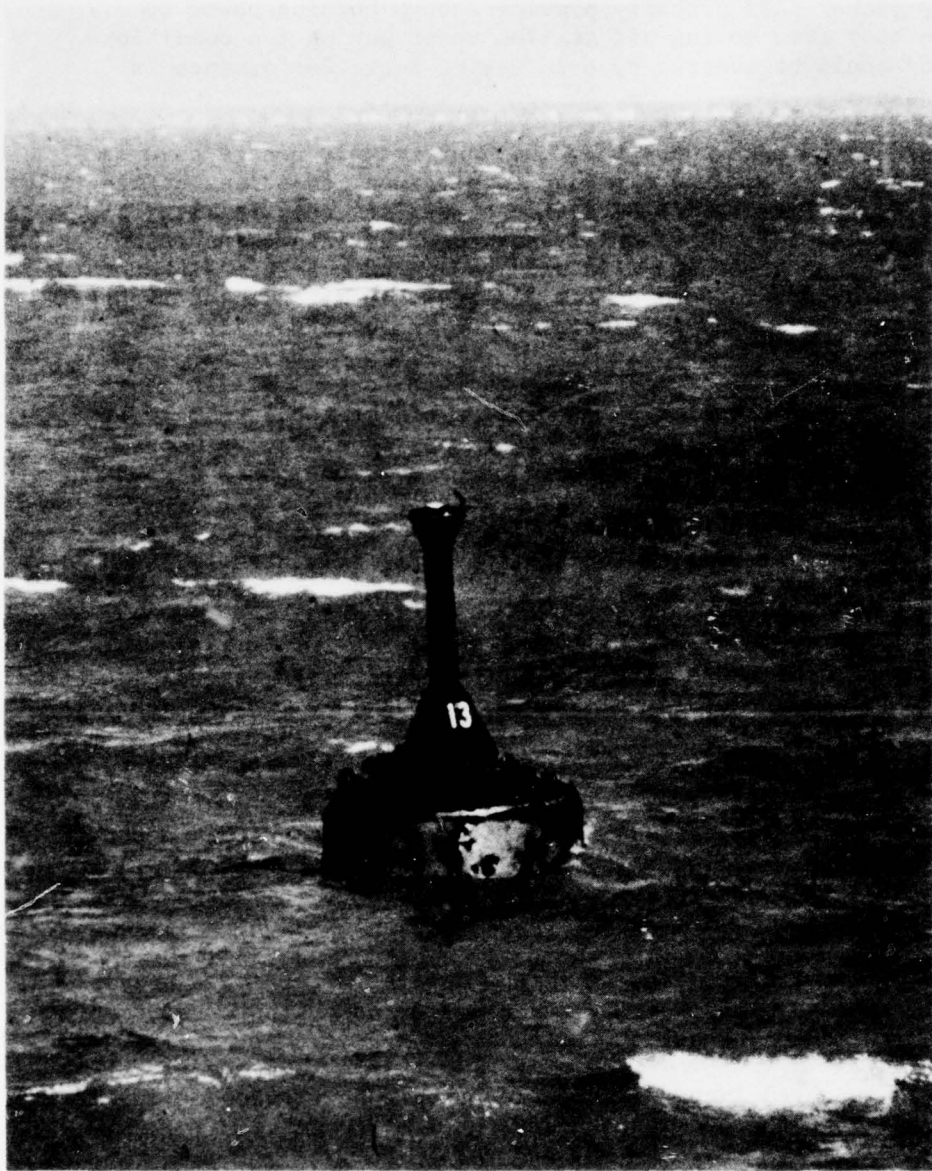
These buoys are submerged by eight to ten inches of moving ice. Lanterns are generally lost (Figure 1), and the battery pockets have been ripped open and flooded on occasion (Figure 2). On some areas of the hull, paint was scraped off to the primer or bare metal. Reports from mariners indicate that the buoy can be more difficult to identify if the ice scrapes off the red paint and reveals the dark primer. The characteristic color, therefore, changes. The deep hull of the 9x32 ice buoy presents a large vertical surface to the ice. As the ice pressure increases, the buoy lays over and the hull submerges until just the lantern and pole are above the ice (Figure 3). In thin ice (six to eight inches thick) this appears to be the stable position. In thicker ice (eight to ten inches) the ice force on the hull is too great and the pole and lantern go under the ice. The advantage of the 9x32 and 9x38 buoys is a large reserve buoyancy (16,000 pounds).

Figure 1. 9x32 ice buoy with lantern and paint damage  
(Lake St. Clair LB13 - FY74).

(5) Improved lantern protection should be provided to eliminate lantern damage when the buoy goes under the ice.

(7) The buoy hull paint primer should be the same color as the paint.

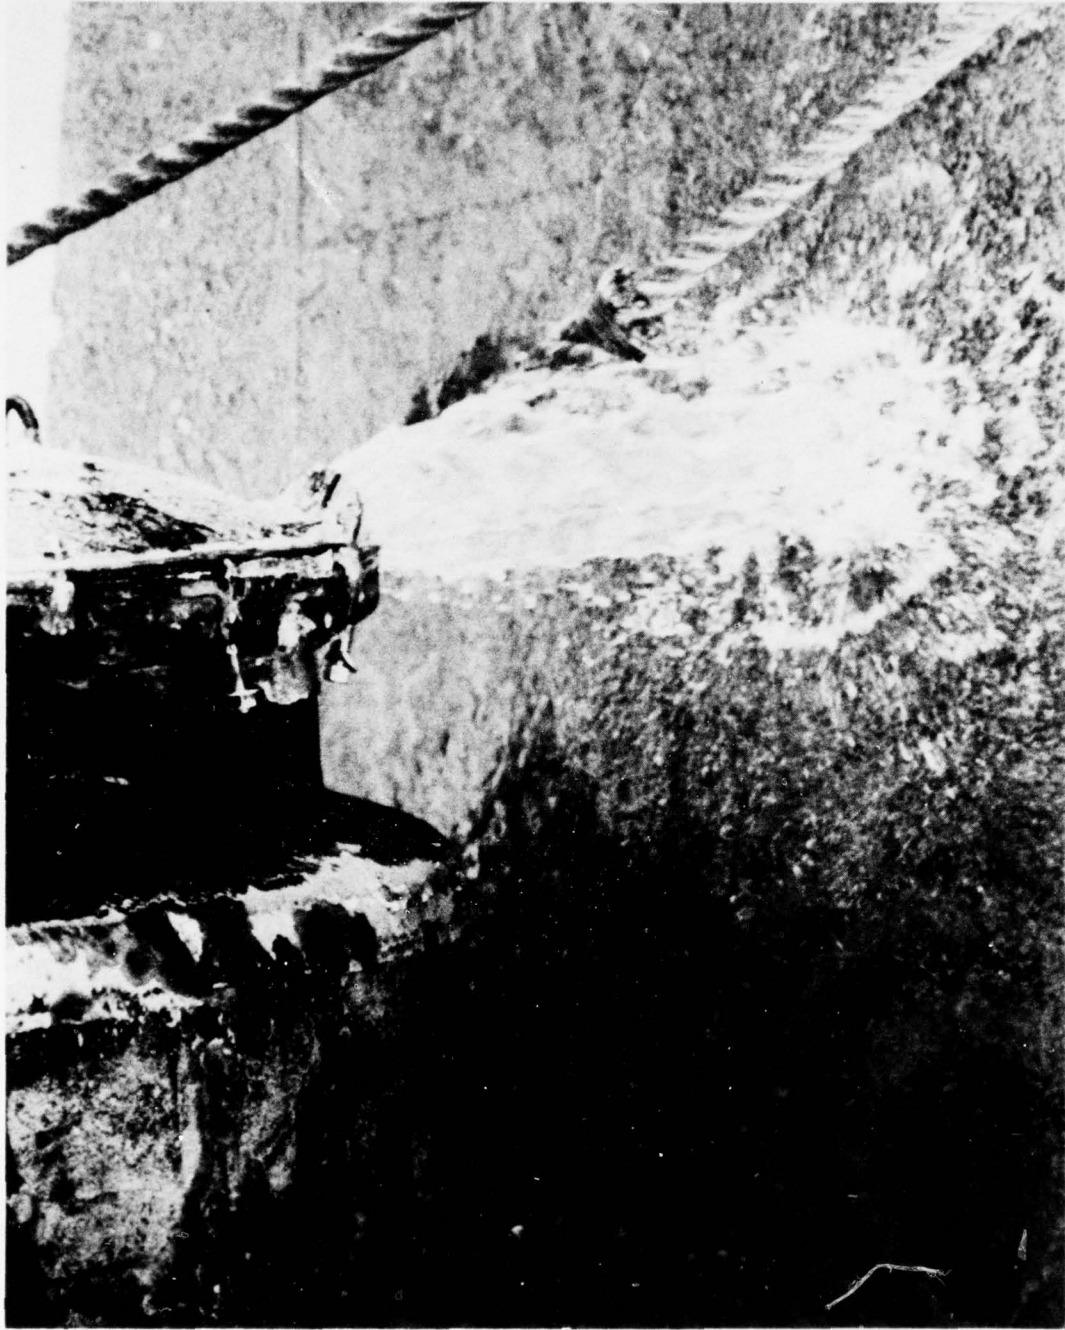
Figure 2. Battery pocket damage on 9x32 ice buoy  
(East Outer Channel LBI - FY74).

(6) Battery pocket covers should be made flush with the hull if practicable.

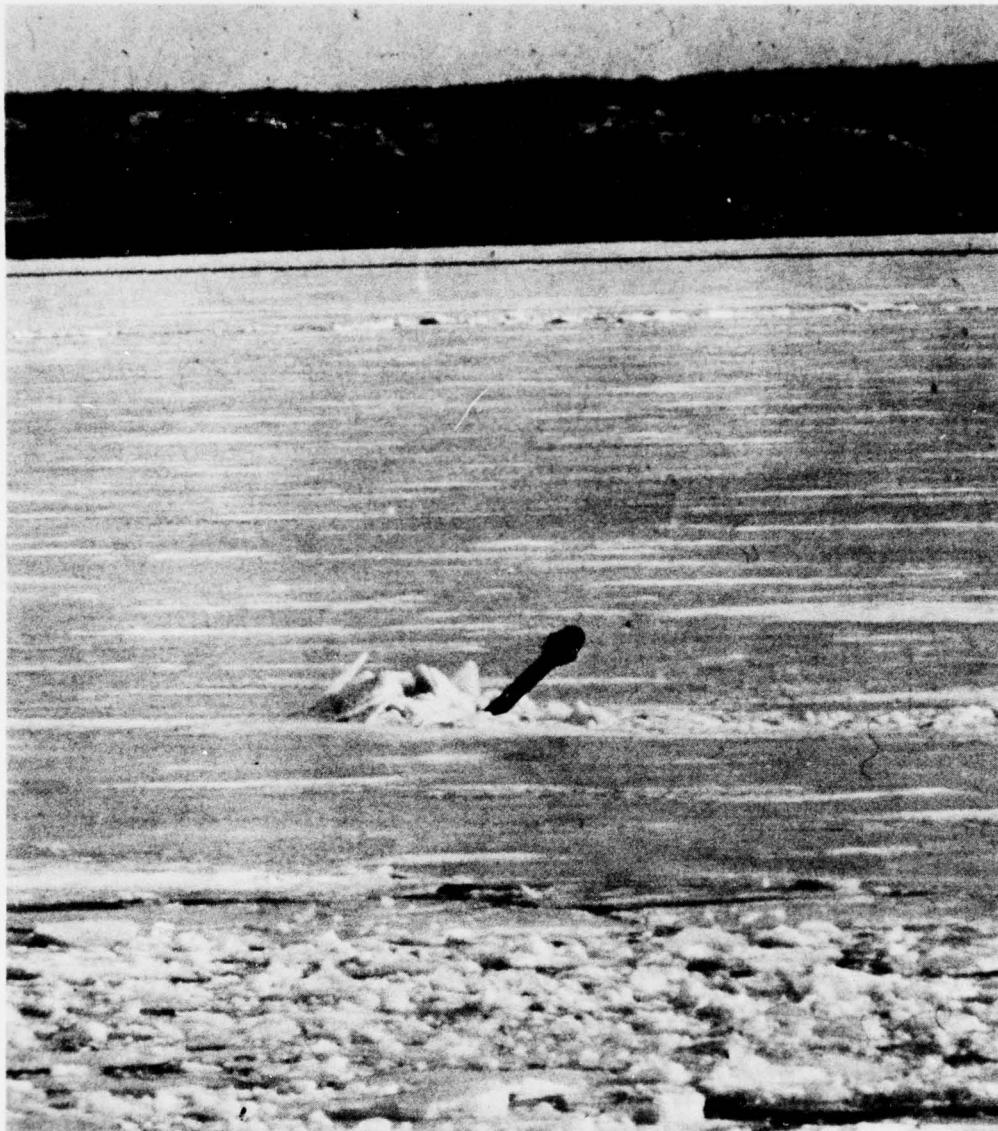
occasionally recorded mooring line tensions of 20,000 to 30,000 pounds. Figure 3 shows Round Island LB32 under approximately eight inches of moving ice. Tensiometer readings of 18,000 to 22,000 pounds were recorded during this period. Since the reserve buoyancy is 16,000 pounds and the angle of the lantern from the vertical has been measured (from photographs) at 45 to 55°, it is calculated that tensiometer readings in that range would indicate that the buoy hull may be under the water.

Figure 3. 9x38 ice buoy under 8 inches of moving ice  
(Round Island LB32 - FY74).

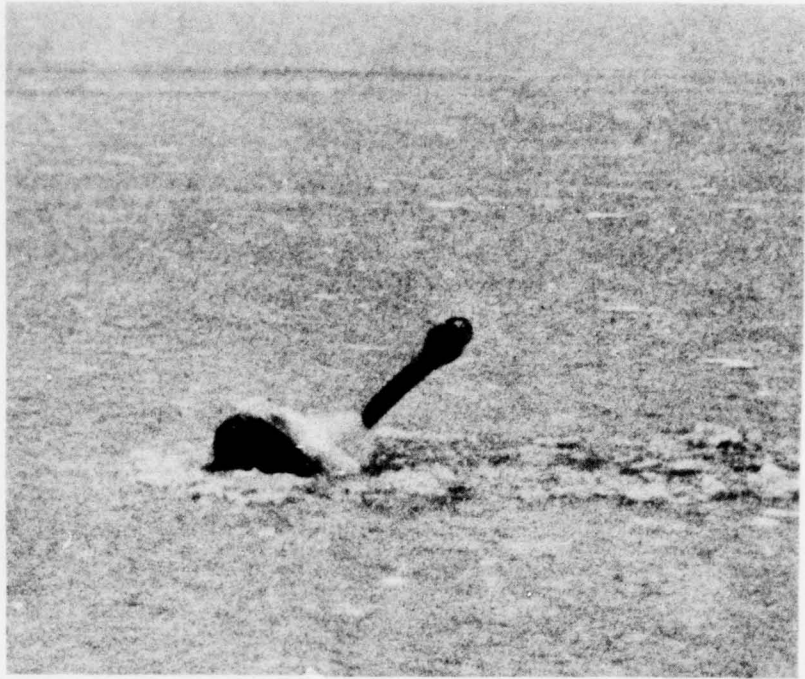
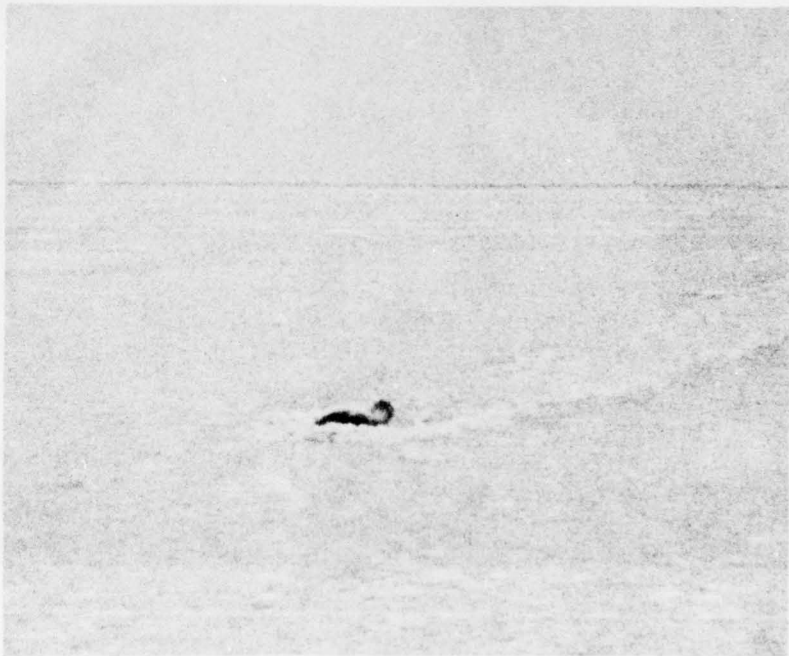
Photographs indicate that the 9x20 is overrun by ice that is approximately six inches thick. It appears to lack the ballast to compensate for the ice force on the hull. Figure 4(a) shows a 9x20 as photographed when it was abeam of a ship that was moving parallel to the ice flow. The buoy is listing approximately 45°. In Figure 4(b), looking back at the buoy after the ship passed, the buoy appears to be on its side. In a third frame (not shown), the buoy has disappeared and only the wake is visible. In Figure 5, ice has filled the lantern cage and snow covers the entire deck. A subsequent photo (not shown) shows the lantern destroyed but the cage undamaged.

Figure 4. 9x20 ice buoy under ice.

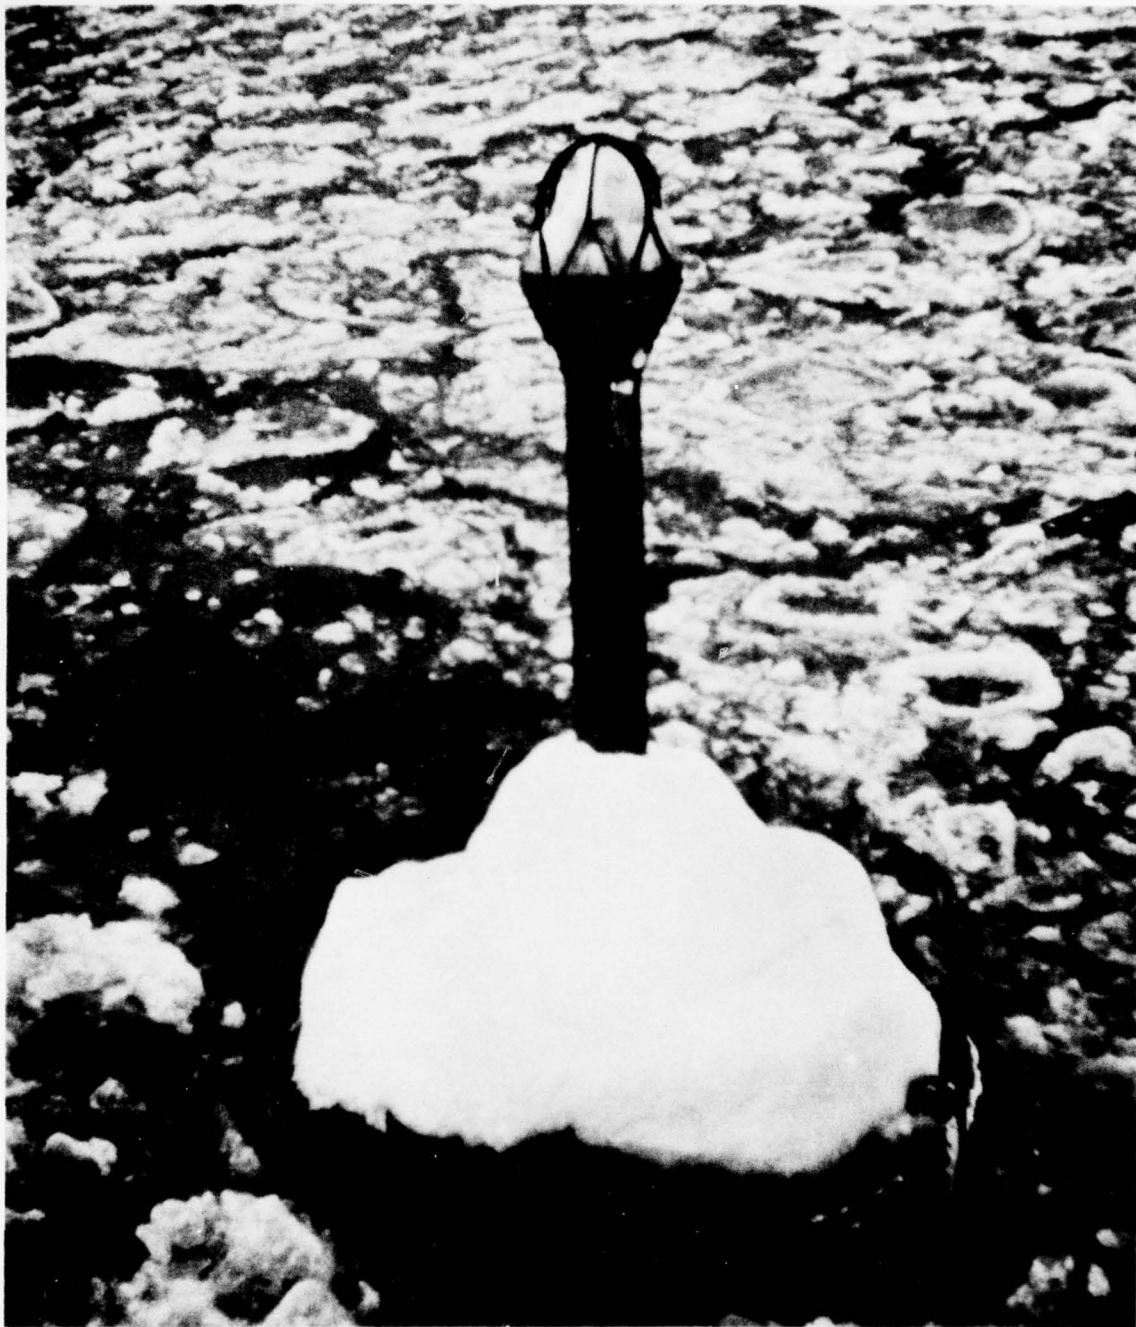
Figure 5. 9x20 ice buoy with ice in lantern case.

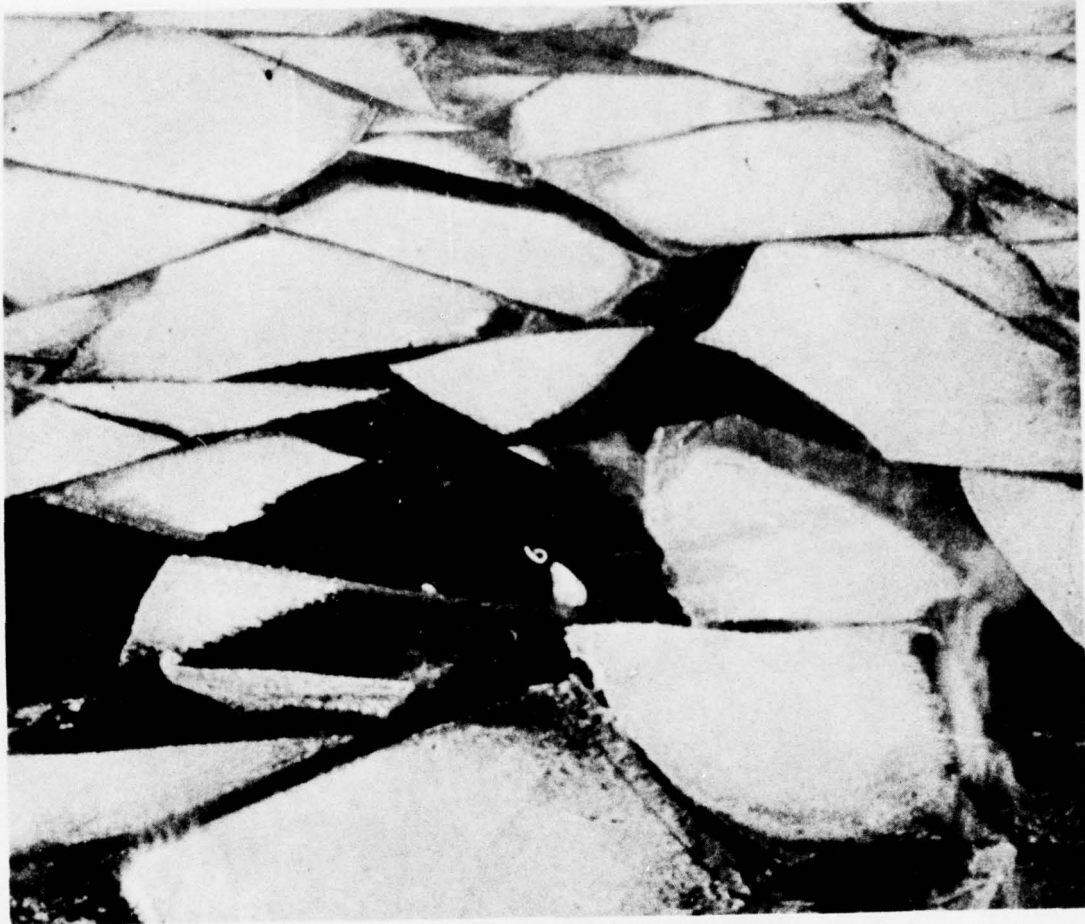
Before ice forms on the river, 5x18 buoys have been observed floating horizontally with large quantities of spray ice on the upper portion (Figure 6). The 5x18 is submerged by four to six inches of ice (Figure 7), and the lantern is generally broken. It has been observed upright in as much as fourteen inches of ice, however. One buoy was under the ice in the St. Lawrence Seaway for 45 days and was functioning upon recovery.

Figure 7. 5x18 ice buoy in 6 inches of moving ice.

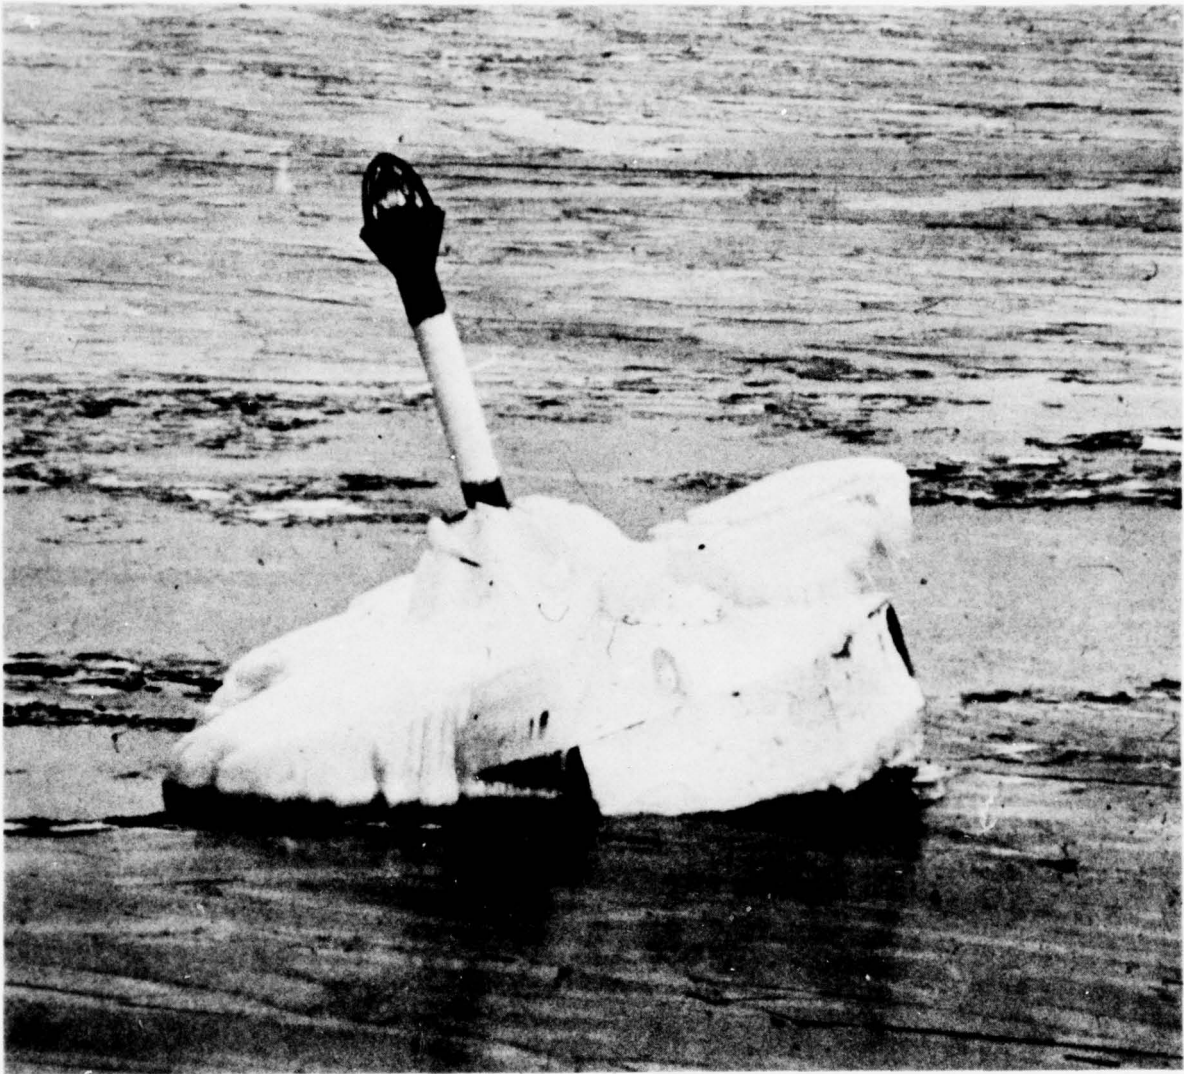
During FY73 and FY74, this buoy was deployed in locations where moderate ice conditions were encountered. Approximately twelve inches of ice and snow collected on the deck causing the buoy to list approximately 15° (Figure 8). During FY75, it was deployed at East Outer Channel LBI (Detroit), where it was exposed to thick and fast-moving ice. The buoy functioned well at this location except for one notable exception. In January 1975, the buoy was reported 1000 yards from charted position. The bottom is reported on charts and Simplified Aids-to-Navigation Data System (SANDS) reports as clay and soft, respectively. The anchor is assumed to have been silted in. The buoy deck was reported to be so covered with ice and snow that it caused the buoy to list approximately 80°. The light was approximately one foot from the ice. It is theorized that, with the buoy listing so badly, the large flat bottom presented a large area to the ice, allowing for high ice forces. The buoy may have been dragged across the anchor, causing the anchor to tumble out. At that time, the ice thickness was two to five inches with rafting up to two feet. The buoy was reset using the original 9000-pound STATO anchor and 12,750-pound concrete sinker plus a 10,000-pound ship's anchor. The original mooring had been in place from 22 December 1973 to 23 January 1975, although previous ice buoys had been attached to it.

Figure 8. 16-foot-diameter octagonal ice buoy with ice and snow on deck (Detour Reef Light Station - FY74)
