LABORATORY TEST AND EVALUATION OF A GRAPHITE EPOXY AIRCRAFT WHEEL

MECHANICAL BRANCH VEHICLE EQUIPMENT DIVISION

JUNE 1976

TECHNICAL REPORT AFFDL-TR-76-54 FINAL REPORT FOR PERIOD JULY 1972 - JULY 1975

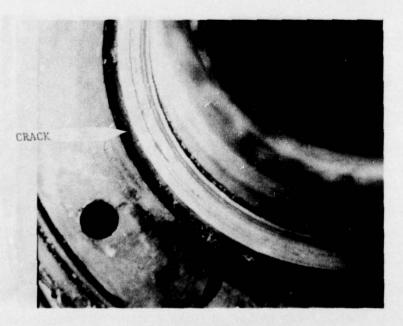
Figure 23. Crack in Composite Near AL Hub

At 260 miles into the straight slow roll test, several events occurred which delayed the tests. During a visual inspection of the wheel, crazing lines were discovered in the outer flange area near the bead seat. At this point the test was stopped and the wheel was disassembled. Figure 22 illustrates the wheel immediately after disassembly. A crack was discovered in the composite structure near the Al hub and this is shown in Figure 23.

This crack appeared to extend over approximately 120° of the circumference. Figure 23 also shows what appears to be graphite epoxy "chips" or shavings in the cavity near the base of the A1 hub. Figure 24 shows the graphite epoxy shavings on the opposite wheel half. This figure also shows what appears to be a wear area on this wheel half. The A1 hub (Figure 22) also was showing signs of wear. The explanation for the wear which occurred between the A1 hub and the composite structure will be discussed in subsequent paragraphs.

The crack was thoroughly examined under a stereo microscope with a magnification up to 50X. The depth of the crack could not be determined but the crack appeared to turn inward toward the hub. This crack did grow into a delamination which will be discussed later in the 1,000 mile inspection.

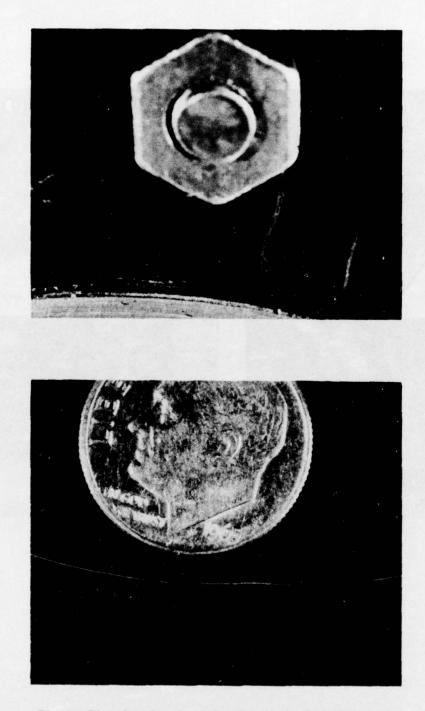
Figure 25. Section 1 of Crack and Scaling Objects

In Figure 25 a dime and a 0.010 in. wire are shown for scale factor purposes. Based on this photograph, the pictures of the crack are a 4X representation of the actual part. The entire length of the crack was split up into eleven segments and overlapping photographs were taken. These pictures are shown in Figures 25 through 28.

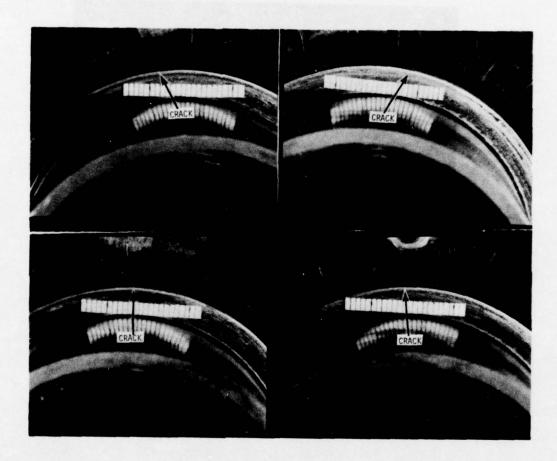
Figure 34. View of the Crack next to the AL Hub

After the examination of the wheel at 260 miles was complete, the roll test was continued. The wheel was disassembled and visually inspected at 10 mile increments for the next 40 miles. No further degradation of the wheel was found and so the tear down and visual inspection was performed at 20 mile increments for the next 40 miles. By this time a total of 340 miles had been put on the wheel. Next the wheel was run continuous for 60 miles, thoroughly inspected, and then run for 100 more miles. By this time a total of 500 miles had accumulated. Once again a thorough visual inspection was performed and a complete set of pictures taken. These photographs are shown in Figures 32 through 35.

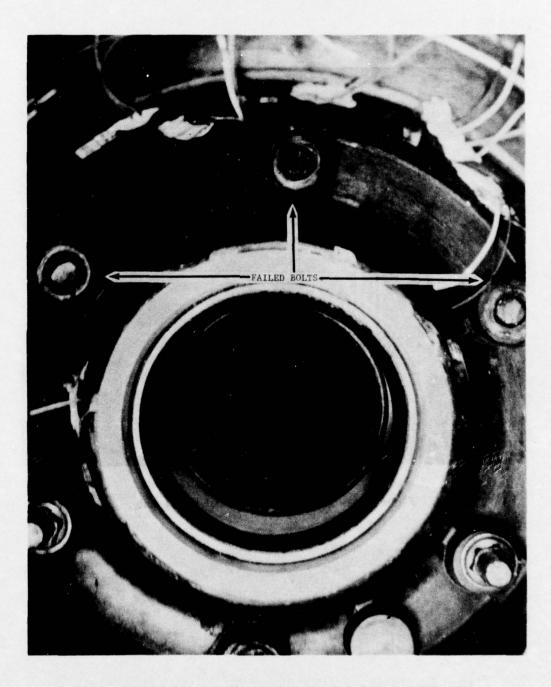
Figure 44. Fatigue Failure of 3 Wheel Bolts at 1093 Miles

At 1093 miles into the straight roll tests a fatigue failure of three wheel bolts occurred and this is shown in Figure 43 and 44. This caused an immediate unbalanced load on the wheel and broke the epoxy bond between the hub and the wheel. As soon as the air pressure in the tire dropped, the dynamometer unlanded the tire and removed the load. The wheel bolts were only torqued to 15 ft-1bs (the torque requirements for the same bolts on the aluminum wheel are 25 ft-1b) and this must have caused the early fatigue failure. A close visual inspection of the wheel revealed no structural damage had been done by this mishap. The Al hub was pressed out of the wheel, cleaned and rebonded again.

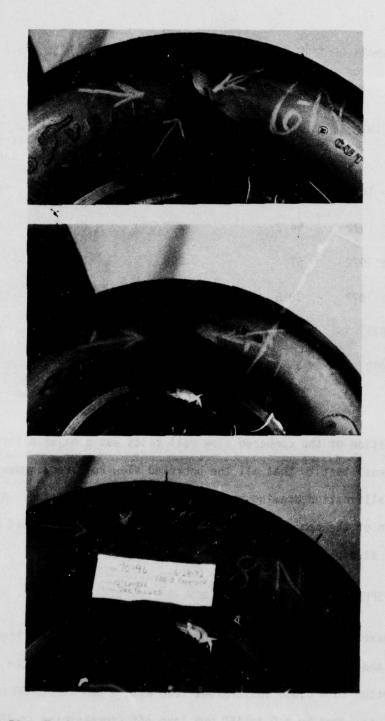
Figure 50. Typical Blow-Outs Sustained during 15° Cambered Slow Roll Tests

The next test conducted was the dynamometer slow roll in the cambered configuration. The goal of the cambered slow roll tests was the completion of 400 miles. Table 1 lists the significant events (tire failures) which occurred during these tests. None of these blow-outs did any damage to the wheel. Figure 50 illustrates three typical blown out tires.

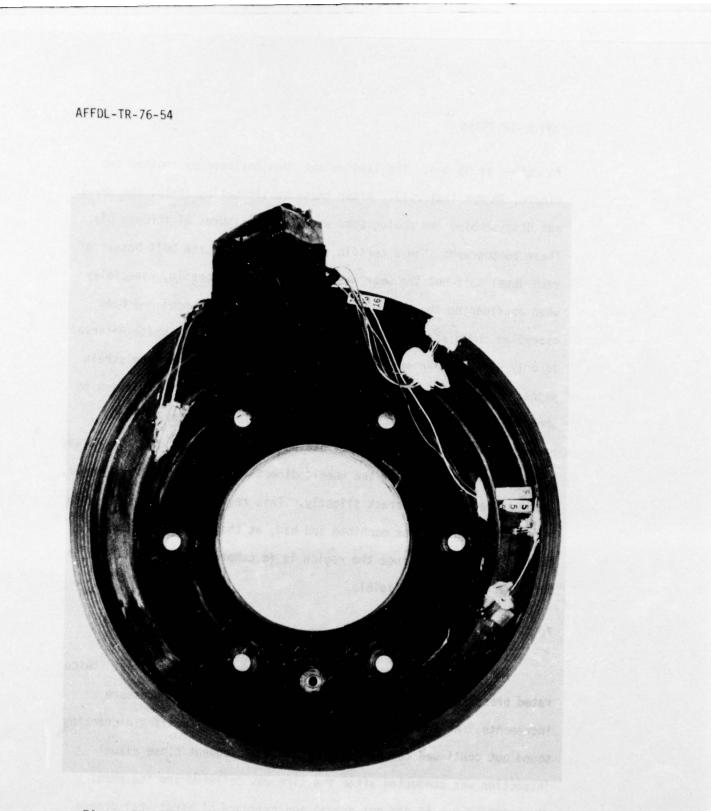
Figure 51. Wheel Half after 1400 Mile Straight Roll and 400 Mile Camber Roll

touchdown at 90 mph. The landing was then followed by another two minute, 30 mph taxi roll. After these qualification tests, the wheel was disassembled and photographs were taken (Figures 51 through 53). These photographs show a certain amount of wear on the bolt bosses of each wheel half but the wear was judged to be reasonable, especially when considering the large number of times that the wheel had been assembled and disassembled. It is pointed out that the white material is only a protective epoxy coating which was applied over the strain gages. It was also noticed that the new Al hub was also beginning to show some signs of wear (see Figure 53). This indicates that the proper epoxy adhesive bond still had not been achieved. Also there was a region in the barrel of the wheel, directly over the "0" ring groove, that was beginning to crack slightly. This region was broken off when the "O" ring groove was machined and had, at that time, been bonded back to the wheel. Since the region is in compression, the effects of this cracking were negligible.

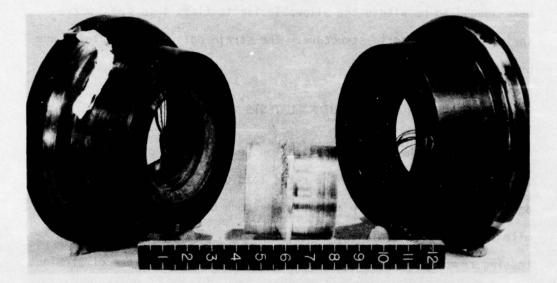
Figure 54. G/E Wheel after 1800 Mile Straight Roll 400 Mile Camber Roll

Figures 54 through 56 illustrate the condition of the wheel at this point in the testing. Figure 55 shows the worst bolt boss of both wheel halves. As stated before, when consideration is made of the large number of times that the bolts had been tightened or removed, it is felt that these bosses were holding up well. Figure 56 shows the crack of the original secondary bond region above the "0" ring groove. Also as stated before, this area is in compression when the wheel is assembled and thus the effects of this crack are negligible.

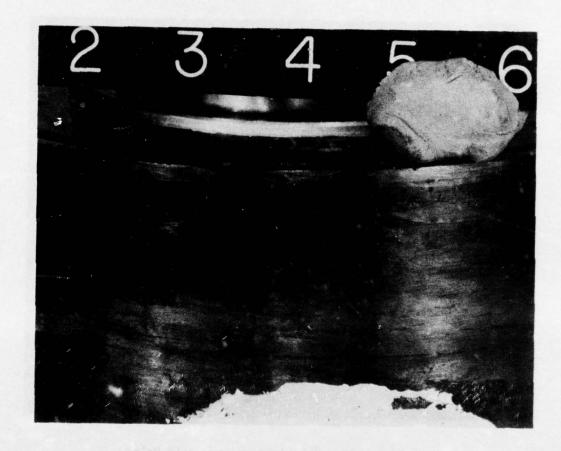
Figure 58. "Crack" in Barrel of Wheel

Figures 57 through 59 show the wheel after an additional 850 miles of straight roll. The crack in the barrel of the wheel (Figure 58) had widened slightly and a localized delamination (Figure 59) developed near one bolt hole. Neither of these defects caused the wheel to lose air and the wheel was visually inspected (on the dynamometer) every 20 to 30 miles. The tie bolts were changed about every 500 miles and after the tire had accumulated 1,270 miles the sidewall developed a void and it was necessary to install a new tire. The wheel was inspected closely during this teardown and no new defects were found. The straight roll tests were restarted and continued until the wheel had attained 1,712 miles. At this time, the wheel had been subjected to a total of 3,112 straight roll miles and 400 camber roll miles. Also, at this time, an air leak developed around the bottom of the air valve boss and the wheel began to lose air at a rapid rate. One of the bolts next to the valve stem broke off, apparently due to fatigue, and this must have caused, or at least contributed to, the air leak at the valve stem. Also when the nut end of the broken bolt was removed, part of the boss chipped off as shown in Figure 60. The wheel was disassembled for inspection purposes and it was found that the "O" ring had not slipped out of the groove. Thus, the air leakage was apparently caused by a defect that developed in the bond between the air valve and the graphite epoxy boss. This air leak was fixed by liberally applying an adhesive around the valve stem. Figure 61 shows an overall view of the same wheel half.

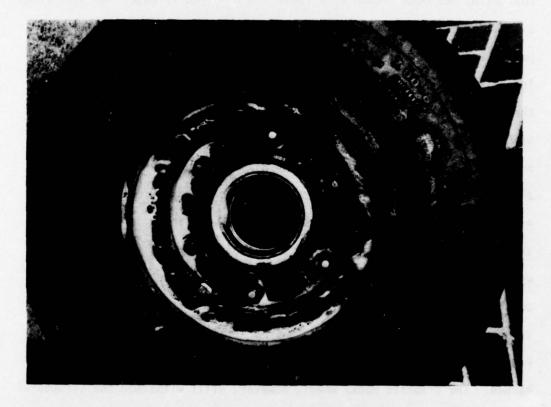
Figure 62. Air Leaks in Wheel

The straight roll tests continued until an additional 3,365 straight roll miles had been accumulated above the required mileage. At this time, a total of 4,765 straight roll miles and 400 camber roll miles had been put on the wheel. At this time, the wheel once again began to rapidly lose air. The wheel would still structurally withstand the loads from the air pressure of 125 psi and it also withstood the rated straight load of 6,150 lbs at the rated pressure but it would not hold the rated air pressure. The wheel was sprayed with a soapy liquid used to help detect air leaks and the results photographed as shown in Figures 62 through 64. After close visual examination, small cracks were found in the bead seat area and also at the bottom of the barrel of the wheel. These cracks were circumferential in nature and extended clear around the wheel. The cracks prevented the wheel from holding air but they did not weaken the structure enough to cause failure. If a metal aircraft wheel had these kinds of cracks, a catastrophic failure would be extremely likely to happen. The graphite epoxy wheel, however, still withstood the structural requirements even though these cracks prevented it from holding air. The significance of these results is that fatigue failure with composite wheels is not as likely to occur as with metal wheels and if the wheel does have a fatigue failure, it is not likely to be catastrophic.

Since this wheel is a unique article, a series of inspection and repair techniques will be undertaken in an attempt to repair the wheel. This will include:

a. Ultrasonic "C"-Scan to see what patterns of the delaminations can be recorded.

- b. Impregnate with XYGLO, photograph, and bake out.
- c. Impregnate with Tetrabromoethane (TBE) for X-ray purposes.
- d. X-ray for delaminations.
- e. Bake out TBE.
- f. X-ray for residue TBE.
- g. Impregnate with epoxy in an attempt to repair the cracks.

h. Assemble with the tire and check for air leaks - repeat g as required.
