FINAL
REPORT OF
PRODUCT IMPROVEMENT TEST OF U-8F
(ECP-BEA-L23-138)
USATECOM PROJECT NO. 4-4-1004-01

22 DEC 1964

AVIATION TEST BOARD

⑥ PRODUCT IMPROVEMENT TEST OF U-8F
(ECP-BEA-L23-138)

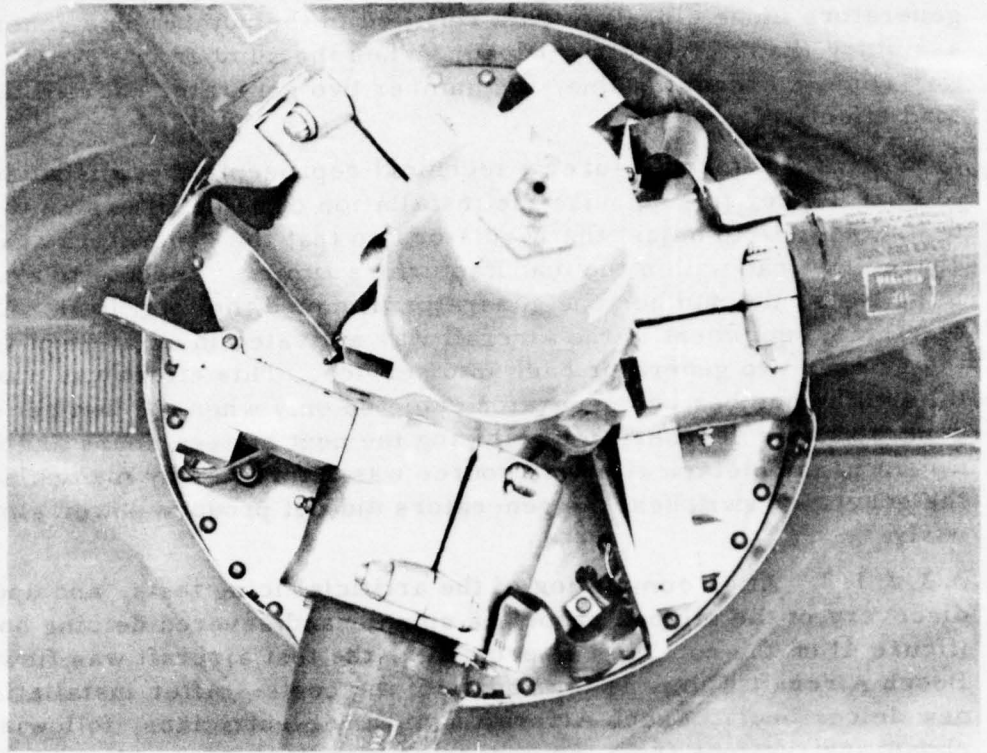
2.3.3.1.3. After completion of the artificial icing tests, and upon discovery of the slipped propeller spinner and severed deicing boots (figure 4) on the number one propeller, the test aircraft was flown to Beech Aircraft Company for repair of the boots. After installation of new deicer boots, Beech Aircraft Company electricians, following telephonic instructions from the generator manufacturers, attempted to parallel the generators. During this attempt the voltage adjusting mechanism on the number two generator voltage regulator failed. The aircraft was then flown to an airport near the generator manufacturer's plant in Waynesborough, Virginia. The voltage regulator of the number two generator was replaced, and both regulators were adjusted to parallel the generators within the manufacturer's specifications.

Figure 4. Damaged deicer boots

5. Propeller spinner slipped and severed propeller deicing boots.	The propeller boots be modified to prevent damage in the event of propeller spinner slippage.	None.

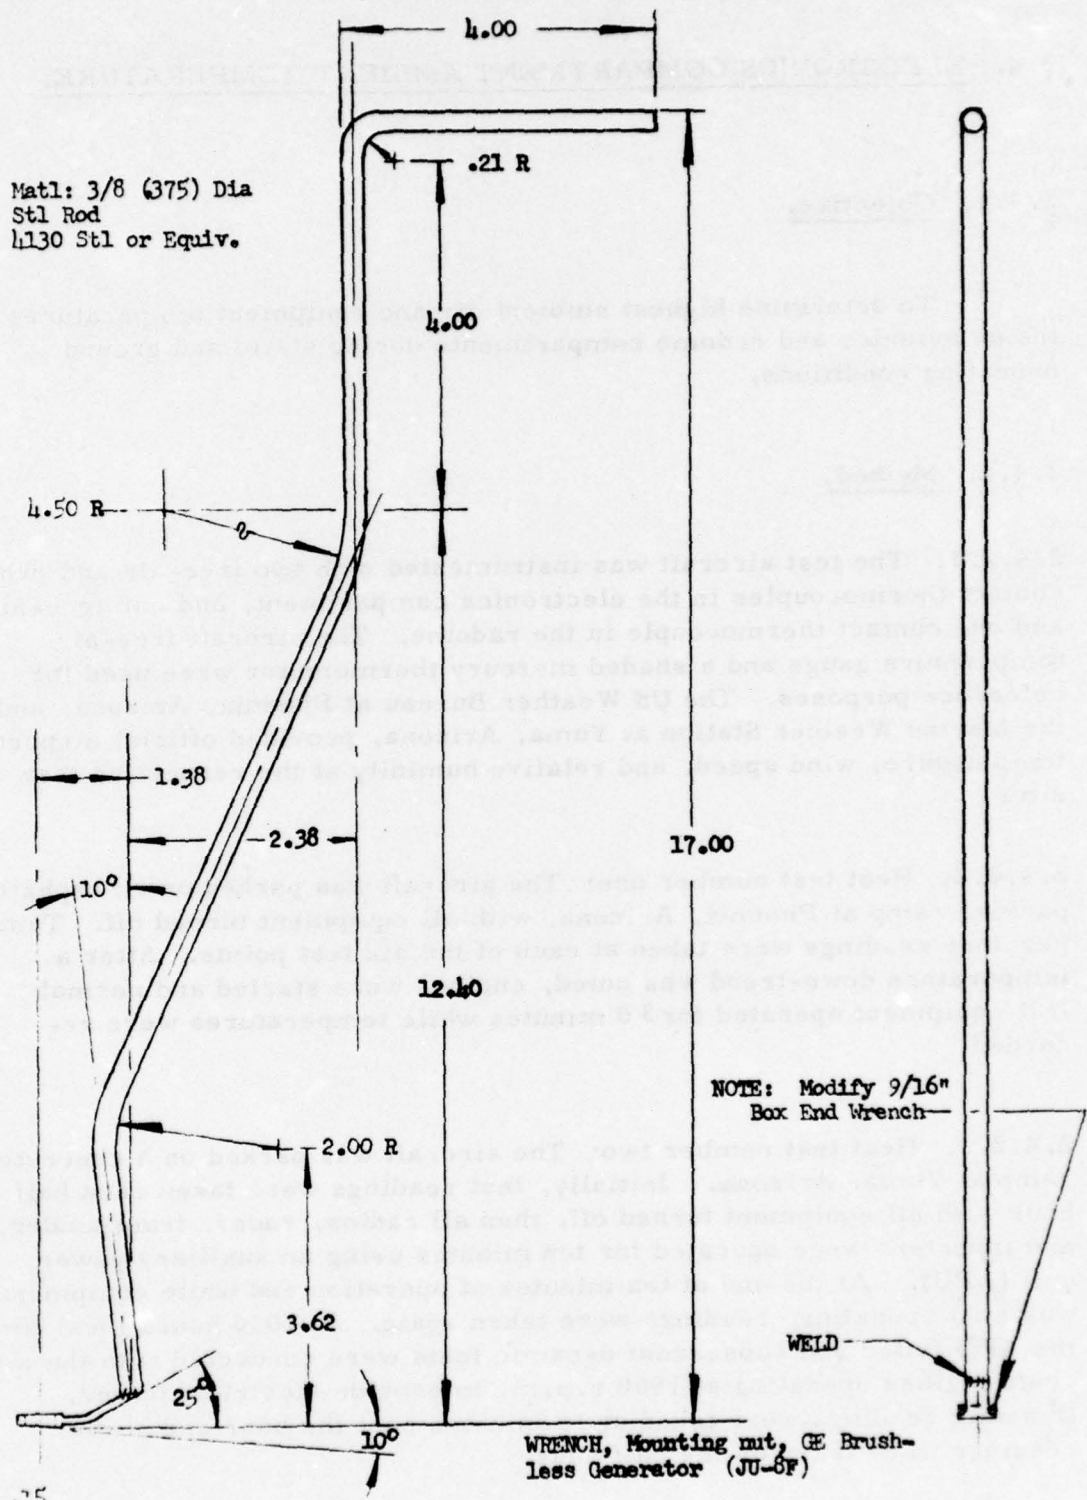
Figure 6. Wrench Specifications

1.7.5. A special tool was required to remove the rearmost generator mounting nuts.

Removal and installation of the generators required modification of an existing 5/8-inch wrench. The wrench specifications are contained in figure 6.

1.9.3. The special tool required to remove rearmost generator mounting bolts be procured with retrofit kits. Tool specifications are contained in figure 6, section 2.
