REPORT NO. NADC-76332-30

INVESTIGATION OF A LIQUID OXYGEN SAMPLER CYLINDER EXPLOSION

J. Danovich and E. R. Wright
Air Vehicle Technology Department ✓
NAVAL AIR DEVELOPMENT CENTER
Warminster, Pennsylvania 18974

10 DECEMBER 1976

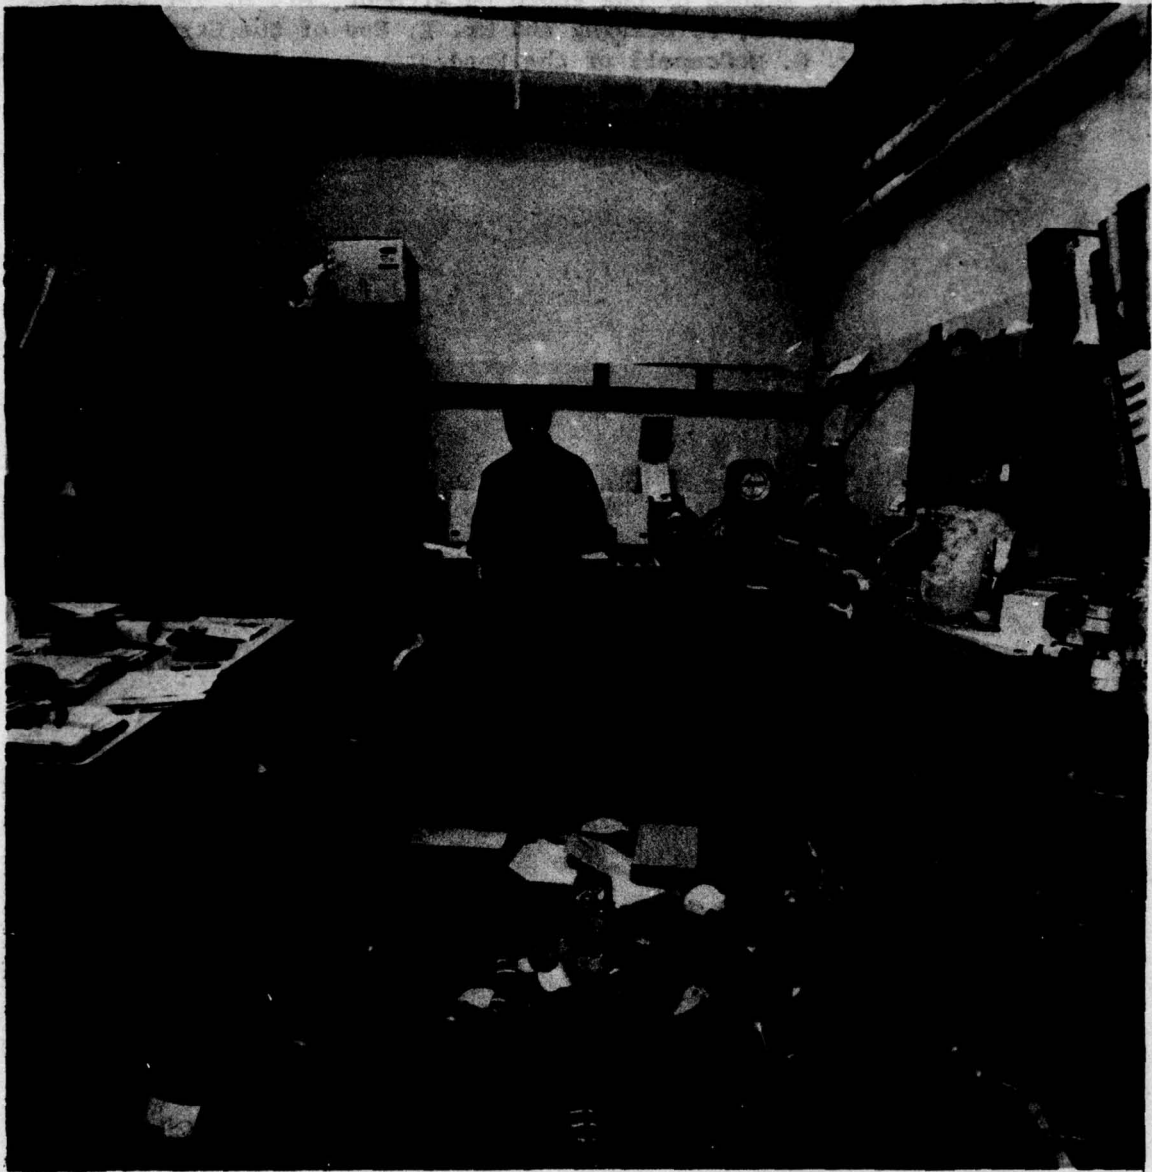
It was noted by laboratory personnel at the time of delivery that one sampler cylinder was completely covered with frost whereas the other sampler was frost-free. While test preparations were underway a steel retaining band on the frosted cylinder cracked and fell to the floor. Approximately five minutes later the frost-covered cylinder exploded. Figures 1, 2, 3 and 4 show some of the extensive physical damage caused by the explosion. A laboratory technician who was standing in the location shown in Figure 1 sustained minor cuts and a temporary loss of hearing. Three major sections of the exploded cylinder came to rest in the locations shown in Figures 2 and 3. Figure 4 shows a typical G-276 LOX sampler cylinder in a stand near an area of the damaged wall in the hallway and some of the shattered steel bands. Figure 5 shows the various parts of the exploded cylinder. It appears that the valve, nipple and sampler filler tube, upon separation from the exploding cylinder, were propelled upward to the ceiling, causing some damage and finally landing on the floor about four feet apart. The wire bands were scattered throughout the area as shown in Figures 1, 2, 3 and 4.

Figure 1. Room Where the Explosion Occurred

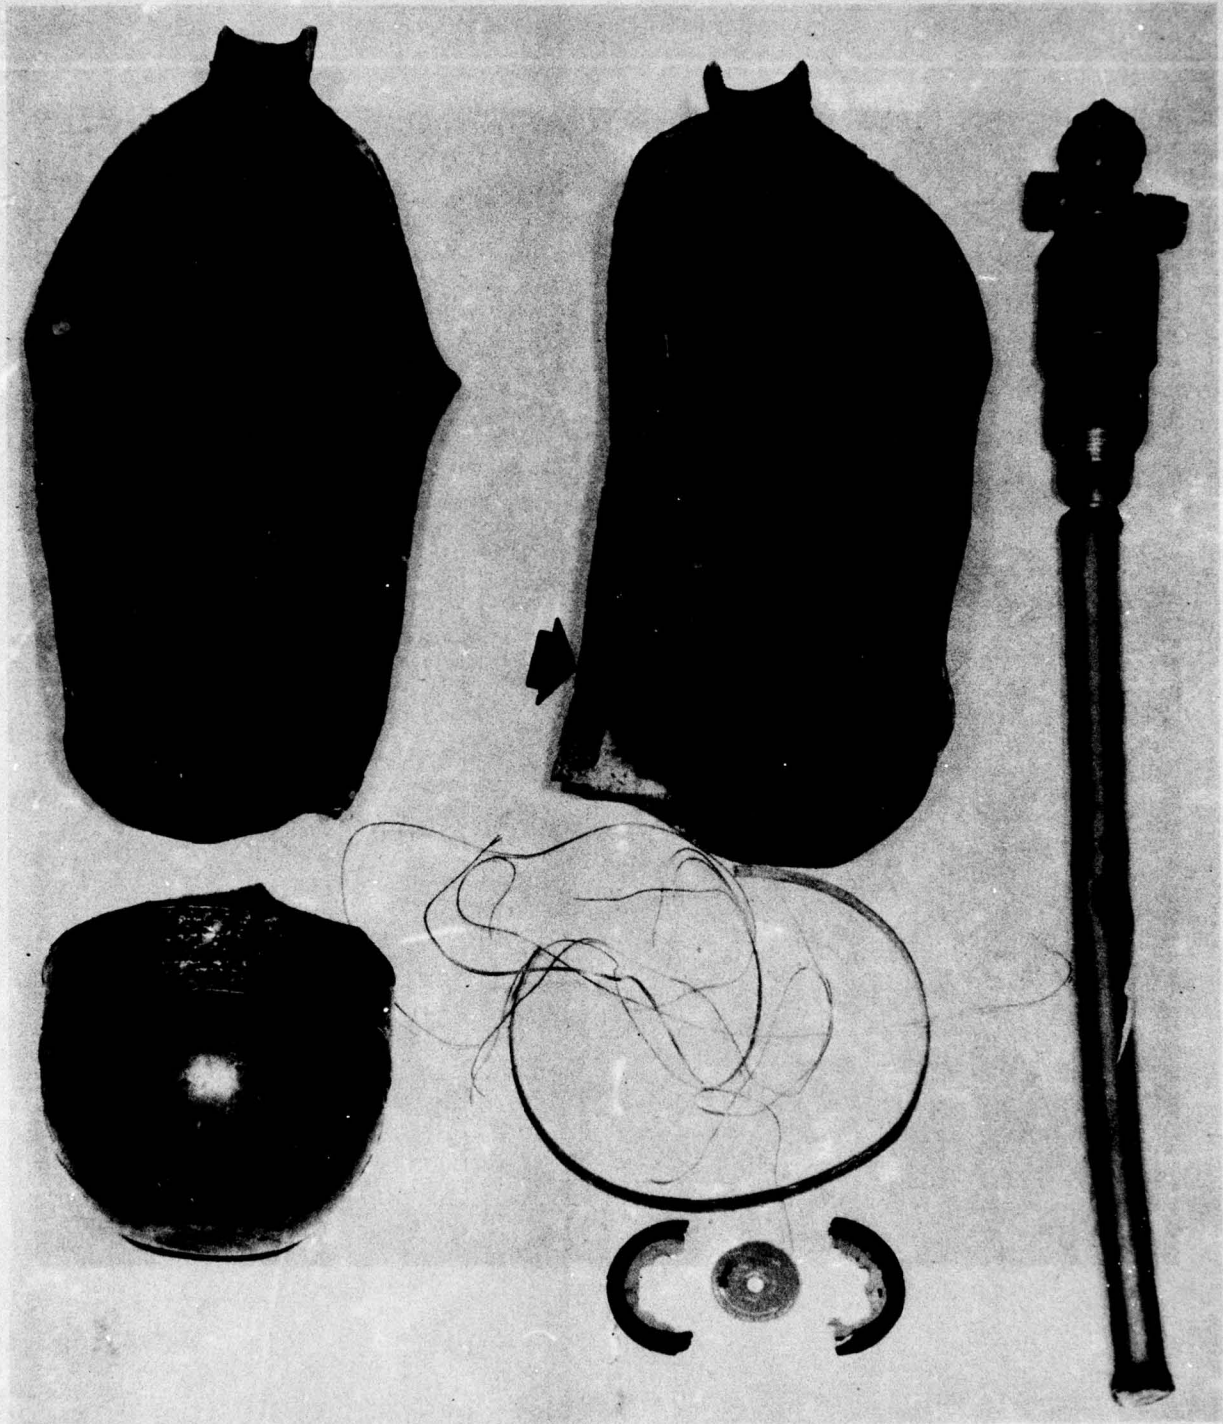
Figure 5. Parts of the Exploded Cylinder
