ROOF MOISTURE SURVEYS AT PEASE AFB, NEW HAMPSHIRE, AND OFFUTT AFB, NEBRASKA

MISCELLANEOUS PAPER M-77-2

Lewis E. Link, Jr.

January 1977
Final Report

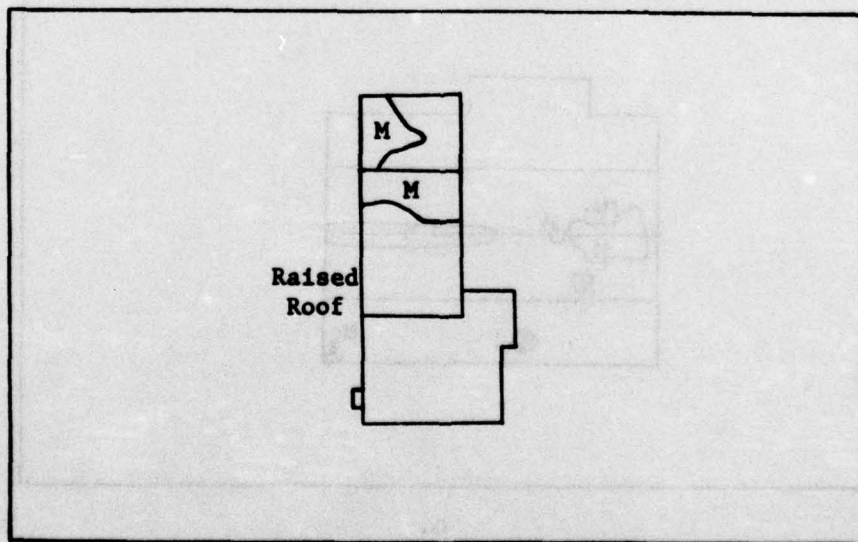
Building No.	Cause of Warm Anomalies	Remarks
31	Entrapped moisture (two areas)	<u>Figure 13.</u> Moisture anomalies are quite evident on IR image; building boundaries are not always evident partially because of fogging of film
130	Entrapped moisture (four areas)	<u>Figure 14.</u> Moisture and vent anomalies are evident on IR image; small area of entrapped moisture located in south corner of building was not observable on imagery but was located with nuclear meter during detailed study
119	Entrapped moisture	<u>Figure 15.</u> One small area found with entrapped moisture; anomalies due to vents were easily identified as to source during image interpretation
35	Entrapped moisture (two areas)	<u>Figure 16.</u> Building outline is difficult to determine without information on actual shape; moisture anomalies are very evident on imagery
36	Entrapped moisture, roof surface change, standing water	<u>Figure 17.</u> Moisture anomaly is very evident on IR image; a warm anomaly (suspected at first to be caused by entrapped moisture) caused by a combination of a change in roof material characteristics (gravel color) and standing water

Figure 13. Thermal IR image (a) and identification of anomalies (b) for building No. 31, Pease AFB, New Hampshire

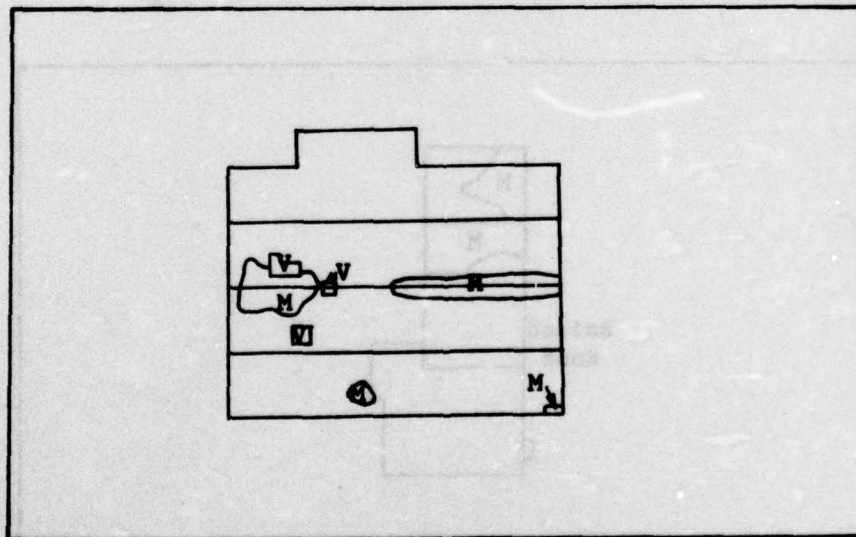
Small wet area in south corner of building was found with the nuclear meter; it was not obvious on the imagery.

Figure 14. Thermal IR image (a) and identification of anomalies (b) for building No. 130, Pease AFB, New Hampshire

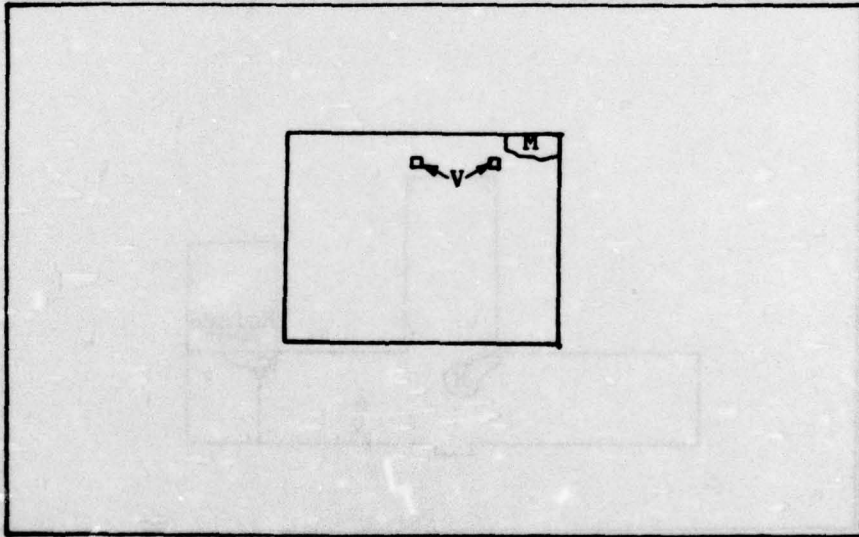
Figure 15. Thermal IR image (a) and identification of anomalies (b) for building No. 119, Pease AFB, New Hampshire

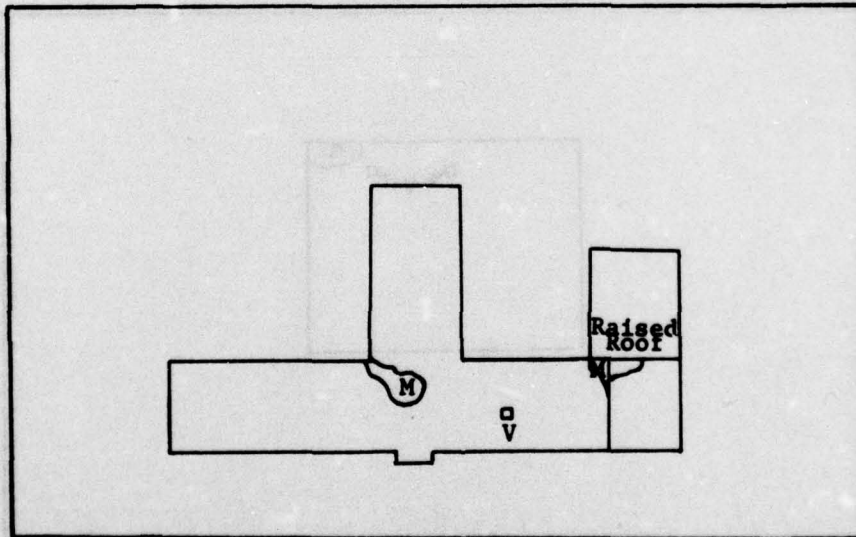
Figure 16. Thermal IR image (a) and identification of anomalies (b) for building No. 35, Pease AFB, New Hampshire

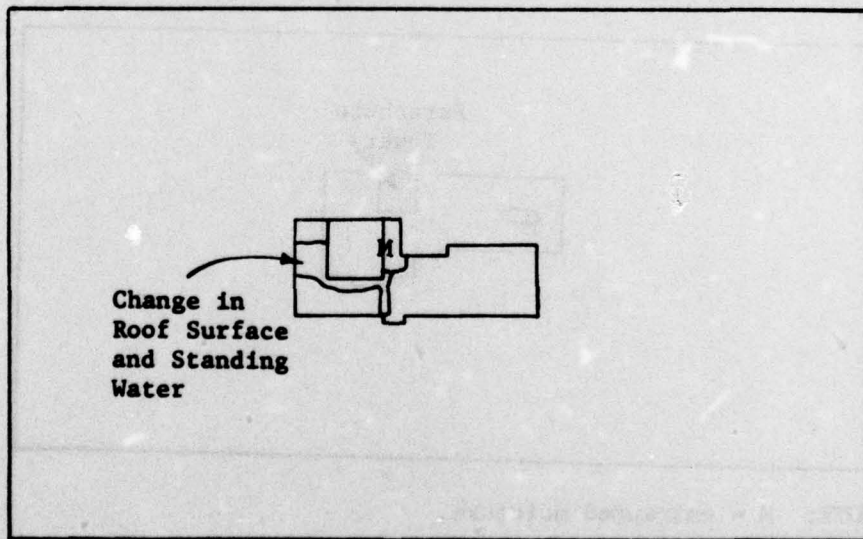
24. Standing water was a partial cause of an anomaly on the image of building No. 36. This emphasizes the fact that thermal IR imagery missions should not be flown when large areas of roofs are covered with standing water (e.g. immediately after a period of rainfall).

Figure 17. Thermal IR image (a) and identification of anomalies (b) for building No. 36, Pease AFB, New Hampshire

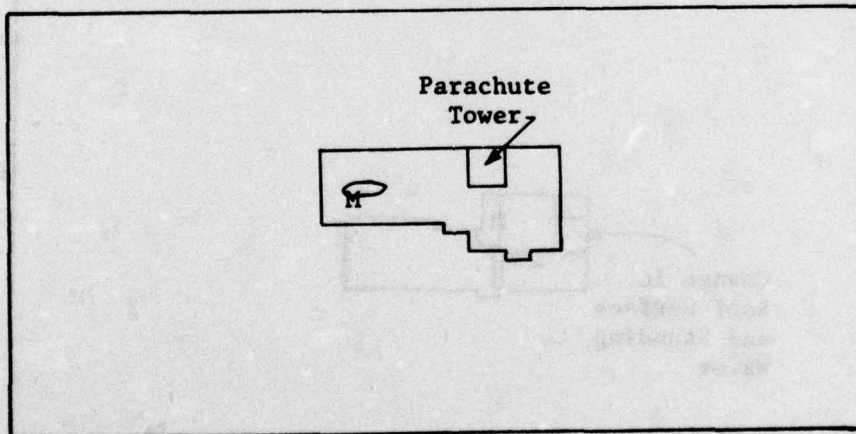
112	Entrapped moisture	<u>Figure 18.</u> Moisture anomaly is very evident on IR image; building outline is not easily discernable because of fog level on image
227	Entrapped moisture	<u>Figure 19.</u> Moisture anomalies are vague on blowup of image in figure but appear more clearly on original imagery negative; degradation in image quality is due to fog level and enlargement process

Figure 18. Thermal IR image (a) and identification of anomalies (b) for building No. 112, Pease AFB, New Hampshire

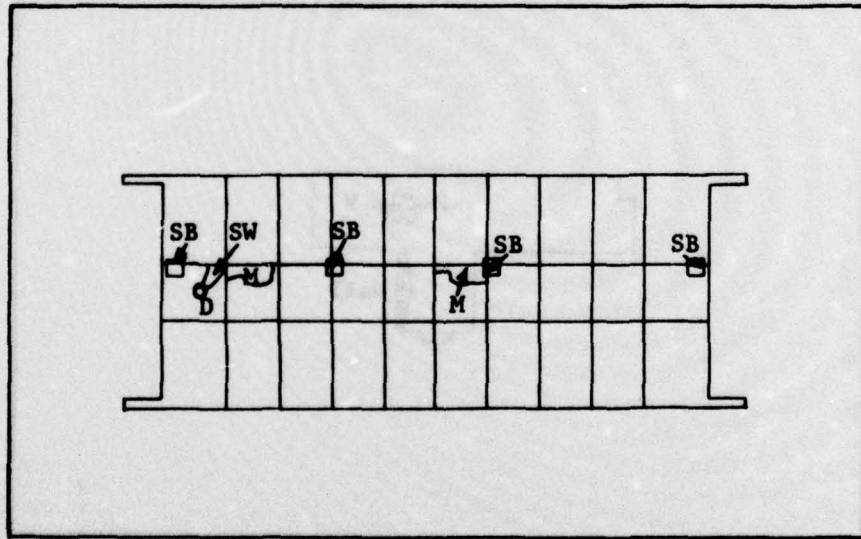
Figure 19. Thermal IR image (a) and identification of anomalies (b) for building No. 227, Pease AFB, New Hampshire

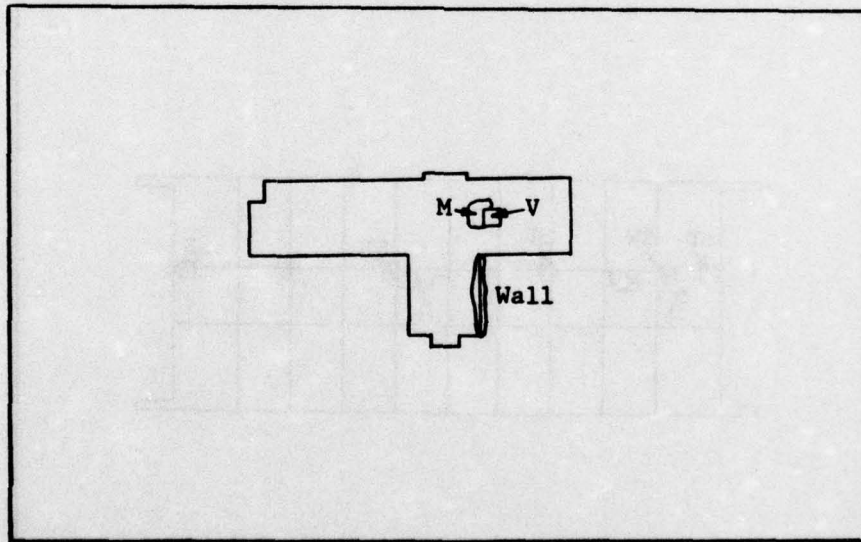
Building No.	Cause of Warm Anomalies	Remarks
43	Entrapped moisture	<u>Figure 20.</u> Building outline is very difficult to delineate on IR image without prior knowledge of shape; moisture anomaly is evident after building outline determined
85	Entrapped moisture, elevated roof structures with vent windows	<u>Figure 21.</u> This building is an in-flight kitchen with elevated structures on the roof that have large windows. The walls of the elevated structures and hot-air vents from the windows created significant anomalies on the image. Prior knowledge of these conditions would have reduced the possibility of interpreting these anomalies as possible areas with entrapped moisture. One area with entrapped moisture was identified correctly
46	Elevated roof structures with vent windows	<u>Figure 22.</u> Same as Figure 21, building No. 85
6	Elevated roof structures with vent windows	<u>Figure 23.</u> Same as Figure 21, building No. 85

Figure 20. Thermal IR image (a) and identification of anomalies (b) for building No. 43, Pease AFB, New Hampshire

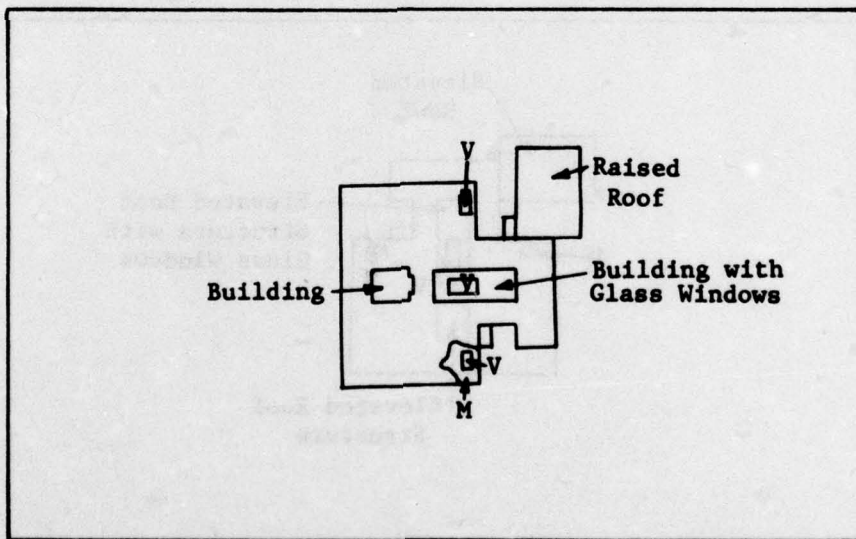
Figure 21. Thermal IR image (a) and identification of anomalies (b) for building No. 85, Pease AFB, New Hampshire

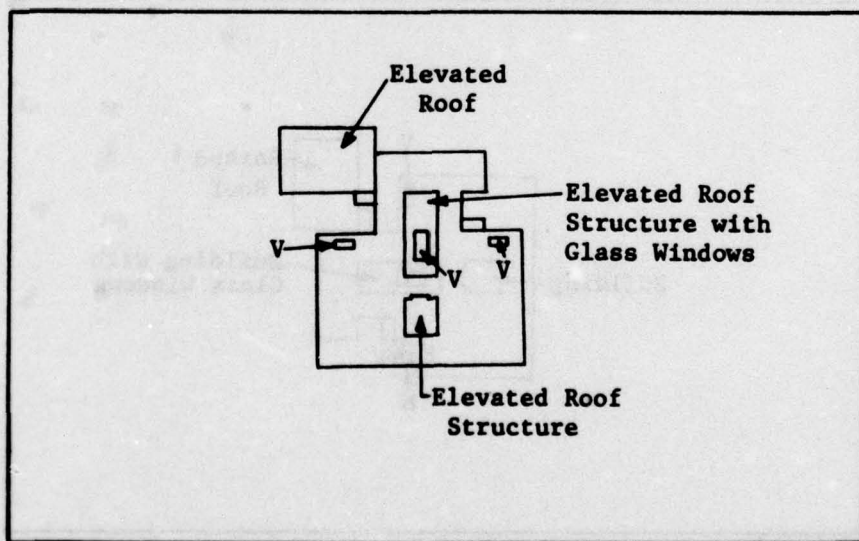
Figure 22. Thermal IR image (a) and identification of anomalies (b) for building No. 46, Pease AFB, New Hampshire

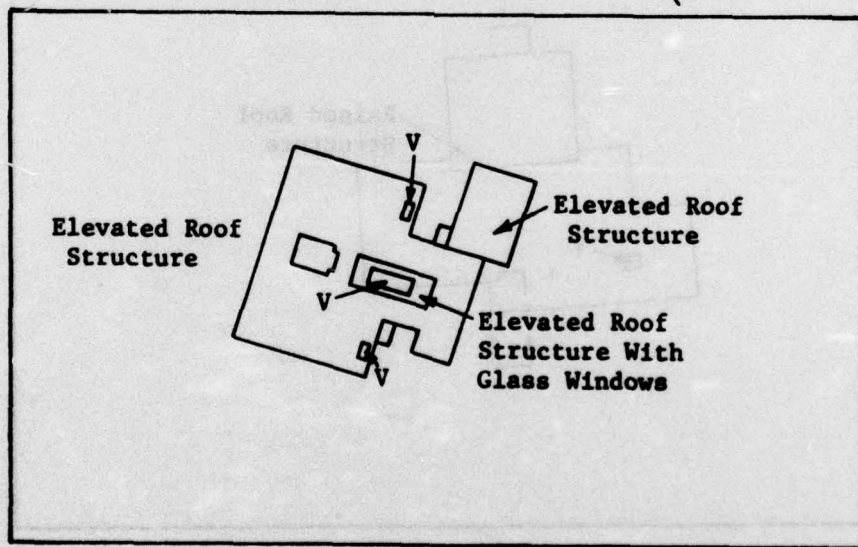
Figure 23. Thermal IR image (a) and identification of anomalies (b) for building No. 6, Pease AFB, New Hampshire

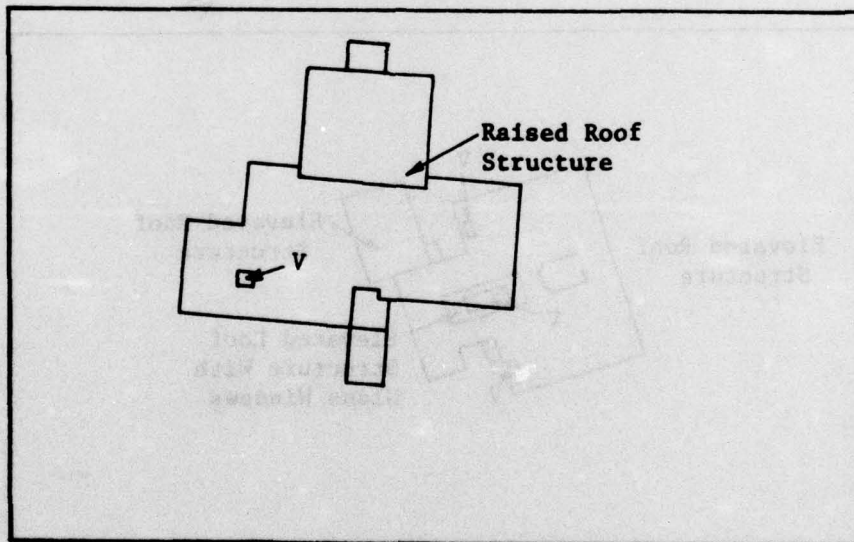
26	Vent	<u>Figure 24.</u> Building outline is difficult to delineate on image without knowledge of building shape. Scalloped effect on edges of building is due to sensor system noise; anomaly on west end of building is due to a vent
38	Entrapped moisture	<u>Figure 25.</u> Building outline is somewhat difficult to delineate on enlarged image but more easily identified on original negative; entrapped moisture anomaly is evident on IR image
120	Entrapped moisture	<u>Figure 26.</u> Area with entrapped moisture is quite small and does not show up well on enlarged image in the figure, but it is evident on original negative of IR imagery

Figure 24. Thermal IR image (a) and identification of anomalies (b) for building No. 26, Pease AFB, New Hampshire

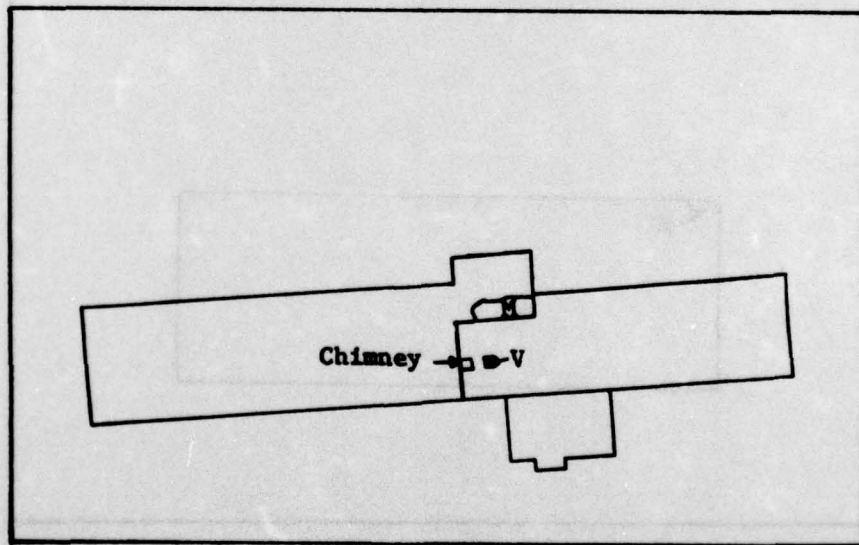
Figure 25. Thermal IR image (a) and identification of anomalies (b) for building No. 38, Pease AFB, New Hampshire

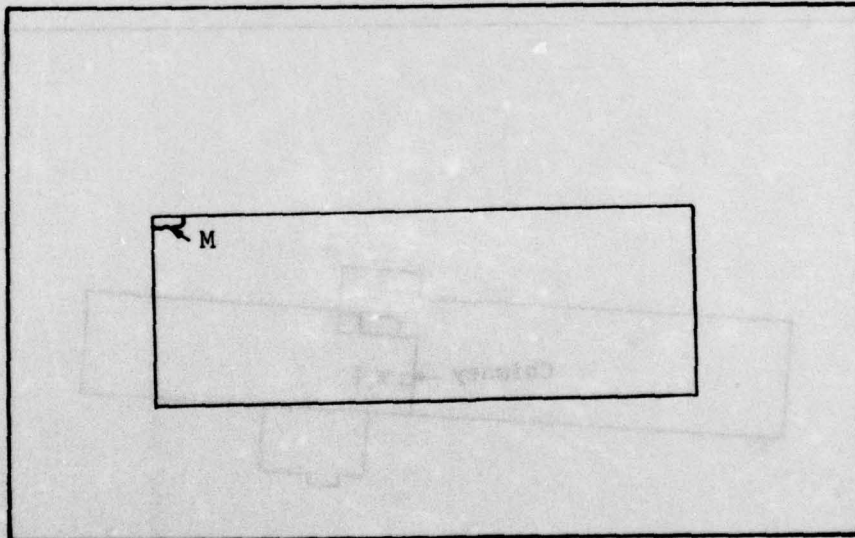
Figure 26. Thermal IR image (a) and identification of anomalies (b) for building No. 120, Pease AFB, New Hampshire

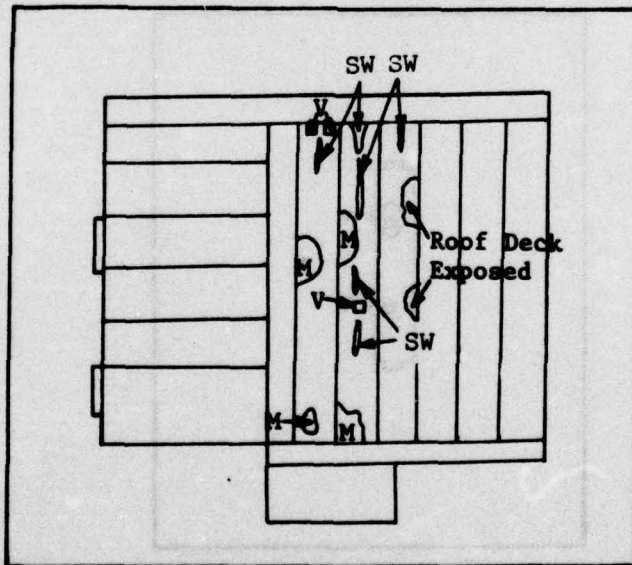
Building No.	Cause of Warm Anomalies	Remarks
301	Entrapped moisture; roof surface change	<u>Figure 27.</u> Only the three bays on which anomalies are outlined in the figure were surveyed in detail. Moisture anomalies are quite evident on the IR imagery. Anomalies designated as "roof surface change" are areas where the insulation and deck of the roof are exposed
526	Air vents	<u>Figure 28.</u> Anomaly identified during the detailed study to be caused by air vent is not readily visible on the enlargement in the figure, but it does appear on the original IR negative
418	Evaporator and standing water	<u>Figure 29.</u> Anomaly suspected to be caused by entrapped moisture was due to a large evaporator on the roof and some associated standing water on the roof around it. This anomaly would have been less likely to be identified as entrapped moisture if the interpreter had had prior knowledge of the presence of the evaporator

Figure 27. Thermal IR image (a) and identification of anomalies (b) for building No. 301, Offutt AFB, Omaha, Nebraska

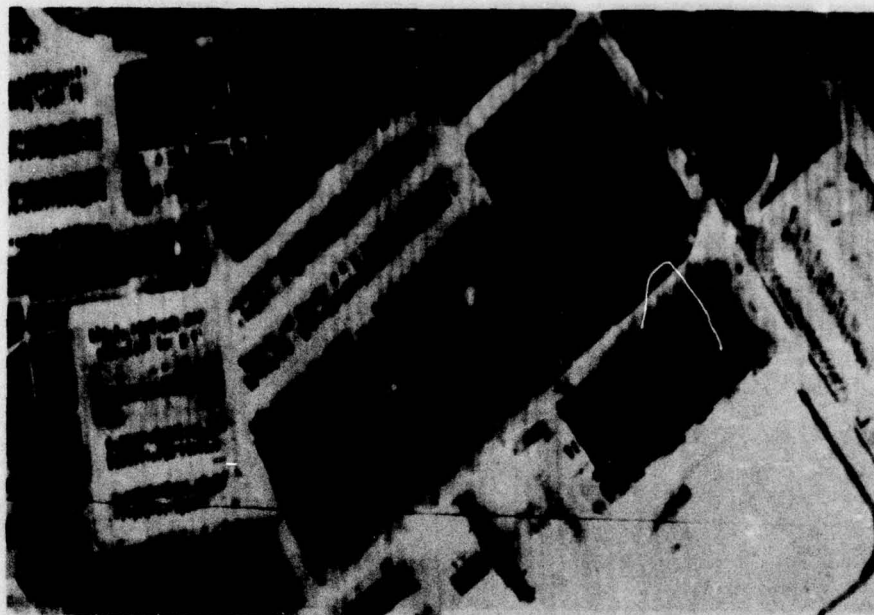
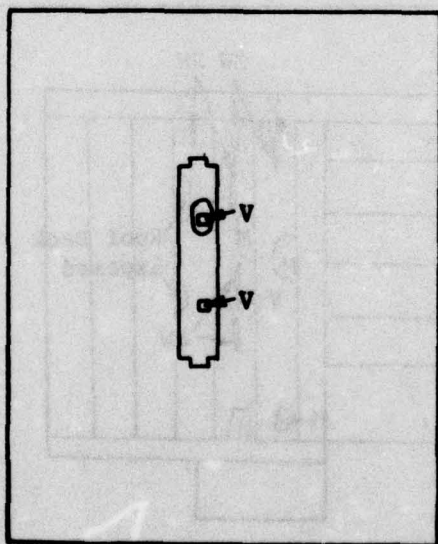
Figure 28. Thermal IR image (a) and identification of anomalies (b) for building No. 526, Offutt AFB, Omaha, Nebraska

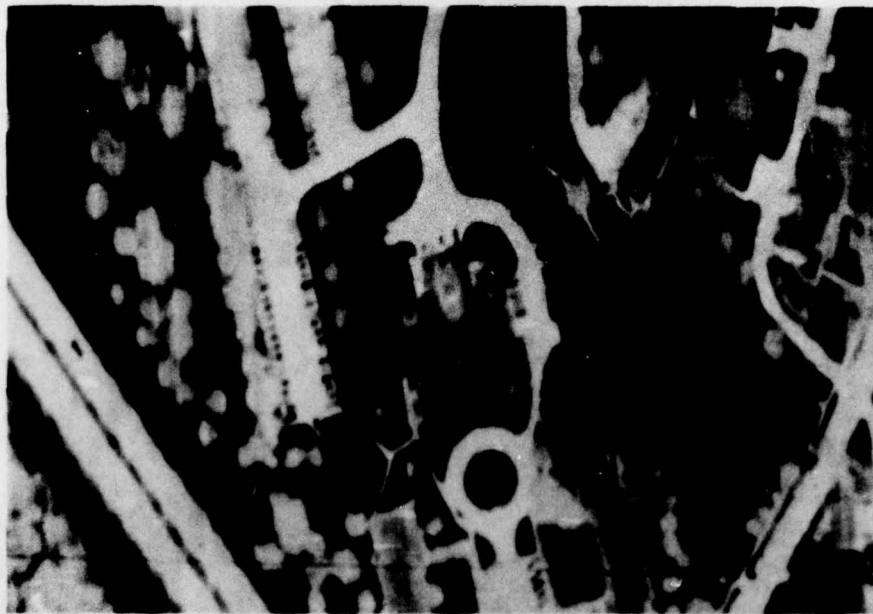
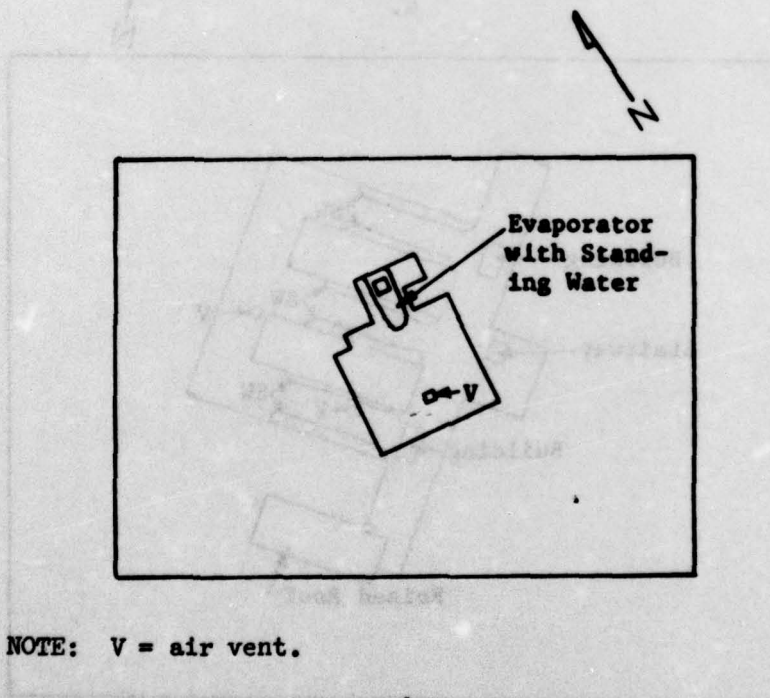
Figure 29. Thermal IR image (a) and identification of anomalies (b) for building No. 418, Offutt AFB, Omaha, Nebraska

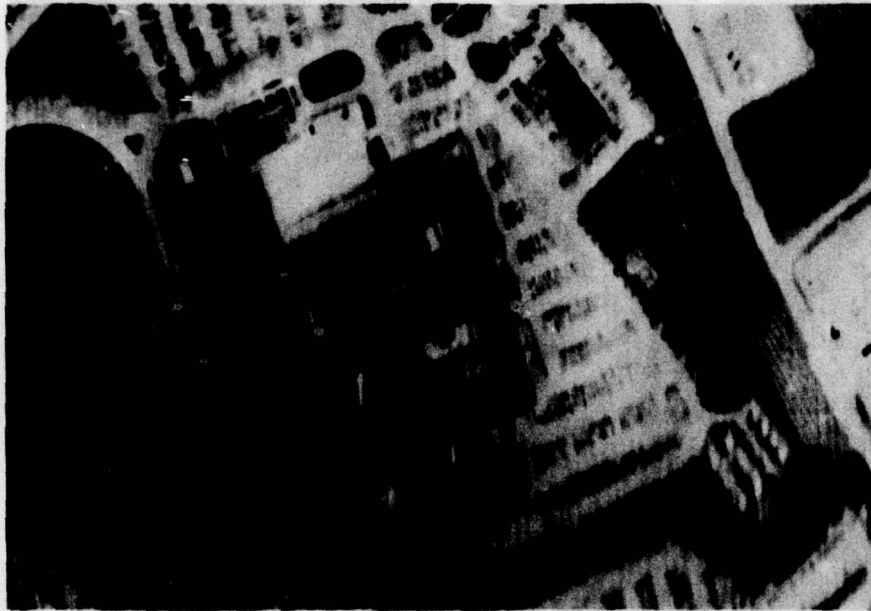
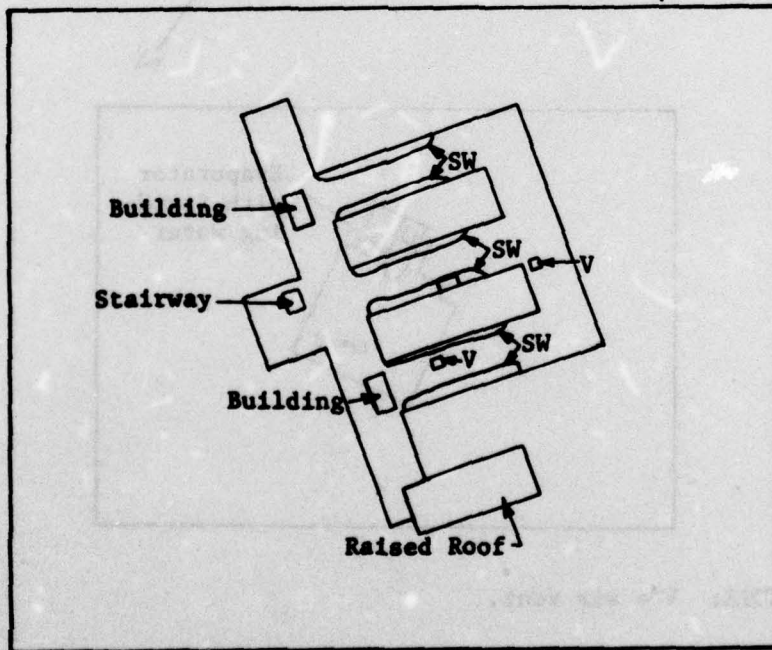
500	Standing water	<u>Figure 30.</u> Areas suspected to have entrapped moisture are slight depressions and had significant standing water. Spot checks with the nuclear meter did not reveal any entrapped moisture
306	Elevated roof structure (control tower)	<u>Figure 31.</u> Anomaly suspected to be entrapped moisture was due to a control tower on the roof. This "false alarm" would have been averted if the interpreter had been aware of the presence of this feature on the roof

Figure 30. Thermal IR image (a) and identification of anomalies (b) for building No. 500, Offutt AFB, Omaha, Nebraska

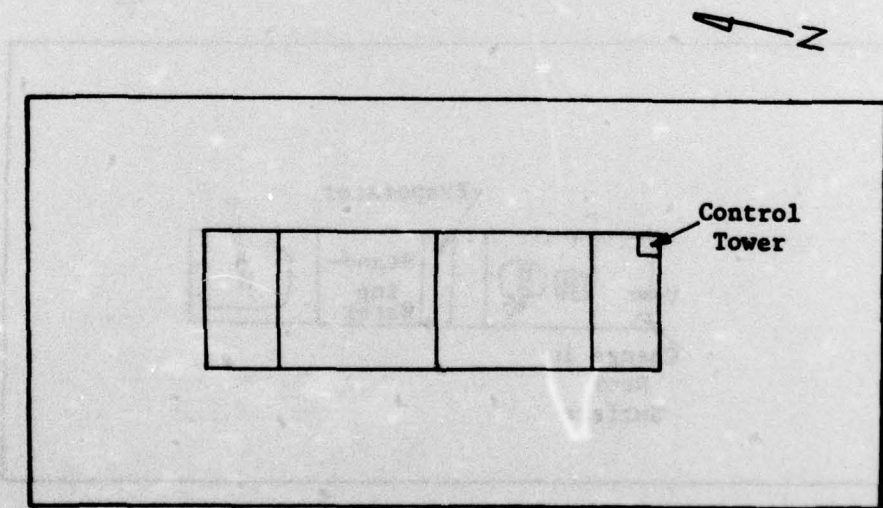
Figure 31. Thermal IR image (a) and identification of anomalies (b) for building No. 306, Offutt AFB, Omaha, Nebraska

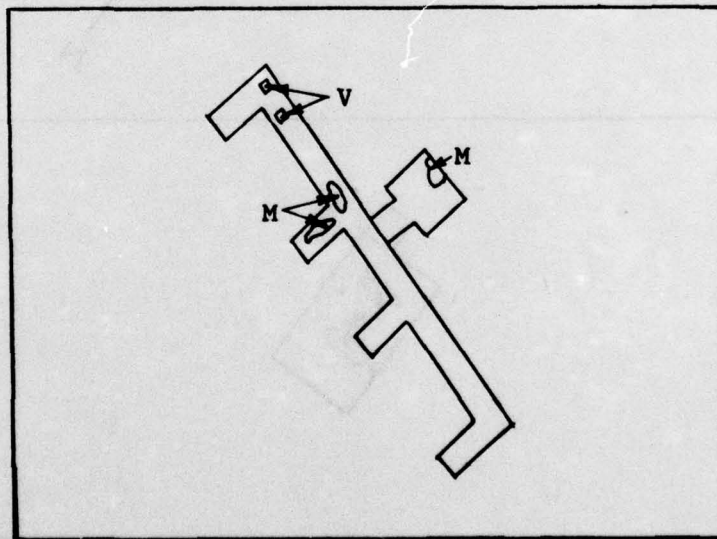
Figure 33. Thermal IR image (a) and identification of anomalies (b) for building No. 324, Offutt AFB, Omaha, Nebraska

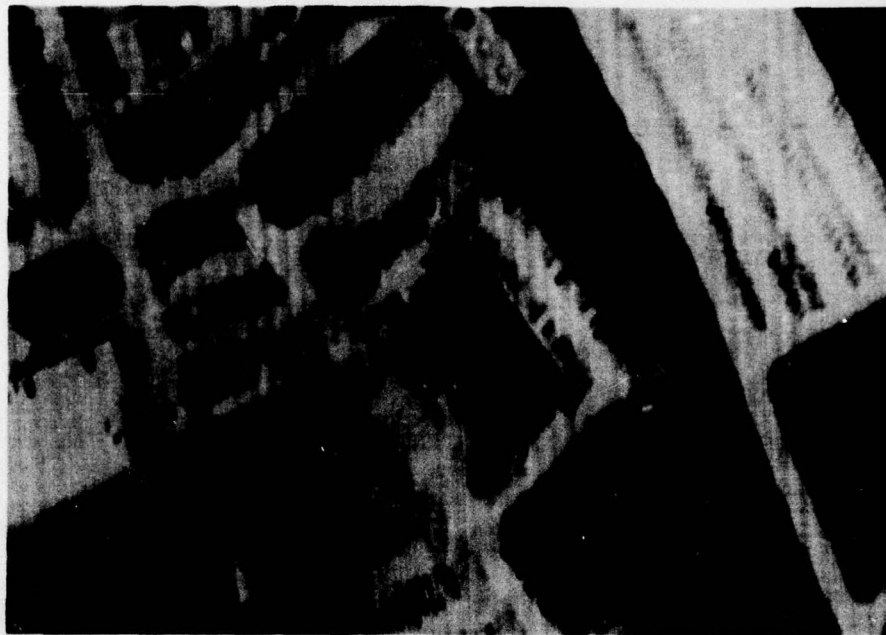
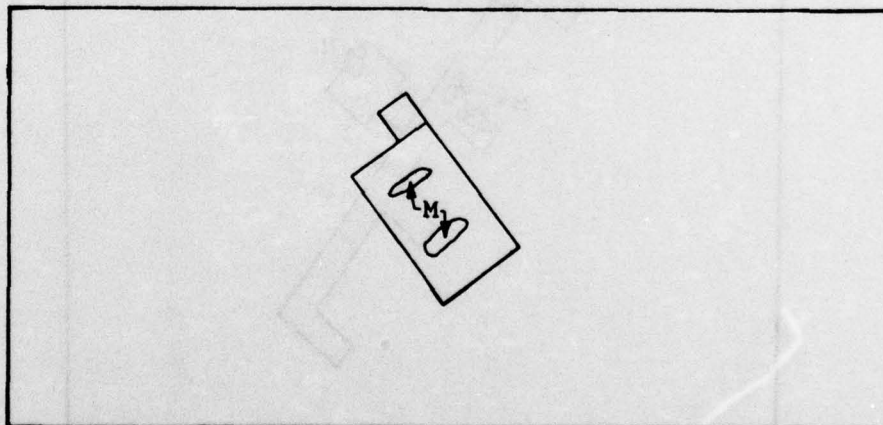
Figure 34. Thermal IR image (a) and identification of anomalies (b) for building No. 407, Offutt AFB, Omaha, Nebraska

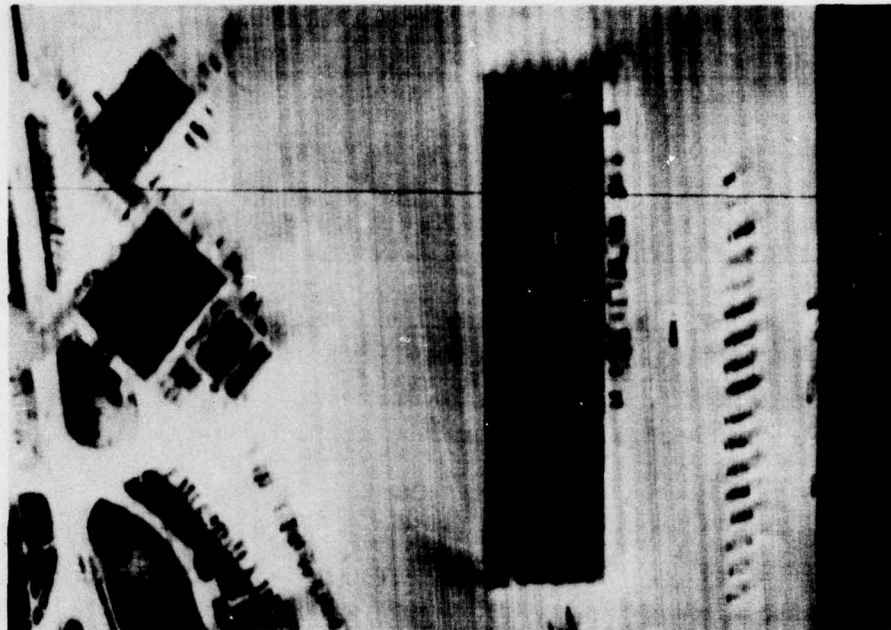
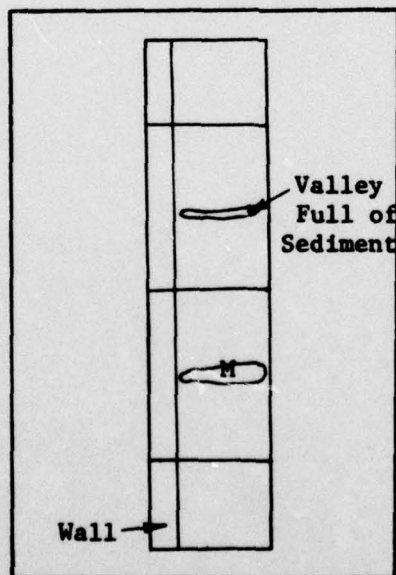
307	Entrapped moisture, valley with sediment buildup	<u>Figure 35.</u> Entrapped moisture anomaly is evident on the IR imagery. Anomaly on north section of roof is due to a valley (the roof has two major peaks) filled with fine materials washed off higher portions of the roof
