USAACOM-TR-77-14

**FLIGHT TEST EVALUATION OF OH-58A
TAILBOOM FAILURE DURING AUTOROTATION
LANDINGS**

Thomas L. Sanders
BELL HELICOPTER COMPANY
Post Office Box 482
Fort Worth Texas 76101

14 March 1973
Final Report

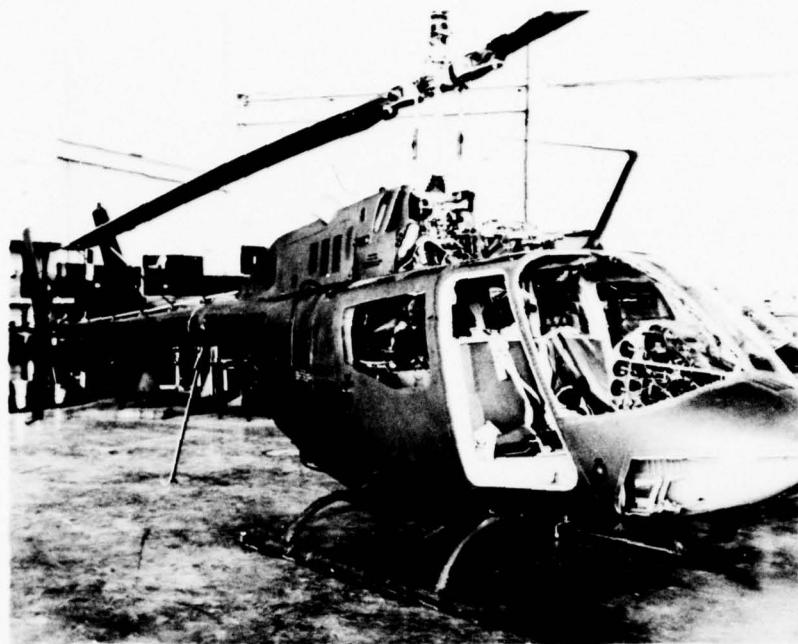
Figure 13 shows aircraft ground contact and subsequent ground roll, and Figures 14 through 20 are photographs depicting test vehicle damage that occurred during the evaluation. Figures 21 and 22 depict the extent of the pylon motion during the failure.

Fig. 14 Model OH-58A, S/N 41080, After Tailboom Failure, BHC Photo 284188

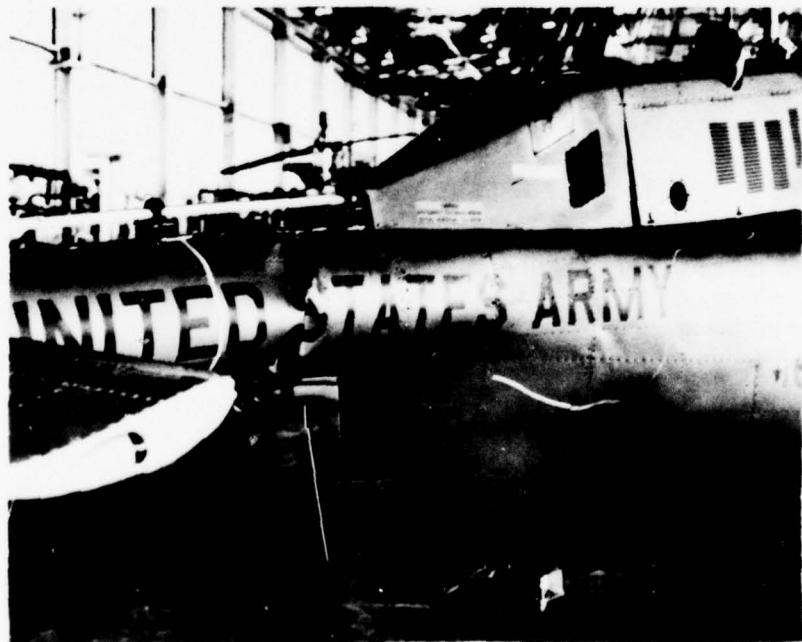
Fig. 15 Model OH-58A, S/N 41080, Right Aft View of Tailboom Failure at Fuselage Sta. 220, BHC Photo 284185

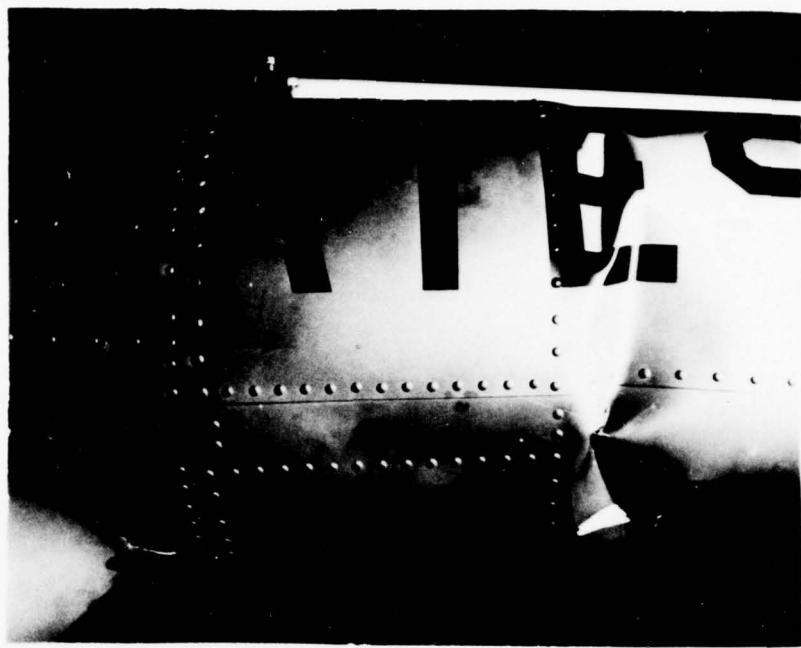
Fig. 16 Model OH-58A, S/N 41080, Tailboom Failure, Left Side, Fuselage Sta. 220, BHC Photo 284177

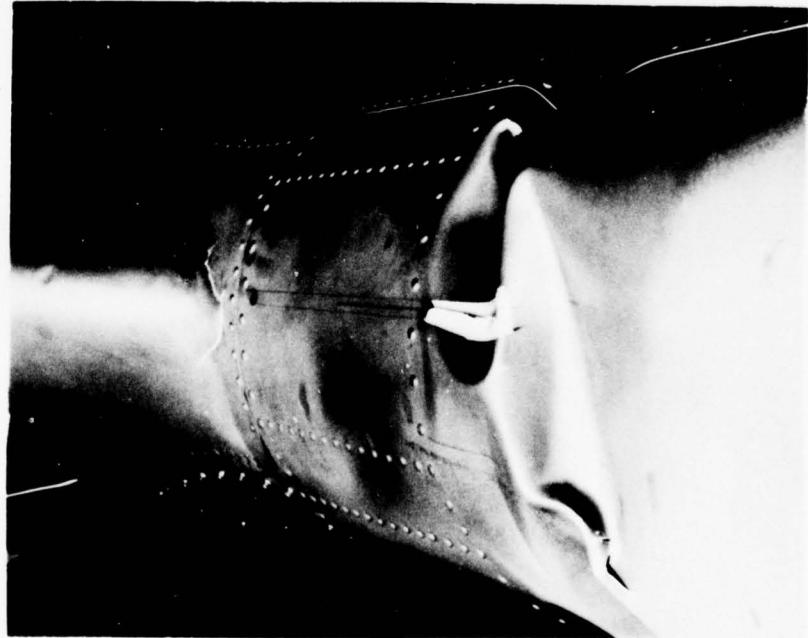
Fig. 17 Model OH-58A, S/N 41080, Tailboom Failure, Lower Surface, Fuselage Sta. 220, BHC Photo 284179

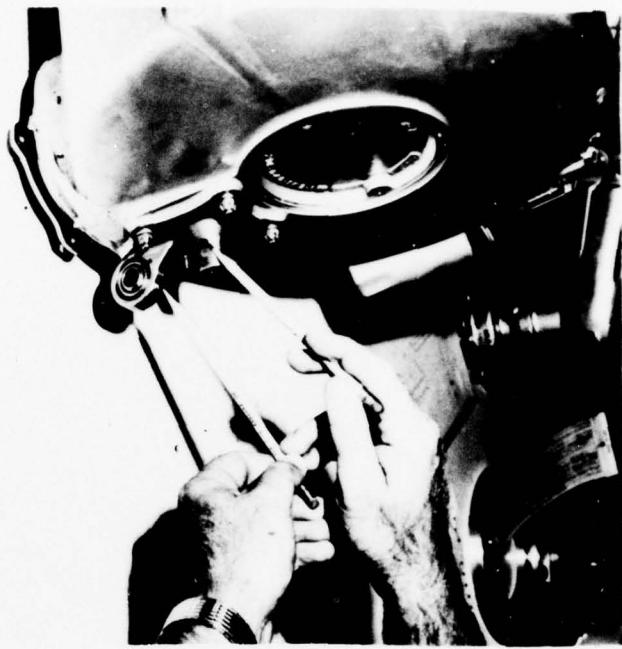
Fig. 18 Model OH-58A, Lower Transmission Case After Failure, BHC Photo 284118

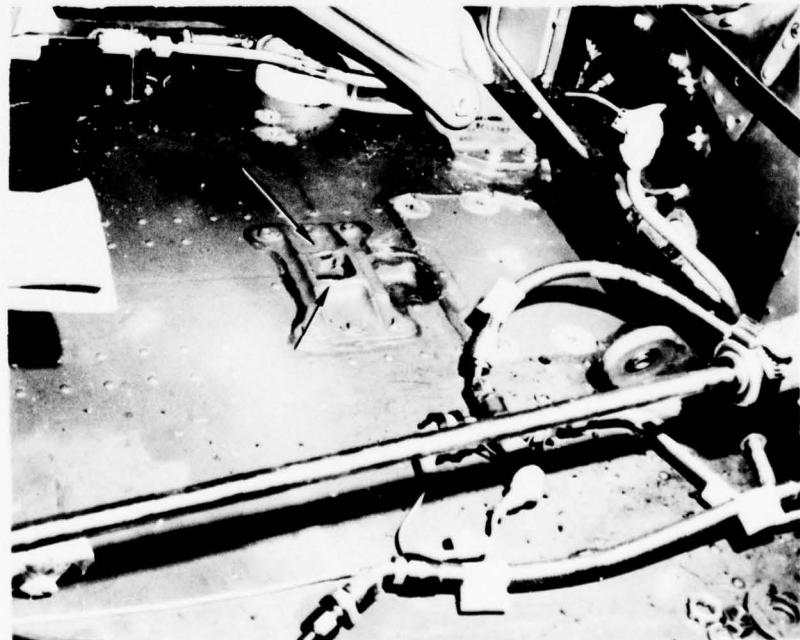
Fig. 19 Model OH-58A, Pylon Area After Tailboom Failure, BHC Photo 284120

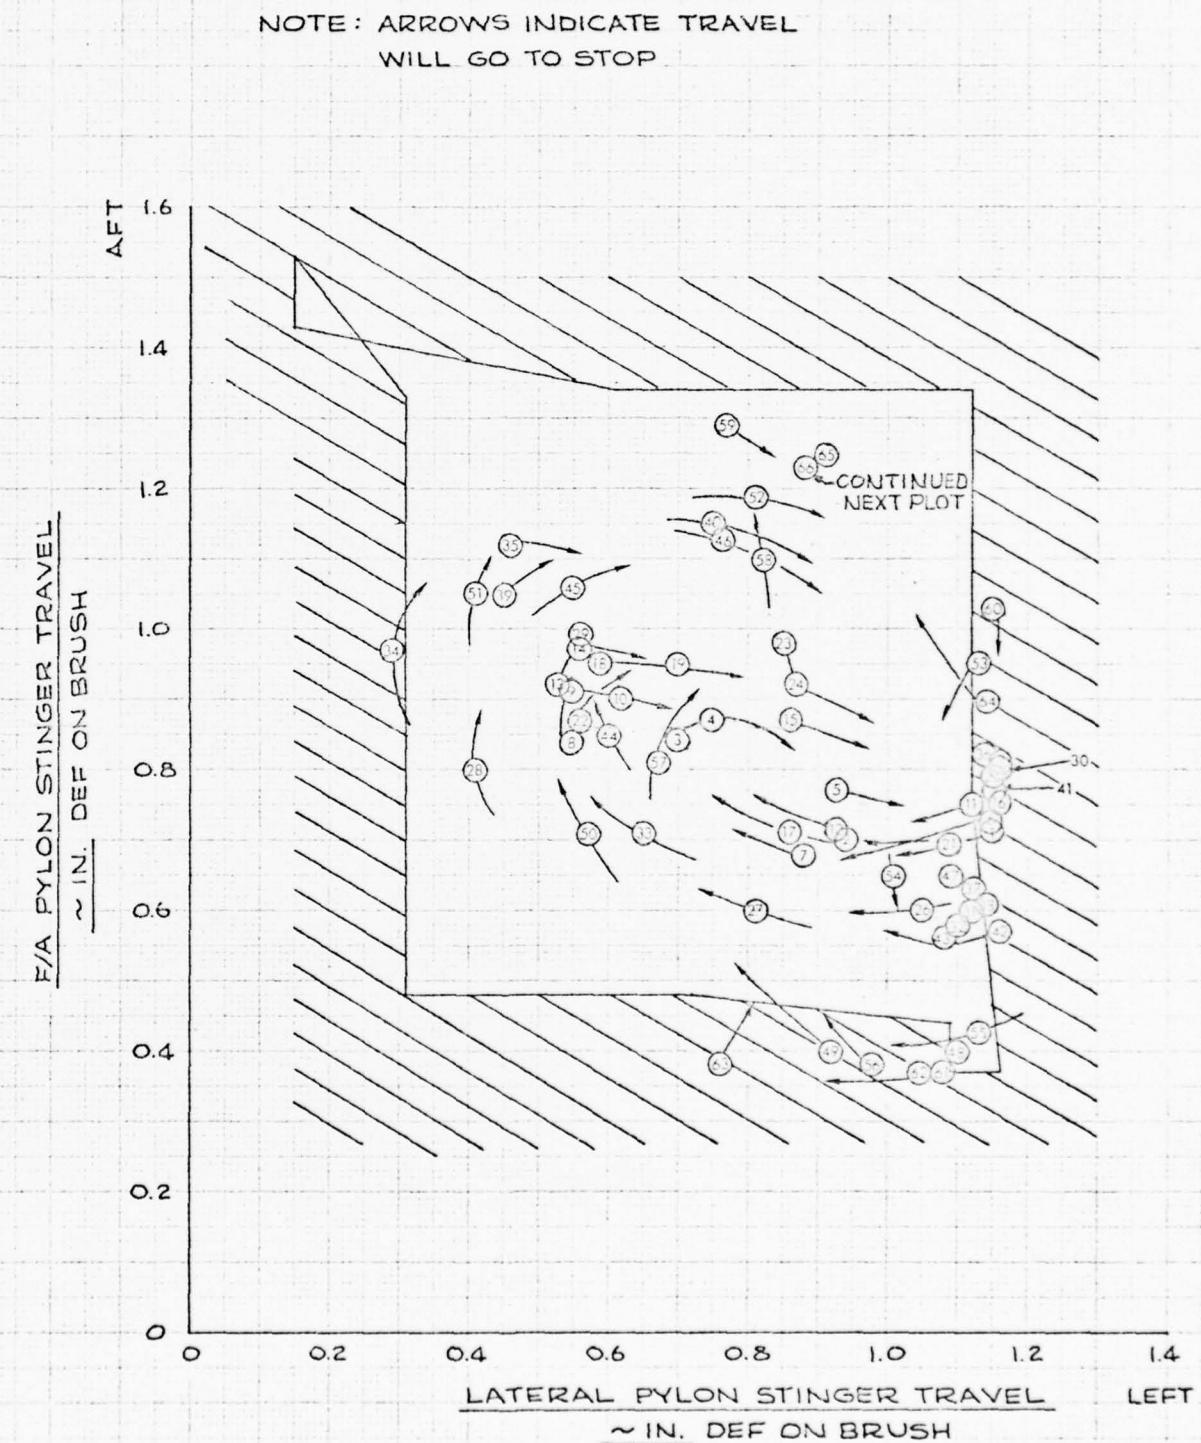
FIG. 21 PYLON POSITION DURING TAILBOOM FAILURE

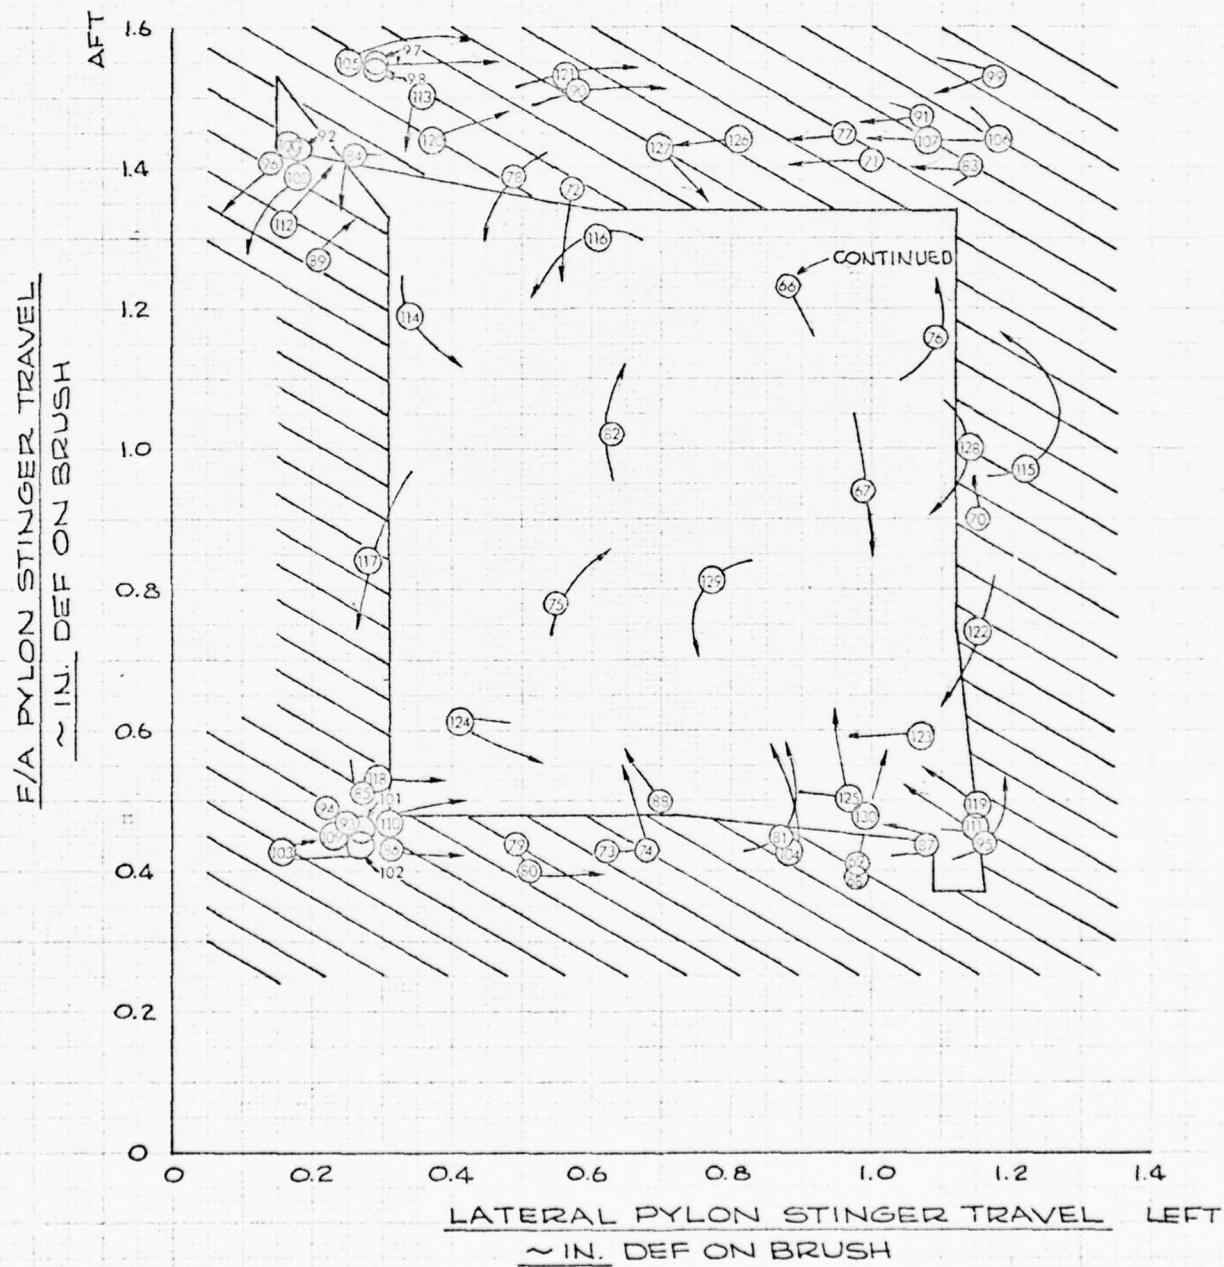
FIG: 22 PYLON POSITION DURING TAILBOOM FAILURE
