RECREATIONAL BOAT SAFETY  
COLLISION RESEARCH-PHASE II

VOLUME II - COLLISION ACCIDENT  
INVESTIGATIONS - 1975

1. Report No. CG-D-129-76		2. Government Accession No.		3. Recipient's Catalog No.	
4. Title and Subtitle RECREATIONAL BOAT SAFETY COLLISION RESEARCH — PHASE II Volume II — Collision Accident Investigations - 1975				5. Report Date July 1976

6. Performing Organization Code	
7. Author(s) R. MacNeill, S. Cohen				8. Performing Organization Report No. MSR 76-39	
9. Performing Organization Name and Address Wyle Laboratories P.O. Box 1008 Huntsville, Alabama 35807				10. Work Unit No. (TRAI5)

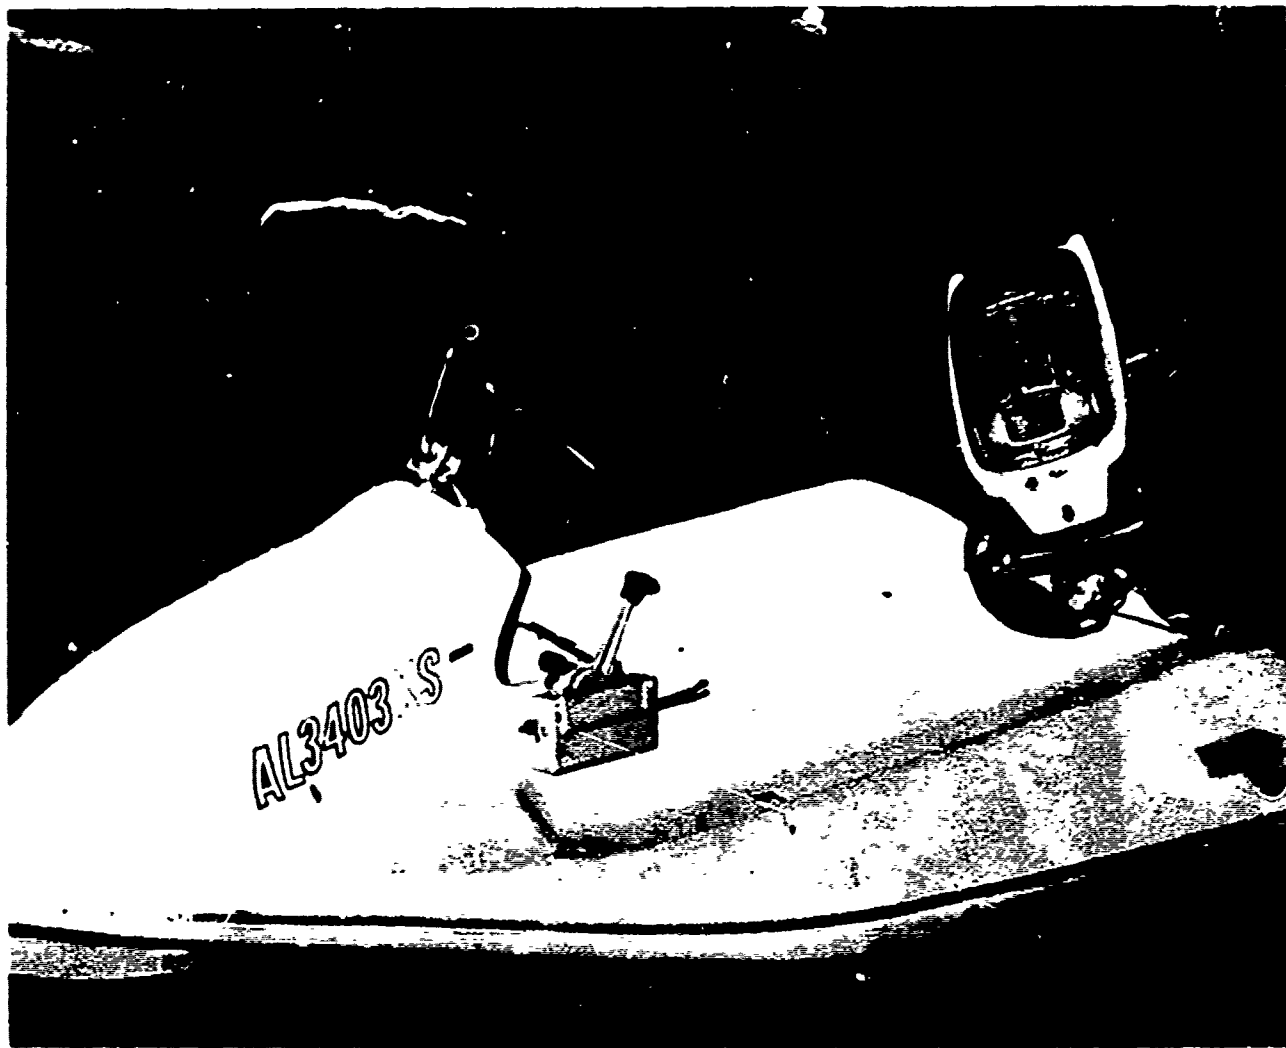
Photograph 2. Water Scooter After Accident No. 166; May 27, 1975

The boat hull photographs, and the testimony of the investigating officer and the bystander all indicate that damage was found on the starboard side of the water scooter as shown in the boat damage sketch (Figure 3).

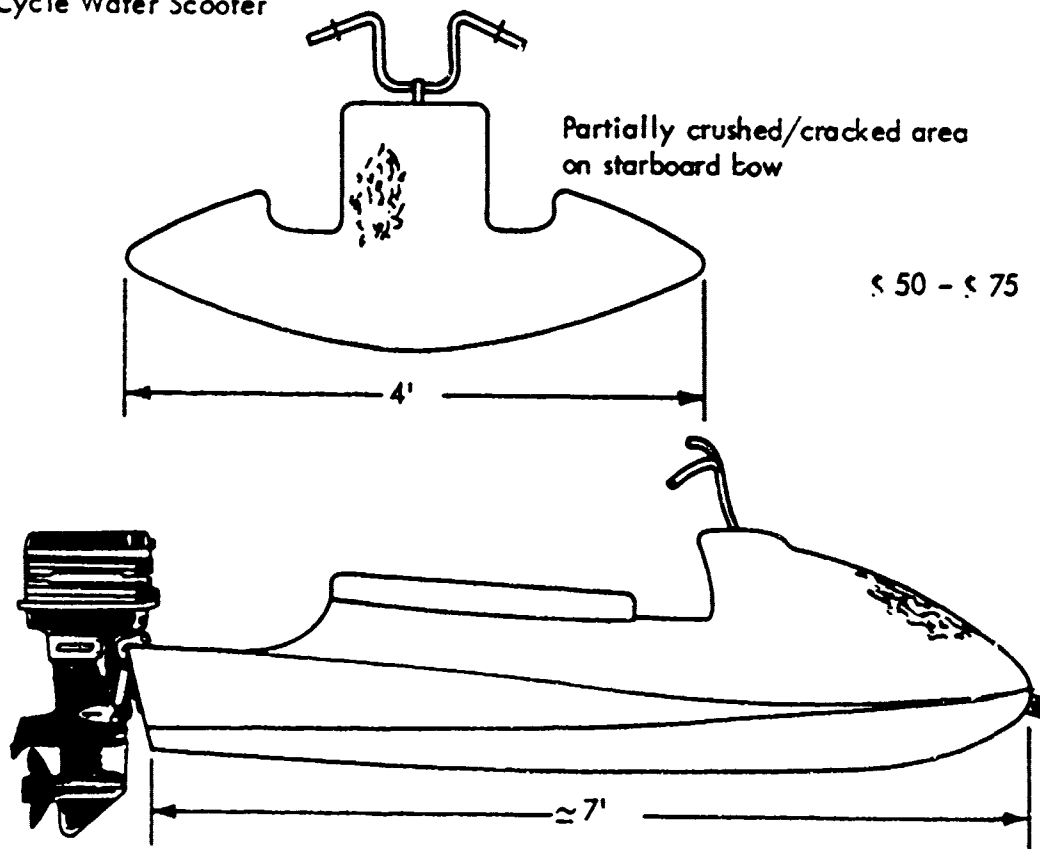
Examination of the boat showed minor damage on the port bow about 6' aft (see Figure 3). Of considerable interest was the fact that this small runabout was equipped with twin 135 hp Mercury outboards with power trim. The transom had been raised to accommodate the motors. They were each equipped with two bladed bronze cupped props. Twin single lever Mercury controls were used. Otherwise, the boat appeared well kept and in good working order. The only exception was that the starboard running light was inoperable (blown lamp). All steering and engine controls operated properly. However, the controls for the power trims were mounted on a wooden panel, but were not connected to any boat structure. They were simply lying on the deck by the operator's right foot. Apparently, the installation was never completed. The 18 gallon tank was about 1/4 full. The boat was kept stored in a garage at the owner's father's home (see photographs 5-8).

Figure 3. Damage to Boats: Several Nick Marks Less Than 1" Long In Gelcoat At Location Shown on the Water Scooter

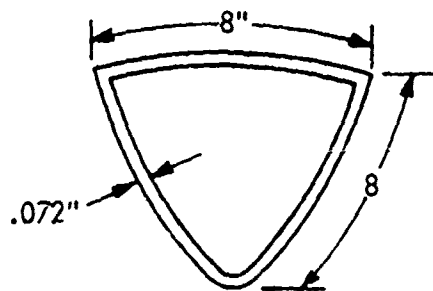
In order to collapse the bow sufficient force must be applied to cause permanent yielding of the aluminum over an area of a curved triangle some 8 in. on a side. See sketch below.

The area of metal involved would be approximately  $3 \times 8 \times 0.072 = 1.728 \text{ in}^2$

The depth of collapse is estimated as at least 8 in.

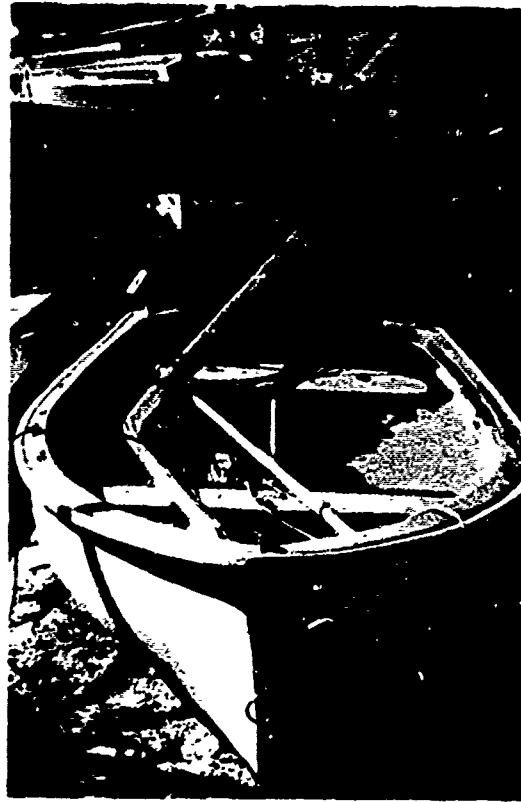
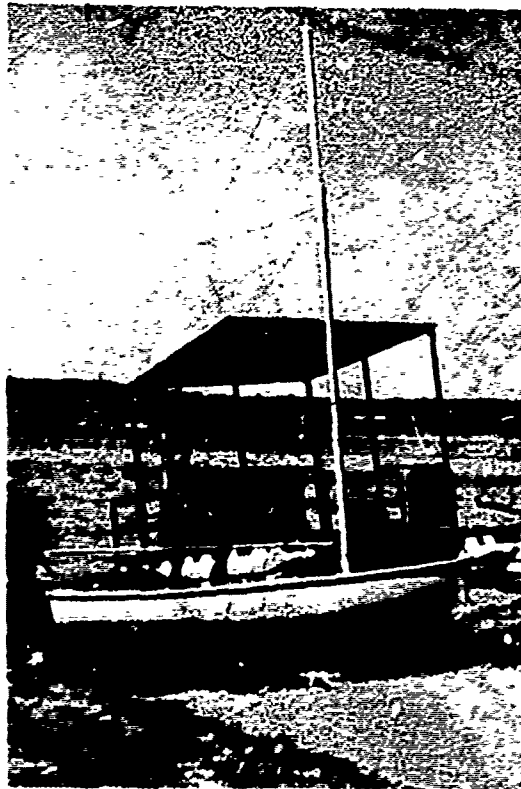
Figure 4. (Top) - Damaged Boat Showing Bent Mast  
(Bottom) - Sistership to Damaged Sailboat

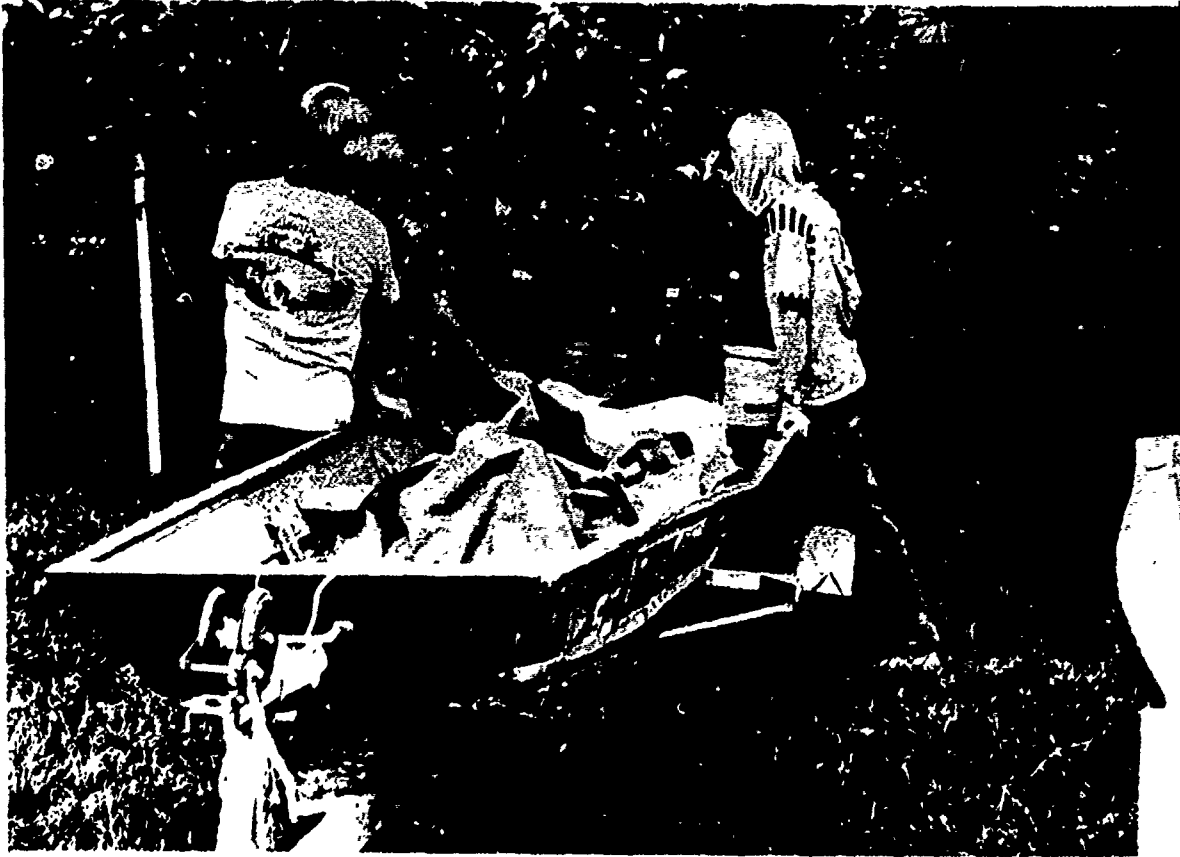
The johnboat's bow was high, making the center of lateral resistance of the hull quite close to the transom. Therefore, when Boat # 1 hit the side of the johnboat, near the bow, the johnboat pivoted about its center of lateral resistance, and in effect, moved out of Boat # 1's path, thus avoiding for more serious damage.

Figure 7      Johnboat - Note Patch Over Damaged Area
