SS SILVER DOVE CARGO SHIFT AND SINKING IN THE NORTH PACIFIC OCE--ETC(U)

MARINE CASUALTY REPORT

**SS SILVER DOVE; CARGO SHIFT AND SINKING
IN THE NORTH PACIFIC OCEAN ON 2 APRIL 1973
WITHOUT LOSS OF LIFE**

REPORT NO. USCG/NTSB - MAR-76-1

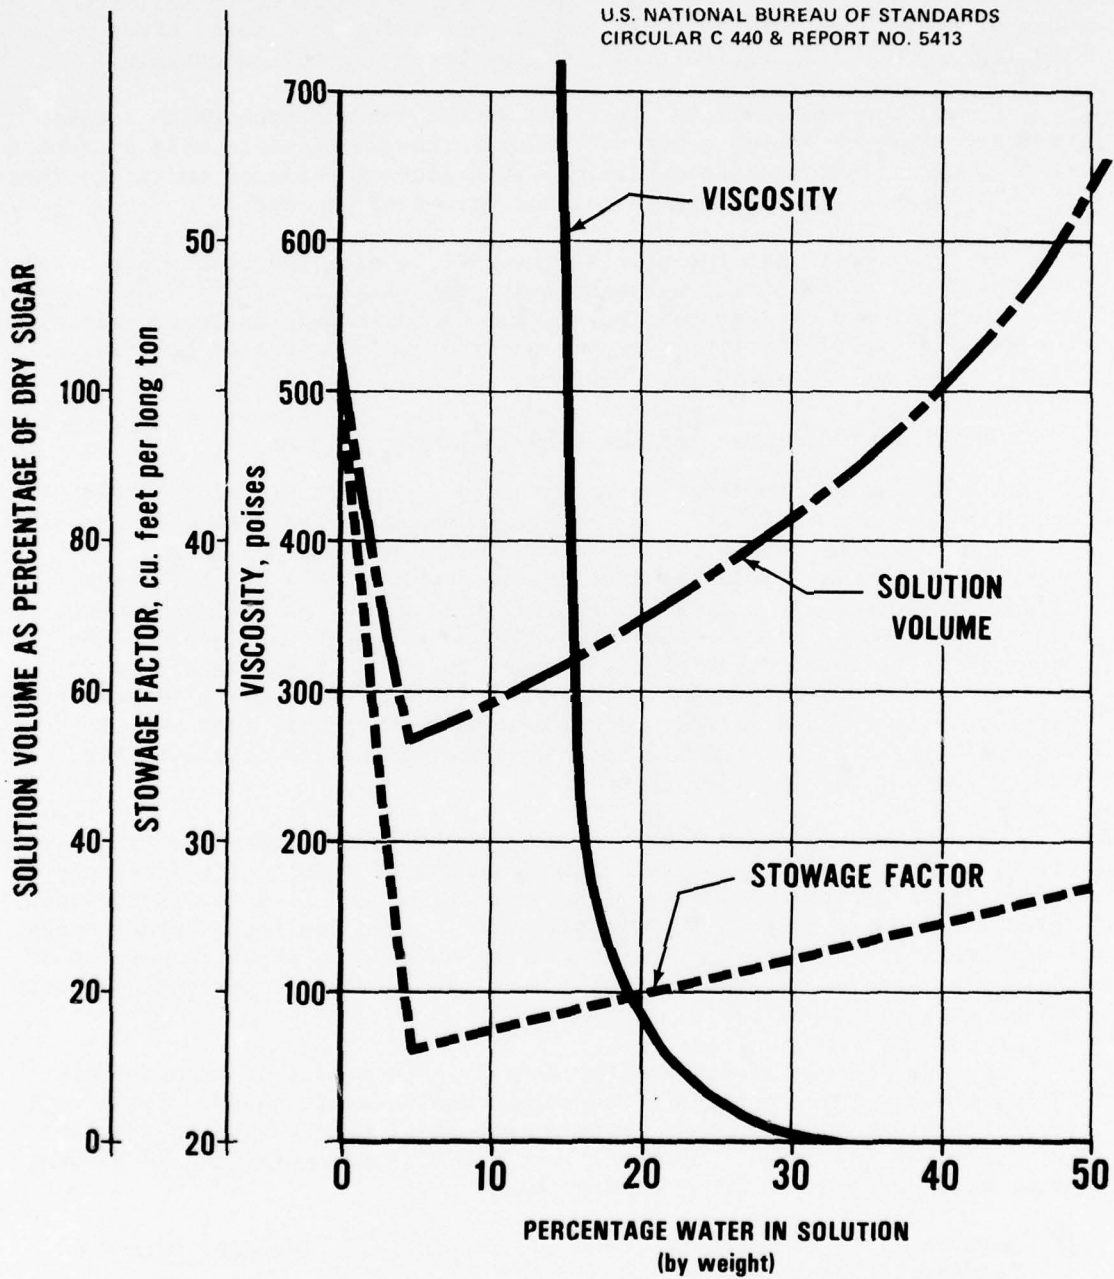
FIGURE 1. CHARACTERISTICS OF SUGAR SOLUTIONS

Raw sugar can also develop sufficient strength to support itself over regions where voids or cavities are created by the addition of water. Because of this, raw sugar in the SILVER DOVE's lower 'tween space and above may have remained above the hatch beams instead of feeding into the void that was created when sugar in the lower hold contracted as water was added. (See figure 2.)

If water infiltrates sugar faster than the sugar can dissolve into a homogeneous solution, gravity causes the excess water to flow through the sugar. This flow washes the liquid coating off the wet sugar crystals creating a solution of increasing viscosity. As the solution's gravity flow slows, it causes the infiltrating water to rise to the surface near its source. Normal vessel motions would be expected to accelerate water infiltration into raw sugar. If the infiltration is stopped or reduced, the liquid concentration near the source will diffuse into the surrounding sugar.

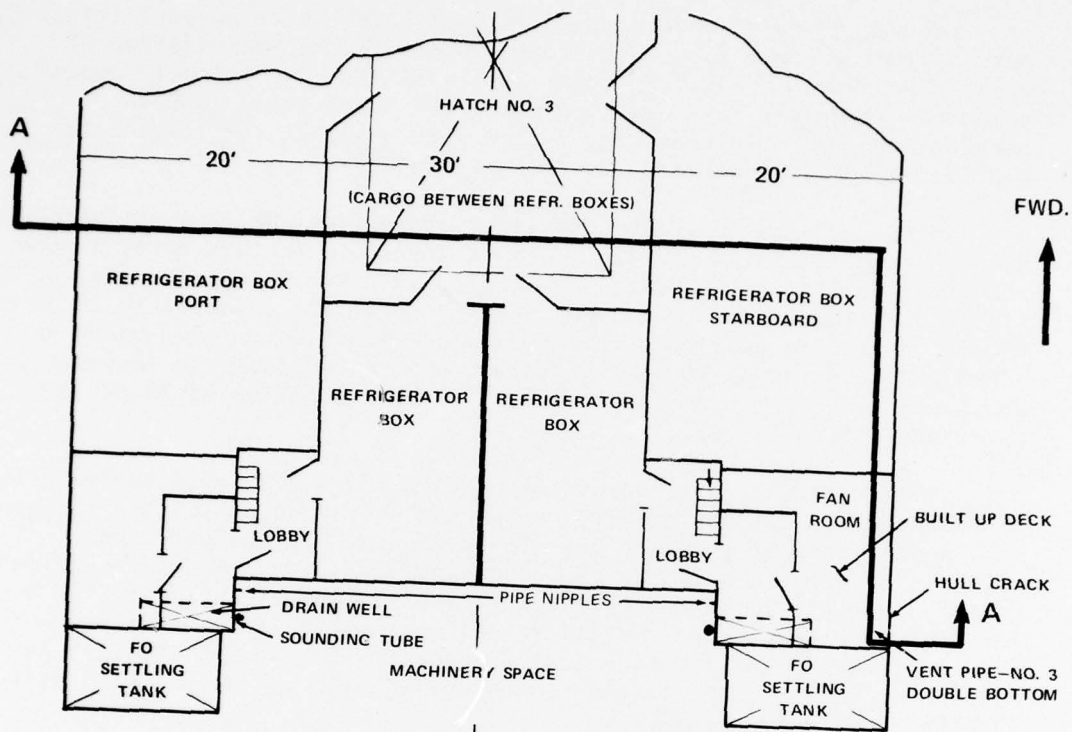
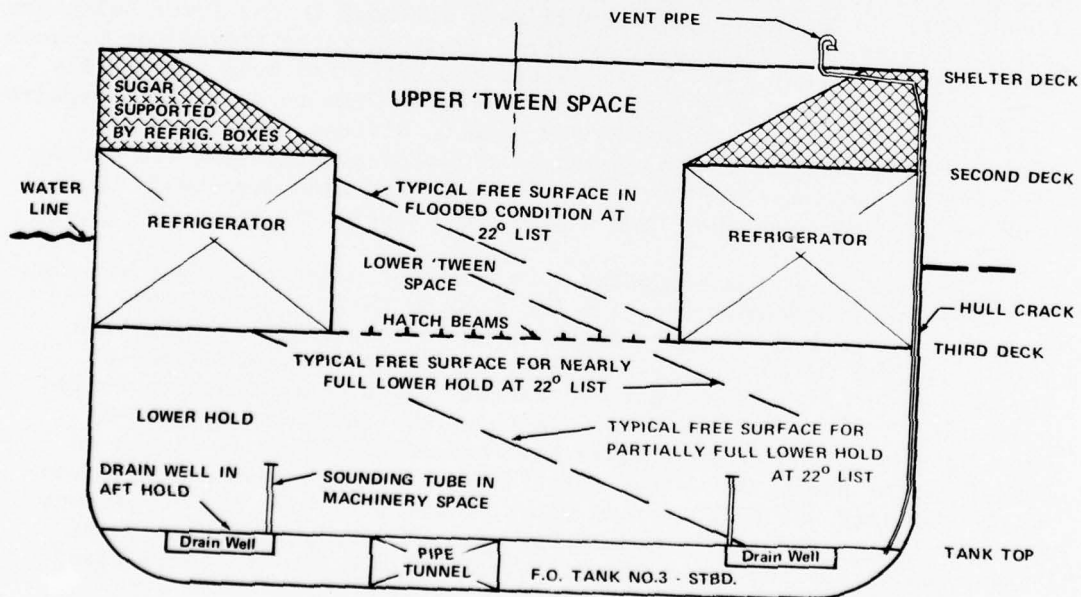
FIGURE 2. CARGO HOLD NO. 3

The existence of a homogeneous solution of water and sugar was not a likely, or necessary, condition for a cargo shift. It was only necessary for the sugar-water solution on the starboard side to flow into a void on the port side. A large void could have developed on the port side if the dry sugar contracted into a concentrated solution containing just 10 percent water. A solution containing 20 percent water on the starboard side would have become sufficiently liquid to flow into the port void as the ship listed. (A heterogeneous solution which contained about 10 percent water on the port side and 20 percent water on the starboard side would have been a likely distribution of water considering the water was infiltrating from the starboard side;

this distribution would have required the infiltration of less than 315 LT of water. More than 315 LT of water could have leaked through the crack before the SILVER DOVE listed 22°.)

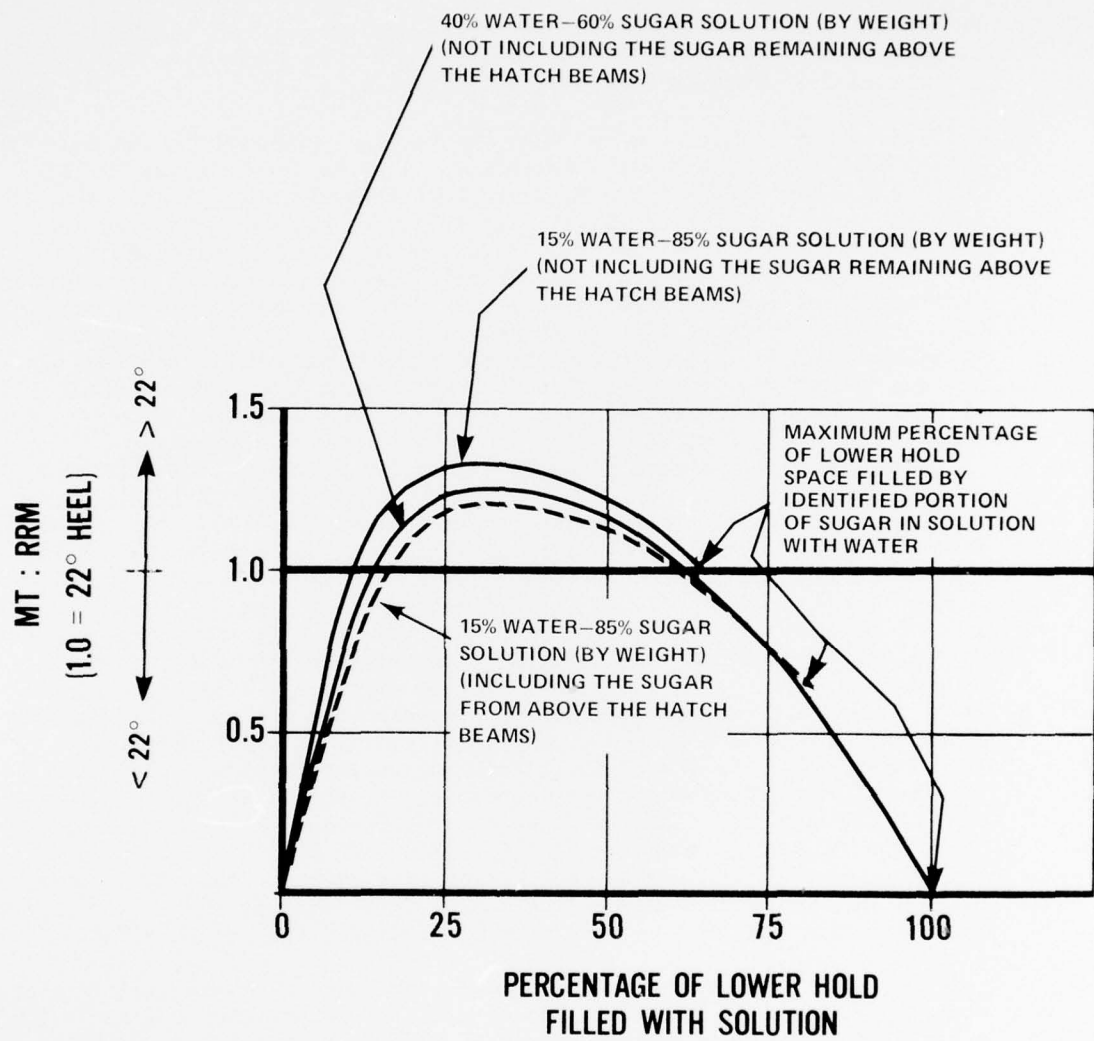
FIGURE 3. RANGE OF CARGO CONDITIONS NECESSARY TO CAUSE 22° LIST

For each sugar-water solution ratio, there is a maximum volume of solution that can be formed in the hold; it is determined from the dry sugar volume and the ratio of water and raw sugar in solution. (See figure 1.) The maximum volume of a solution containing 15 percent water and only the sugar in the lower hold would occupy about 65 percent of the lower hold space. A solution of 40 percent water and only the sugar from the lower hold would require slightly more space than that available in the lower hold. If the sugar above the hatch beams as well as that in the lower hold mixed with water to form a solution that was 15 percent water and 85 percent sugar, it would occupy about 81 percent of the lower hold space. (See figure 3.)

For the ratios of water and sugar considered, the 22° list of the SILVER DOVE would have developed when the sugar-water solution filled about 65 percent of the lower hold space. Greater quantities of solution would not have provided a sufficient void for a cargo shift to cause a 22° angle of heel. If the solution filled between 10 and 65 percent of the lower hold space, the angle of heel would have exceeded 22°. Quantities of solution in less than 10 percent of the lower hold space would not have weighed enough to cause the SILVER DOVE to heel 22°.

Pumping the solution overboard would only have increased the SILVER DOVE's angle of heel until the solution remaining occupied less than 10 percent of the lower hold volume. Not only would it have been necessary to pump at least 1,800 LT of solution overboard to make this reduction, but the ship's heel angle would have had to increase to some maximum angle and then decrease again. Since a steadily increasing list to port was observed, the quantity of water and sugar which caused the 22° angle of heel had to have occupied nearly 65 percent of the lower hold volume. Without pumping a considerable amount of sugar and water solution overboard, the 22° angle of heel would have been caused by mixing of the sugar in the lower hold in a solution with between 15 and 20 percent water.

Nearly 500 LT of solution had to shift to cause the 22° angle of heel. The Coast Guard's calculation of the necessary weight shift, using a KG of 27.2 feet, differed from that of the Safety Board which determined the KG to be 25.9 feet before correcting for the effects of water in the cargo. The Coast Guard probably did not adjust its calculation to correct for the loss of free surface in the initially half-empty No. 2 double-bottom tanks and probably applied too large a correction for the free surface in No. 5 deep tanks at 22° heel angle.
