12
B.S.
PTPD REPORT NO. 77-14
AFPEA PROJECT NO. 77-P7-5 ✓

VIBRATION TEST OF ACA-805

CONTAINER FOR BL-755

March 1977

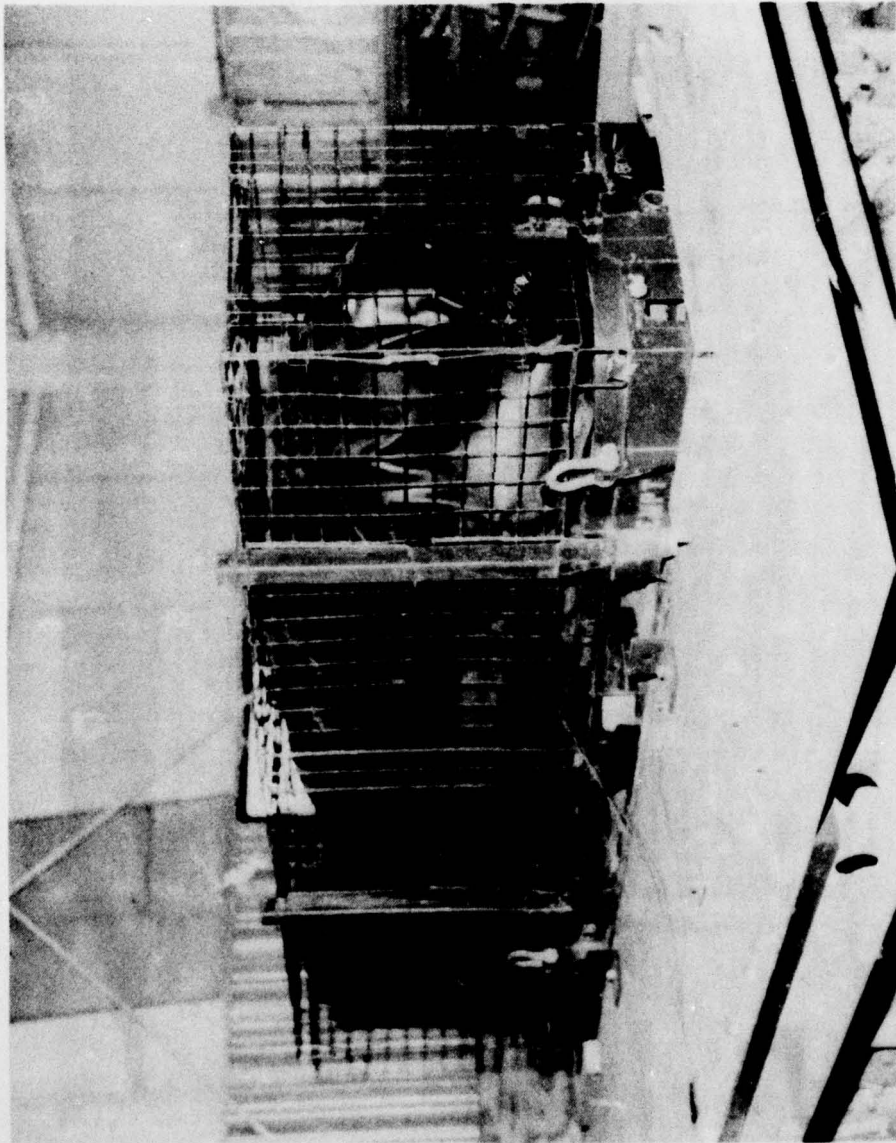
DESCRIPTION OF TEST SPECIMEN: The overall dimensions of the prototype were L 108" x W 28 1/2" x H 33". The gross weight of the prototype was 1100 pounds. The net weight of the BL-755 was 605 pounds. A general view of the prototype is shown in Figure 1. An end view of the prototype is shown in Figure 2. The prototype consisted of a metal base with elastic shock mounts and sheet metal cradles to support the BL-755. A sheet metal cap conforming to the upper half of the BL-755 body was connected to the supporting cradles by means of four adjustable latches on each side. A heavy duty, flexible, rubber-like fabric bag serving as a waterproof barrier was fitted over the BL-755 and was sealed in a groove along the entire perimeter of the base by an air pressure tube integral to the bag. The load was boxed in by a wire cage-like structure and four metal posts fastened to the base.

FIGURE 1 - GENERAL VIEW OF ACA-805 CONTAINER

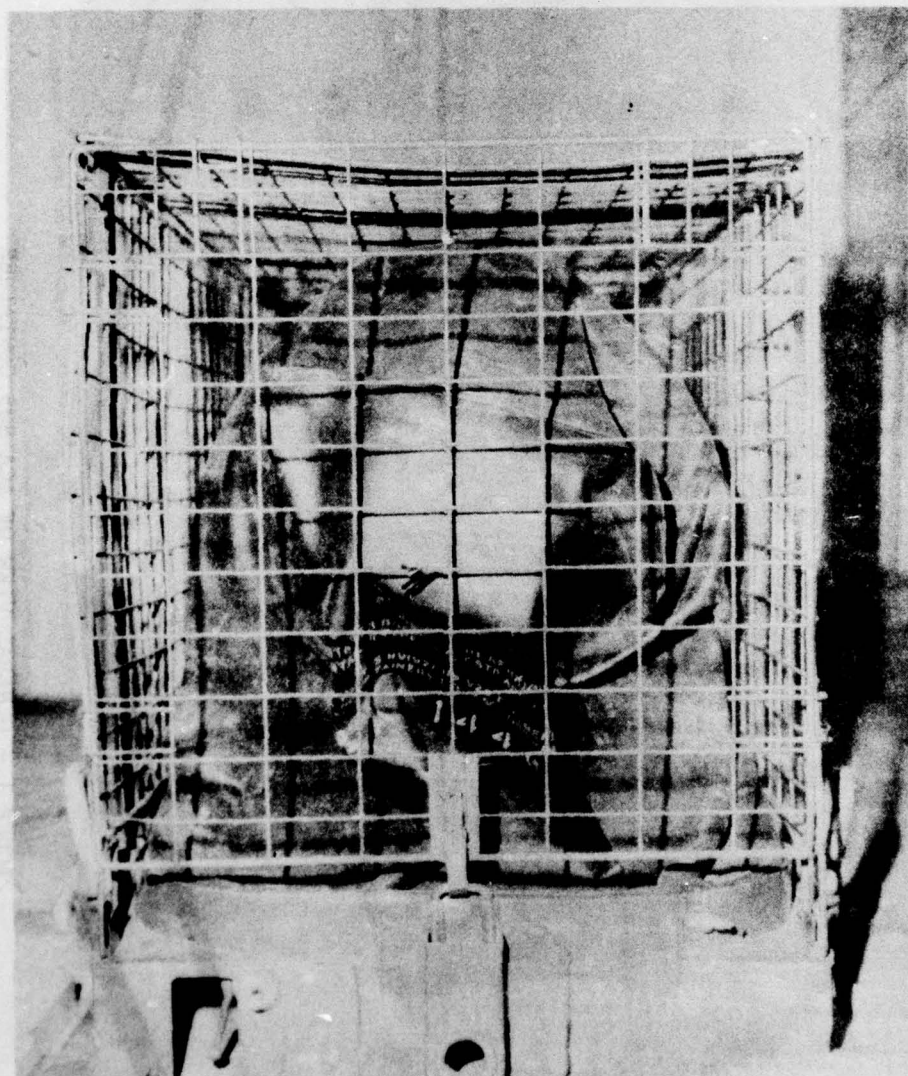
INITIAL INSPECTION: During initial prototype inspection, it was noted that the prototype was intact and no external damage had been incurred during shipment (Eglin to AFPEA). The end latches of the wire cage had become unlatched. It was further noted that the wire cage components were tied together by bits of wire at numerous points. Although the cage was somewhat loose, the pins inserted through the lower end of the posts served to hold the cage down.

FIGURE 2 - END VIEW OF PROTOTYPE AS RECEIVED

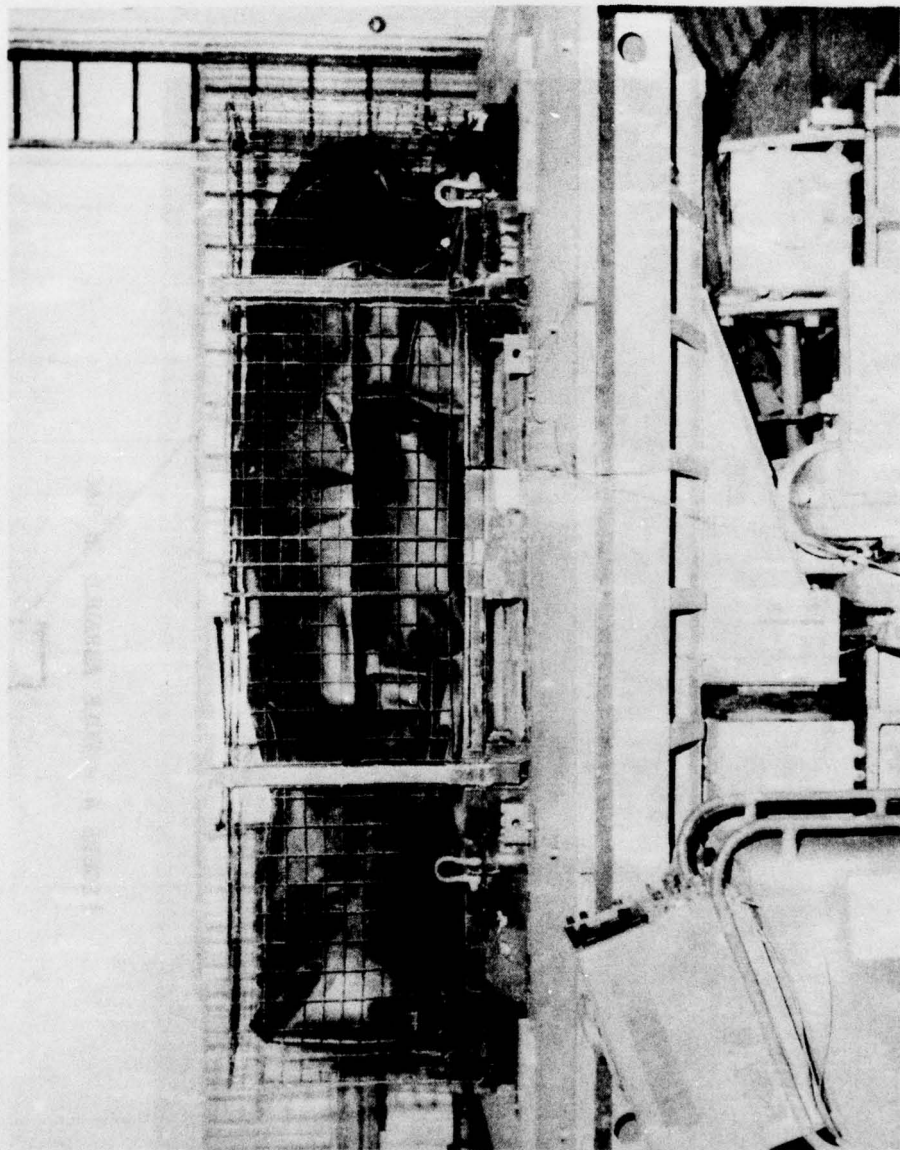
VIBRATION APPARATUS: A L.A.B. Corporation vibration machine, Serial No. 56801, type 5000-96B, which has a frequency servoloop constant displacement cam linked motor drive, was used. The vibration machine's maximum load capacity is 5000 pounds vibrated at 3 Gs peak sinusoidal acceleration from 0 to 40 Hertz (Hz). A 144" x 96" x 1.5" plywood deck was mounted on the 96" x 98" vibration machine table which provided an adequately supported, flat bearing surface for the 1100 pound prototype. Excessive horizontal container motion was limited by barricades nailed to the plywood deck 1/2 inch from the container which was centered on the vibration machine table. Figure 3 shows the prototype mounted on the vibration table.

FIGURE 3 - PROTOTYPE ON VIBRATION MACHINE

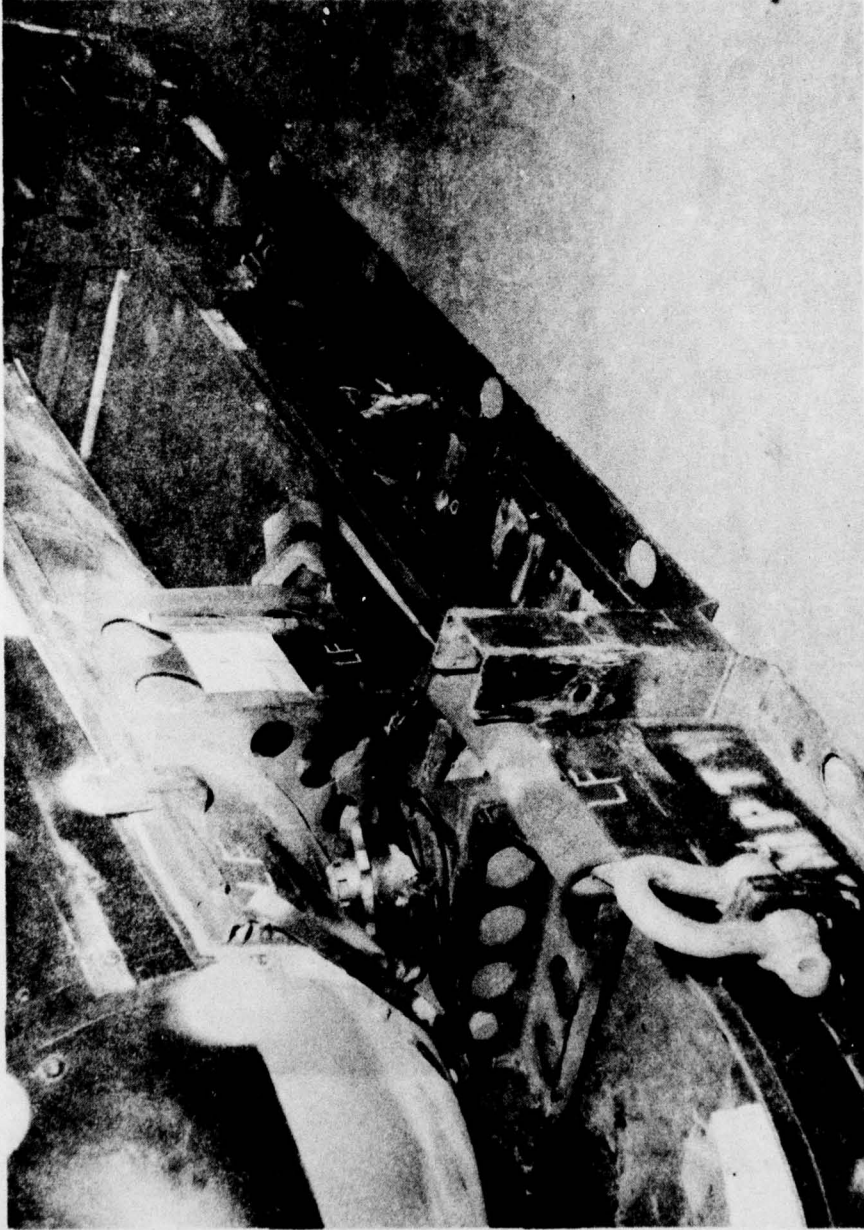
The front sheet metal suspension support was completely collapsed so that the left and right vertical shock mount pins had abraded the underside of the cradle and had significantly dented both the cradle and the BL-755 item skin. These conditions are shown in Figures 6 and 7. A general view of the BL-755 and mountings after vibration test is shown in Figure 8. The apparent under design of the suspension structure, the heavy load reaction at this point, and the observed initial buckling (see initial inspection) are considered to be factors contributing to total collapse of the front suspension system. Generally, the rubber in the shear isolation mounts incurred rubber metal bond failure and tearing of the rubber.

FIGURE 6 - - LEFT FRONT MOUNT AFTER VIBRATION
