USAARL REPORT NO. 77-7

AEROMEDICAL EVALUATION OF UH-1 INTERNAL ADVANCED PERSONNEL RESCUE HOISTS
WESTERN GEAR CORPORATION HOIST MODELS 42277R1 AND 42305R1
BREEZE CORPORATION HOIST ECP-720 MODIFICATION

February 1977

US Army Aeromedical Research Laboratory
Fort Rucker, Alabama 36362

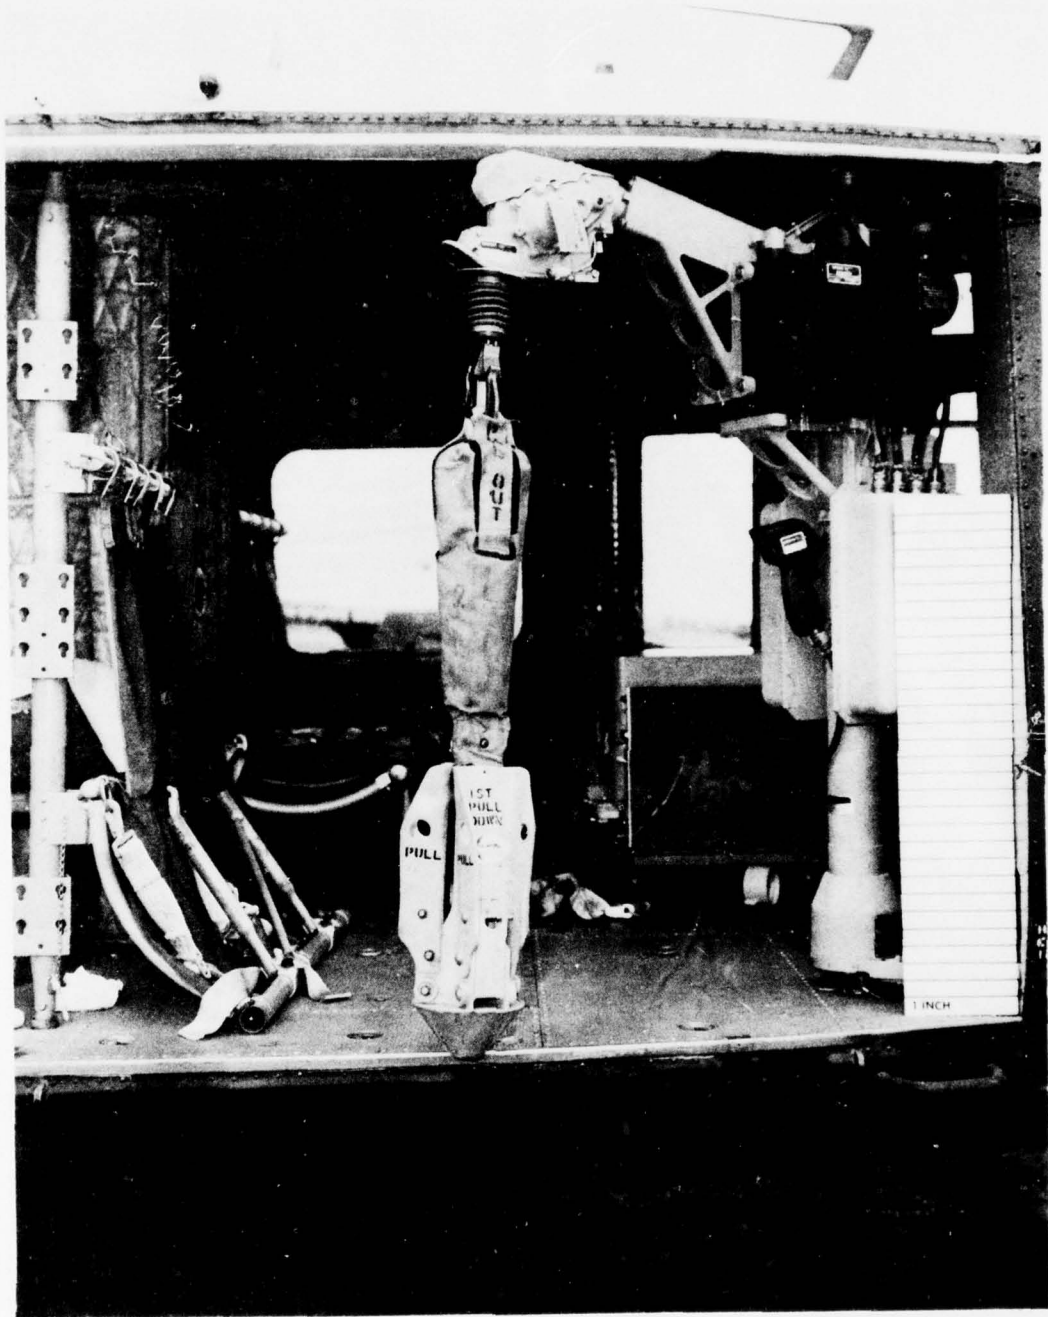
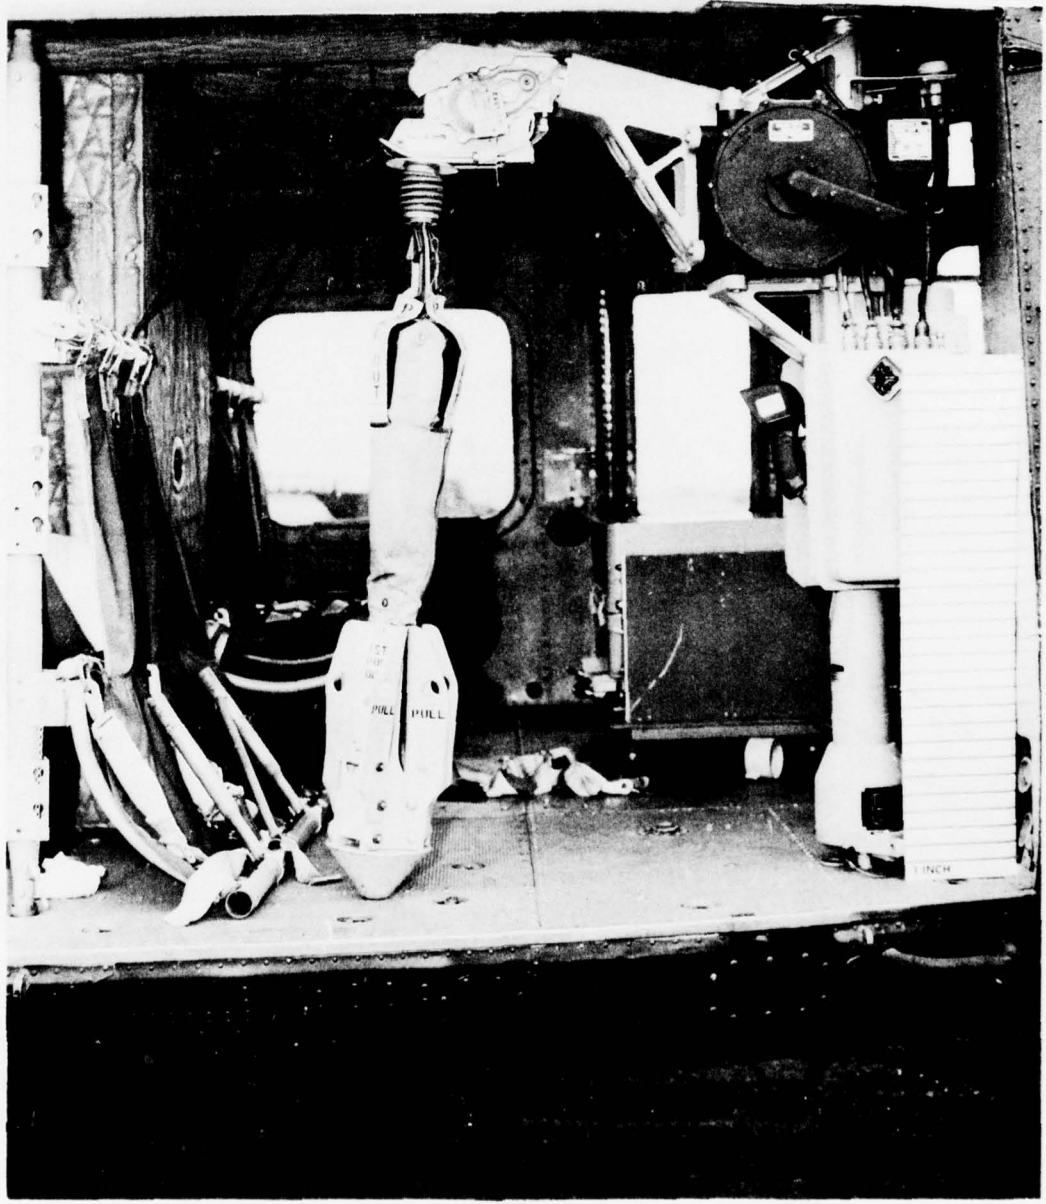
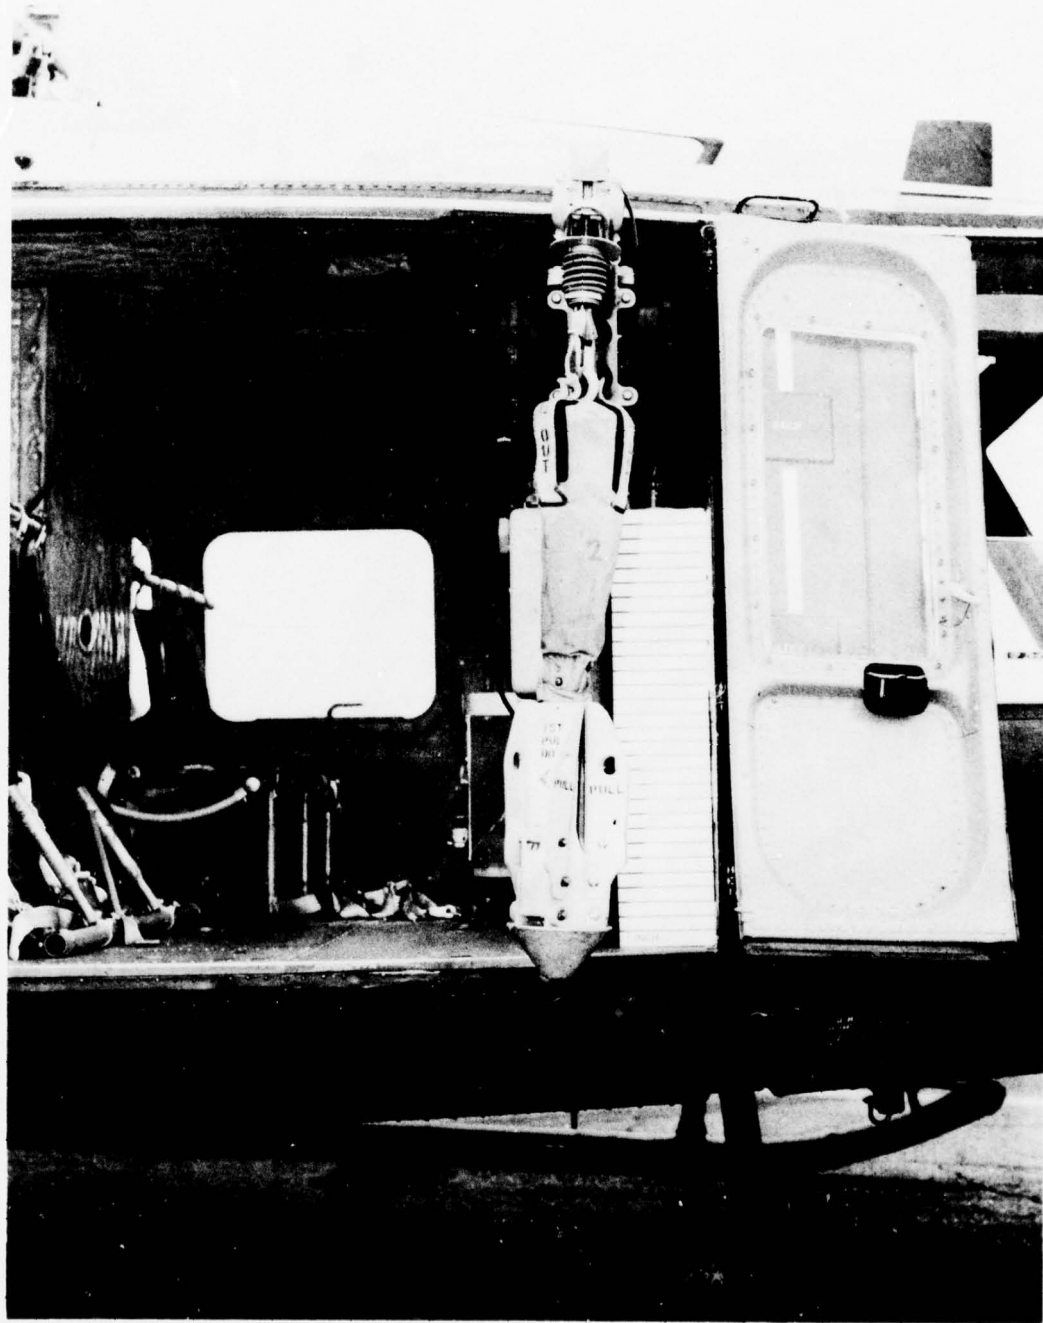
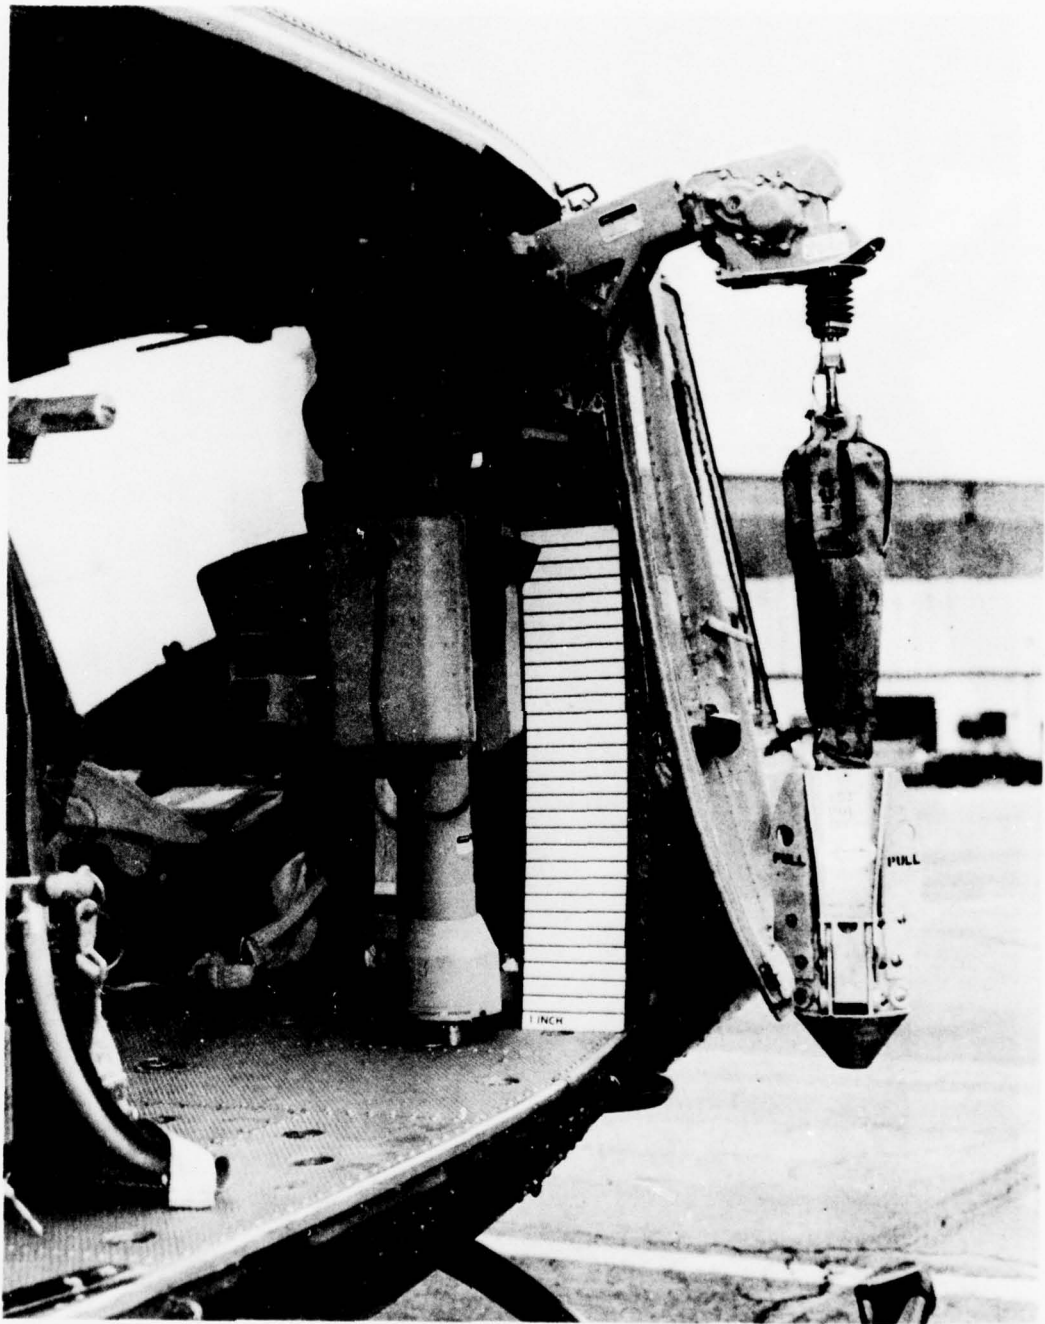
Photographs A, C, E, and G illustrate the WGH hoist effect on entrance door and cabin space compared to the Breeze ECP-720 hoist photographs B, D, and F. Conservation of entrance door space, as well as absence of actuator base plate, is noted in photographs of WGH.

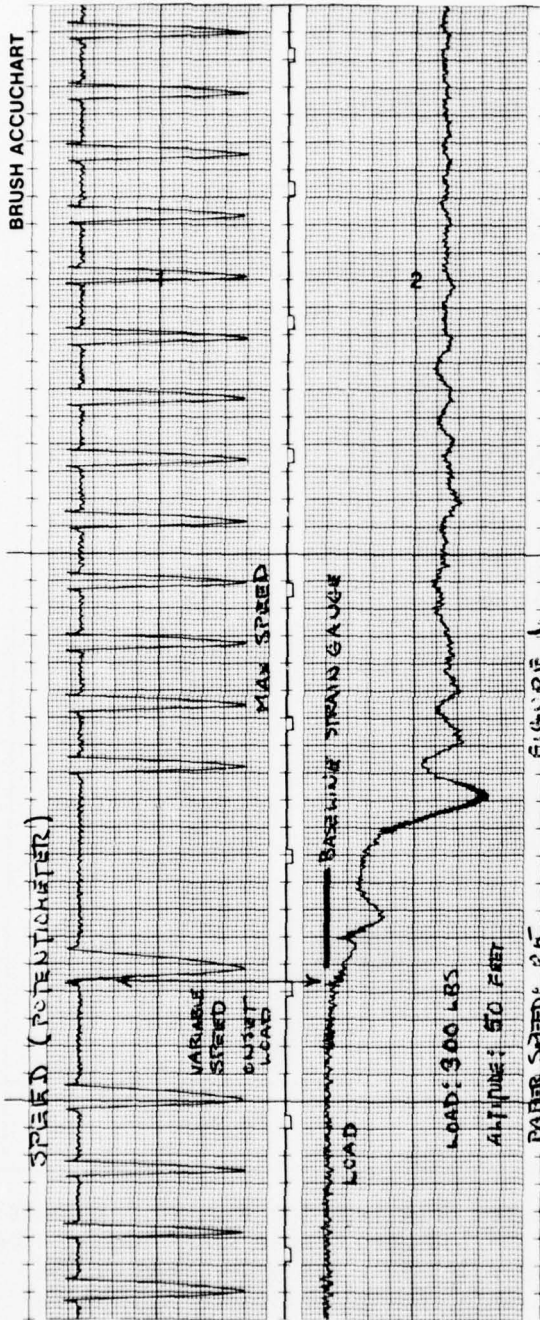
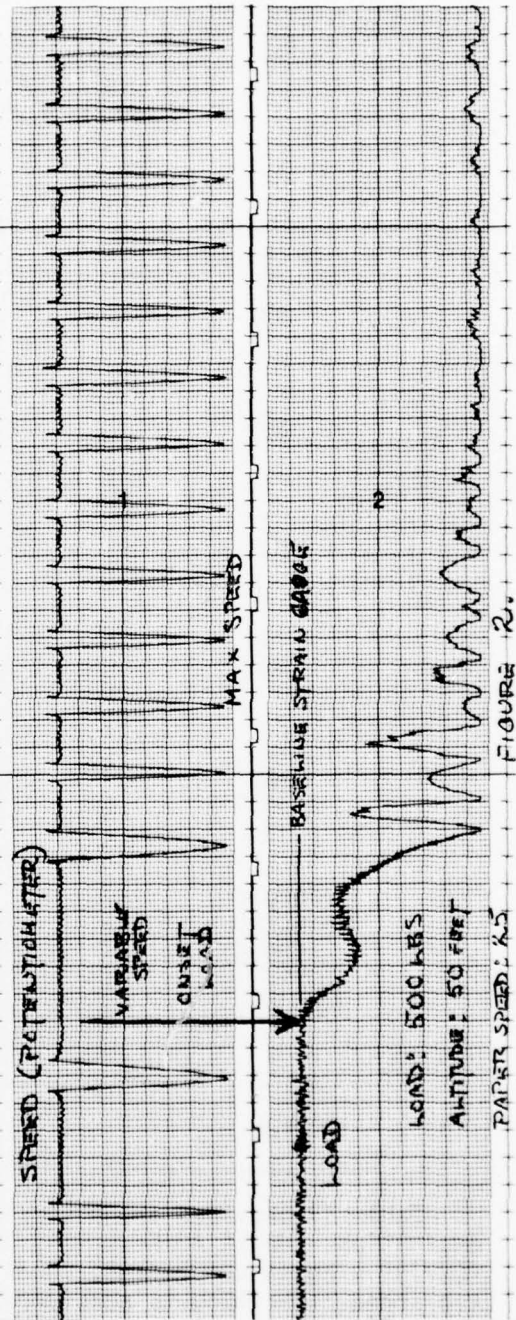
Figures 1 and 2 illustrate data obtained for speed determination.
