CRITICAL DESIGN REVIEW UH-1N HELICOPTER RESCUE HOIST

TECHNICAL REPORT ASD-TR-73-25

JULY 1973

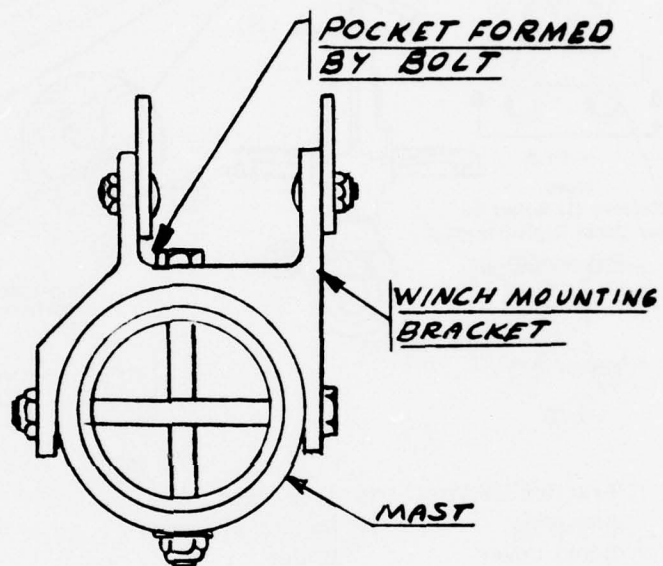
FIGURE 2

(4) Winch-to-Mast Connection - The brackets which facilitate mounting the winch on the vertical mast have been analyzed and found to be structurally adequate. It was determined, however, that a potential cable snag area is formed by a hex head bolt in the top mounting bracket (Fig 2). This condition can be corrected by substitution of an oval head machine screw.

(9) Upper Winch Mount - Replace the hex head bolt in the upper winch mount with an oval head machine screw to eliminate a pocket for potential cable fouling (Fig 2).

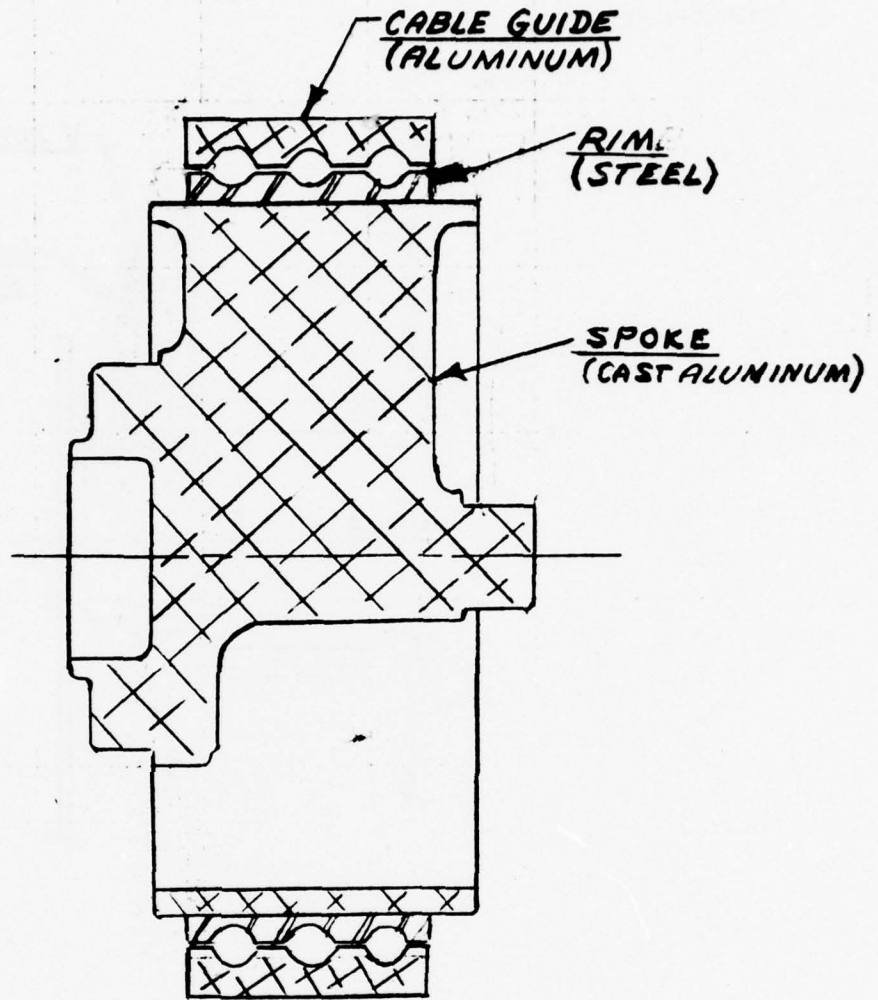
FIGURE 3

(a) Failed Spokes - At 4,000 lift cycles (last 1,400 at 600-pound load) into the cable evaluation portion of the CDR, the secondary capstan spokes failed with resulting cable failure. Suspected cause of the capstan failure was metal fatigue in the cast aluminum spokes. The hoist involved came to the CDR directly out of overhaul. Overhaul records do not record previous hoist use (cycles or hours); however, it was shown that the secondary capstan had never been replaced.

(b) Capstan Rim Slippage - At 1,551 cycles into the electro-mechanical evaluation testing (51 cycles at 600 pounds load), the cable failed. An exterior inspection of the winch was made and no cause could be determined. A new cable was installed and the cycling continued at 600 pounds load. At 1,771 cycles the cable again failed. Both cables were inspected and it was found that the inner core failed while the outer strands were still intact; i.e., there was no visible indication of damage until final failure. At this point the winch was partially disassembled and it was found that the grooved steel rim had slipped 1/16 inch axially along the cast aluminum capstan body and had forced the cable against the aluminum cable guide (Fig 3). Cable failure was attributed to the binding and pinching action between the rim and bear claw. No definite cause of rim slippage was determined. However, there were three noteworthy, associated conditions. There was a snapping noise in the secondary capstan area which started at about 1,500 cycles. Subsequent inspection revealed that the shrink fit dimensions between the rim and capstan were slightly loose and out of tolerance. Finally, both spoke failure and rim slippage occurred at 600 pounds load.

(c) Corrective Design Change - The in-house review team and Breeze Corp analyzed the failures described in (a) and (b) above. The out-of-tolerance condition was considered a possible cause for the lateral rim slippage but was discounted as a reason for spoke failure. Excessive winch bearing mount deflection was also considered as a potential cause of both the spoke failure and the rim slippage. This consideration was based on the fact that original winch qualification (endurance cycling at high load) was conducted at Breeze Corp with the winch mounted on a relatively massive test fixture. The CDR testing was conducted with the winch mounted on the relatively flexible mast. It was agreed that verification of such a theory would require additional extensive testing. The correction that appeared most promising was incorporation of a steel capstan of heavier section than the present cast aluminum/steel design.

(2) Secondary Capstan - Incorporate a steel secondary capstan in the winch to replace the existing aluminum and steel unit (Breeze P/N BL-5164). Configure the grooved surface so that the need for a side spacer (P/N BL-8079) is eliminated.

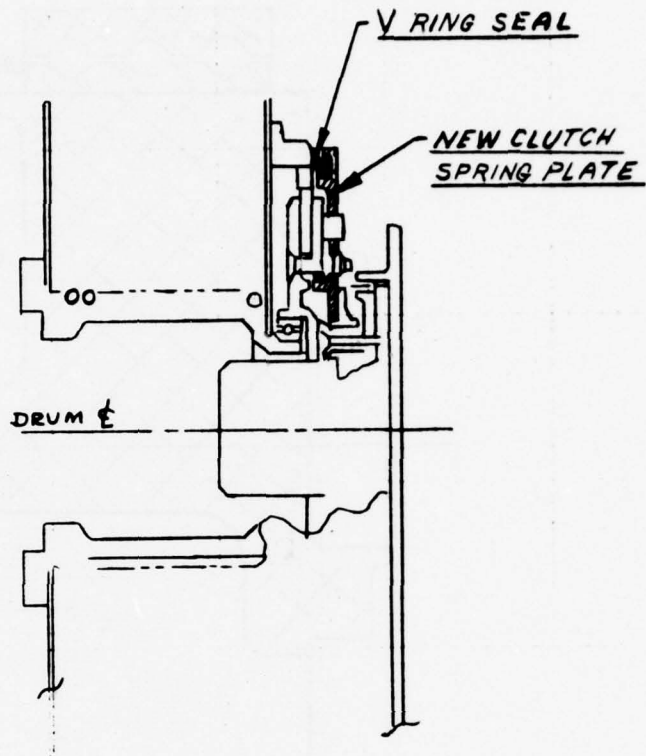
FIGURE 4

(a) Cable Spooling - When foreign material, such as water or grease, infiltrate the clutch area, the tensioning function of the clutch deteriorates to the point where the cable spools on the storage drum. This spooled cable can, and does, loop over the drum flange and fouls/binds when cable is subsequently payed out. This binding action creates excessive tension which finally severs the cable. Entry of foreign material can be stopped by installing a permanent clutch area seal (Fig 4).

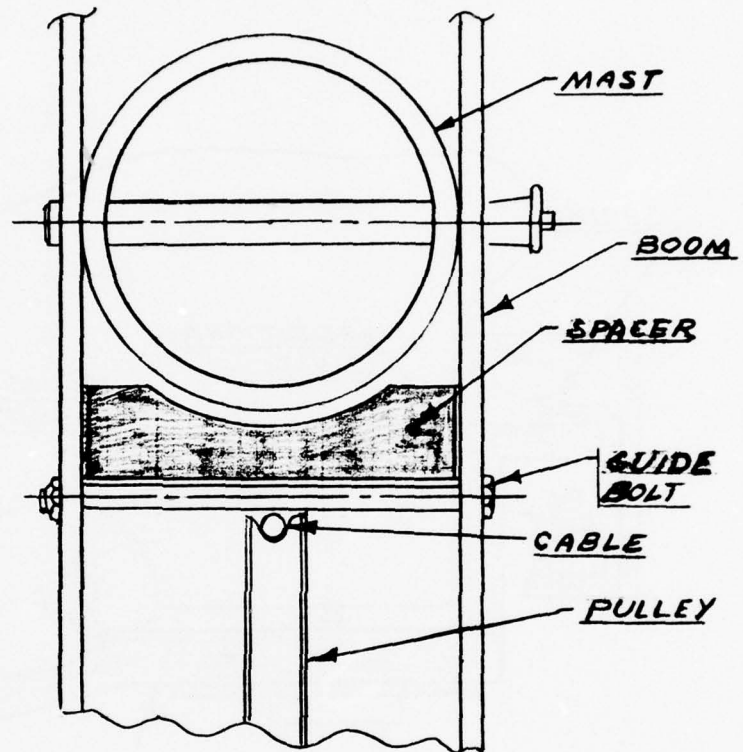
FIGURE 5

(2) Pulley - Although smaller than recommended by cable manufacturers for optimum cable life, the inboard boom pulley (Fig 1, item 28) is considered adequate in structure and cable interface. The adequacy is, however, dependent on cable replacement within prescribed intervals. With regard to installing a new cable on the hoist, there is a configuration in this area that has led to a misreeved and subsequently failed cable. The cable guide bolt (Fig 1, item 34) is located so that cable can be reeved over the bolt rather than properly between the bolt and pulley. The potential for misreeving could be greatly reduced by incorporating a spacer to block out the area between the bolt and the mast. The area in question and spacer configuration are schematically depicted in Fig 5.

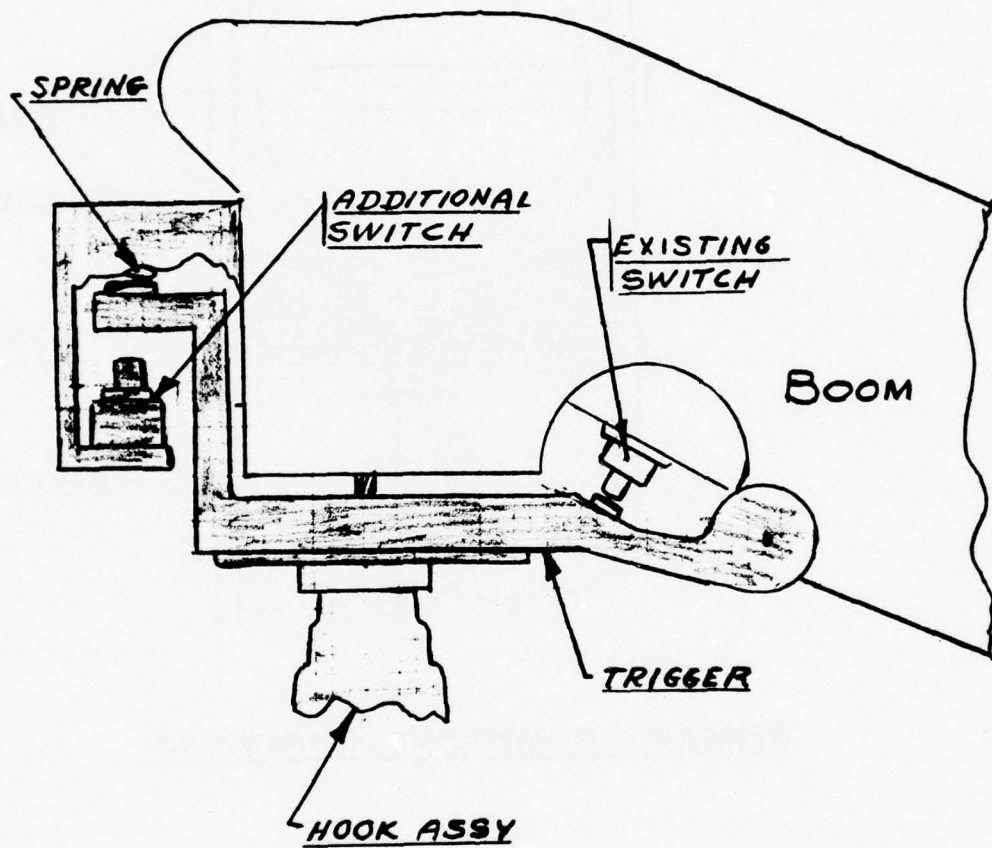
FIGURE 6

1. Adjustment - As the adjusting bolt is backed off, the two block force (tension in the cable caused by powering the hook assembly against the boom) becomes progressively higher. This force reaches approximately 3,000 pounds when clearance between the adjusting bolt and switch is such that the hook assembly contacts the rollers (Fig 1, view B) prior to switch activation. Considering that the cable's ultimate strength is 3,300 pounds, failure in the cable can be expected at any time there is a gross misadjustment (manually set or through vibration) or malfunction in this area.

2. Electric Short - If the limit switch shorts in the closed position and plunger activation does not open the series circuit to the motor power relay, two block forces will reach 2,800 pounds. Cable failure in this case will again be imminent.

3. Trigger Deformation - Another potential cause of excessive two block forces is permanent deformation in the trigger structure. Such deformation would allow the bumper assembly to contact the boom mounted rollers prior to limit switch activation.

(c) Corrective Design Change - Considering the above, it is apparent that a rather extensive up limit switch assembly redesign is required to insure near fail safe performance. A design of this type would incorporate full redundant electrical circuitry, would not be adjustable in the field, and would have rugged construction to resist deformation. One such design is schematically depicted in Fig 6.

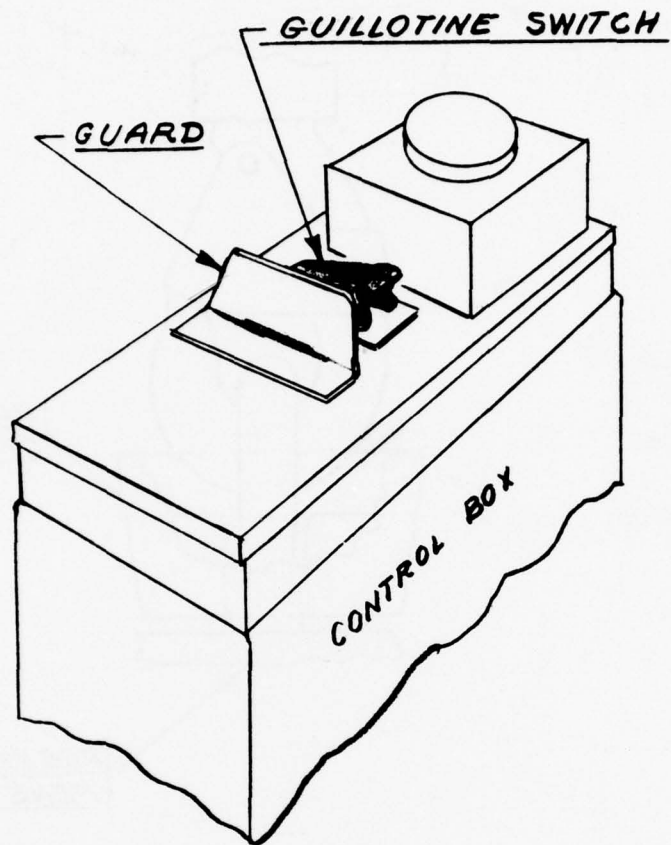
FIGURE 8

(4) Guillotine - The guillotine assembly proper (Fig 1, item 4) is considered adequate. There is, however, a potential problem in its activating switch located on the electric control box. The existing switch and safety cover actuate in the same direction of rotation. This means that a single motion, single direction, manual manipulation could expose and activate the switch. Such a configuration in the present location is susceptible to inadvertent actuation. Incorporating a switch guard (Fig 8) would greatly reduce this hazard.

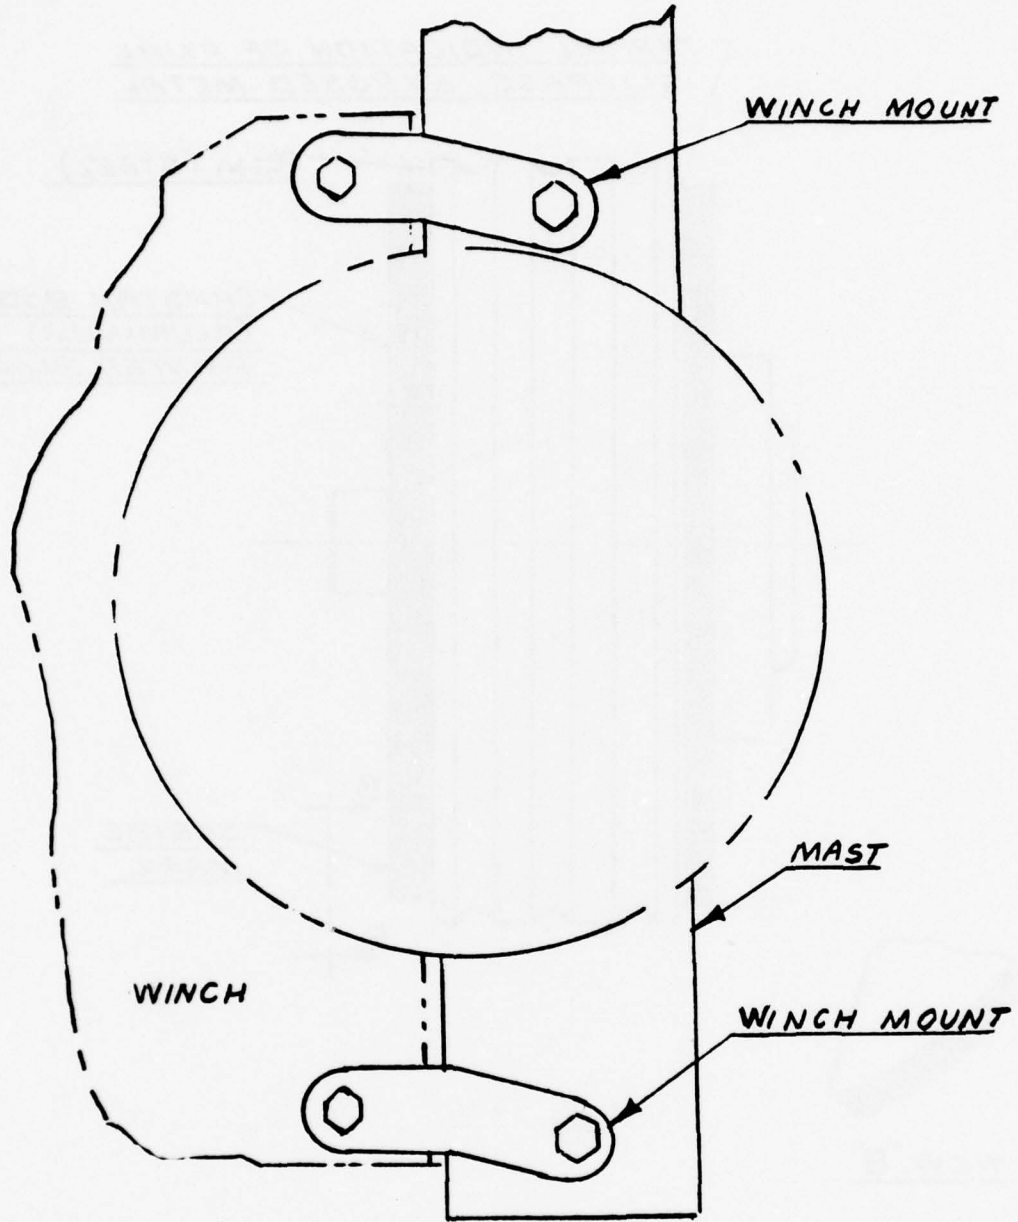
FIGURE 9

b. Winch Mounting - The winch manufacturer considers it a distinct possibility that secondary capstan fatigue failure may be caused by excessive displacement of one winch mount (Fig 9) with respect to the other, and that mast deflection would cause this displacement. With this in view, it is recommended that the contractor investigate the feasibility of incorporating a single "strong back" mount to reduce displacement.

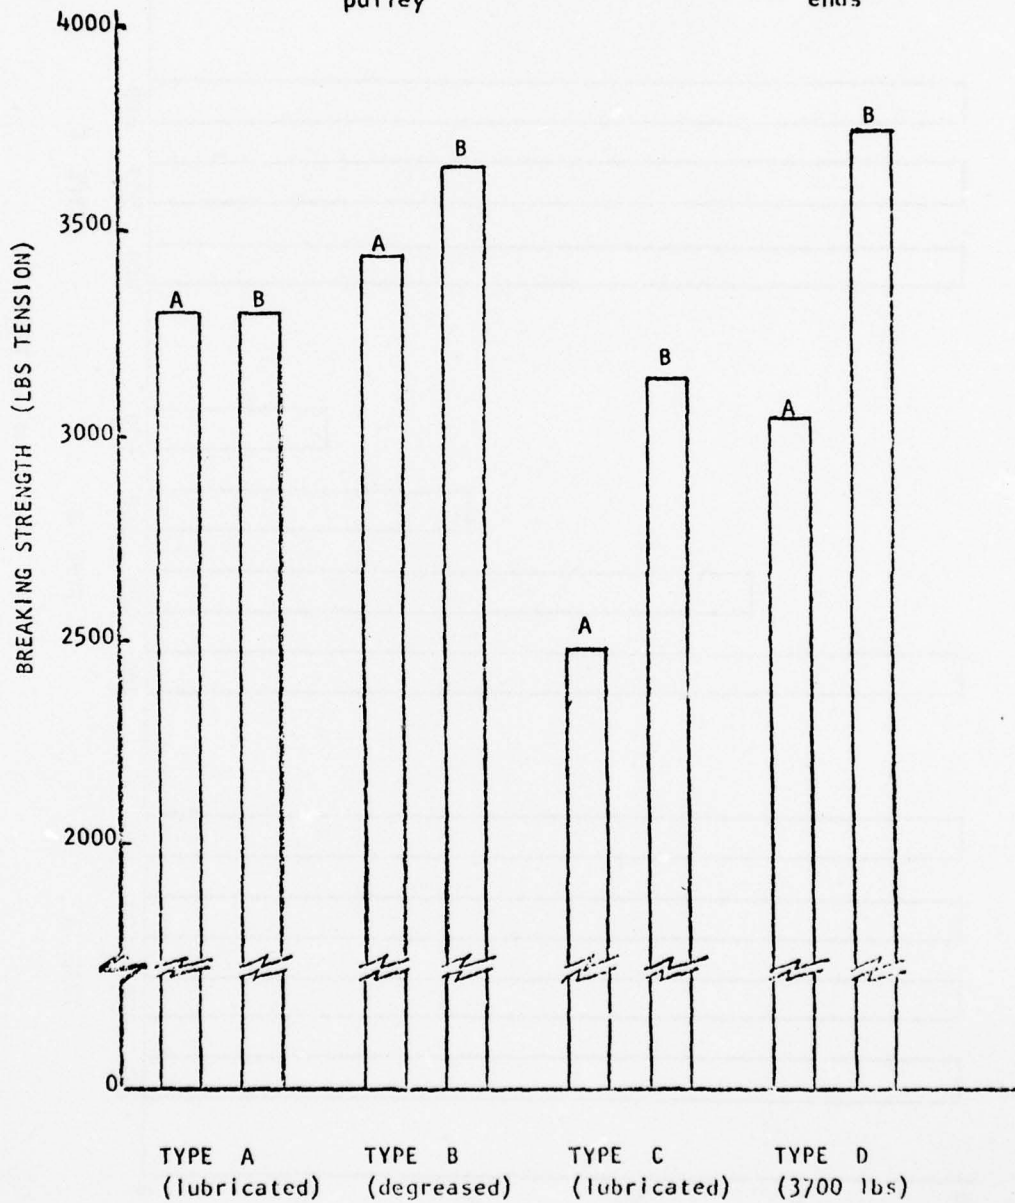
Figure 4 COMPARISON OF CABLE BREAKING TECHNIQUES

e. The method of breaking cables as presently contained in MIL-W-83140 is not representative of true cable strength in the UH-1N hoist applications. Our testing used a free end set-up which showed a decrease in cable strength of approximately 10-25 percent in some cases, which is considered significant. This phenomenon is characteristic of non-rotating or spin resistant cable due to its construction in that a certain amount of torque is developed when the cable is under a tensile load. If one end of the cable is free to rotate, a torque unbalance occurs which tends to tighten the inner strand lay and unwrap the outer lay strands. If the unbalance is significant, the result is a large decrease in ultimate breaking strength. The degree of torque unbalance generated varies directly with tensile load and appears to be primarily dependent on the ability of the contractor to obtain a uniform and stable torque-balanced cable construction during manufacturing. Consequently, since each contractor uses a unique set of wire sizes, wire material, strand lays, and rope lays, somewhat different characteristics are obtained, depending on the source of the cable. Figure 4 readily shows these differences.
