TECHNICAL REPORT  
NATICK/76-062 - CEMEL

**FLAME TEST FOR MEDICAL UNIT,  
SELF-CONTAINED TRANSPORTABLE  
(INFLATABLE SHELTER ASSEMBLY)**

24 June 1977

UNITED STATES ARMY  
NATICK RESEARCH and DEVELOPMENT COMMAND  
NATICK, MASSACHUSETTS 01760

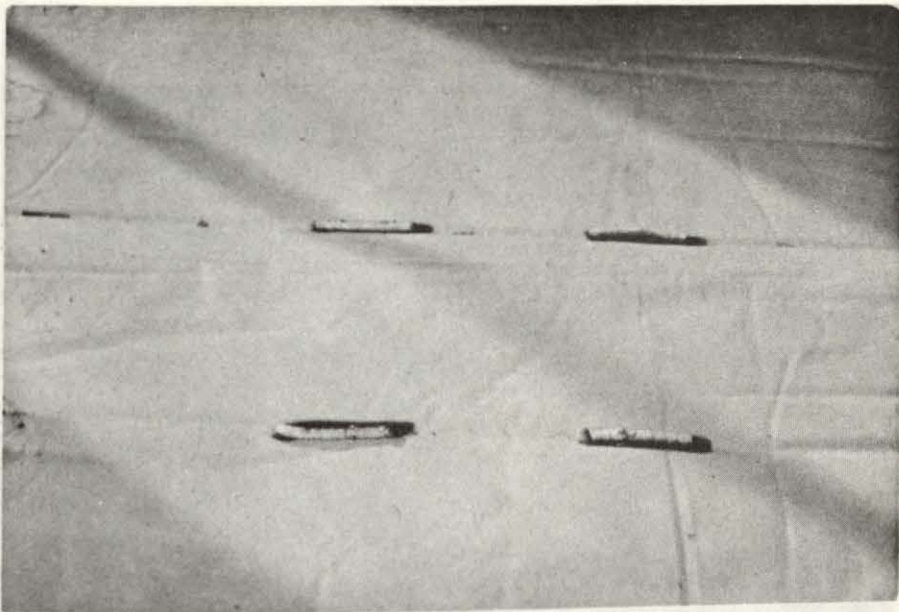
1. Cigarette test. All six shelters were subjected to the cigarette test. Four lighted cigarettes were placed on the floor of the MUST Shelter and allowed to burn to the end (see Figure 3). The cigarettes charred the floor without any flaming.

Figure 3. Effects of Lighted Cigarettes on MUST Shelter Floors

The results of the interior fire tests show that lighted cigarettes were no threat to the MUST Shelters. The cigarettes burned out with some slight charring to the floor. The torch test indicated that plenum fabric, with air blowing through, melted and formed a hole when subjected to the propane torch. The plenum fabric showed signs of charring but no ignition, due to the outrushing air dissipating combustible products. However, this

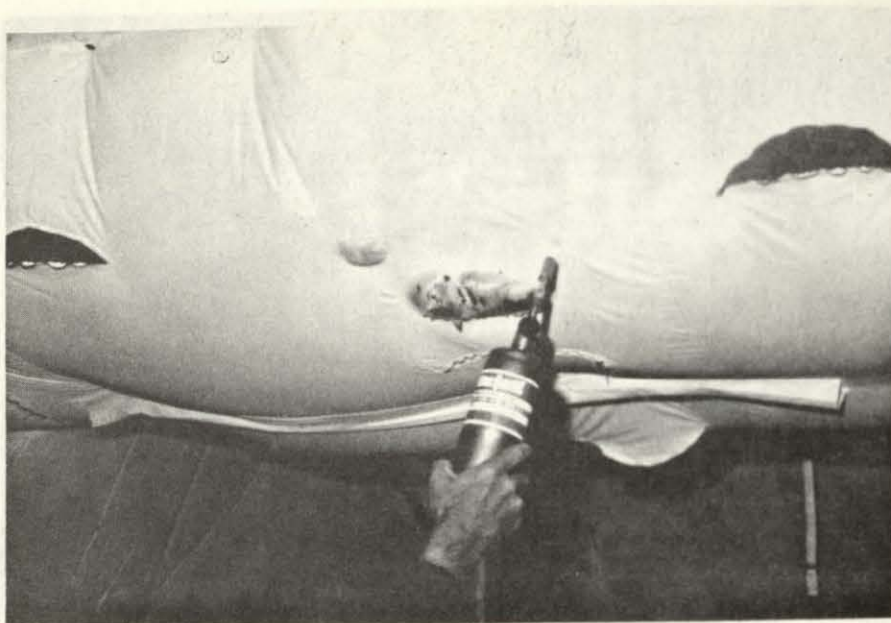
2. Torch test. All six shelters were subjected to the torch test. The air-conditioning distribution plenum was subjected to the flame of a propane torch for 10 seconds (see Figure 4). The coated fabric melted, with slight charring, but did not ignite.

Figure 4. Effects of a Propane Torch on the Air Distribution Plenum.

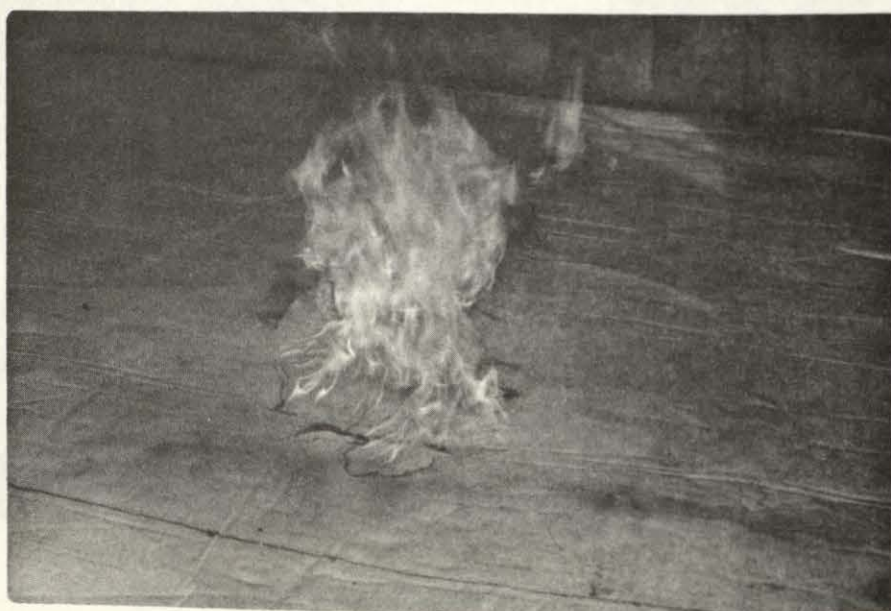
Figure 5. Effect of a Spilled Alcohol Fire, Immediately After Ignition.

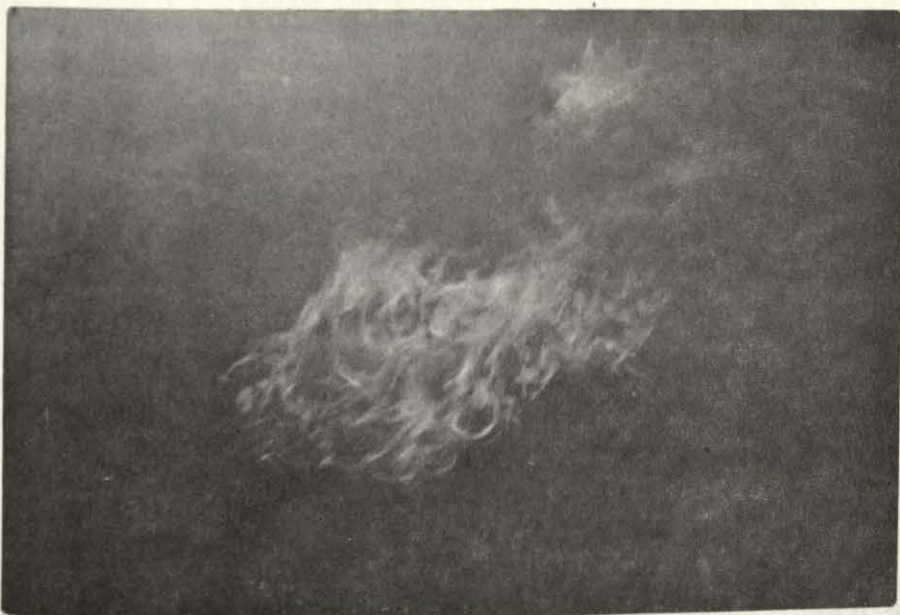
after ignition, dense black smoke was produced (see Figure 6) and increased in density (see Figures 7 and 8) so that the shelter was usually evacuated by test personnel within 60 seconds of ignition. The fire did not spread rapidly during the test, but in general contained itself to an area of 3 feet (.915 m) in diameter (see Figure 9) and appeared to be self-extinguishing. The residual fire was easily extinguished with a carbon-dioxide fire extinguisher.

Figure 7. Effect of an Alcohol Fire, 45 Seconds After Ignition.

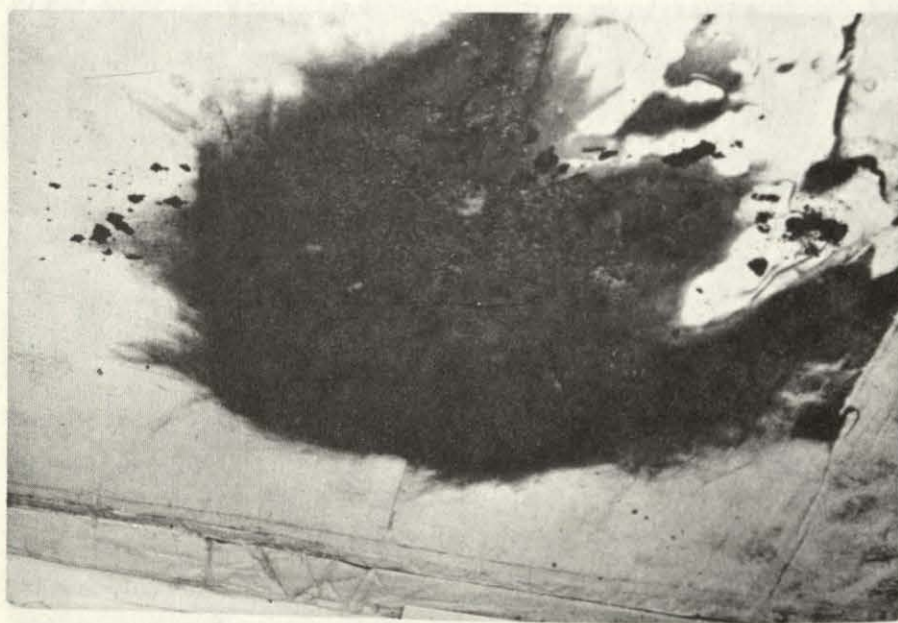
Figure 9. Damage to the Floor Caused by the Alcohol Test.

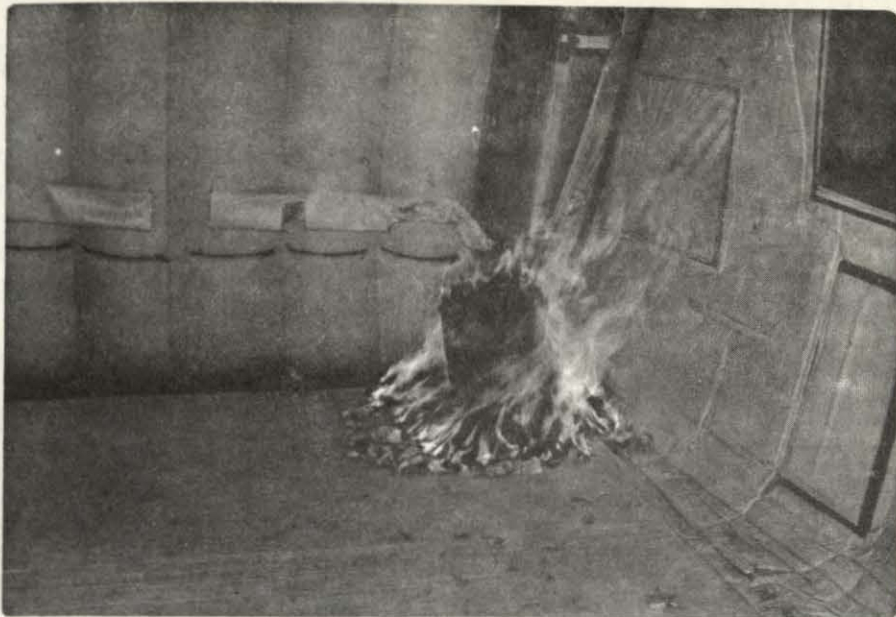
Figure 10. Effect of an Interior Wastebasket Fire.  
(Note ruptured inner side wall)

The wastepaper basket tests showed that in those tests where the wastepaper basket was positioned in a corner against the shelter, approximately 25 seconds after ignition of the paper one of the inflated cells would rupture, scattering the flaming newspaper throughout the shelter and propelling the wastepaper basket several feet across the room. When totally unexpected, it was a startling experience. The scattered paper burned out quickly and the fire in the wastepaper basket was easily extinguished. The damage to the cell was severe enough to require more than a "field repair".

7. Wastebaskets should not be placed in a corner or within two feet of a wall.
8. There appeared to be no major differences in the overall response of the three manufacturers' shelters to the fire hazards experienced in this study.

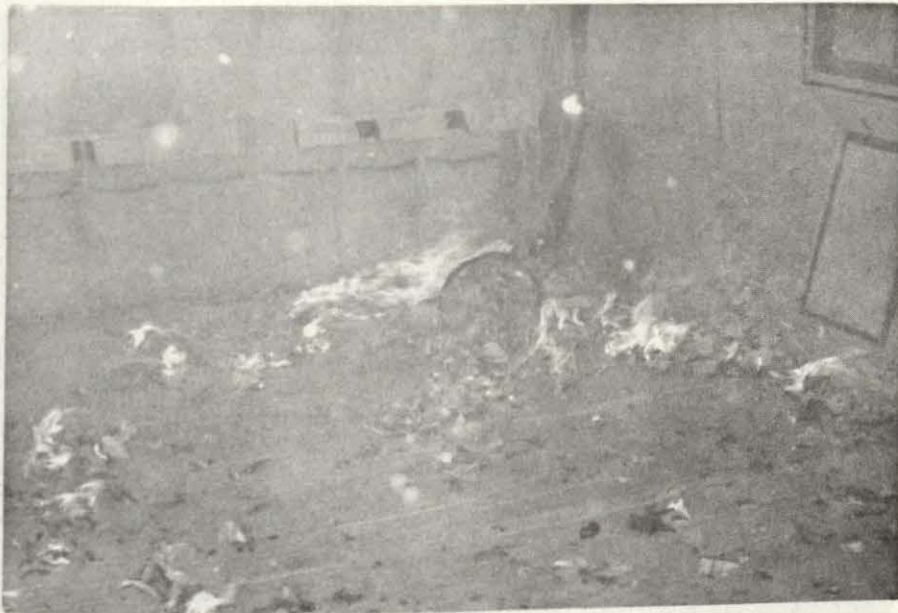
Figure 11. Effect of an Interior Wastebasket Fire, 25 Seconds After Ignition  
(Note bladder has exploded, scattering burning debris)

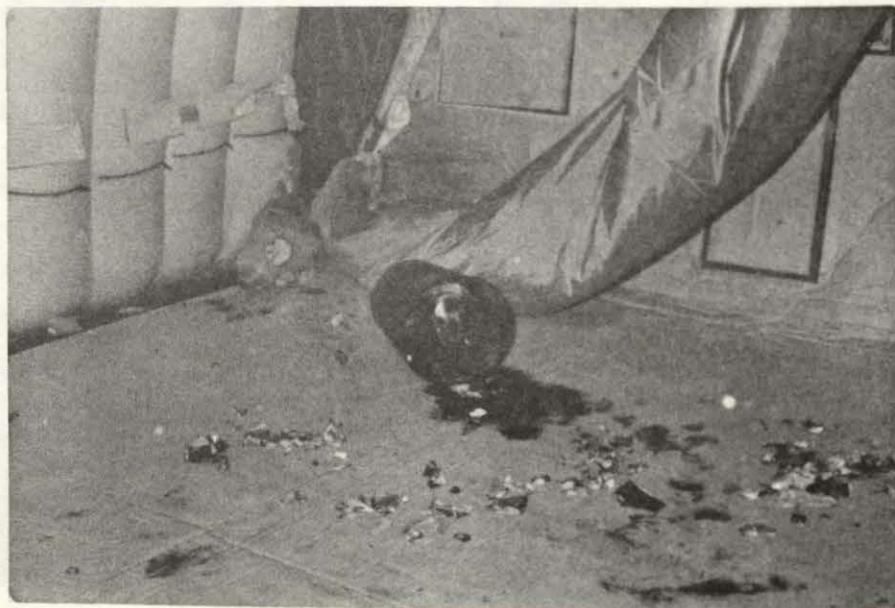
Figure 13. Effect of Interior Wastebasket Fire, Several Minutes After Ignition.  
(Note debris on the floor has self-extinguished)

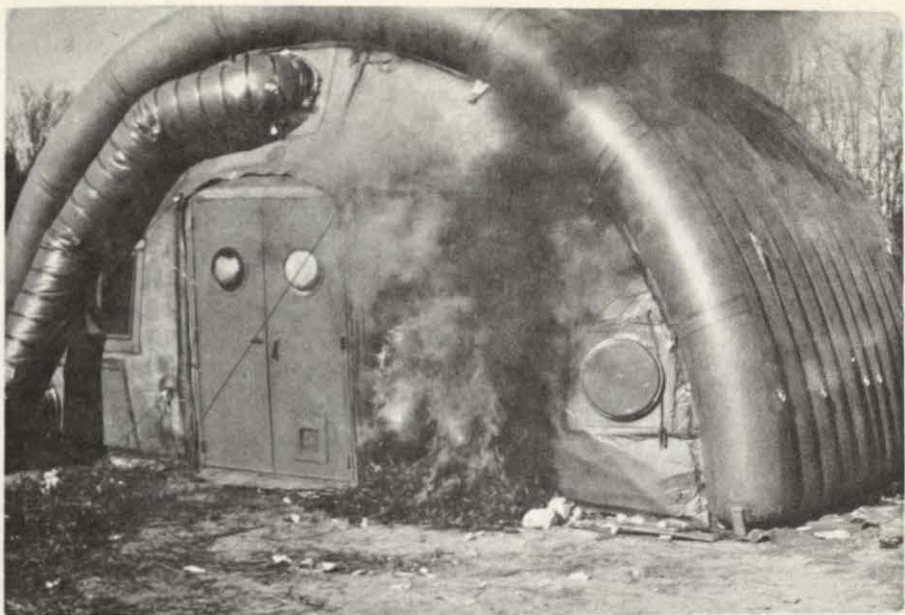
1. Exterior Fire No. 1. (Standard Test) Six pounds (2.7 kg) of shredded newspaper were placed along the outside of, and in contact with, an end panel and ignited. Shelters 3, 4, and 5 were tested in this manner. The shelters ignited, with self-sustaining flames, within 20 to 25 seconds (see Figure 14). In general, the fire produced a hole in the shelters within 30 to 60 seconds after ignition of the paper (see Figures 15 and 16). An inflated cell ruptured in shelter 4 two and one-half minutes after ignition of the paper. The fire in all the shelters was extinguished within three minutes of ignition of the paper in order to save the shelters for additional tests. The fires were easily extinguished with water.

Figure 14. Exterior Fire 1, 6 lbs. of Shredded Newspaper  
Approximately 45 Seconds After Ignition.

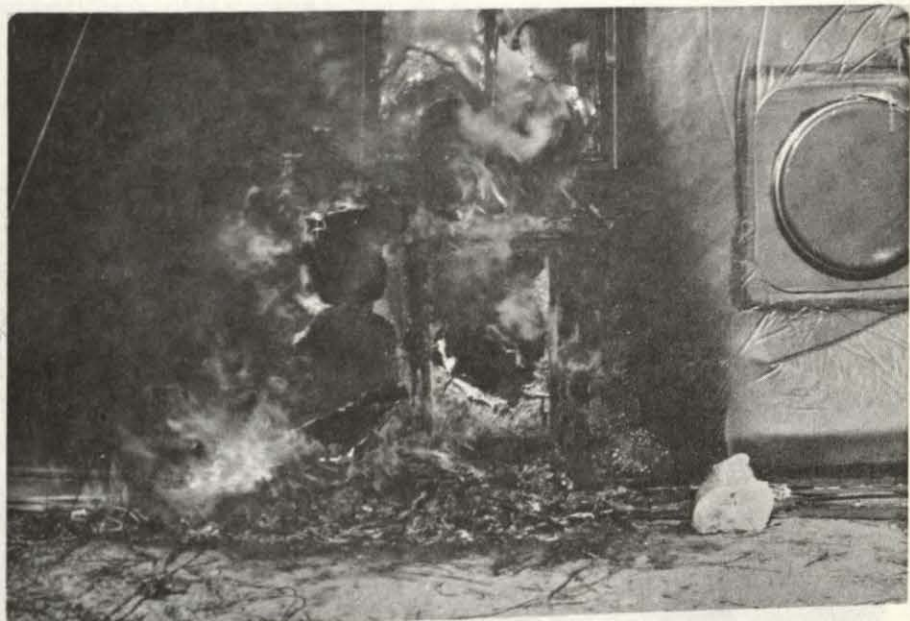
Figure 15. Exterior Fire No. 1, Approximately 75 Seconds After Ignition.

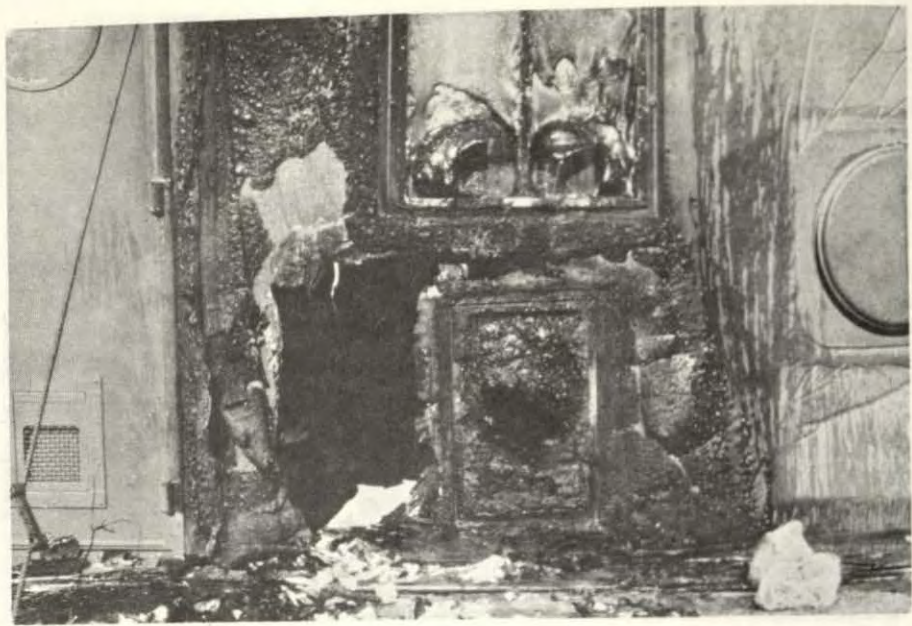
Figure 16. Damage Caused by Exterior Fire No. 1  
(Fire Extinguished by H<sub>2</sub>O)

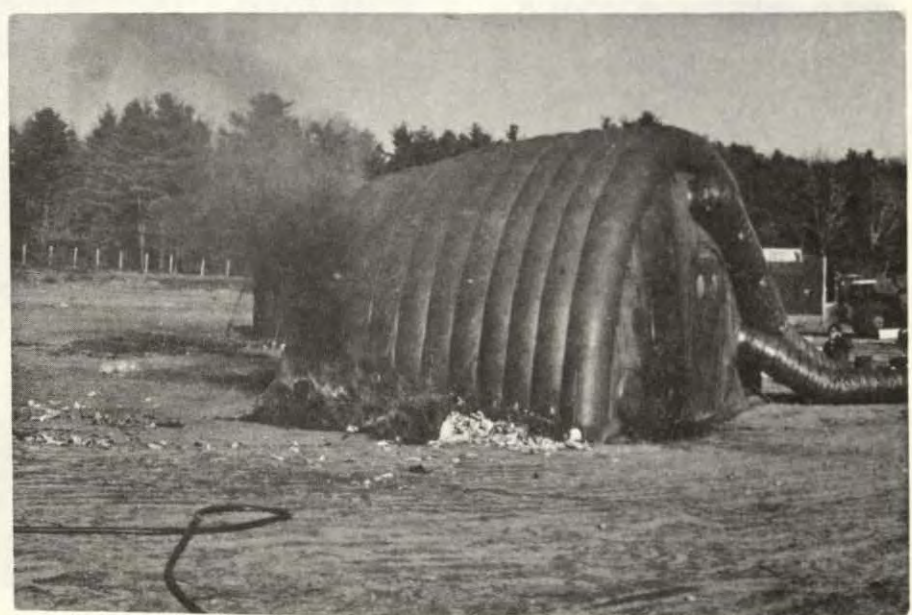
Figure 17. Exterior Fire, No. 2, Approximately 30 Seconds After Ignition  
26 lbs. of Shredded Newspaper Along the Inflated Tubes

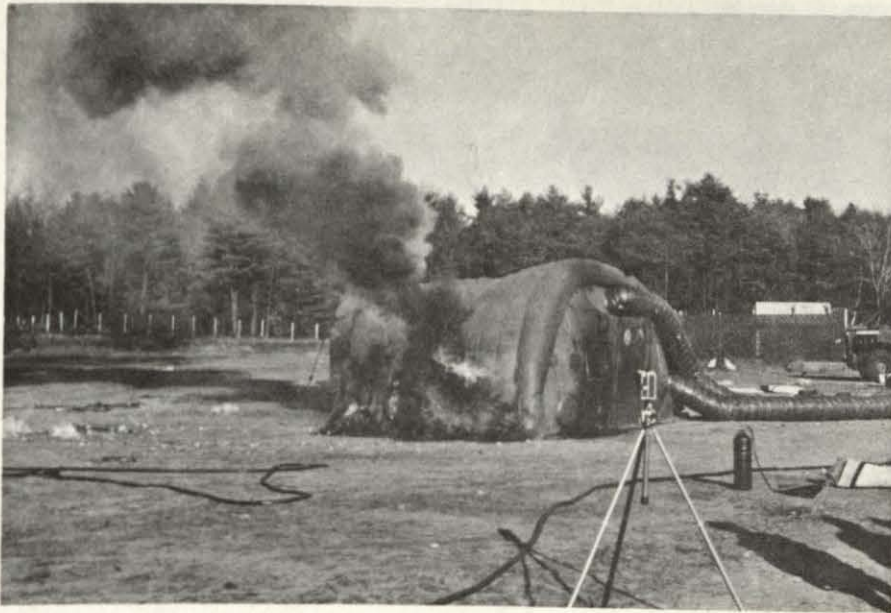
Figure 18. Exterior Fire No. 2, Approximately 50 Seconds After Ignition.

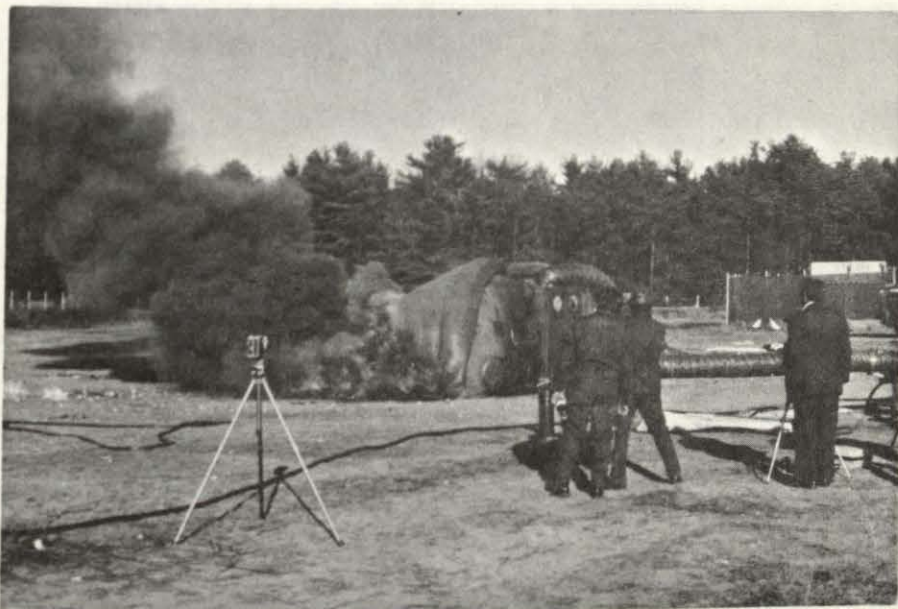
Figure 19. Exterior Fire No. 2, Approximately 2 Minutes After Ignition.

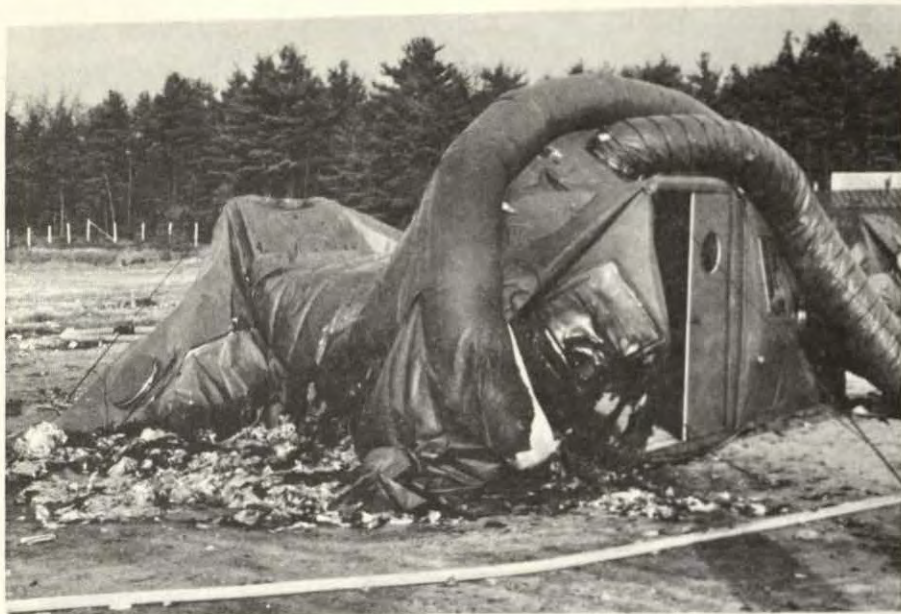
Figure 20. Damage Caused by Exterior Fire No. 2.

1. The MUST Shelters tested were found to be extremely vulnerable to extensive external fires.
2. The greatest danger from an external fire came from the rapid collapse of the shelter when the fire originated along the inflated side of the shelter.

8. Utilize the internal arch support frame (MIL-S-43766 (GL)) which was designed and intended to furnish support of shelter sections when there is no internal pressure in the inflated tubes, as required by regulation, to prevent total collapse of the shelters when pressurized cells are ruptured.

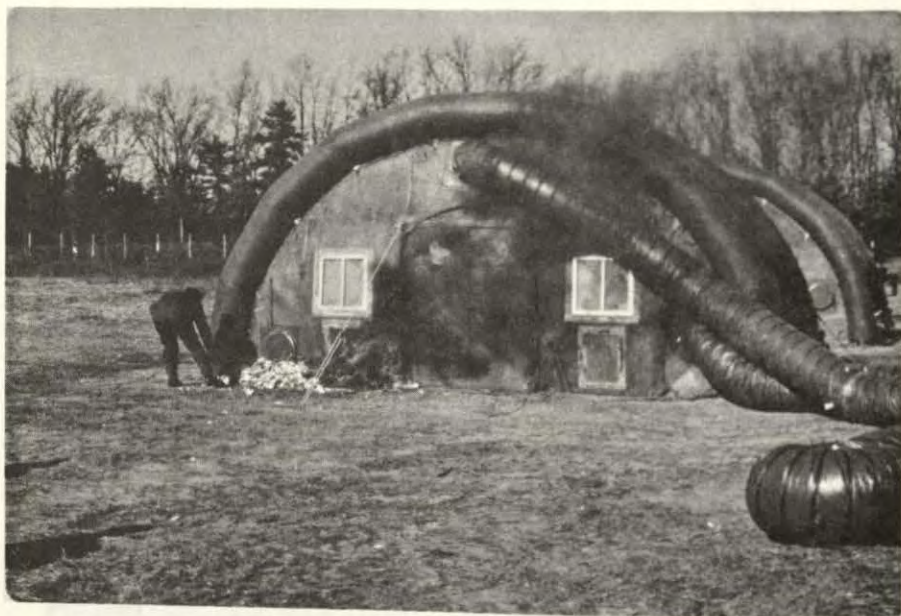
3. Exterior Fire No. 3. Similarly, in order to simulate a large external fire at the end panels, twelve pounds (5.4 kg) of shredded newspaper was placed along the outside of a panel. Shelters 1, 2, and 6 were used for this test. The shelters were ignited with self-sustaining flames 20 to 30 seconds after the ignition of the paper (see Figure 21). With shelters 1 and 6, an end cell exploded 30 seconds after the ignition of the paper. A number of cells ruptured in all the shelters within two to two and one-half minutes after the ignition of the paper (see Figure 22). Shelter 1 was allowed to burn unchecked and the shelter collapsed three minutes after the ignition of the paper. Figure 23 depicts the typical

Figure 21. Exterior Fire No. 3, 12 lbs of Shredded Newspaper, several Seconds After Ignition.

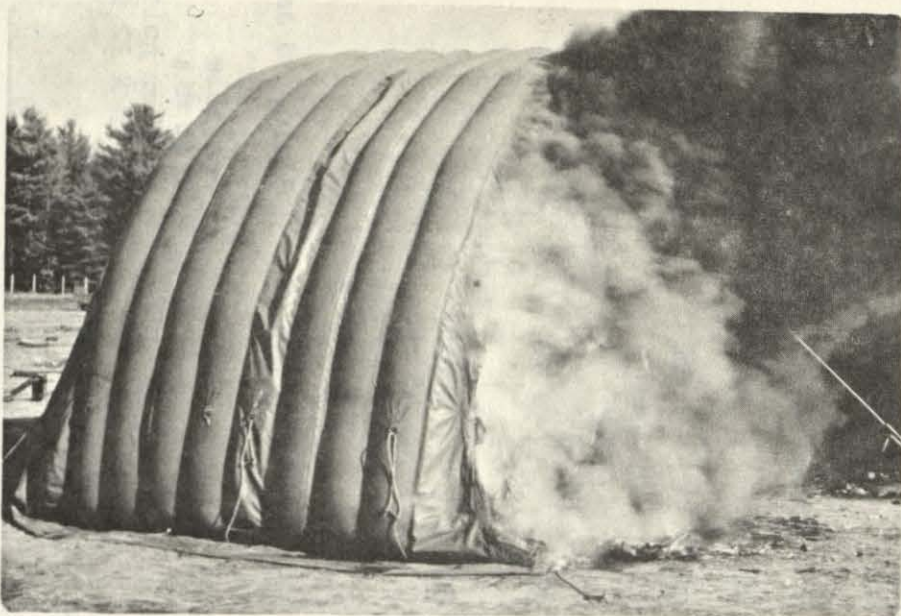
Figure 22. Exterior Fire No. 3, Approximately 2 Minutes After Ignition.

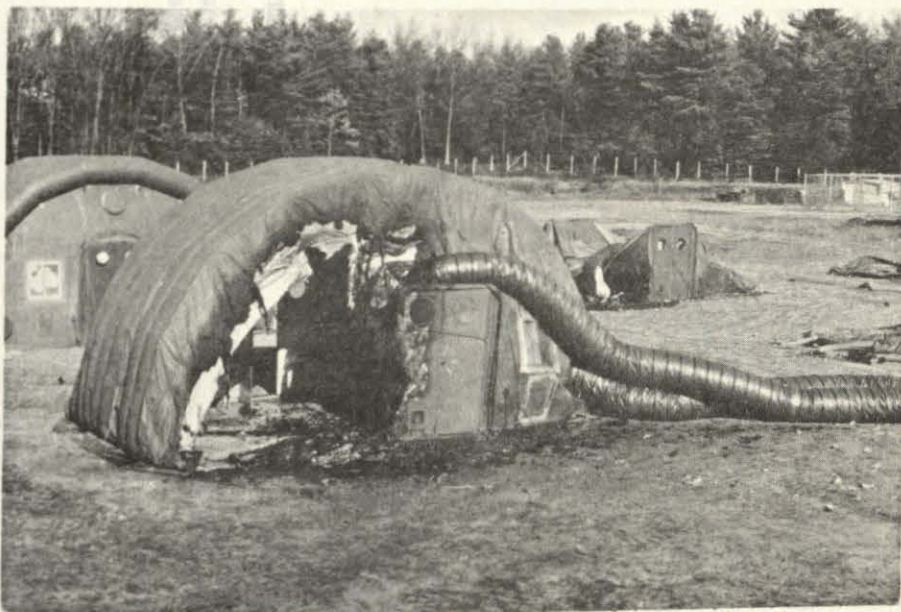
damage caused to an end panel by this type of fire (Shelter 6).

Figure 23. Damage Caused by Exterior Fire No. 3.  
(Fire Extinguished by Water)

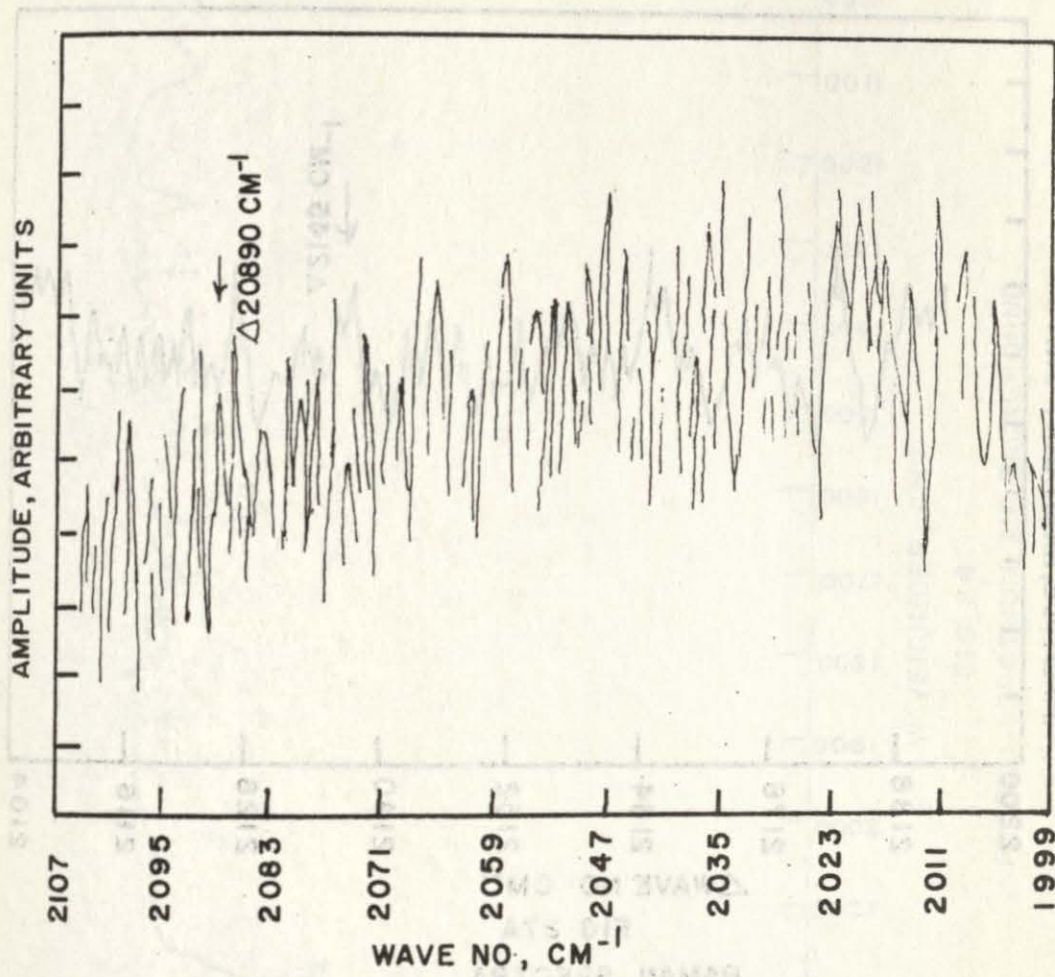
FIG. 27

SCAN RANGE, 2000-2107 CM<sup>-1</sup>  
 NO DETECTABLE HCN, 2089 CM<sup>-1</sup>  
 SENSITIVITY, 30 X  
 RAMAN SPECTRA

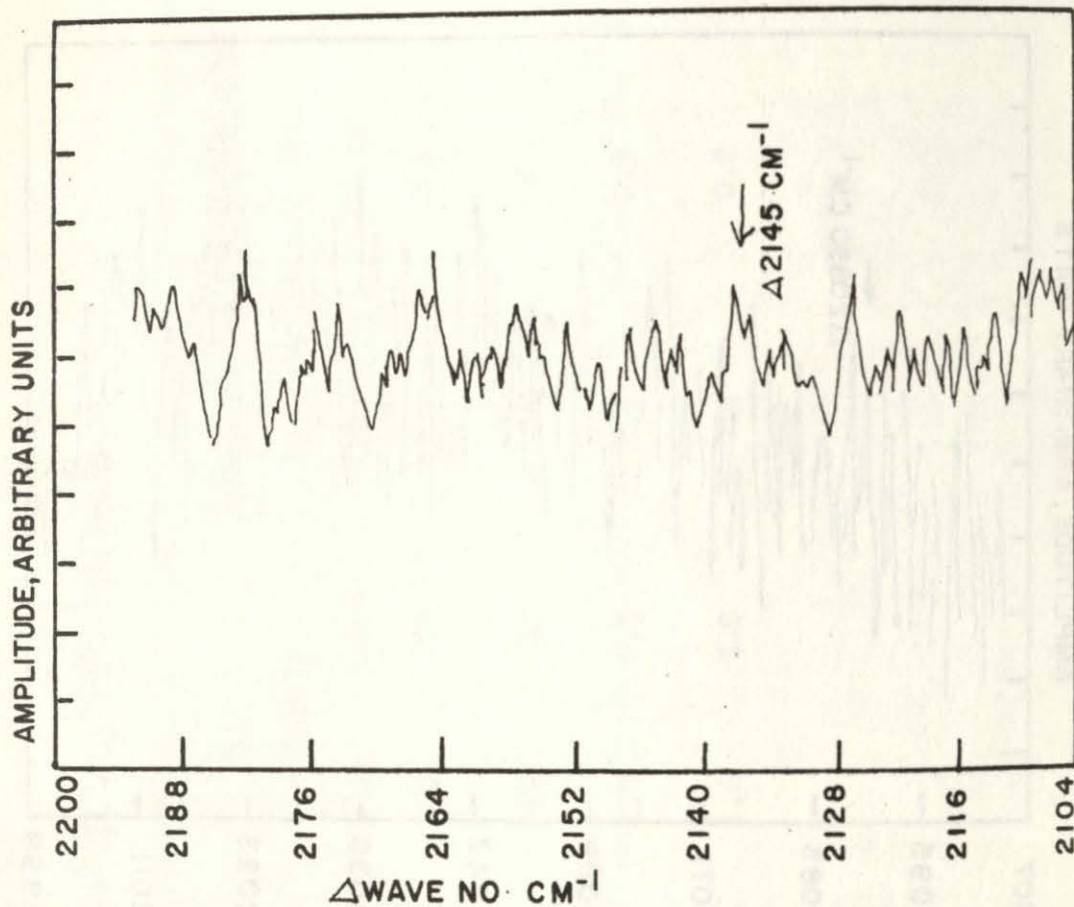
FIG. 27A

RAMAN SPECTRA  
 SCAN RANGE, 2104-2200  $\text{CM}^{-1}$   
 NO DETECTABLE  $\text{CO}$ , 2145  $\text{CM}^{-1}$   
 SENSITIVITY, 100 X

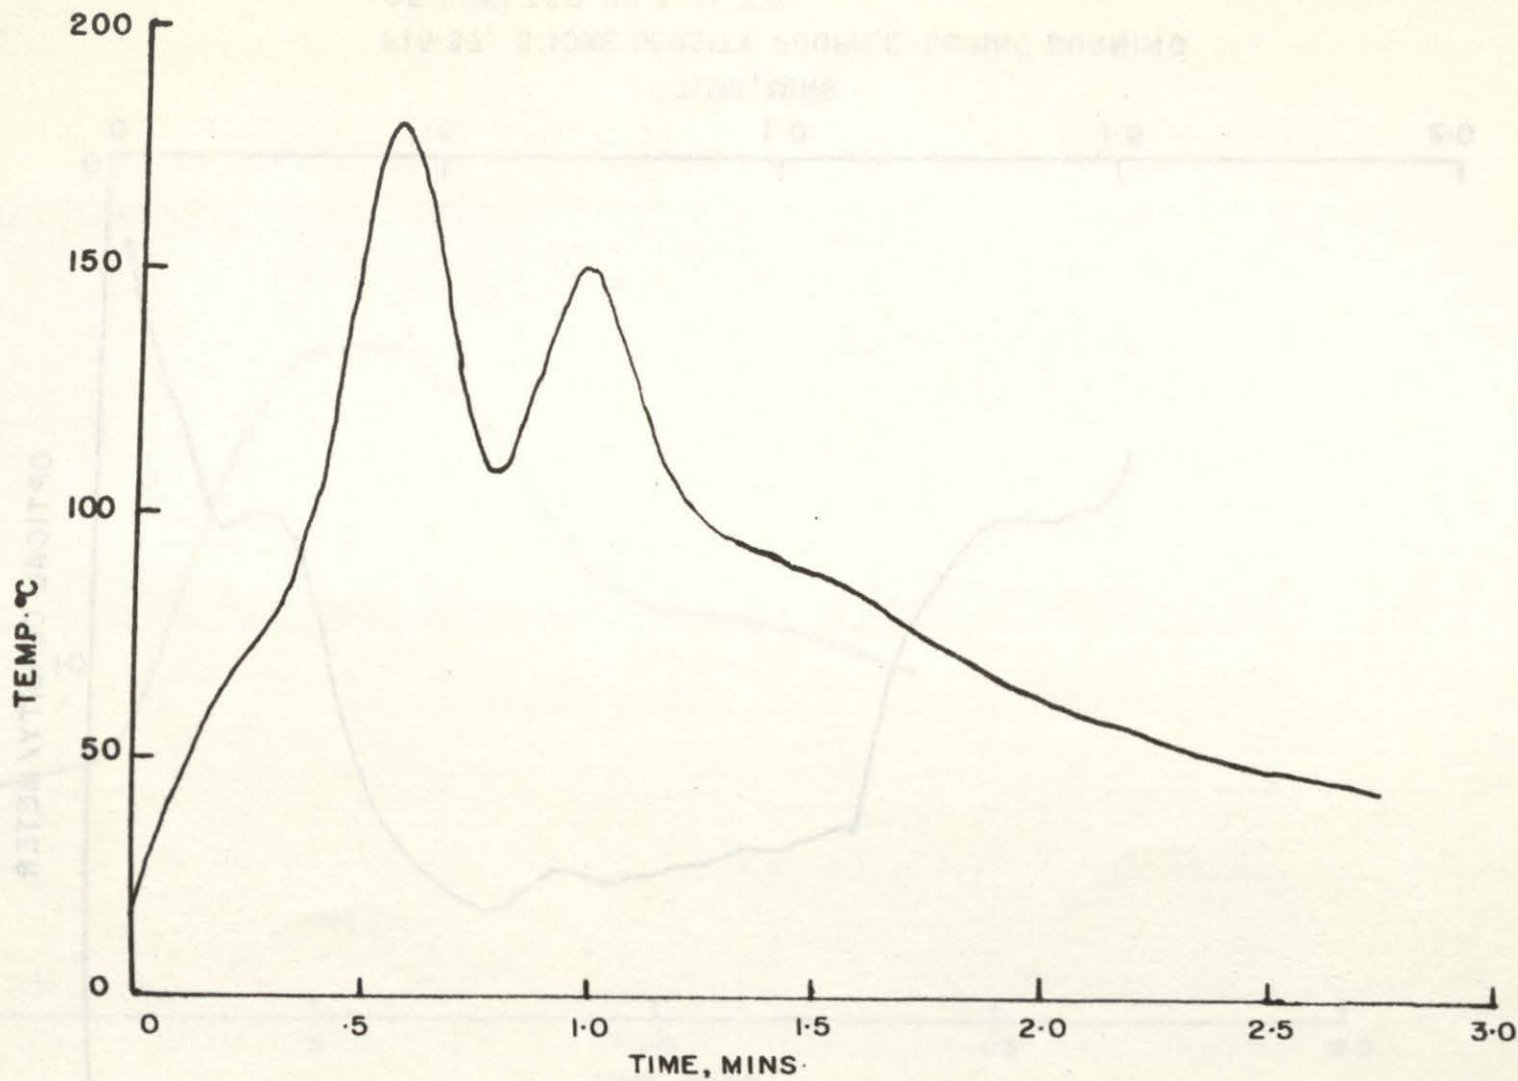
TIME, MINS.  
FIG-38

TIME TEMPERATURE PROFILE DURING BURNING OF. SHELTER NO 5 FLOOR

occur at distances of 6, 2, and 2 meters for the Firestone, Inflated Products, and Air Cruiser Shelters, respectively, while total darkness could be anticipated at distances of 8, 2.7, and 2.7 meters. The optical density curves indicated these conditions would persist for the first one to two minutes, after which the shelter's exhaust system would clear the air.

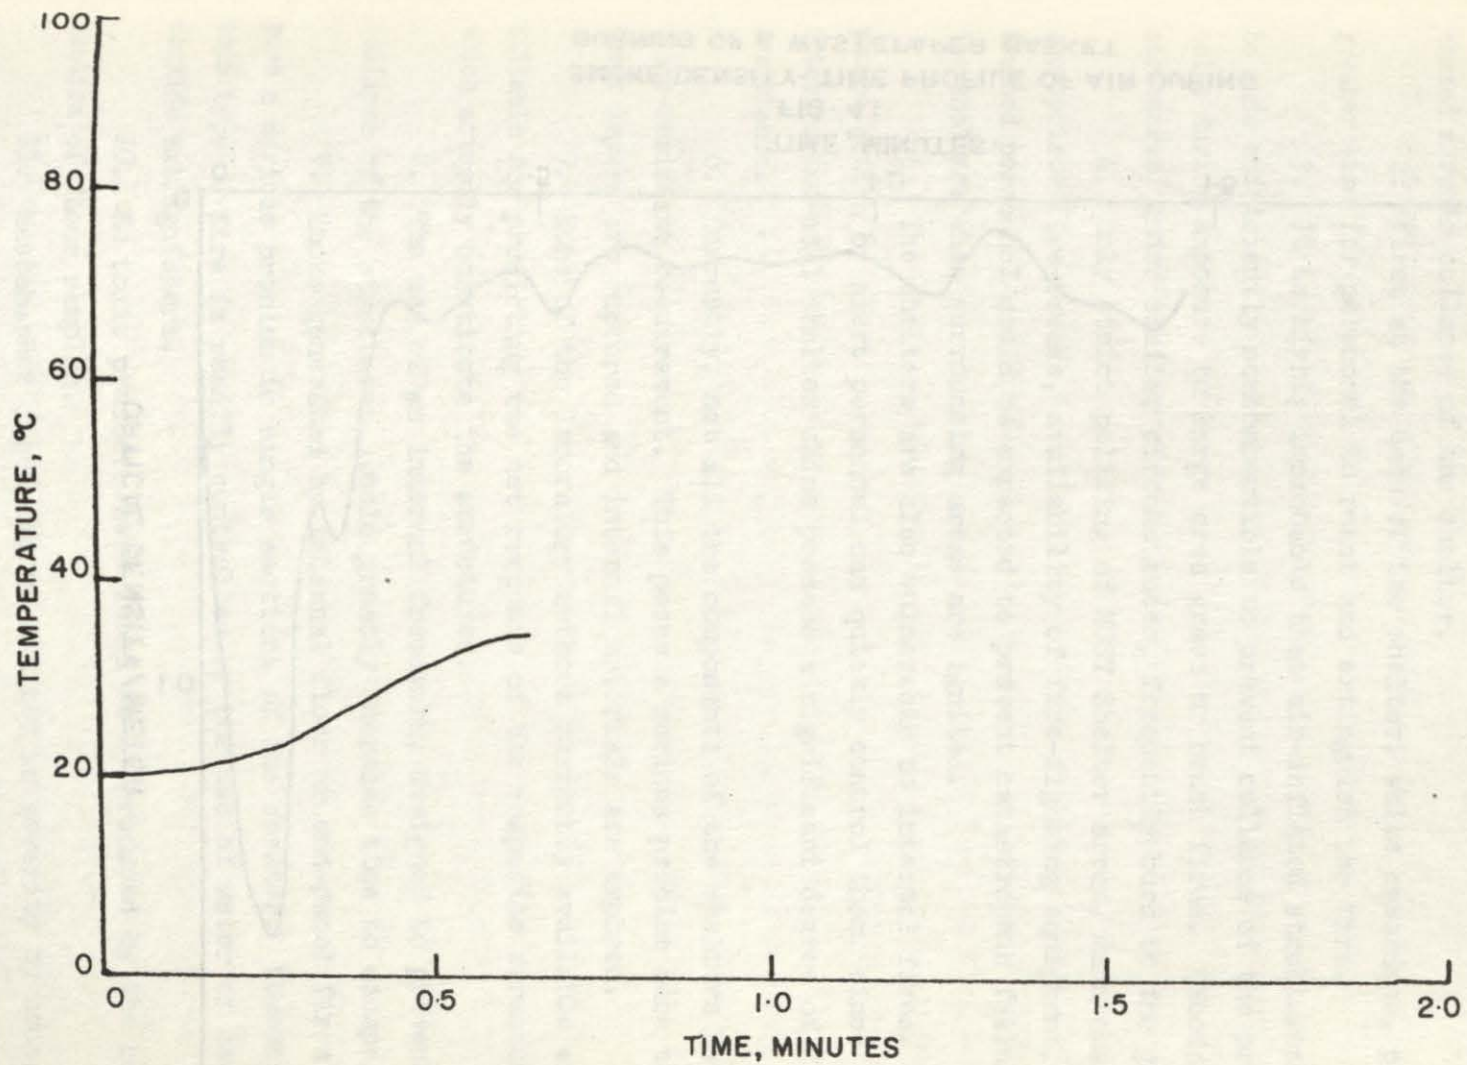
Temperature and visibility measured above a burning wastebasket, the curves of Figures 40 and 41, indicate again that this type fire poses a lesser threat than the spilled alcohol. The temperature rise directly above the fire was minimal, and while a relatively high optical density was initially observed, the smoke was quickly reduced by the shelter's exhaust system.

FIG. 40  
TIME-TEMPERATURE PROFILE OF AIR  
DURING BURNING OF A WASTEPAPER BASKET

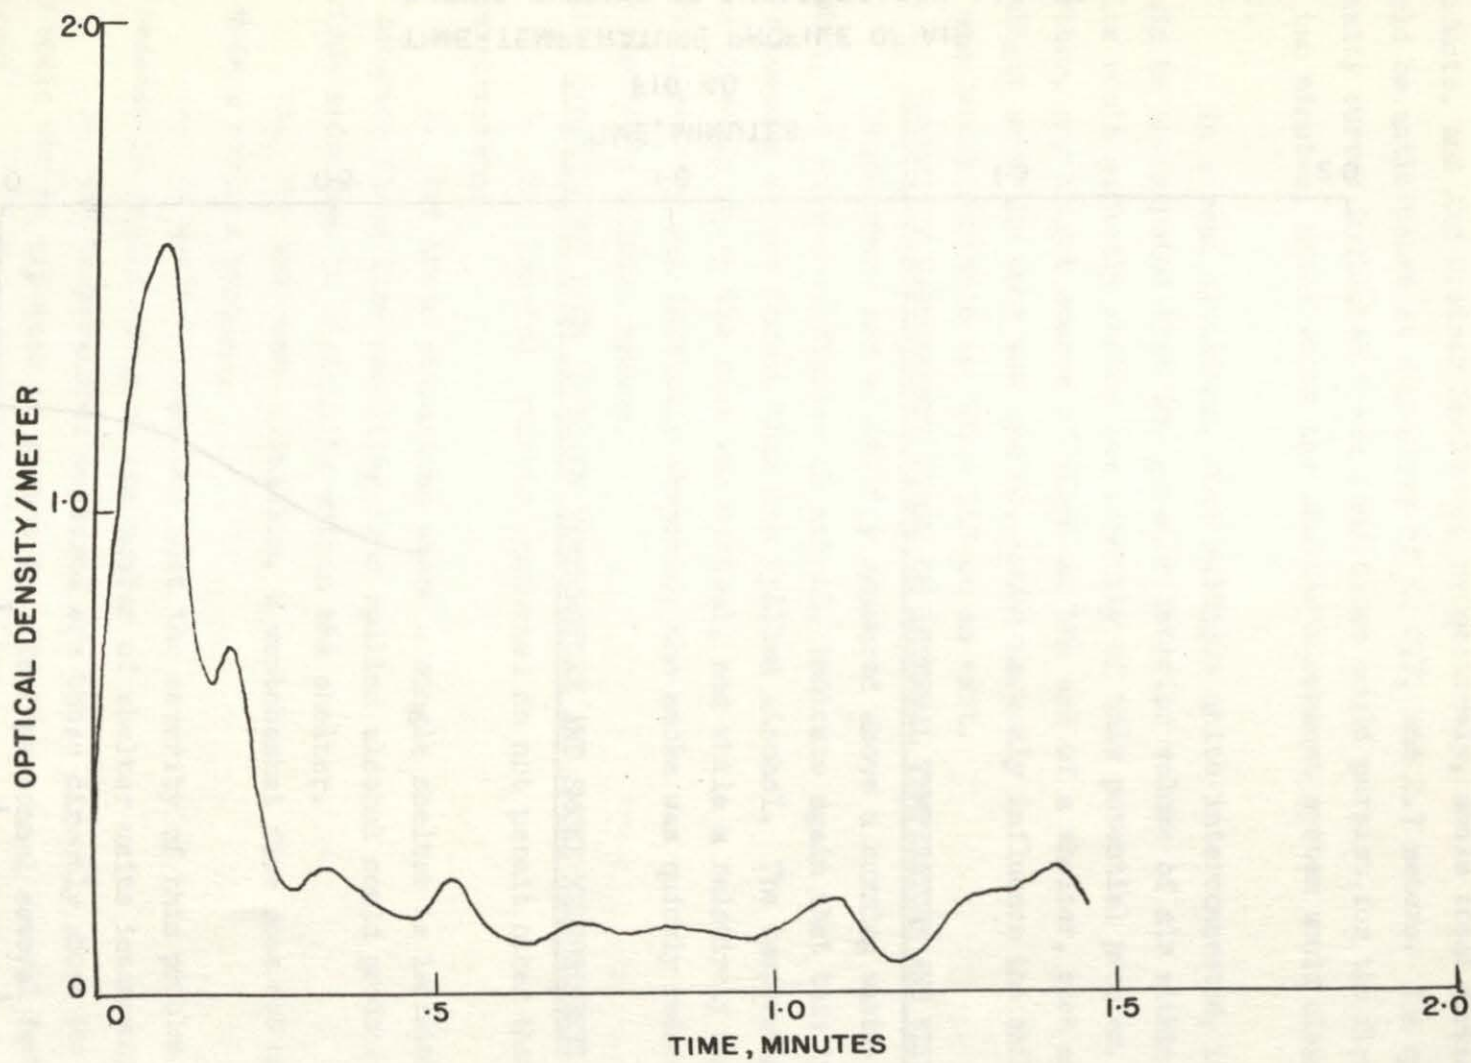
FIG. 41  
SMOKE DENSITY-TIME PROFILE OF AIR DURING  
BURNING OF A WASTEPAPER BASKET
