TN no. N-1496

title: INVESTIGATION OF SPRAY-APPLIED
POLYURETHANE FOAM ROOFING SYSTEMS - I

author: Robert L. Alumbaugh, Ph D
John R. Keeton, P.E.

date: July 1977

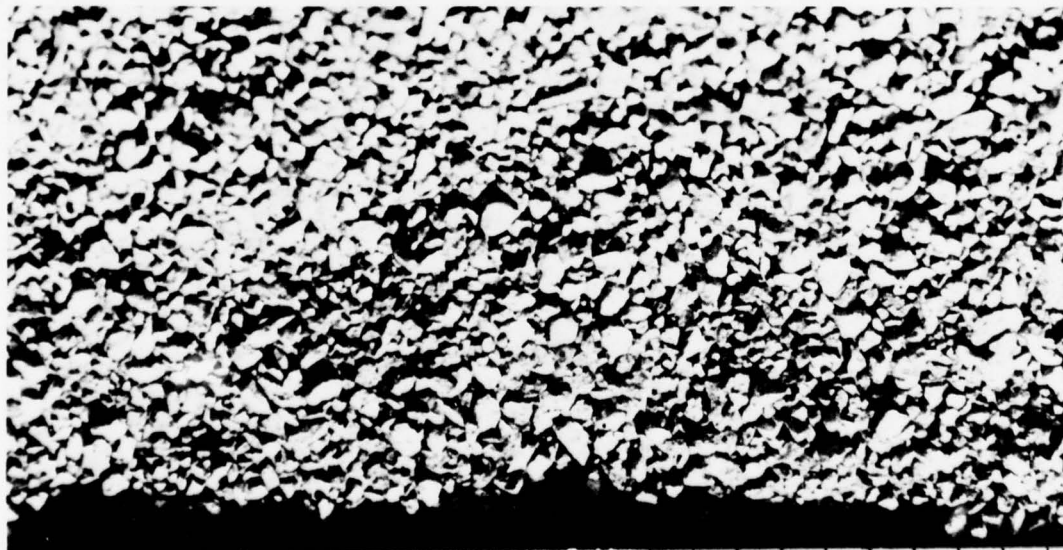
Figure 8. Effects of roofing granules on dirt retention.

(a) Dirt retention on catalyzed silicone rubber (System 1) after 18 months of exposure.

(b) Practically no dirt retention visible on catalyzed silicone rubber with granules (System 1G) after 18 months of exposure.

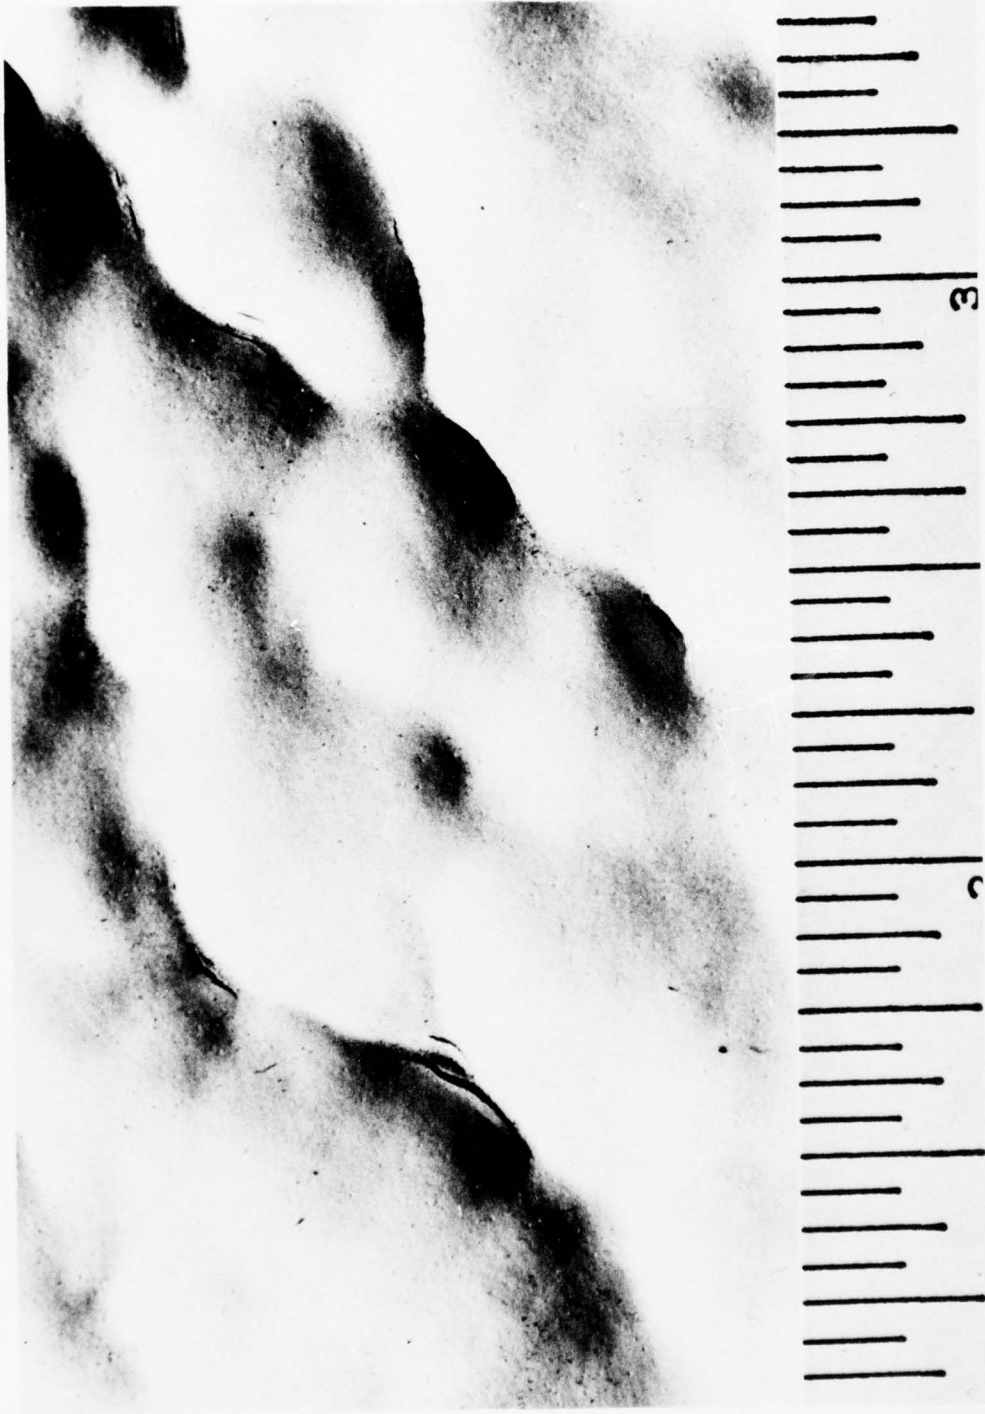
Systems 2 and 2A - Moisture-Curing Silicone Rubber. These systems are similar to System 1 except that this silicone cures by reacting with moisture in the air and thus does not require special spraying equipment to apply. After 1 year of exposure at Pickel Meadows, the performance of System 2 is rated as excellent. Figure 9 shows typical checking or cracking of the coating which occurred in depressions on the Port Hueneme and China Lake panels before these panels were exposed; it has not become more severe after two years of exposure. The performance of the systems at these two locations was rated as very good for their respective exposure periods.

System 2A panels were prepared after the checking or cracking was noted on System 2. Performance of System 2A was rated as excellent after 6 months of exposure at China Lake and Pickel Meadows and 1 year at Port Hueneme. Like the System 1 silicone, the System 2 moisture-curing silicone rubber also retains dirt; the white topcoat attains a dirty gray appearance on exposure which has not affected its performance.

Figure 9. Checking or cracking of moisture-curing silicone rubber coating (System 2).
(China Lake; before exposure.)

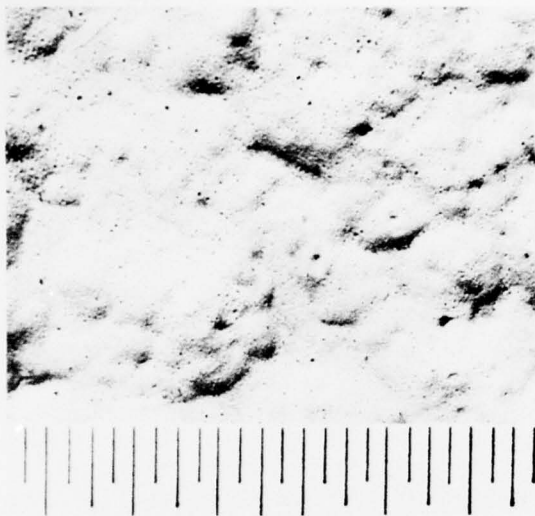
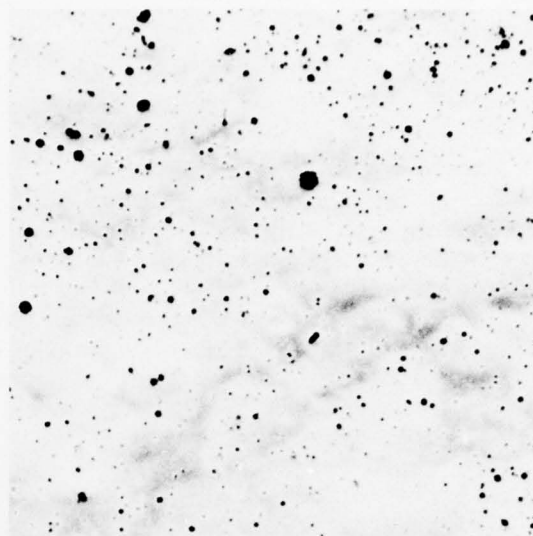
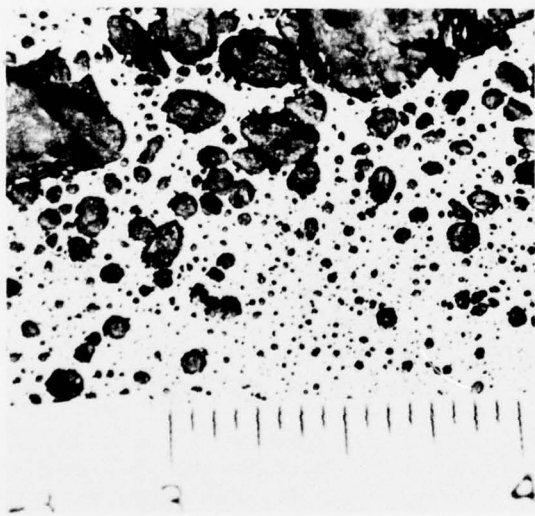
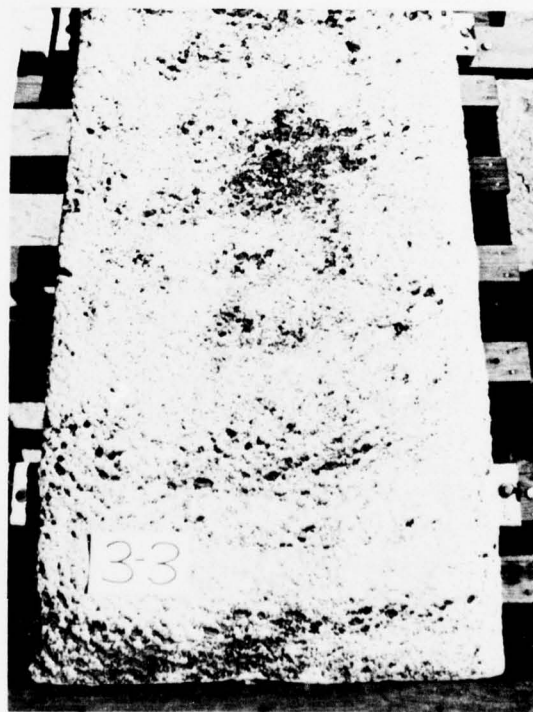
System 3 - Catalyzed Butyl-Hypalon. The dense solvent pinholes in the topcoat of this system were the focal points for incipient deterioration. The topcoat tended to lose adhesion and curl back from the base coat in the general area of the pinhole. The photomicrographs in Figure 10 show this quite dramatically for the panel exposed at China Lake for various periods of weathering. The topcoat of hypalon gradually peeled, exposing the butyl base coat which then deteriorated and exposed the foam directly to the weather. The most rapid deterioration of the system occurred at China Lake where it had failed by the end of the first year of exposure. Performance of System 3 was almost as poor at the Pickel Meadows site, where the system was also nearing failure following one year of exposure. The exposure at Port Hueneme was not quite as severe and the system was rated as good to poor after 2 years of weathering.

Figure 10. Progressive degradation of catalyzed butyl-hypalon (System 3) after various periods of weathering at China Lake.

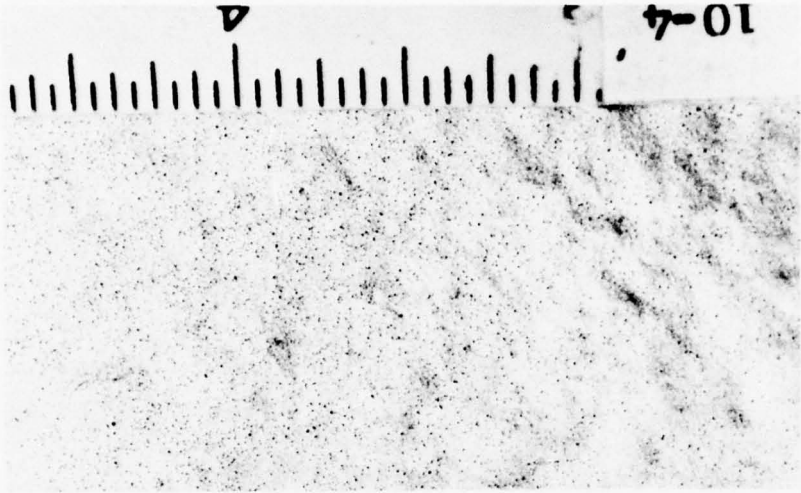
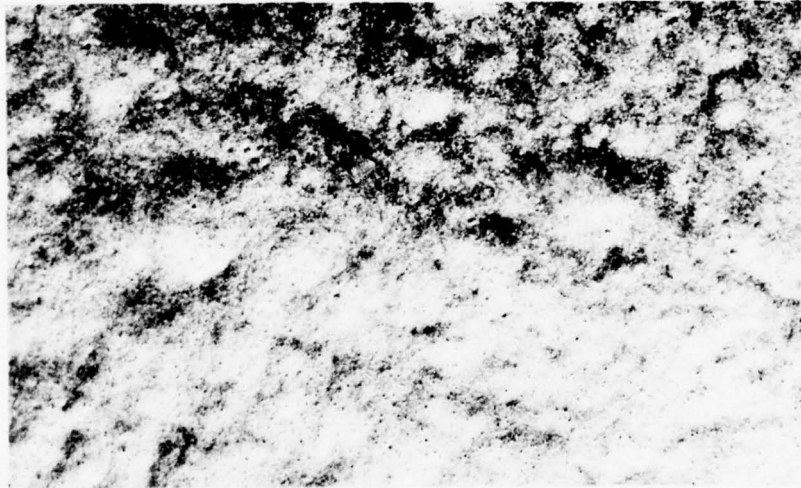
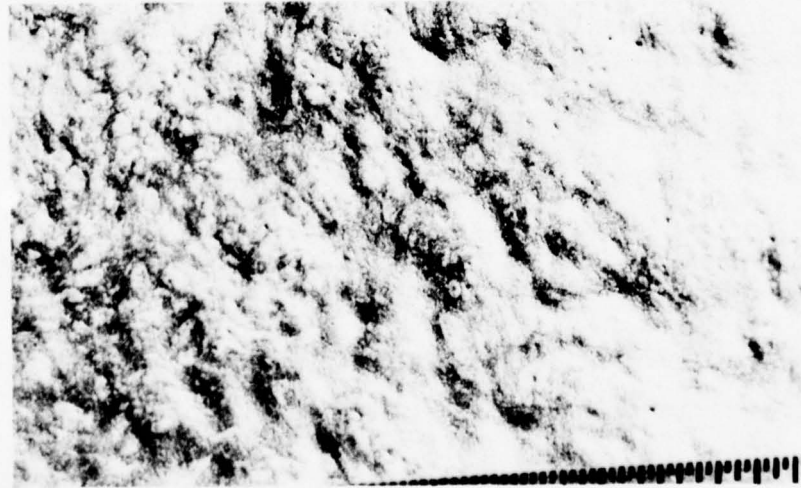
System 10 - Aluminum-Pigmented Catalyzed Urethane. As mentioned earlier, this system tended to flow into low areas on the panel when applied and to attain a much greater thickness at these points. As a result, the coating was somewhat thinner on the higher areas of foam. To date this has not affected its performance, but incipient deterioration may be occurring as indicated in Figure 13 by the increasing number of black specks becoming evident with additional exposure. Its performance was rated as excellent after 2 years at Port Hueneme and excellent after 1 year at the other two sites.

Figure 13. Progressive development of black specks in aluminum pigmented catalyzed urethane (System 10) at Pickel Meadows.

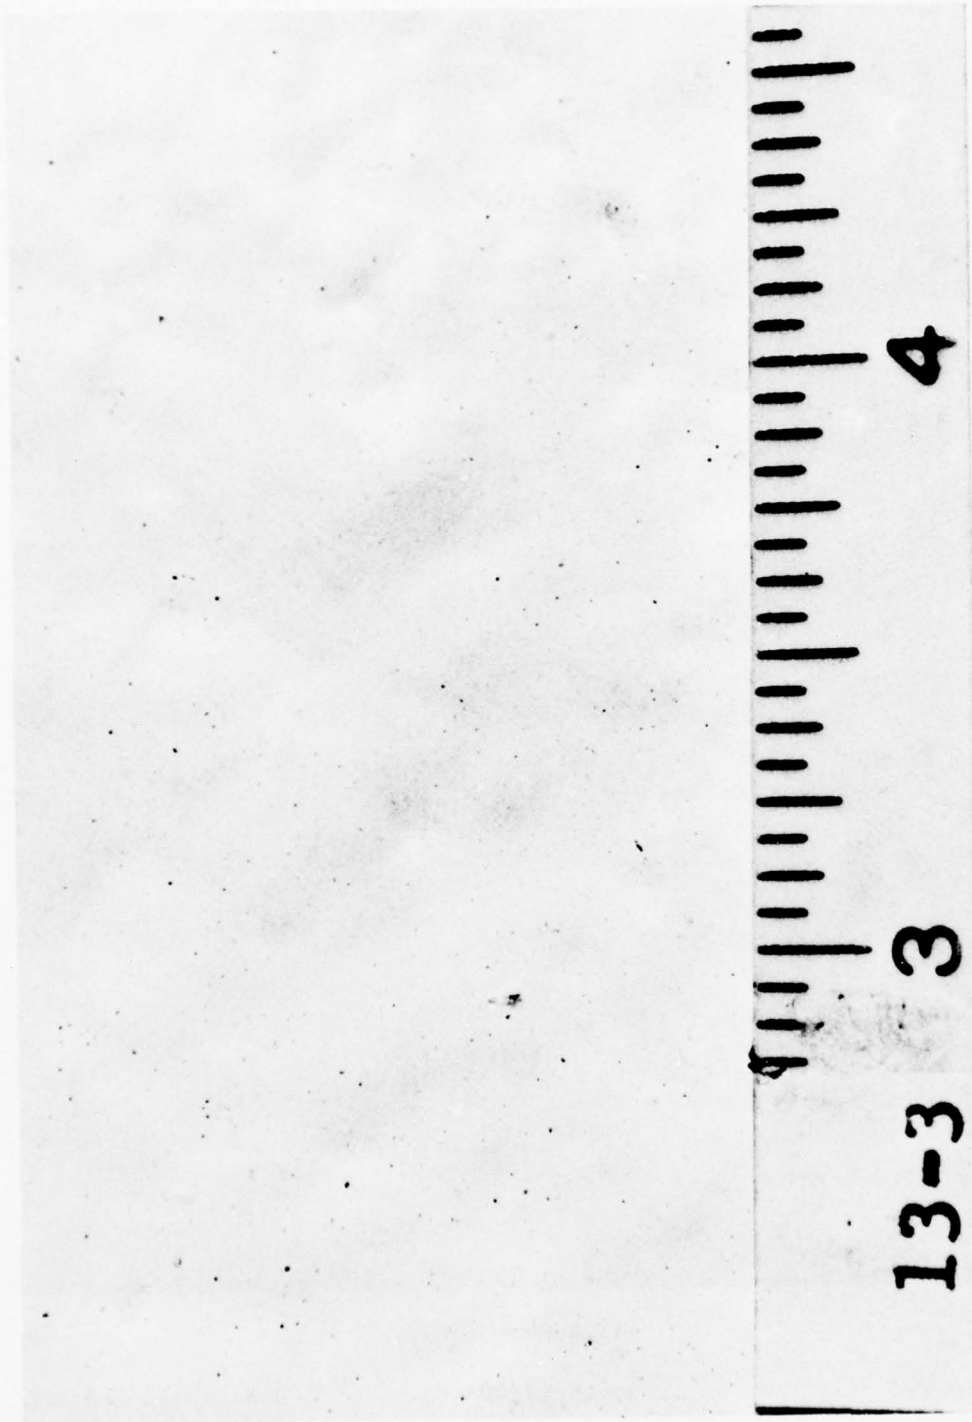
System 13 - Catalyzed Urethane Elastomer. This urethane elastomer has a combination of excellent appearance and performance that has been outstanding to date. It has a glossy white appearance and does not retain dirt, thus maintaining its excellent reflective surface, as shown in Figure 15. After 1 year of exposure at China Lake and Pickel Meadows and 1.5 years at Port Hueneme, the performance of this system was rated as excellent.

Figure 15. Excellent clean and glossy surface of catalyzed urethane (System 13) after 1 year at China Lake.

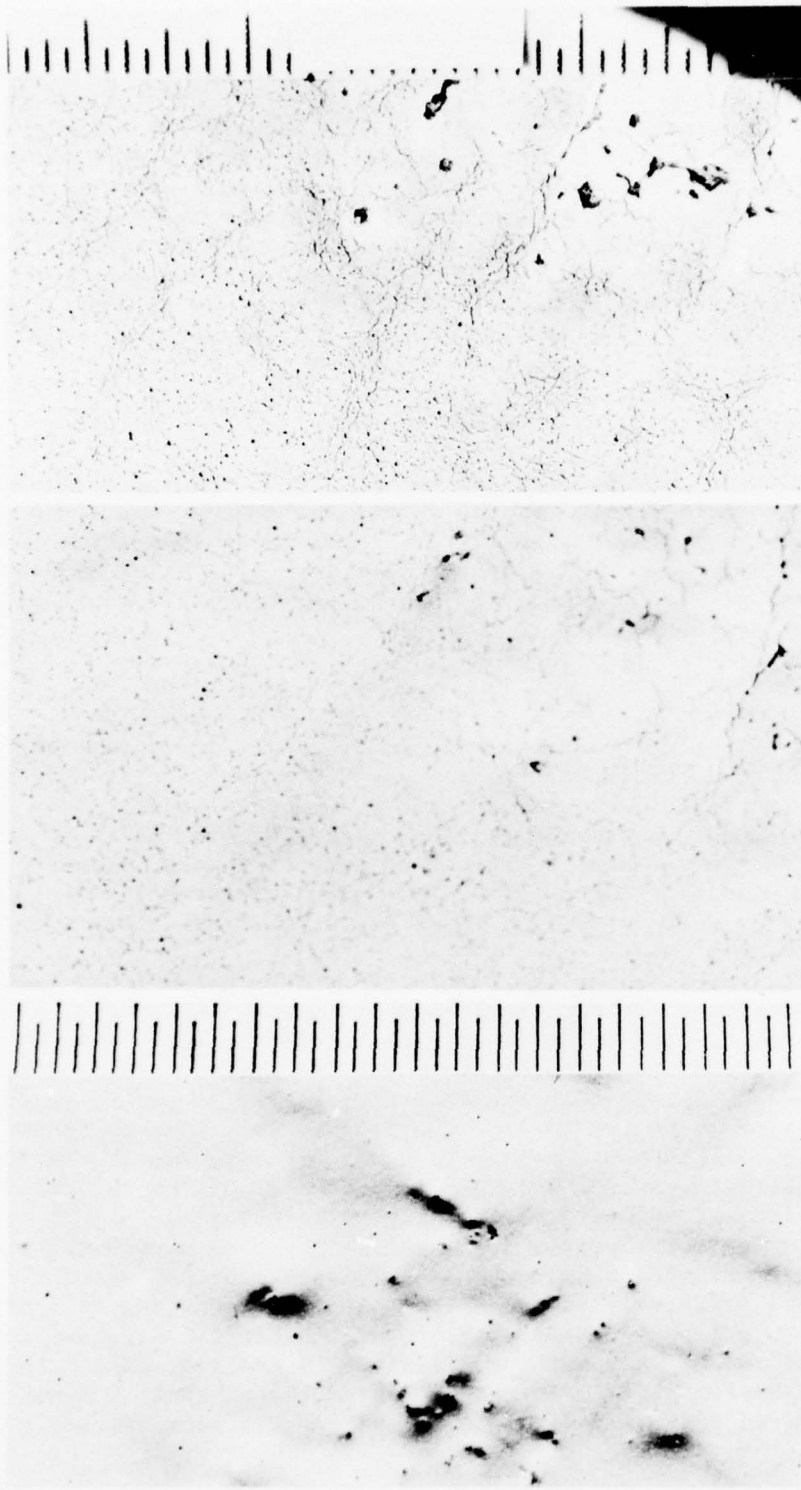
Systems 14 and 14A - Moisture-Curing Urethane Elastomer. Great difficulty was encountered with the application of System 14. As a result, System 14A was applied under the direction of the manufacturer's representative. As with Systems 12 and 12A, System 14 had dense solvent pinholes up to 1/16-inch in diameter all over the panel, while System 14A had very few pinholes. Although these pinholes contributed to deterioration, they were not the only cause. The coating tends to chalk very heavily and shows severe checking and flaking, all of which are attributed to regression of the urethane elastomer and all of which contribute to progressive deterioration such as shown in Figure 16. After 1 to 1-1/2 years exposure, the performance of this system is rated as poor to failed. System 14A however, although chalking heavily, is performing better, and after 6 months to 1 year of exposure, its performance is rated as excellent at all three sites.

Figure 16. Progressive deterioration of moisture-curing urethane (System 14) after various periods of exposure at Pickel Meadows.

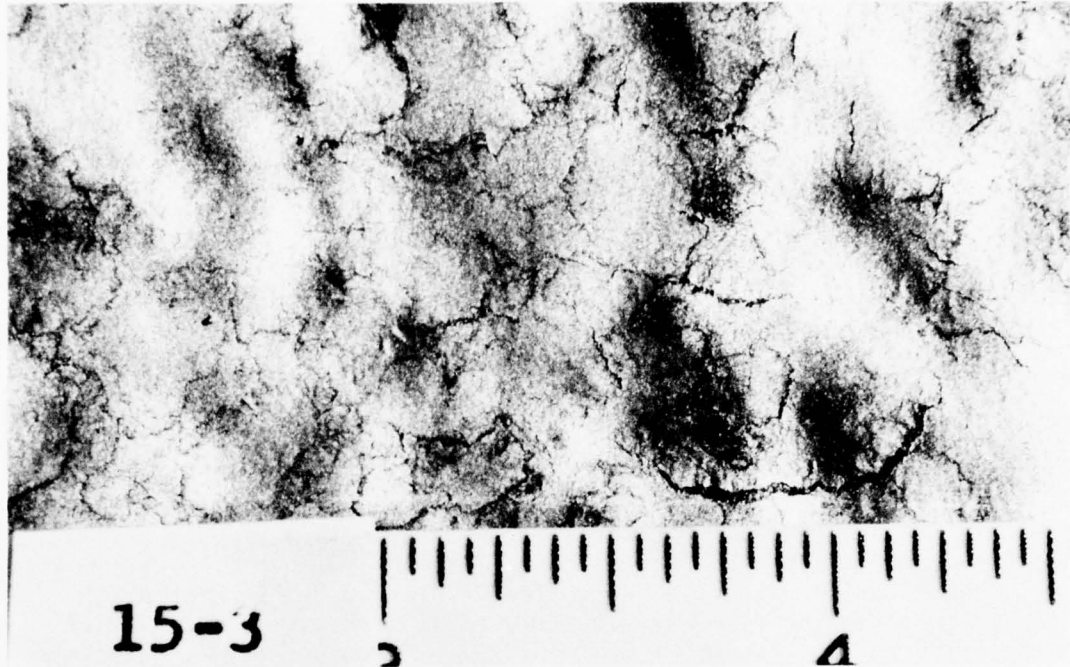
System 15 - Fibrated Aluminum-Asphalt. Asphalt and aluminum-asphalt coatings have been widely used over foam in spite of poor performances in the field. System 15, a high quality fibrated-aluminum asphalt, was included as a control. After only 6 months of exposure at the China Lake and Pickel Meadows sites, light deterioration in the form of alligating was noted, as shown in Figure 17. In addition, this system was the only coating investigated that was damaged by hail at the Pickel Meadows site; hail damage can be seen in Figure 18. However, neither of these forms of deterioration was severe and this system was rated as very good at both China Lake and Pickel Meadows after 6 months of exposure. System 15 was performing better at Port Hueneme and was rated as excellent after 12 months in a marine atmosphere.

Figure 17. Alligatoring of aluminum-asphalt (System 15) after 6 months at China Lake.
