Coso Geothermal Corrosion Studies

by
Stephen A. Finnegan
Research Department

OCTOBER 1977

NWC Technical Publication 5974

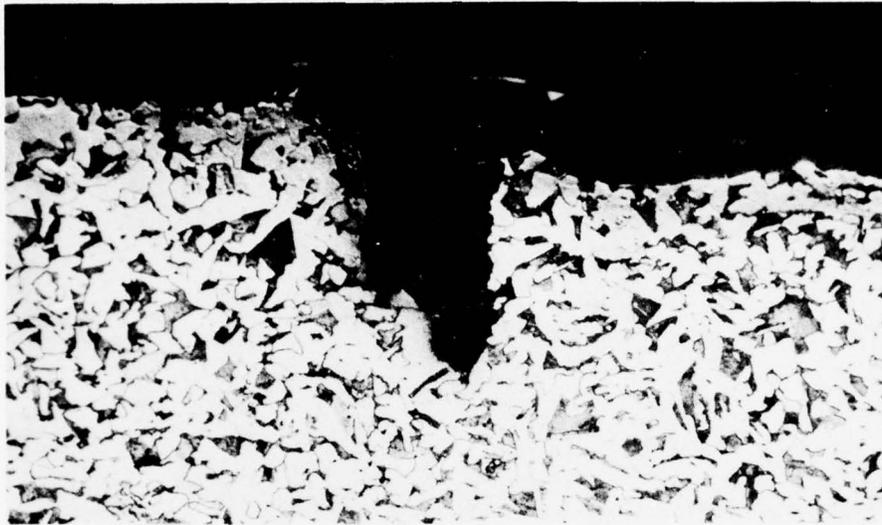
FIGURE 3. A Photomicrograph Showing Pitting Corrosion in Steel Exposed to Anaerobic Acid-Sulfate Steam. (200X)

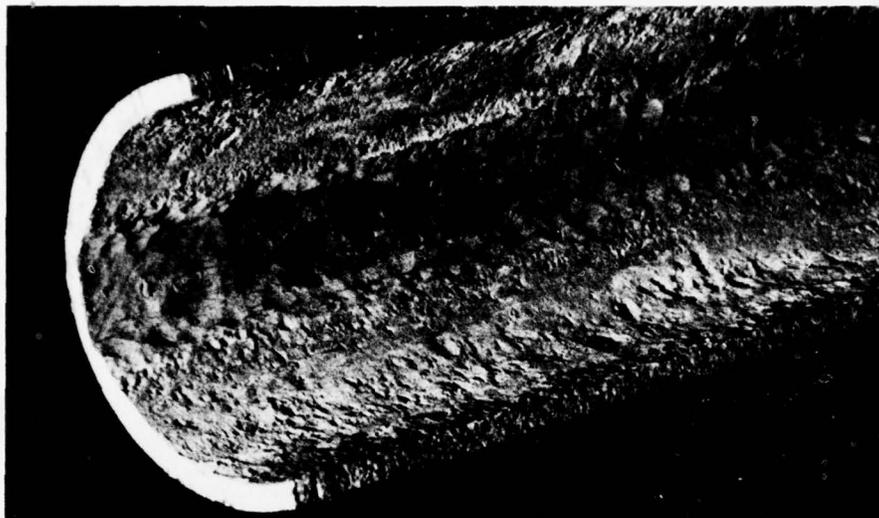
FIGURE 5. A Corrosion Channel in the Bottom of the Pipe Described in Figure 4, After Cleaning.

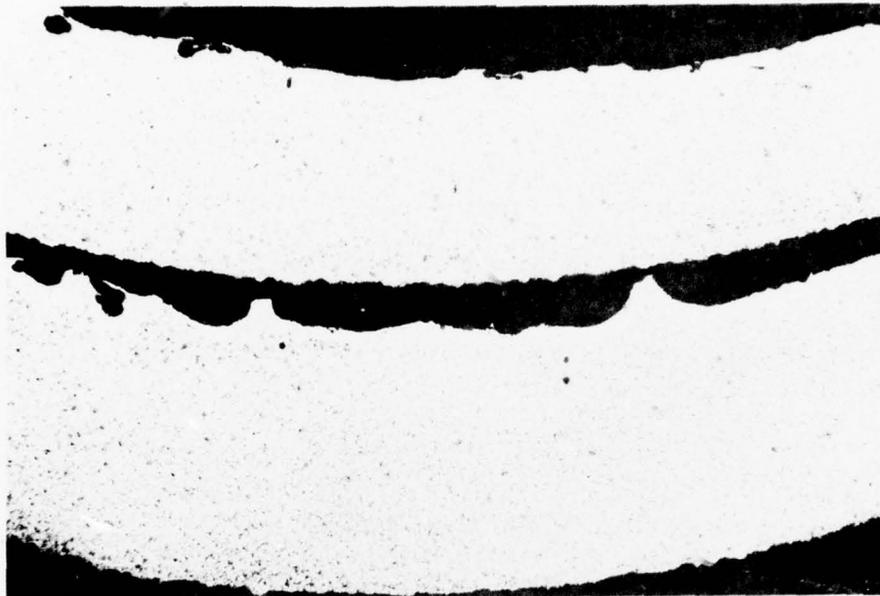
FIGURE 6. A Section View of Gray Cast Iron Exposed to Anaerobic, Acid-Sulfate Steam, Showing Surface Irregularities.

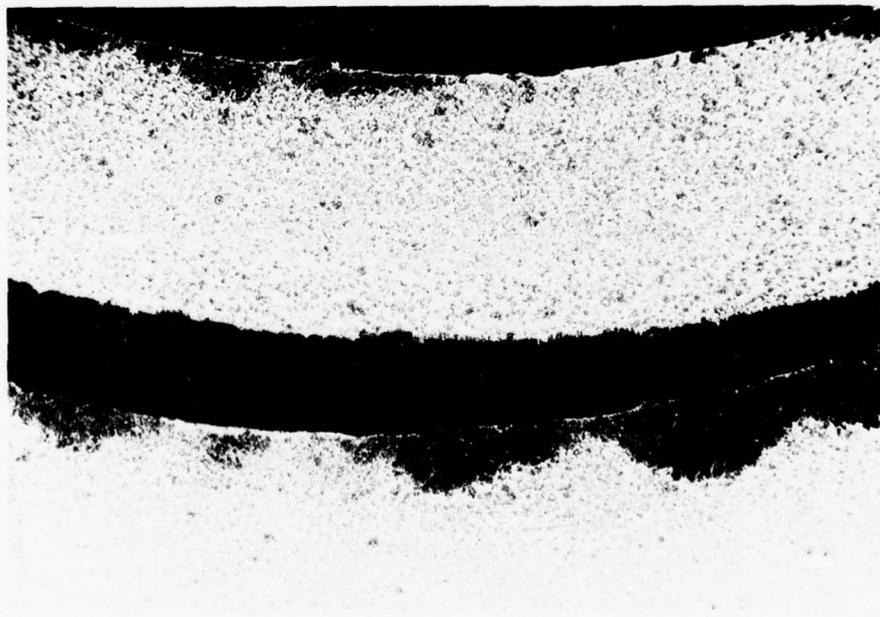
The aerated specimen was covered with a layer of ferric oxides and hydrated oxides identical in appearance to those found on the steel pipe, only considerably thinner in depth. Corrosion of the cast iron underneath was low and quite uniform within the condensate channel. No corrosion channel was formed on the bottom as on the steel pipe although the normally rough cast iron surface was leveled and smoothed by the corrosion process. A possible graphite-rich zone about 1.8 mm deep was found next to the surface in the cast iron on the bottom of the condensate channel near the downstream end (Figure 7). An analysis of the

FIGURE 7. A Section View of Gray Cast Iron Exposed to Aerated, Acid-Sulfate Steam, Showing a Zone of Possible Graphitization Next to the Surface.

microstructure did not reveal whether the zone was due to corrosion of the iron phase (graphitization) or simply an agglomeration of graphite particles. A sample of wall material was analyzed with x-ray fluorescence which discovered an excess of silicon in these soft black-colored areas. The presence of carbon could not be verified with this method. Adjacent microstructure contained predominantly type D graphite flakes (Figure 8) which would indicate some degree of undercooling.²⁹ The material at the surface also showed evidence of possible chilling. This specimen clearly needs additional study. The graphitization of gray cast iron in a dilute sulfuric acid solution has been observed previously²⁶ and appears to proceed if the graphite phase remains exposed to the attacking fluid. Attack generally stops or slows once the graphite becomes covered with corrosion products.

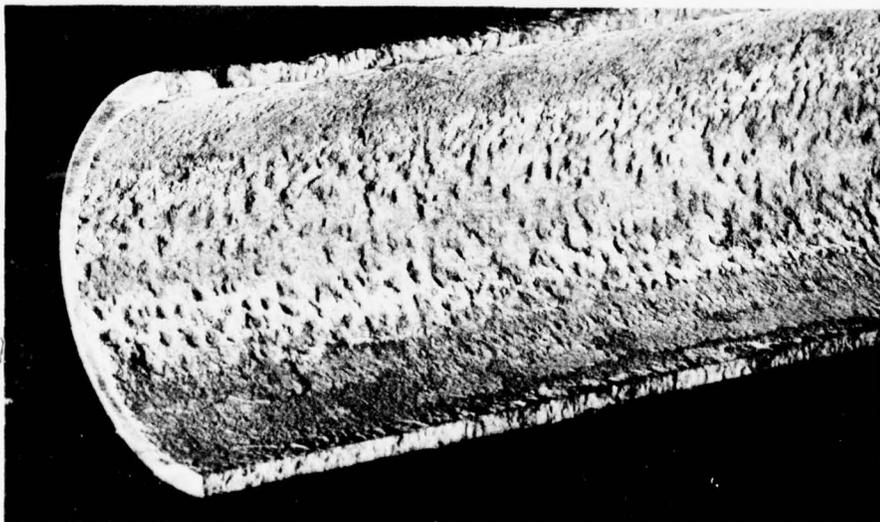
FIGURE 9. Outlet End of an Open, Galvanized Steel Pipe Exposed to Aerated Acid-Sulfate Steam, Showing Pitting Corrosion.

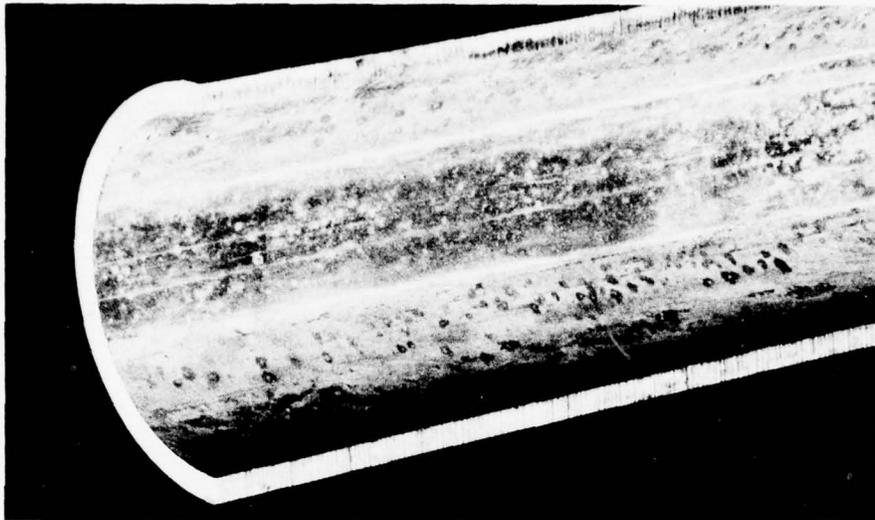
FIGURE 10. Outlet End of an Open Aluminum Pipe Exposed to Aerated Acid-Sulfate Steam, Showing Pitting Corrosion on the Walls Under a Thin Film of Brown Precipitates.

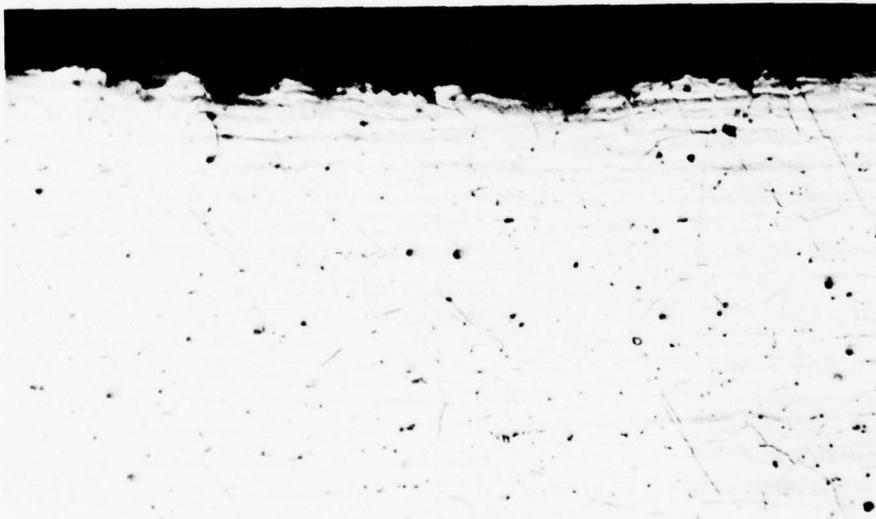
FIGURE 11. A Photomicrograph Showing Minor Pitting Corrosion and Grain Boundary Attack of a Stainless Steel Pipe Exposed to Aerated, Acid-Sulfate Steam. (200X)

oxygen to the surface of the metal. In addition to pitting, the surface showed minor attack to grain boundaries (Figure 11).

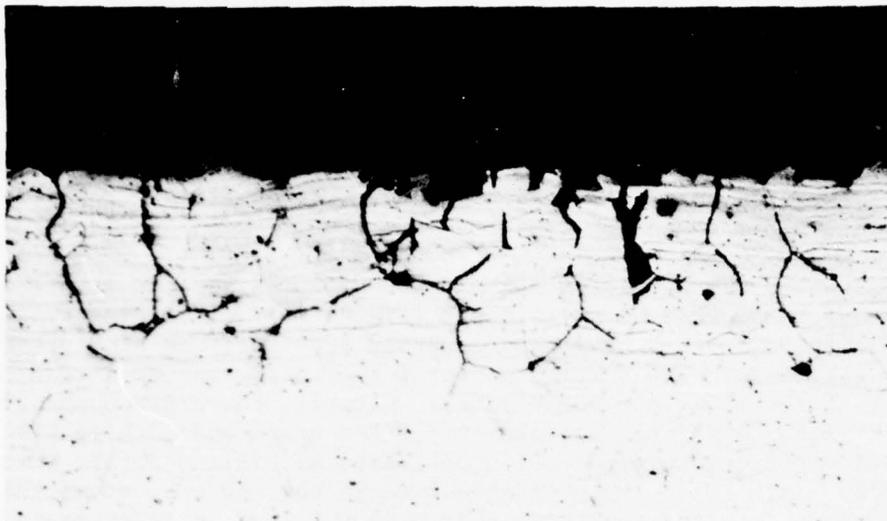
FIGURE 12. A Photomicrograph Showing Intergranular Corrosion Adjacent to a Welded Seam in the Sample Described in Figure 11. (200X)

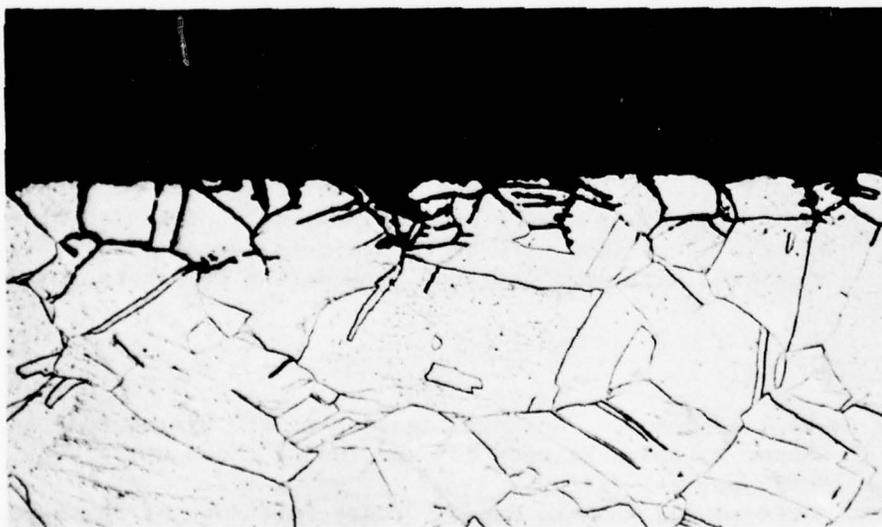
FIGURE 13. A Photomicrograph Showing Intergranular Corrosion of a Copper Tube Exposed to an Anaerobic, Acid-Sulfate Steam. (200X)

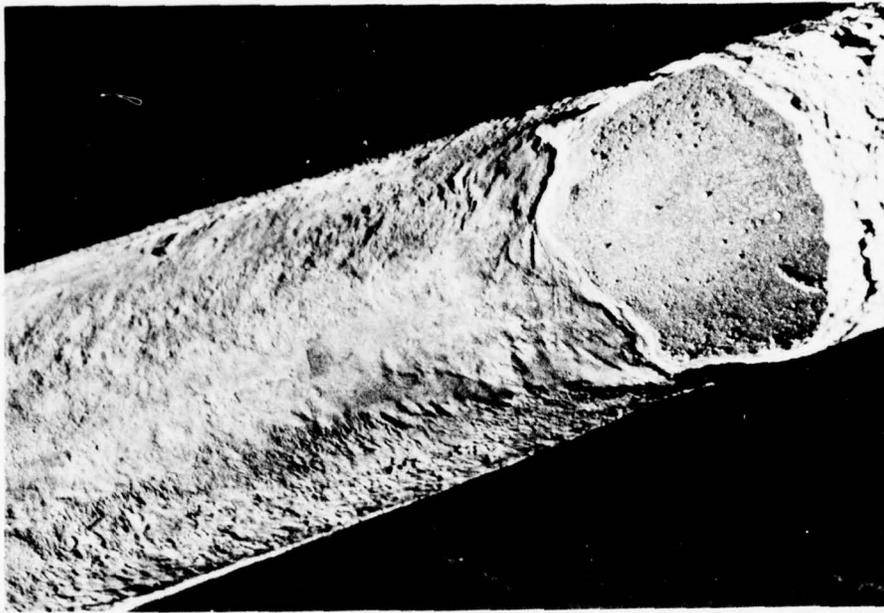
FIGURE 14. Inlet End of an Open Copper Pipe Exposed to an Aerated, Acid-Sulfate Steam, After Cleaning.

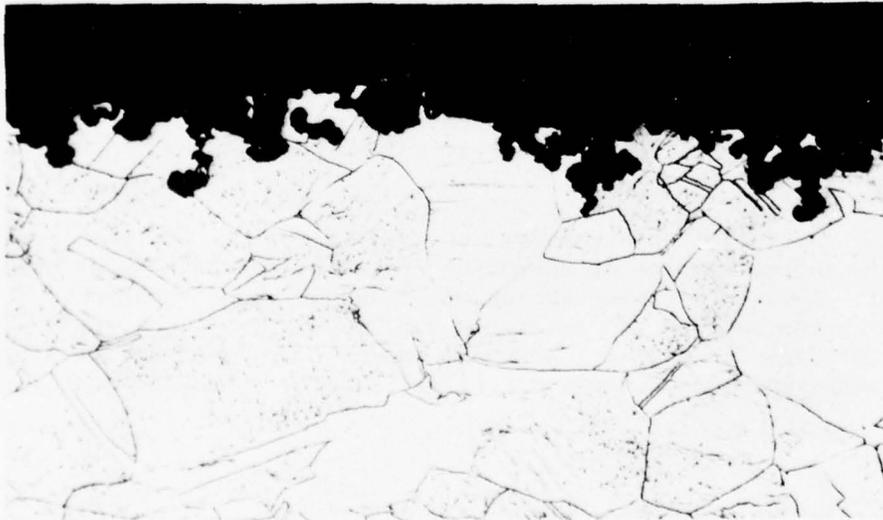
FIGURE 15. A Photomicrograph Showing Pitting Corrosion of an Open Copper Tube Exposed to an Aerated, Acid-Sulfate Steam. (200X)

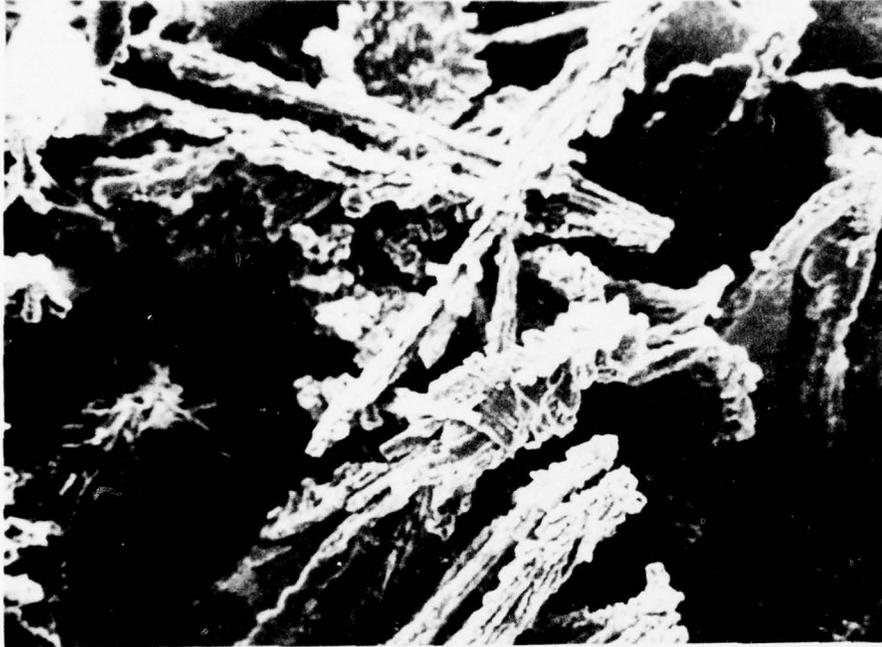
FIGURE 16. A scanning Electron Microscope Photomicrograph of Dendritic Structure Found in Corrosion Products Removed From the Specimen Shown in Figure 14, Tentatively Identified as Recrystallized Copper. (1700X)

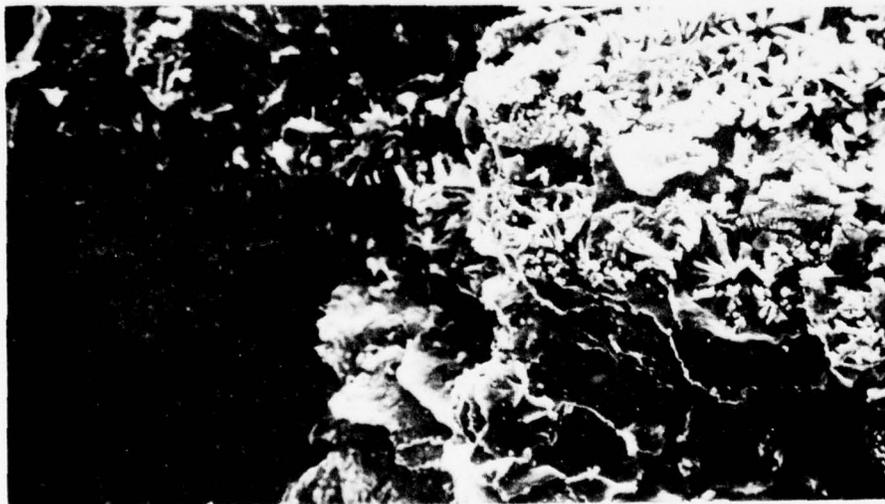
FIGURE 17. A Scanning Electron Microscope Photomicrograph of Sheet-Like Crystals Found in Corrosion Products Removed From the Specimen Shown in Figure 14, Tentatively Identified as Bladed Covellite, CuS . (330X)

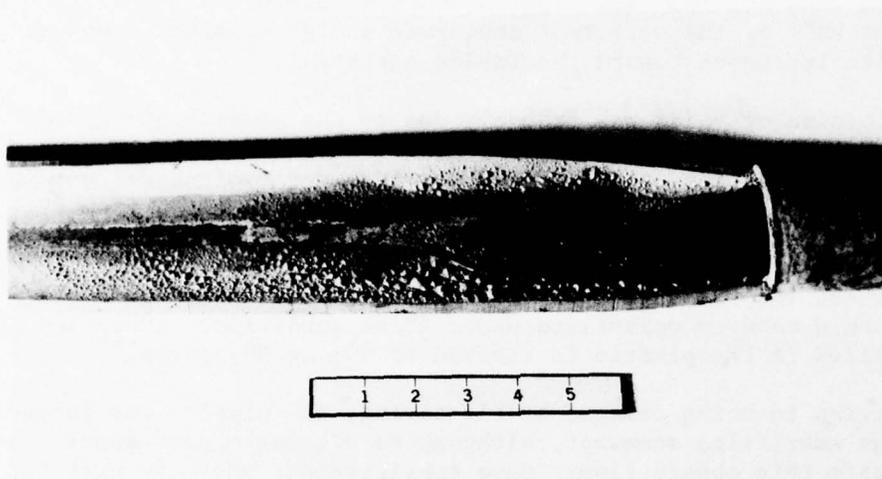
FIGURE 18. Inlet End of an Open PVC Pipe Exposed to an Aerated, Acid-Sulfate Steam, Showing Blistering of the Surface. Flow is from right to left. Scale in inches.

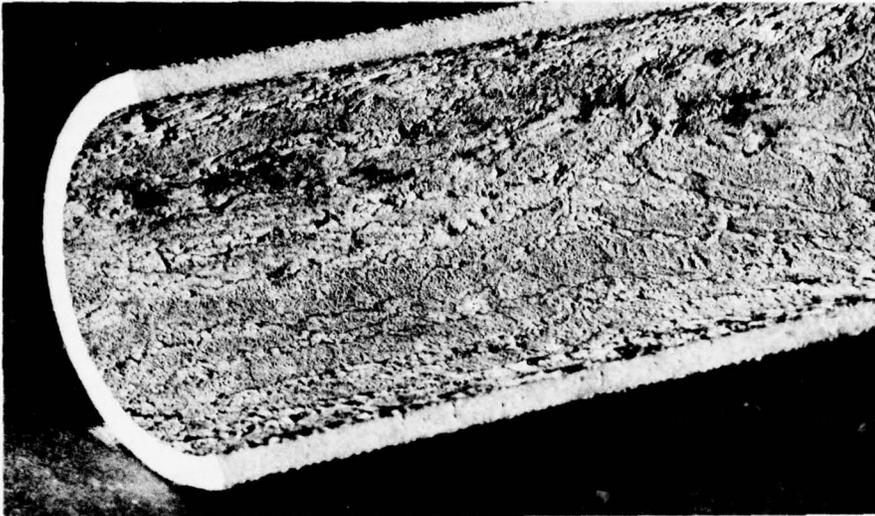
FIGURE 19. Outlet End of an Open Gray Cast Iron Pipe Exposed to Aerated Groundwater-Diluted Steam, After Cleaning, Showing Surface Grooves.

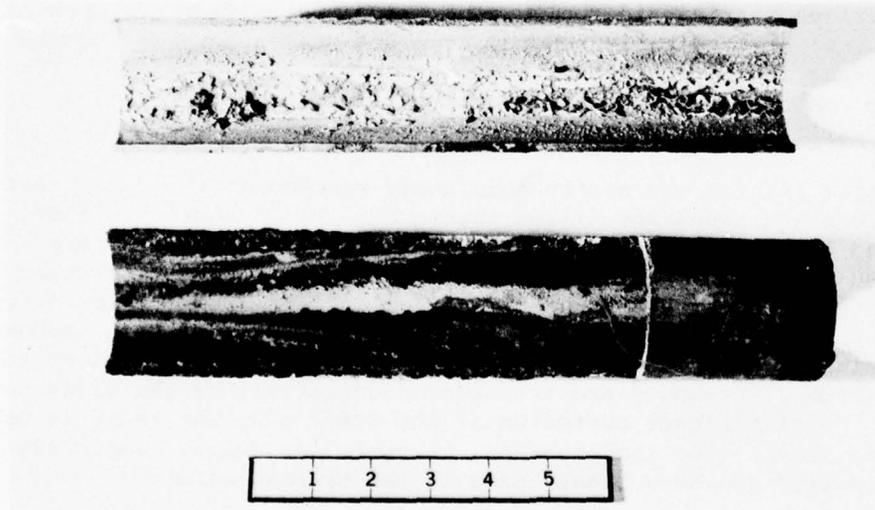
FIGURE 20. View of the Outlet (top) and Inlet (bottom) Areas of an Open, Galvanized Steel Pipe Exposed to a Groundwater-Diluted Steam. Flow is from right to left. Scale in inches.

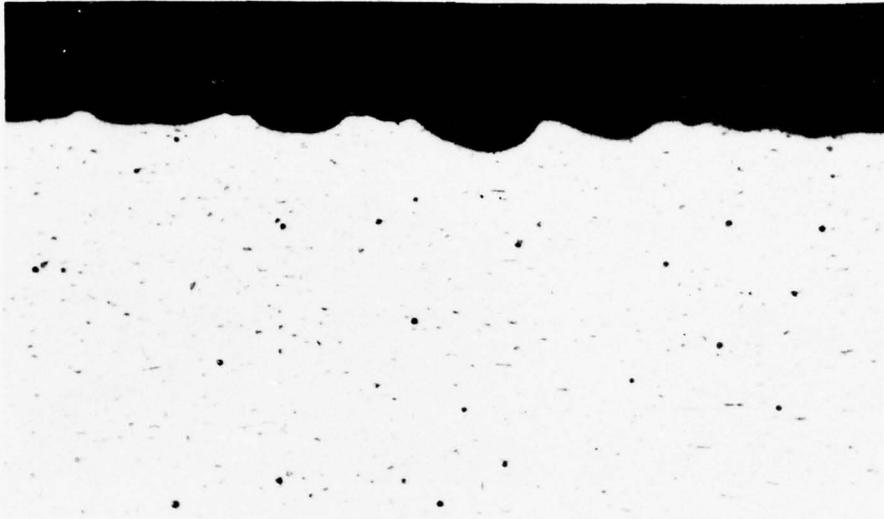
FIGURE 21. A Photomicrograph Showing Pitting Corrosion in an Open Aluminum Pipe Exposed to Aerated Groundwater-Diluted Steam. (200X)

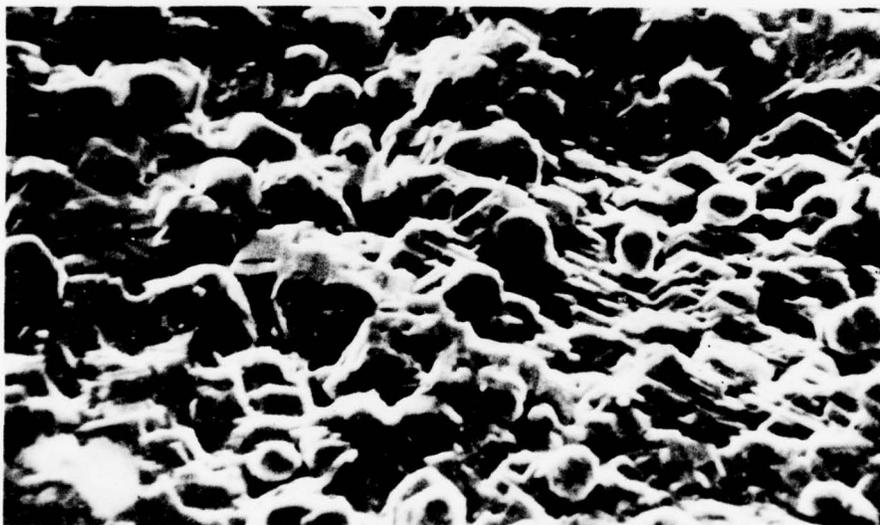
FIGURE 22. A Scanning Electron Microscope Photomicrograph of Silver-Gray, Plate-Like Sulfide Corrosion Products in a Closed Copper Tube Exposed to Anaerobic Groundwater-Diluted Steam, Identified as Cu_2S , Chalcocite. (320X)

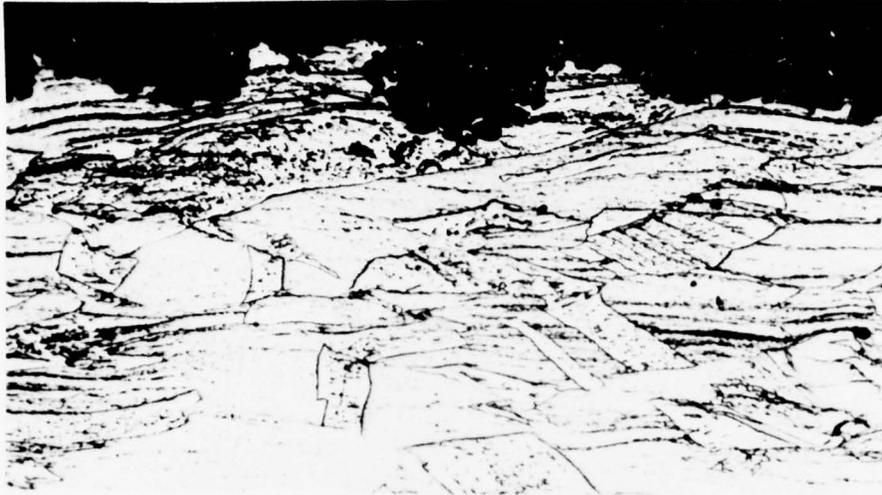
FIGURE 23. A Photomicrograph Showing Pitting Corrosion in an Open Copper Pipe Exposed to Aerated Groundwater-Diluted Steam. (200X)

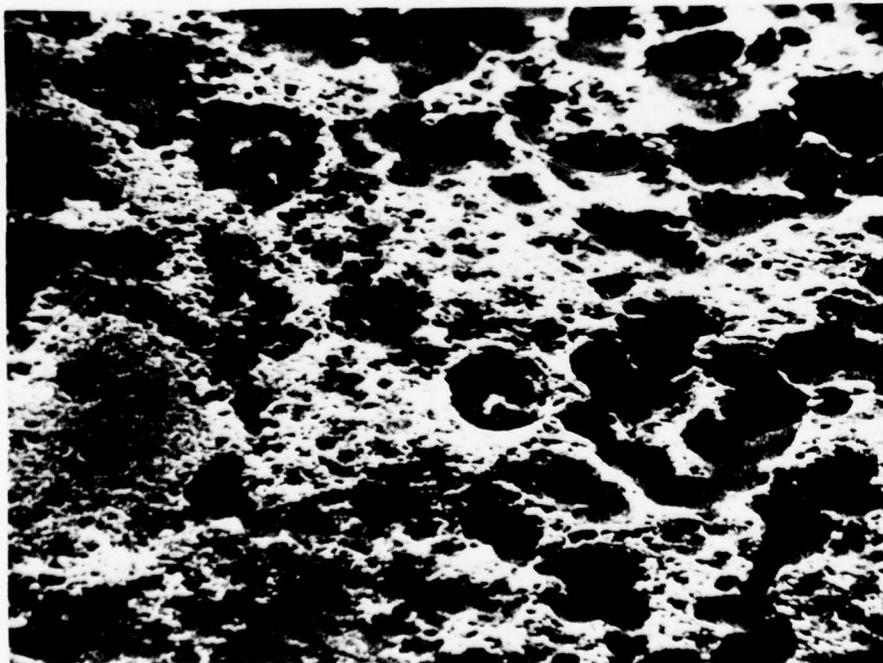
FIGURE 24. A Scanning Electron Microscope Photomicrograph Showing Pitting Corrosion of the Copper Specimen Described in Figure 23. (210X)

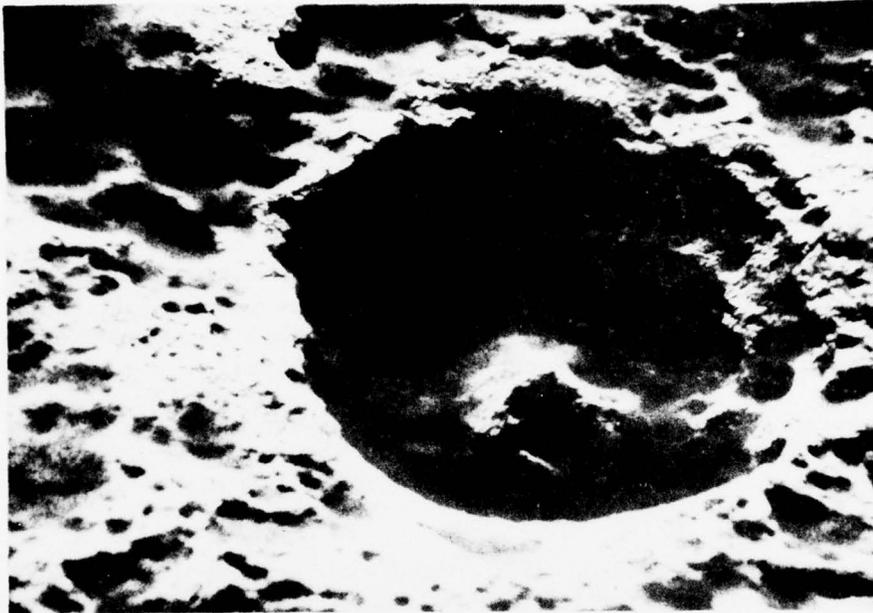
FIGURE 25. A Scanning Electron Microscope Photomicrograph Showing the Bottom of a Pit Viewed in Figure 24. (1060X)

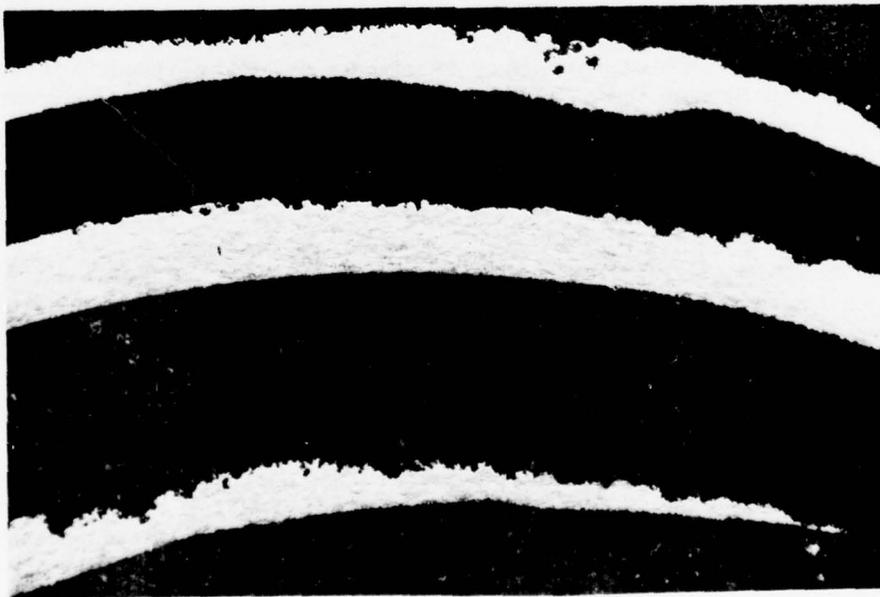
FIGURE 26. A Section View of the Specimen Described in Figure 23 Showing Pitting Corrosion of the External Copper Surface.

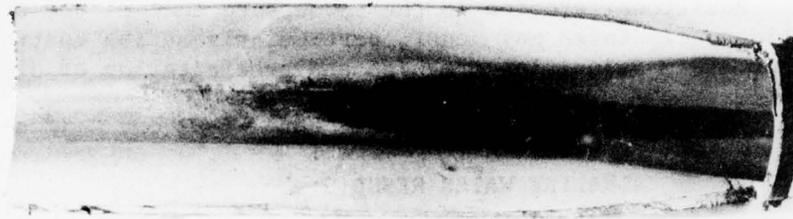
FIGURE 27. Inlet End of an Open PVC Pipe Exposed to Aerated Groundwater-Diluted Steam. Flow is from right to left. Scale in inches.

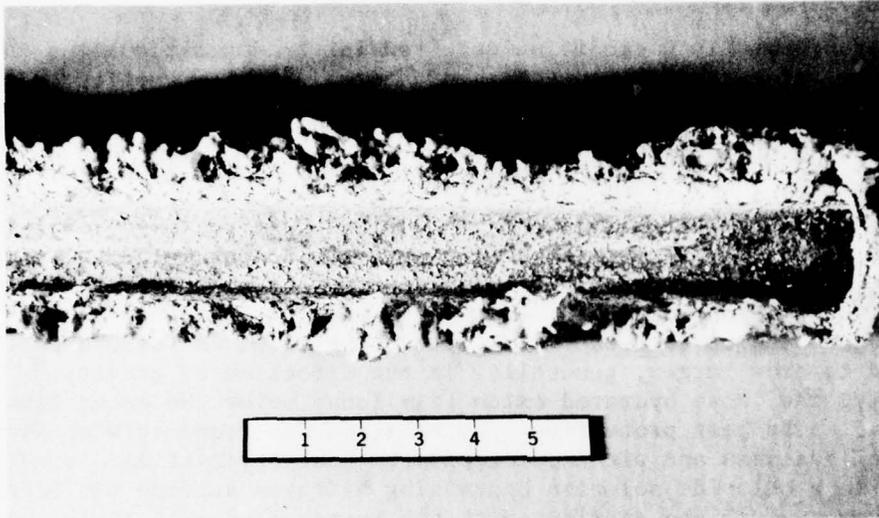
FIGURE 28. Inlet End of an Open Aluminum Pipe Exposed to Hot Aerated Alkaline Water Showing Sodium Chloride Precipitation. Flow is from right to left. Scale in inches.

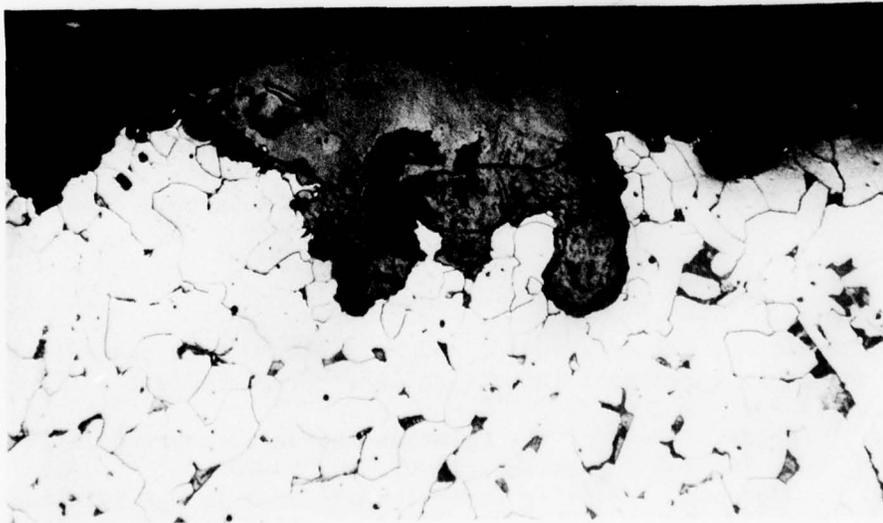
FIGURE 29. A Photomicrograph Showing Pitting Corrosion in a Closed Steel Pipe Exposed to Hot, Anaerobic Alkaline Fluids. (200X)

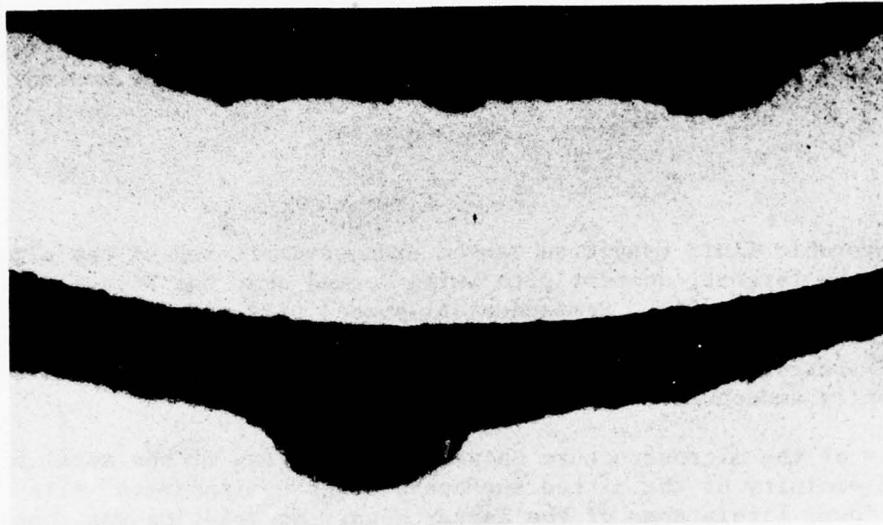
FIGURE 30. A Section View of an Open Steel Pipe Exposed to Hot, Aerated Alkaline Fluids Showing Pitting Corrosion.

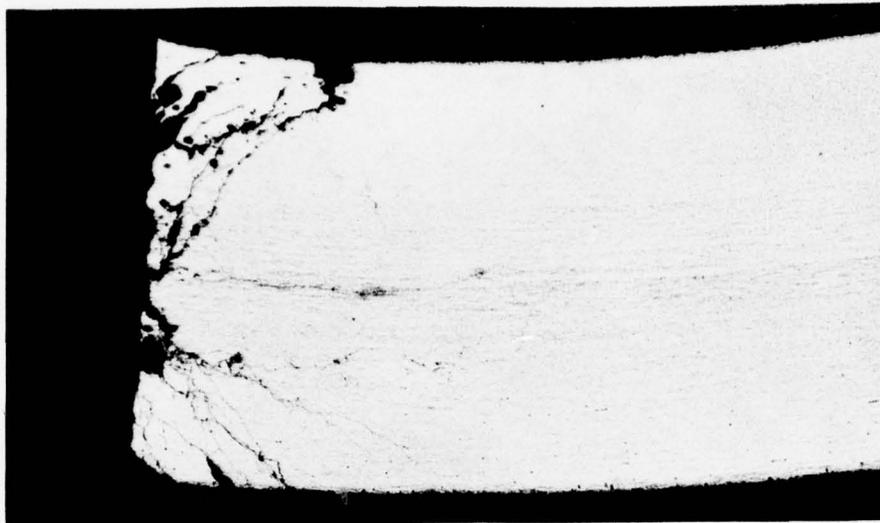
FIGURE 33. A Section View of an Open Stainless Steel Pipe Exposed to Hot, Aerated Alkaline Fluids, Showing Transgranular Stress-Corrosion Cracking.

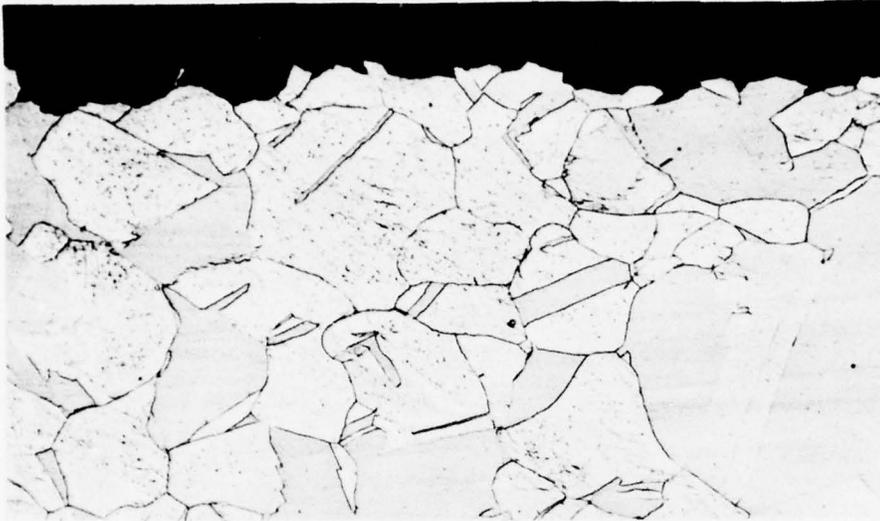
FIGURE 34. A Photomicrograph Showing Surface Corrosion of a Closed Copper Tube Exposed to Hot, Anaerobic Alkaline Fluids. (200X)

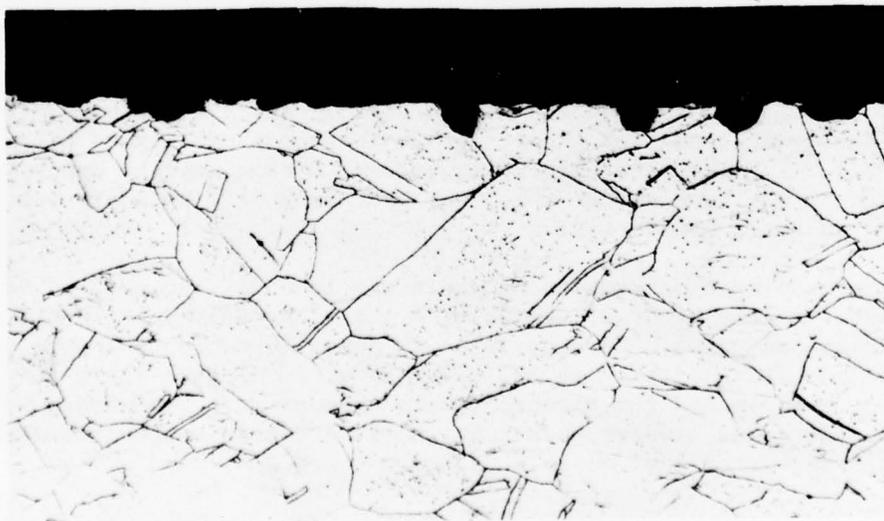
FIGURE 35. A Photomicrograph Showing Pitting Corrosion of an Open Copper Tube Exposed to Hot, Aerated Alkaline Fluids. (200X)

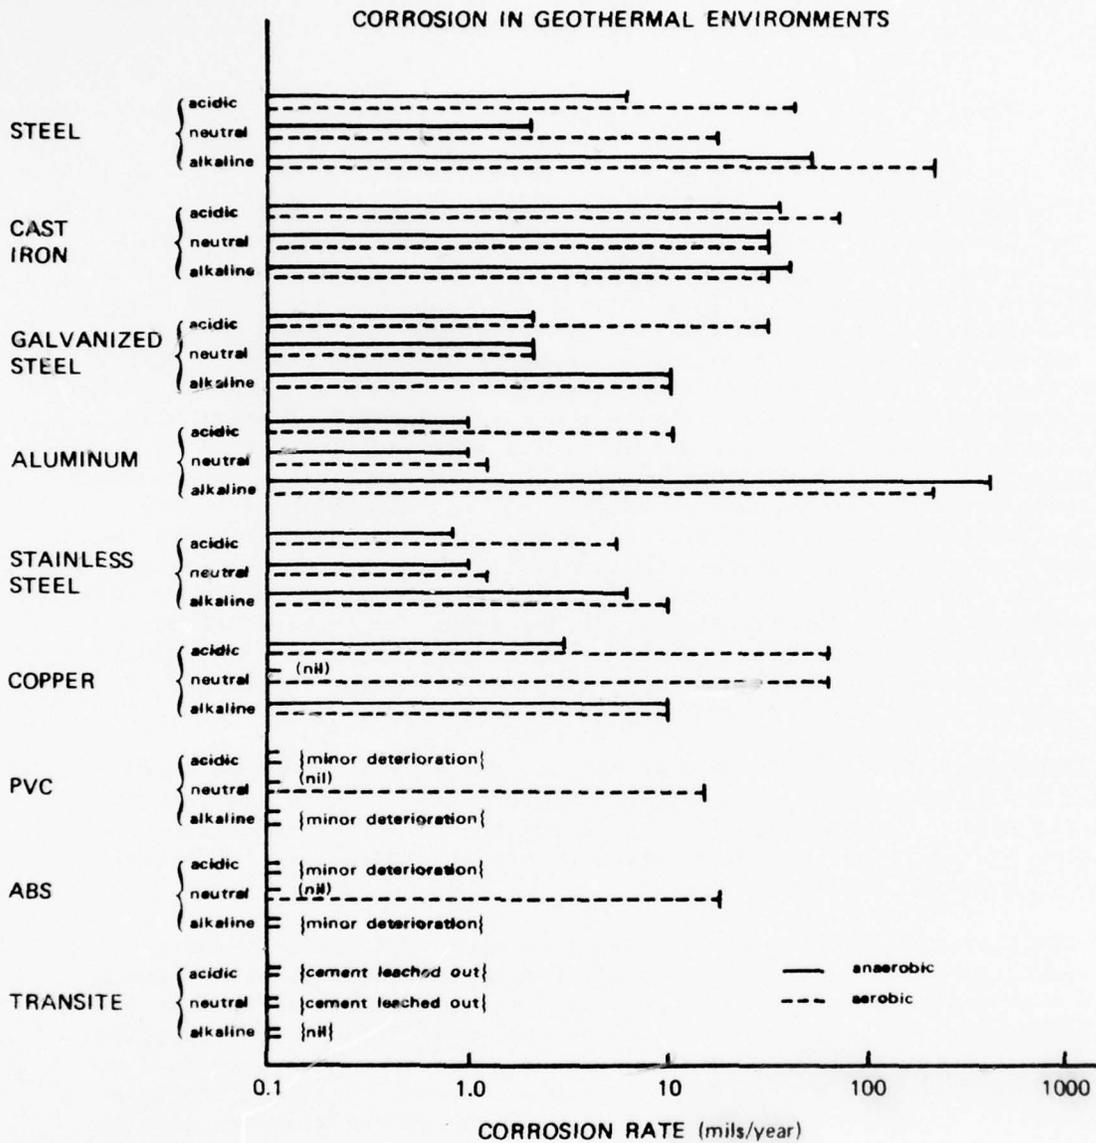
FIGURE 36. A Comparison of Corrosion Rates for Various Materials in Three Geothermal Fluids Found at the Coso Thermal Area.
