USAAEFA PROJECT NO. 77-05

**ICING EVALUATION  
U-21A AIRPLANE WITH  
LOW REFLECTIVE PAINT**

FINAL REPORT

MAY 1977

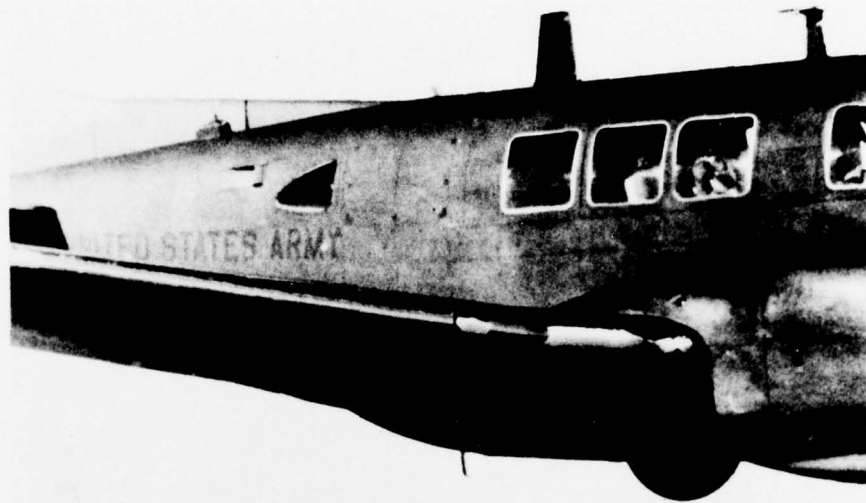
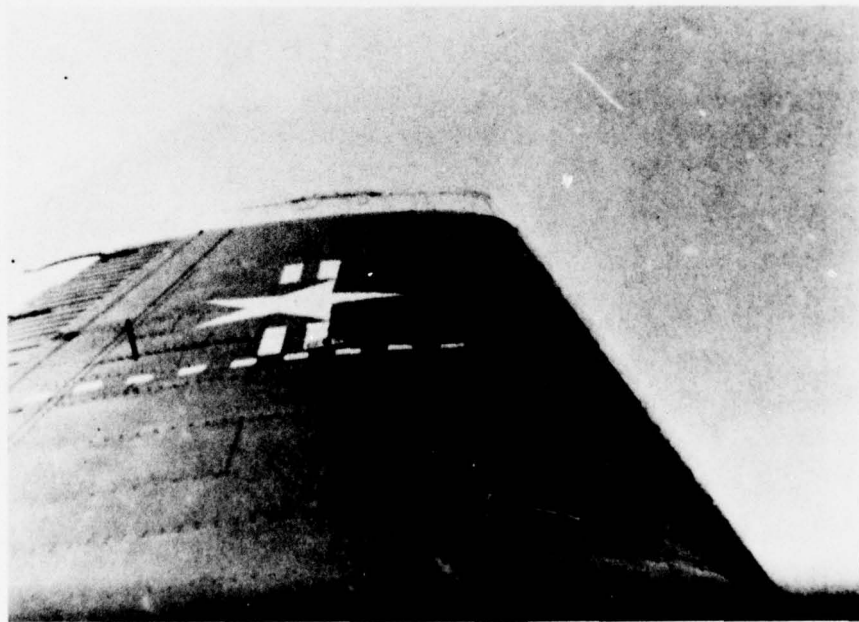
10. With constant power for 170 KCAS in level flight, an ice accumulation of 0.5 to 1 inch on the leading edges of the deicing boots resulted in a 20- to 30-knot loss in airspeed. At this same ice accumulation level, 170 KCAS could be maintained with full power applied to both engines. Photos 7 and 8, appendix B, show an ice accumulation of approximately 1 inch on the leading edges of the pneumatic deicing boots. After activation of the boots, the power required for level flight was reduced. The effectiveness of the deicing boots is further discussed in paragraph 13. To prevent unnecessary concern on the part of the flight crew the following NOTE should be incorporated in the operator's manual:

**Photo 7.** Approximately One Inch of Ice Accumulated on Leading Edge of Wing of Test Aircraft.

**Photo 8.** Approximately One Inch of Ice Accumulated on Leading Edge of Wing of Standard Aircraft.

At constant power an airspeed loss of 20 to 30 knots can be expected with flight in moderate icing conditions.

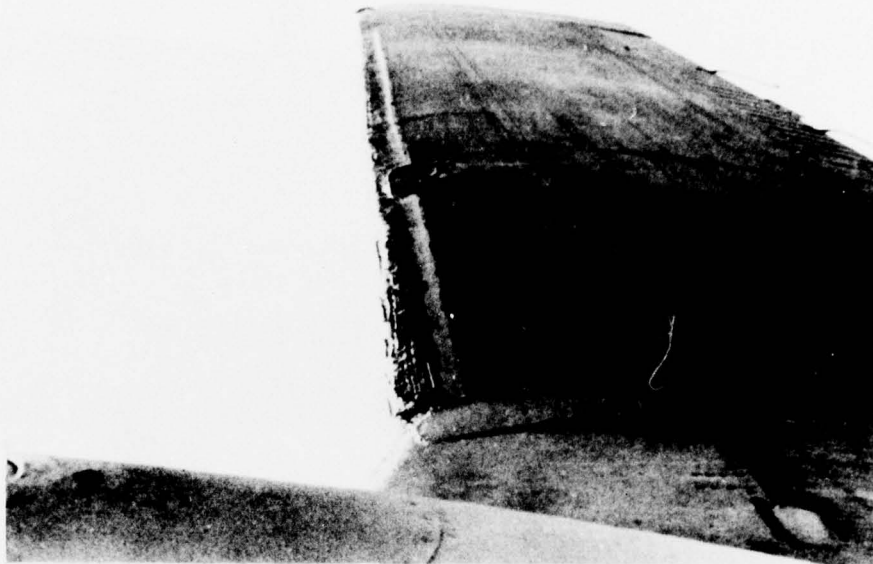
13. The effectiveness of the pneumatic boots differed with the type of ice that accumulated on the wing. With rime icing the boots did not adequately clear the ice. Photo 9, appendix B, depicts rime ice accumulation prior to activation of the boots. Photo 10 shows the wing after the boots were activated. Repeated use of the boots (six attempts) did not significantly clear more ice. With clear or mixed icing the boots were effective and ice was cleared by one application of the boots. The landing lights were used in one attempt (approximately 1 minute) to clear the large ice build-up on the wing tip. In the short period the landing light was used the ice did not shed from the wing tip. In any future U-21 icing tests, the possibility of anti-icing/deicing the wing area outboard of the boots by use of the landing lights should be investigated. The ineffectiveness of the deice boots with rime ice accumulation is a shortcoming.

**Photo 9. Approximately Two Inches of Rime Ice Accumulation on Leading Edge of Test Aircraft.**

26. The shortcomings should be corrected.
27. Future U-21 icing tests should investigate the use of landing lights for anti-icing or deicing the wing area outboard of the pneumatic boots (para 8).
28. Conduct further testing to determine the effects of ice accumulation inside engine inlets and determine the effectiveness of the engine ice vanes in preventing foreign object damage (para 18).
29. Incorporate the following NOTE in the operator's manual (para 10):

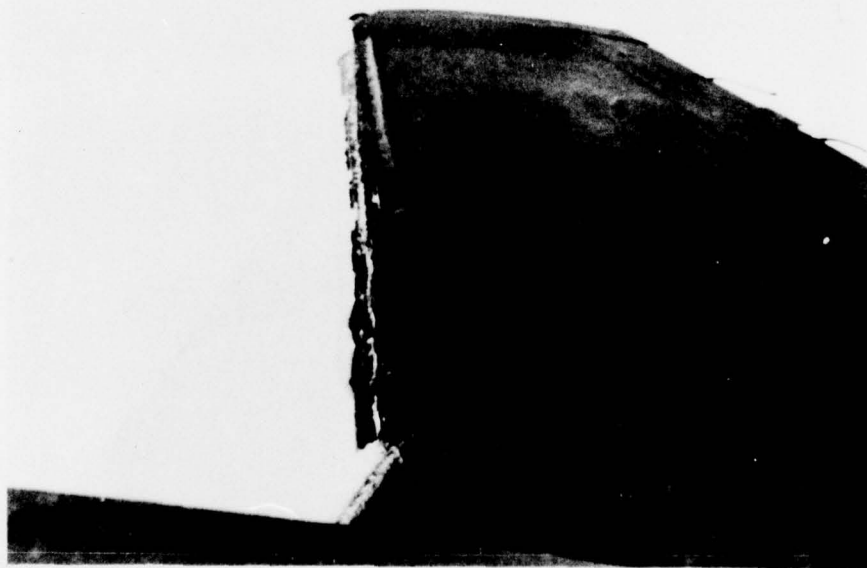
**Photo 10. Rime Ice After Activation of Wing Deicer Boots.**

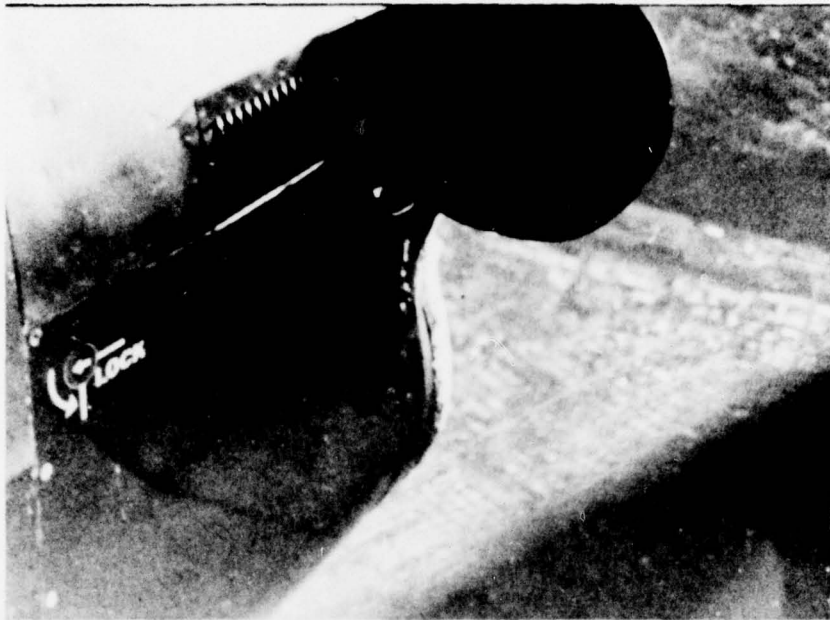
14. Photos 11 and 12, appendix B, show ice accumulation at the engine air inlet lip boots. Although this area incorporates electrothermal deicing and was in use at the time this photograph was taken, ice still formed on the lip boots. The air inlet boots were checked by maintenance personnel and found to be operational. Ice formation on the engine air inlet lip boots was typical for both aircraft. The inability of the engine air inlet anti-ice system to prevent formation of ice on the inlet lip boots is a shortcoming.

Photo 11. Rime Ice Accumulation on Engine Air Inlet Anti-ice Lip Boot.

Photo 12. Glime Ice Accumulation on Engine Air Inlet Lip Boot.

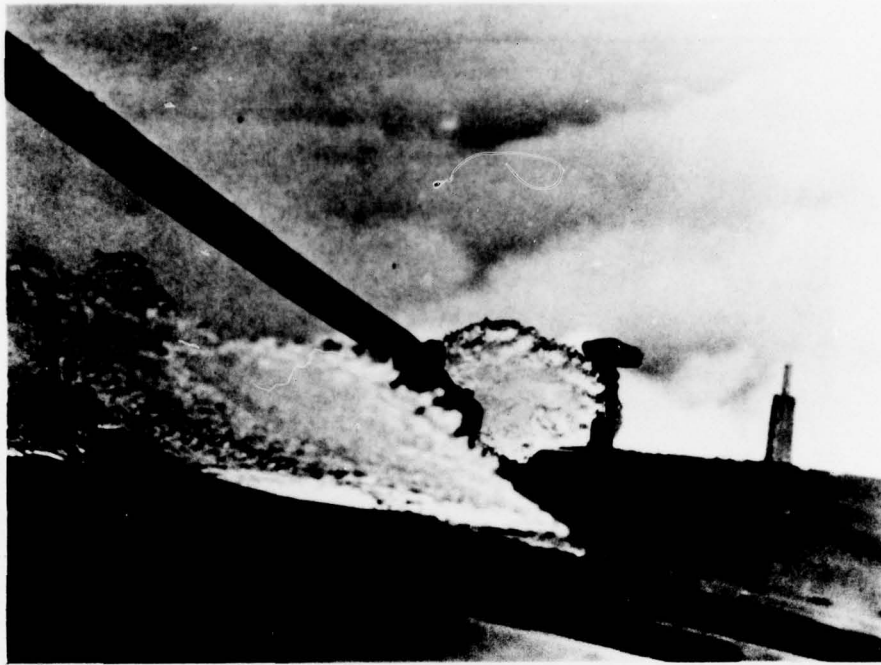
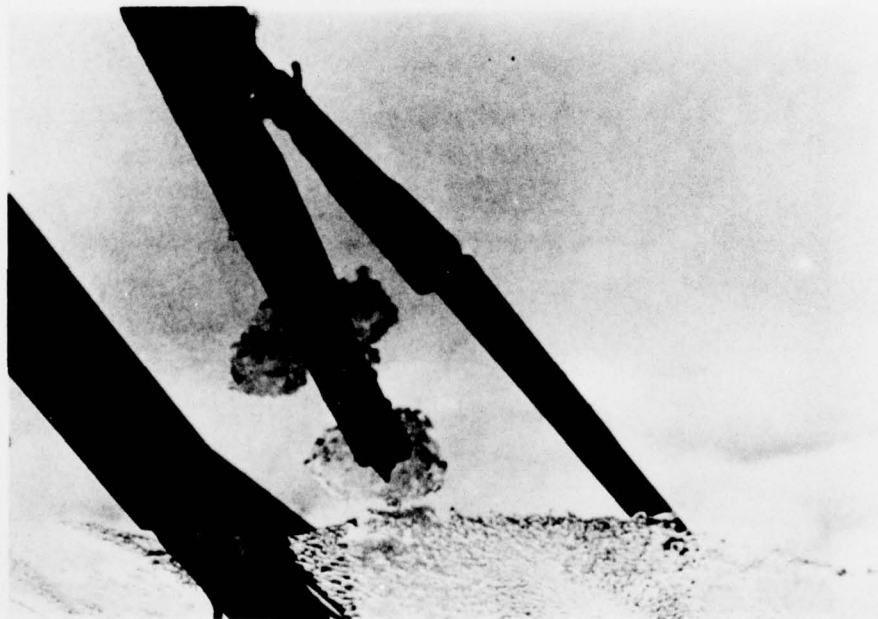
16. Ice accumulation and patterns of accumulation were the same for both aircraft except for ice formation on the windshields. The IR-painted aircraft incorporated a windshield electrothermal anti-ice system. The JU-21D with high gloss paint had an unheated windshield and could only use defrost air to prevent windshield icing. With use of the electrothermal system only a small amount of ice formed on the windshield (photos 13 and 14, app B), and most of this ice was in the area of the windshield wipers. Although considerably more ice formed on the unheated windshield, the defrost air did maintain an area of the windshield clear that was sufficient for landing the aircraft. One test was conducted after application of ice-phobic material to the windshield. The purpose of this test was to determine if ice-phobic material would prevent ice from forming on the windshield or enhance natural shedding. Although icing conditions were not encountered on this flight, further use of the ice-phobic material was discontinued when the pilot complained of reduced visibility and distortion.

**Photo 13. Windshield and Windshield Wiper Icing on Test Aircraft.**

**Photo 14. Windshield and Windshield Wiper Icing on Test Aircraft.**

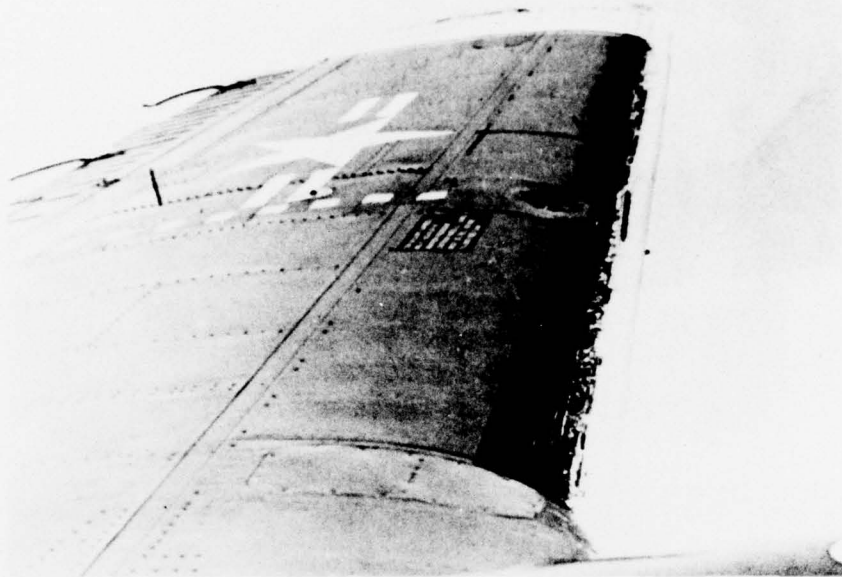
17. When ice accumulation reached an approximate depth of 2 inches, the aircraft could not maintain level flight at 140 KCAS with maximum power. Photo 15, appendix B, depicts the aircraft with an ice accumulation of 2 inches. After the pneumatic boots were activated power requirements were greatly reduced. However, because of the ice build-up on surfaces that do not have an anti-ice/defice capability, the power required after activation of the pneumatic boots was still increased over that for the initial entry conditions.

**Photo 15. Approximately Two Inches of Glime Ice Accumulation  
on Leading Edge of Standard Aircraft.**

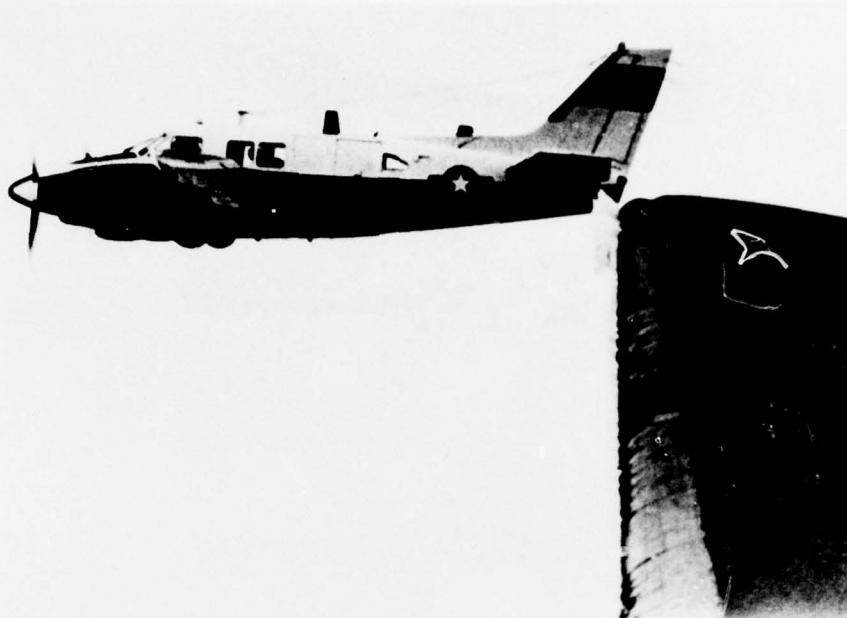
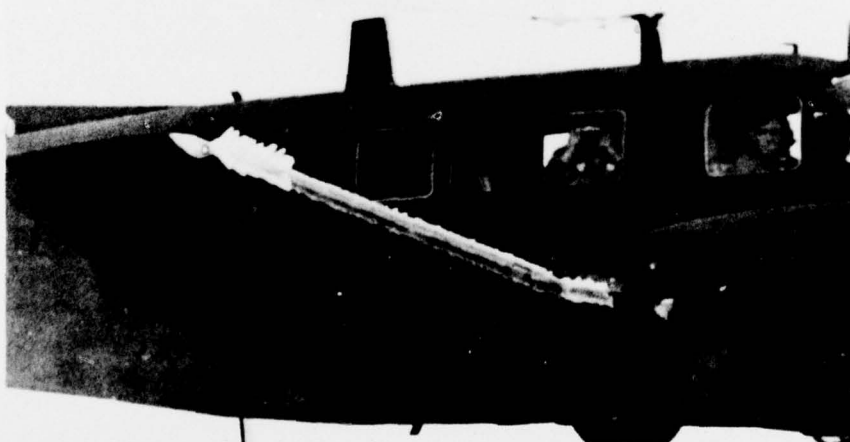
19. A substantial amount of ice (approximately 6 inches thick and 6 inches high) accumulated outboard of the pneumatic boots. This large build-up of ice is shown in photos 25 and 26, appendix B. Throughout the tests this large block of ice fell from the aircraft prior to landing. Should such a large piece of ice fall in a populated area, the result could be damage to property and/or bodily injury. The lack of anti-ice/deice capability for the wing area outboard of the pneumatic boots is a shortcoming.

Photo 25. Wingtip of Test Aircraft with Rime Ice Accumulation.

Photo 26. Wingtip of Test Aircraft with Rime Ice Accumulation.
