PROCEEDINGS OF THE DICE THROW SYMPOSIUM 21-23 JUNE 1977

Volume 3

General Electric Company—TEMPO
DASIAC
816 State Street
Santa Barbara, California 93102

July 1977

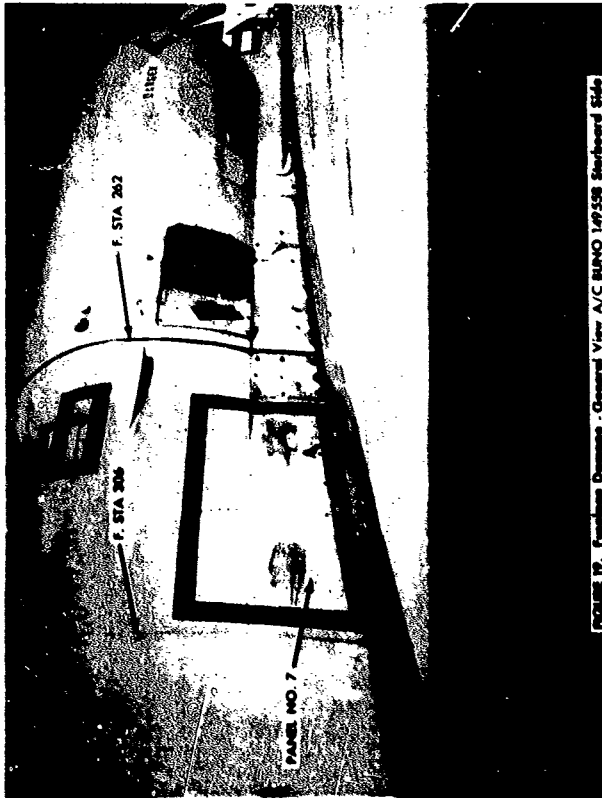
FIGURE 19. Post-Explosion Damage - General View A/C BUONO 149358 Starboard Side

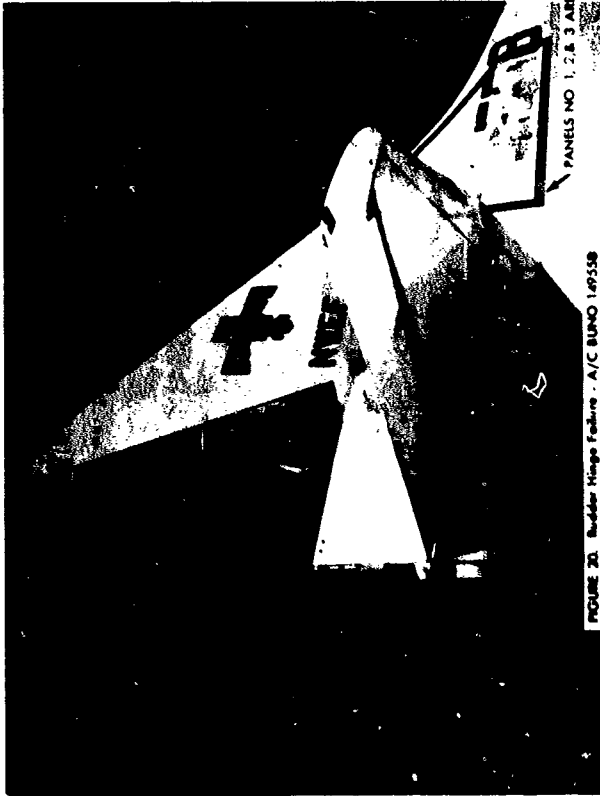
FIGURE 20. Rudder Hinge Failure - A/C BUNO 149558

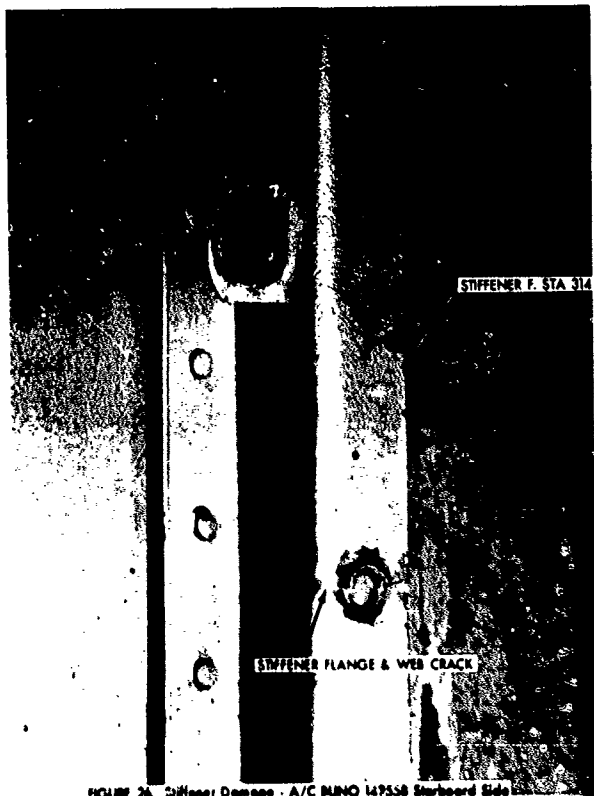
FIGURE 26. Stiffener Damage - A/C BUONO 147558 Starboard Side

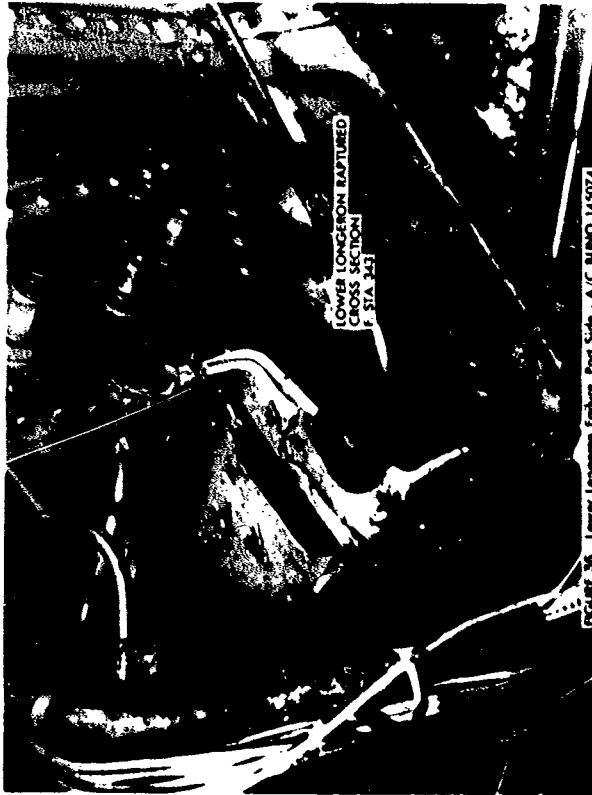
FIGURE 36. Lower Longeron Failure, Port Side - A/C BUND 145074

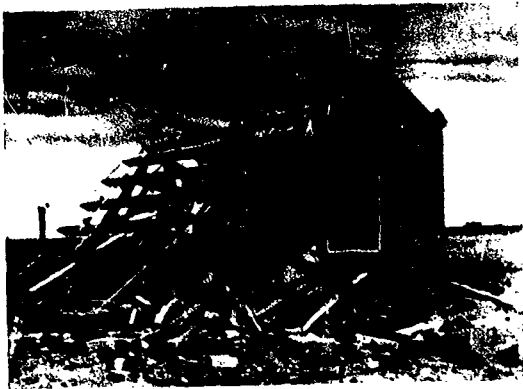
A preliminary review of the test movie for Structure No. 1 indicated that as the inward center deflection of the timber posts of the front wall became large, the mortise joints in the bottom plate fractured, except for those at the two end posts. With removal of the bottom support for the posts, the wall panels rotated inward at the bottom under the blast forces. When this occurred, the top plate of the front wall was essentially spanning the distance between the two end posts. Under the influence of the high roof dead loads, and possibly some blast forces, the top plate deflected downward at the center placing an eccentric load on the corner post between the west front and south side Fachwerk walls. The corner post fractured at the top and collapsed outward from the corner.

FIGURE 30 TWO PANELS REMAINED STANDING IN SOUTH SIDE FACHWERK WALL STRUCTURE NO. 1

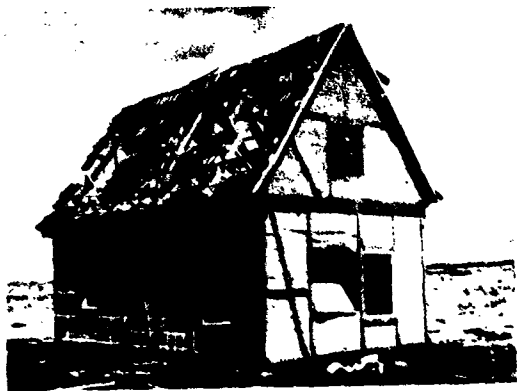
FIGURE 40 DAMAGED WEST FRONT AND SOUTH SIDE
FACHWERK WALLS STRUCTURE NO. 2

Figures 40 and 48 show the damage to the roof tile. Each half of the roof had 12 rows of 43 tiles for a total of 516 tiles. As shown in Figure 40, the front tile was damaged in all sections of the roof, but damage was

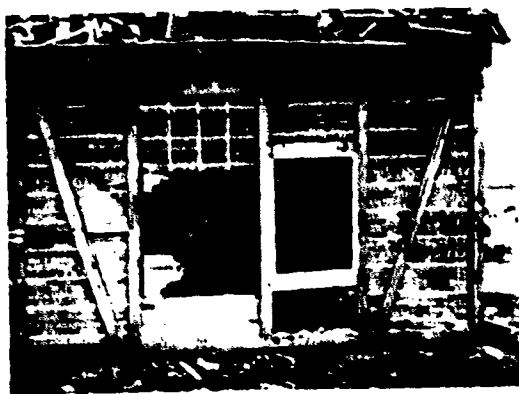
FIGURE 41 DAMAGED WEST FRONT FACHWERK WALL STRUCTURE NO. 2

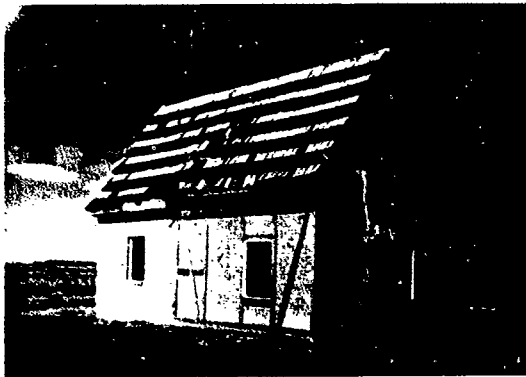
Figures 49 and 51 show the minor damage to the roof tile. Of the 516 tiles on the front roof surface, 20 percent were broken or missing. As noted previously for Structure No. 2, the tile damage for Structure No. 3 was also concentrated in the lower courses on the front roof and the upper courses on the rear roof.

FIGURE 49 POST-SHOT VIEW OF STRUCTURE NO. 3

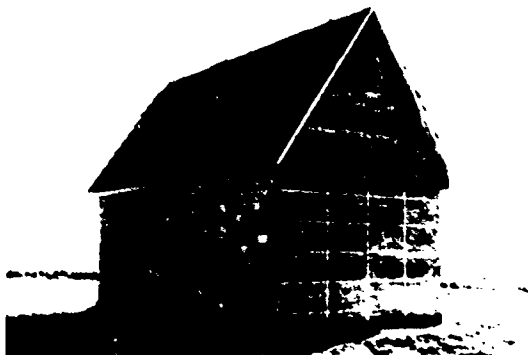
FIGURE 10. DAMAGE TO WOODEN SHED STRUCTURE NO. 3
