⑥ Modification and Repair of Surface-Vessel Bathythermograph OC-2B/S.

⑩ R. C. HINCK ENGINEERING DIVISION

⑭ NEL-516

U. S. NAVY ELECTRONICS LABORATORY, SAN DIEGO, CALIFORNIA  
A BUREAU OF SHIPS LABORATORY

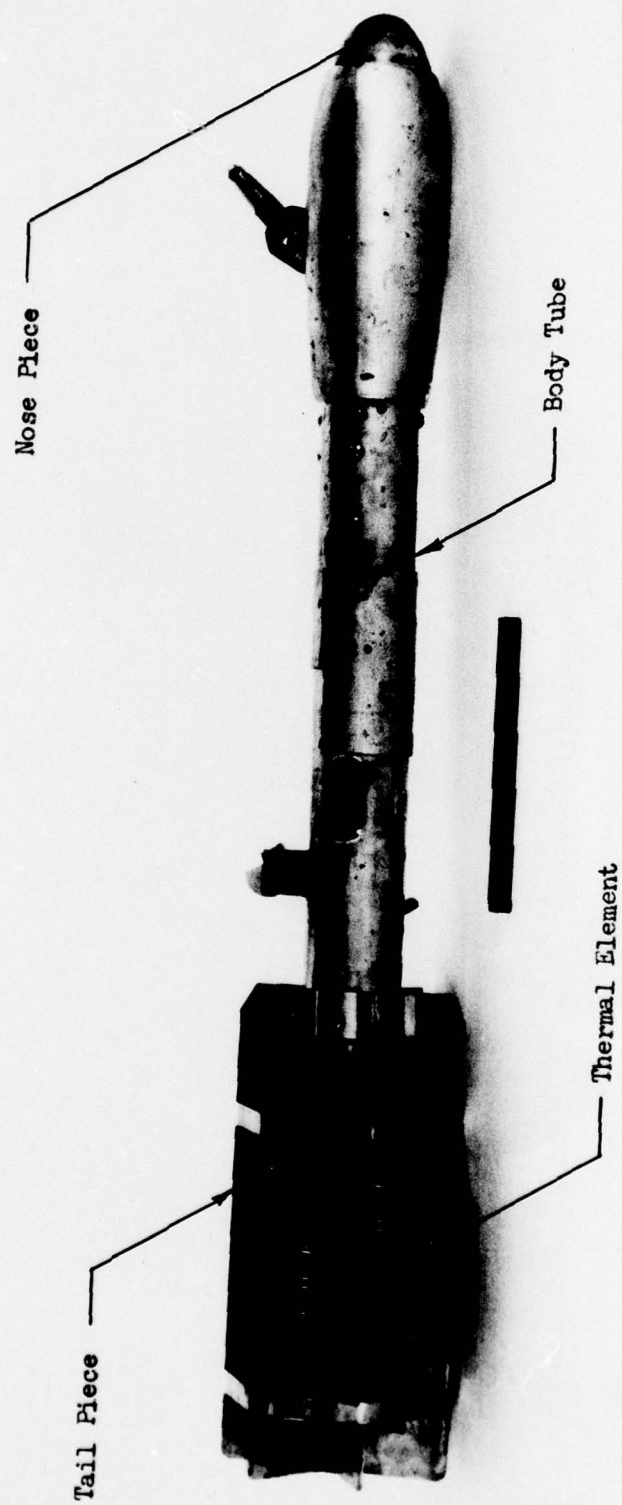
Figure 1. Side View of OC-2B/S Bathythermograph

The function of the Surface-Vessel Bathythermograph OC-2B/S is to obtain the relationship of temperature and depth down to a maximum of 450 feet. The bathythermograph, normally referred to as BT, is cylindrical in shape, approximately 2 inches in diameter and 31 inches in length (fig. 1). The pressure element, mounted inside the center portion of the instrument (fig. 2), supports a smoked slide which it moves longitudinally with respect to a stylus, as a function of depth. The thermal element is mounted in the aft end and moves the stylus transversely across the smoked slide as a function of temperature.

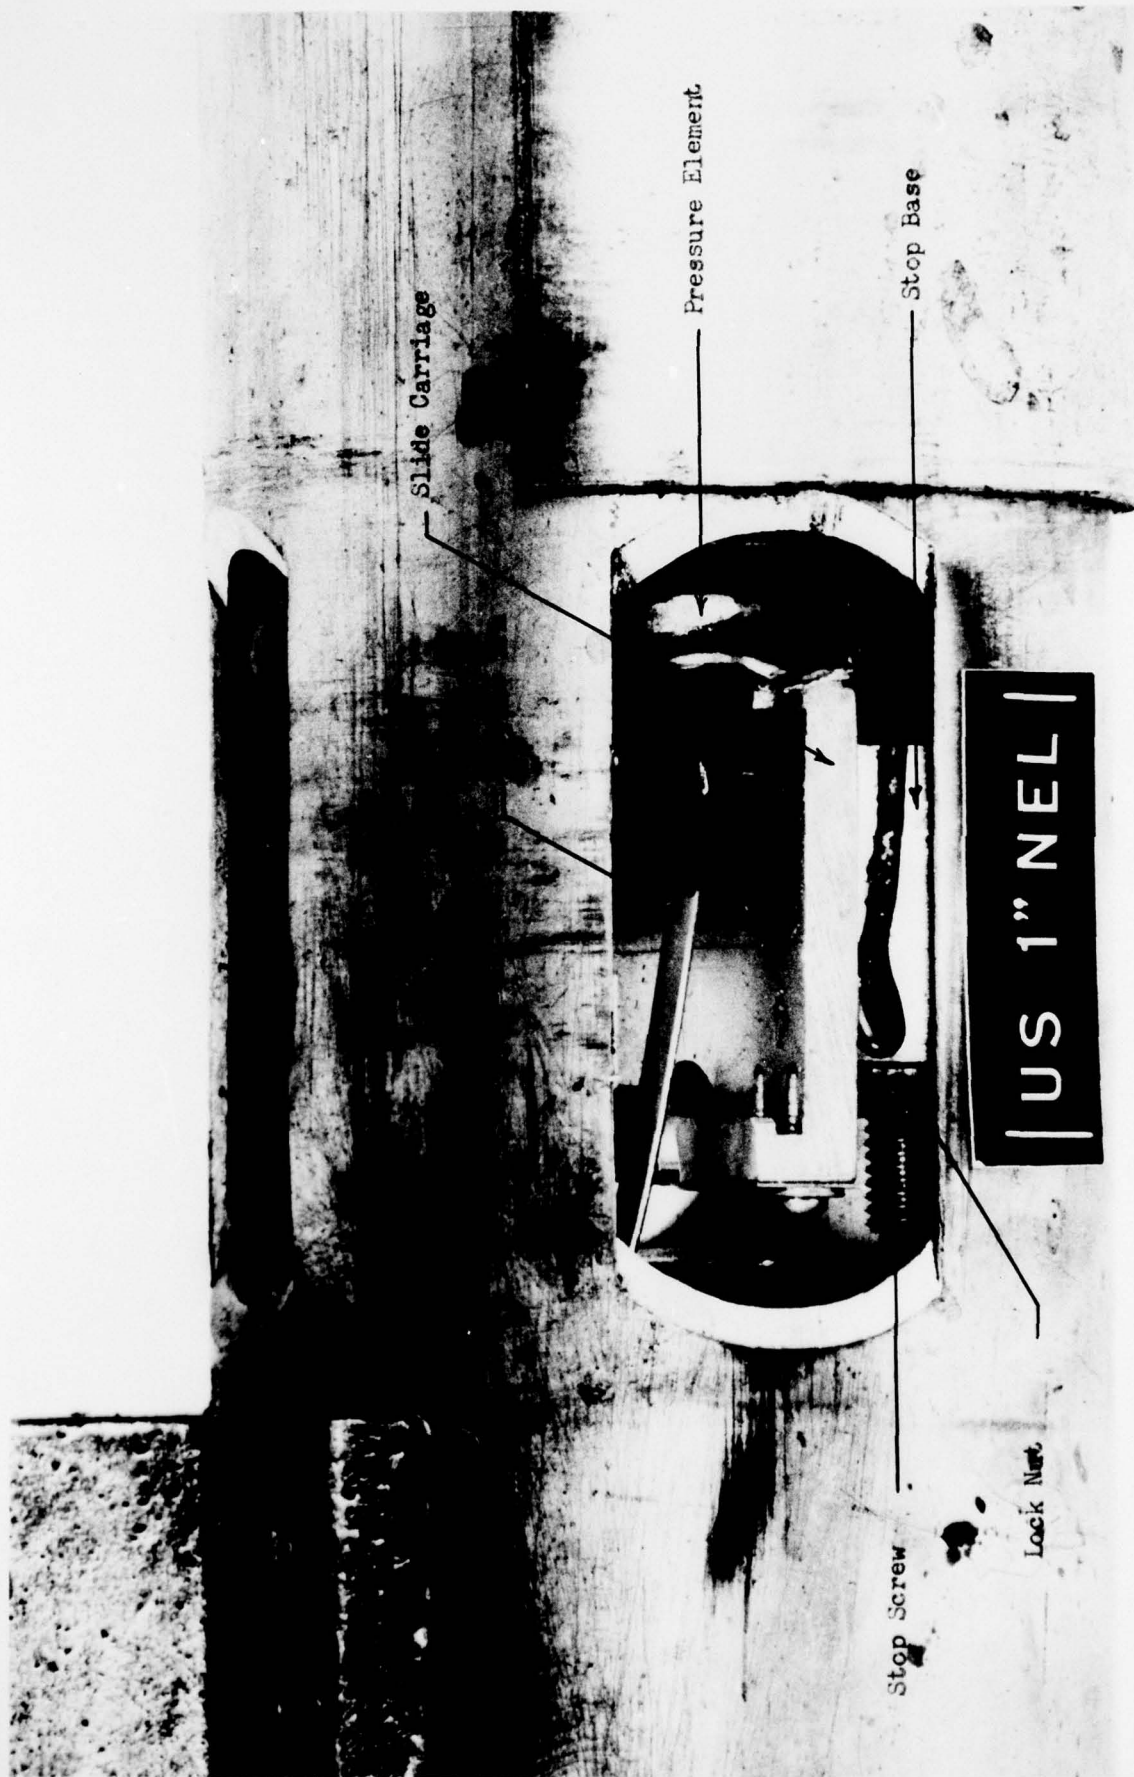
Figure 2. View of Installed Stop in OC-2B/S Bathythermograph Body Tube.

1. The screws holding the tail piece and nose piece were loose as a result of either insufficient tightening during assembly or the vibration and shock encountered during transportation.
2. A shock blow along the longitudinal axis of the BT in its shipping case caused the pressure element to elongate and come in contact with the end of the stylus. This caused the stylus arm to be bent such that it would not touch the glass slide.

Disassemble the bathythermograph. At the aft end of the body tube, drill two holes (no. 28 drill), for attaching a stop base (fig. 3). Attach the assembled "stop" inside of the body tube. File smooth any protuberance on the outside of the body tube. Holding the pressure element securely, gently raise or straighten the pressure relief tube ( $1/32$  inch sealed copper tubing at aft end of element) and bend it slightly outboard to clear the stop base. If necessary, bevel the forward corner of the stop base to clear the solder seal at the base of the tubing. Care must be taken to avoid breaking the tubing at the solder seal.

Install the pressure element in the body tube, and with a screwdriver adjust the stop screw for a clearance of approximately  $1/32$  inch against the end of the pressure element (without clearance the pressure element may not return to the zero position). Tighten the lock nut to hold the screw in place.

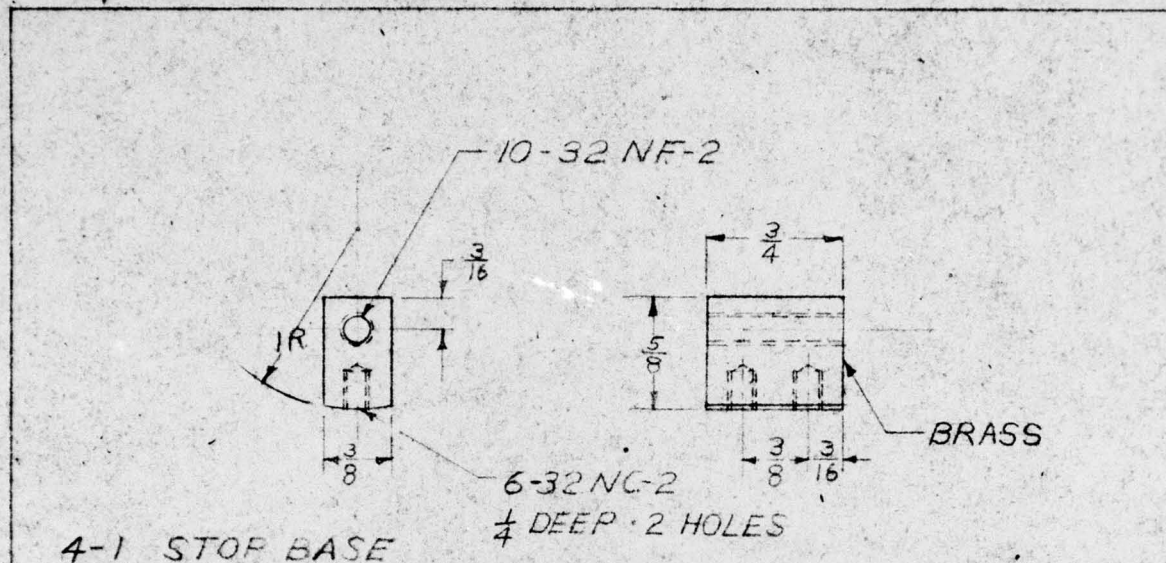
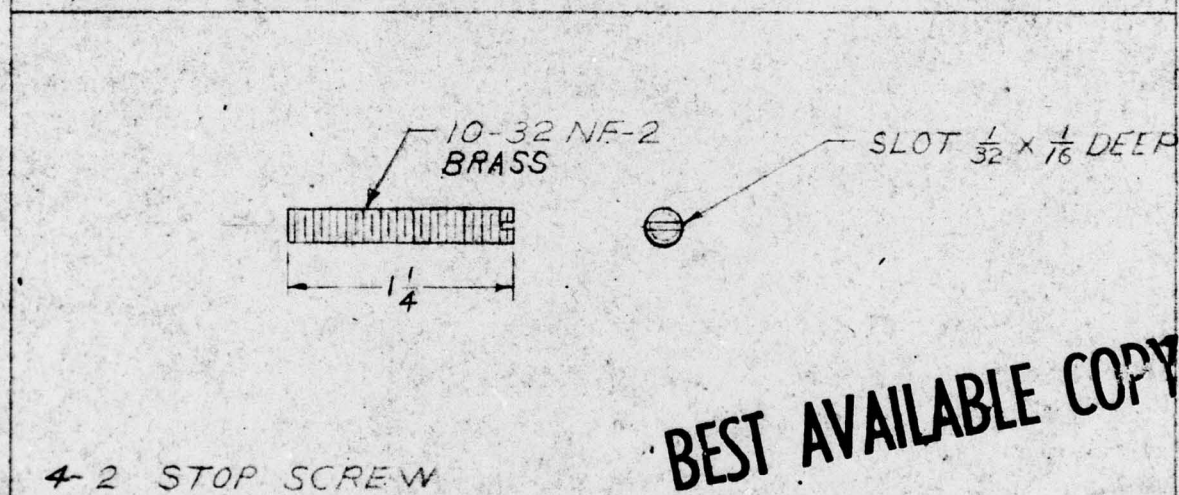
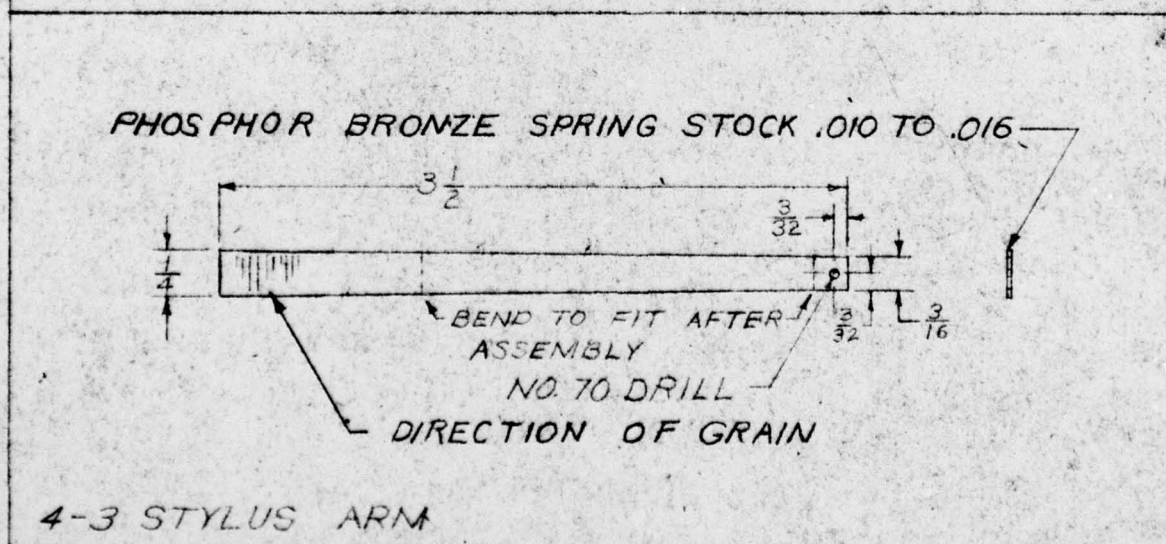
FIGURE 4 STOP AND STYLUS DETAILS  
FOR QC-2B/S BATHYTHEROGRAPH

1. The stylus arms had received a permanent set such that the stylus would no longer touch the glass slide. This set was caused by overtravel of the pressure element during shock.

Note or mark the position of the stylus arm on the temperature element and with a small soldering iron remove the stylus arm. Remove and save the stylus point from the arm. Make from bronze spring sheet stock (0.010 to 0.016 inch thick), a duplicate stylus arm. Cut the new arm lengthwise across the grain of the stock to permit bending. Drill a no. 70 hole in the center of the small end of the arm and solder the stylus point in place (fig. 4). Solder the new stylus arm on the temperature element, holding to the original stylus position as closely as possible. Bend the stylus arm as necessary to insure firm pressure of the point on the glass slide. Reassemble the BT, installing split lock washers on screws of the nose and tail pieces. Stamp the letter "A" following the serial number to indicate first recalibration. Calibrate the BT and make new corresponding viewing grids as per standard calibration procedure.
