REPORT 77-31

Roof moisture survey

Ten State of New Hampshire buildings

ROOF MOISTURE SURVEY: TEN STATE OF NEW HAMPSHIRE BUILDINGS

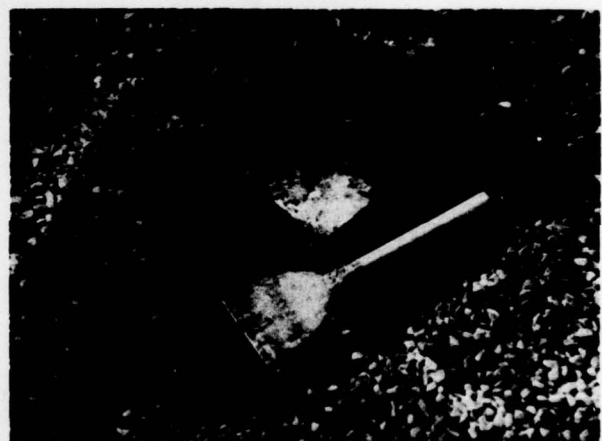
Figure 9. Ice 1/2 in. thick was present under the membrane at point O.

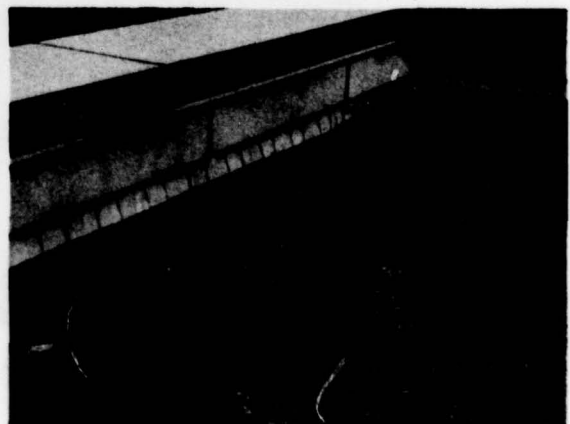
Figure 11. Damaged parapet wall counter flashing.

expected in the future. Such problems can be delayed somewhat by patching the numerous flashing flaws and eliminating other visible defects where water can enter the membrane.

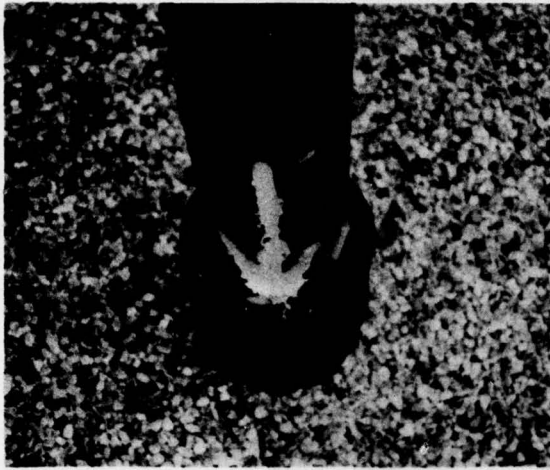
Figure 12. Cracked bitumen in a pitch pocket surrounding a vent pipe.

was lightly bonded with mortar to form a smooth substrate for the membrane. The clinkers were relatively dry, having a water content of only 4%. In the past, clinkers were used to provide slope for drainage of flat decks. The source of the ice at point O is not apparent. However, the deteriorated flashing around the building indicates that numerous points are available where water could get in under the membrane. Examples of flashing problems on this roof are shown in Figures 10 and 11. Other entry points for moisture are also present as shown in Figure 12. Portions of the roof are blistered.

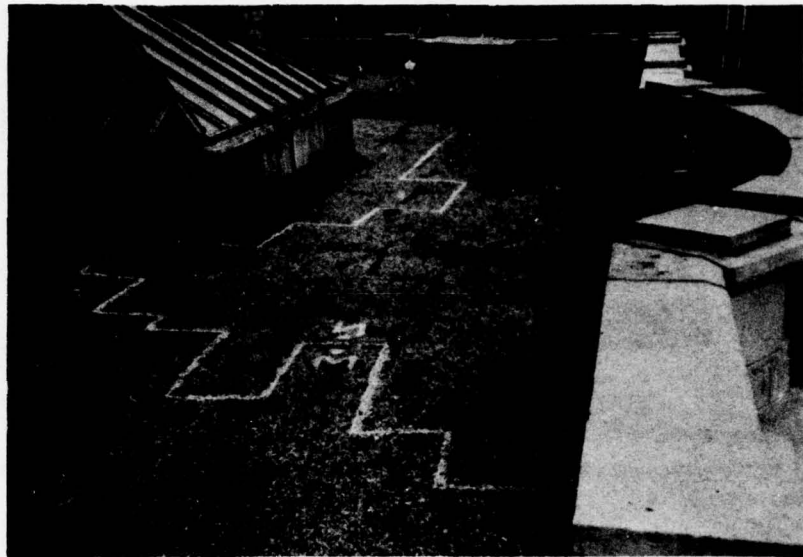
Figure 16. The area outlined in spray paint appeared darker than all other portions of the State Library roof.

The spray painted boundary in Figure 16 was stepped since it follows the edges of board stock insulation. Core samples of the 1 $\frac{1}{8}$ -in.-thick wood fiber insulation at N and M had water contents of 32% and 211% respectively. Although insulation in the area represented by sample N was much drier than that of the rest of the roof, it contained enough moisture (32%) to seriously reduce its thermal effectiveness.

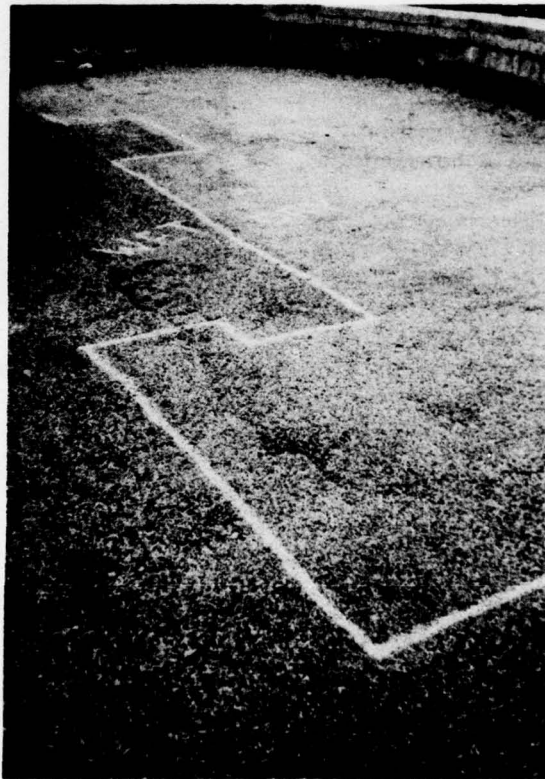
Figure 17. The spray painted area coincided with the area on which frost formed. This was the driest portion of the roof but the insulation contained enough moisture (32%) to reduce its thermal effectiveness over dry insulation.

All of the insulation on this roof was either damp or wet and the membrane was dry, brittle and obviously not water-tight. Consequently the membrane and insulation should be removed and new insulation and a new membrane installed. Because the deck below the wet insulation is probably wet, it will be important to ventilate the new system to prevent trapped moisture from destroying the new membrane.

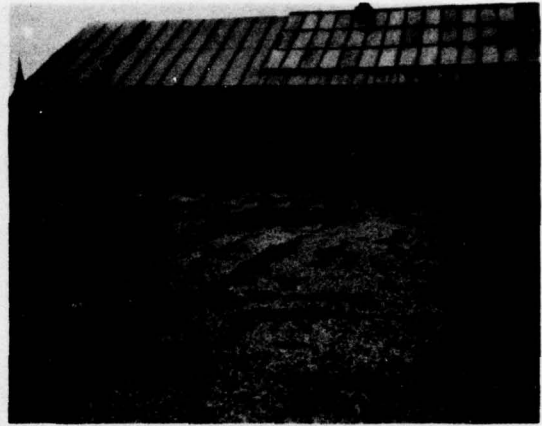
Figure 19. Large blisters on the State Library roof.

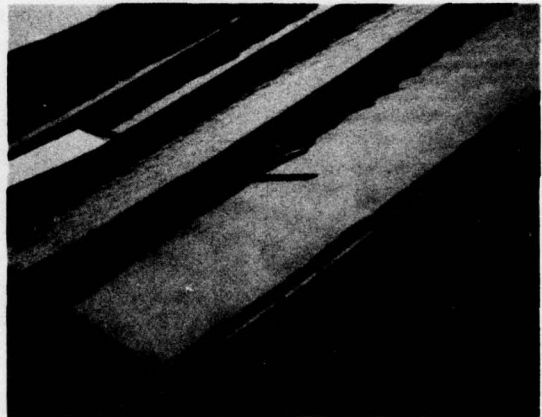
Skylight caulking was in bad condition (Fig. 20). Ample opportunities exist for water to enter the roof from that area. Major improvements to better seal the skylights will be required in conjunction with new roofing.

Figure 20. Skylight caulking needs repair.

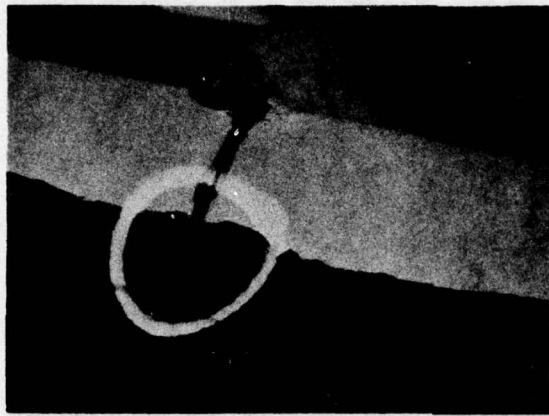
Figure 21. Mastic between the pieces of metal fascia has been split by thermal movements of the fascia, Legislative Office Building.

perimeter, movements of the sectional metal fascia had split the mastic at joints (Fig. 21). These locations were circled in white spray paint. In a few areas the splits extended down to the level of the gravel on the built-up membrane. A more reliable method of sealing the fascia should be devised to prevent entry of unwanted moisture and rapid deterioration of this currently excellent roof.

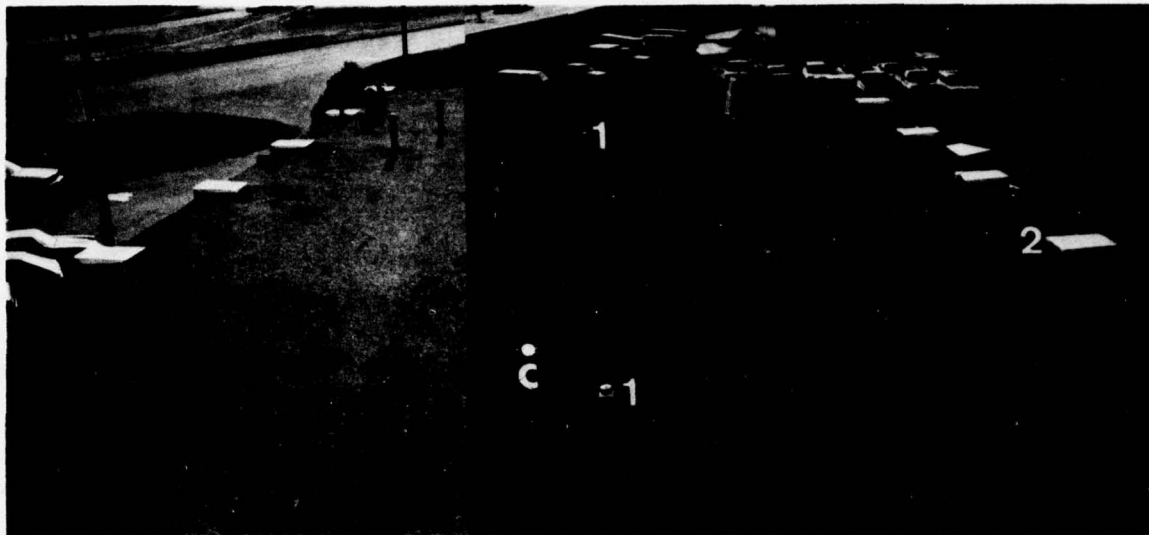
A panoramic view of level 3 was attained from level 2 (Fig. 23). A three-thermogram mosaic was also obtained from the same position (Fig. 24). The thermogram mosaic is mottled, fairly bright and contains dark lines which span the width of the roof. Large concrete beams under the roof insulation are the cause of the dark lines. They have caused the roof directly above

Figure 23. View of level 3, Highway Garage (1 – breather vents, 2 – typical cap where concrete frame protrudes).

Figure 24. Thermogram mosaic of level 3 (1 – breather vent, 2 – typical cap where concrete frame protrudes).

to be colder than the surrounding roofs. Two breather vents were installed in this roof when the membrane was replaced (Fig. 23). The vents were intended to dry out the light-weight vermiculite concrete insulation since it was known to be wet. However, there was no thermal indication that the light-weight concrete was drier around those vents than at any other place on that roof. Samples of the membrane and light-weight insulation were taken at points C and E. Water contents of the insulation were 32% and 40% respectively.

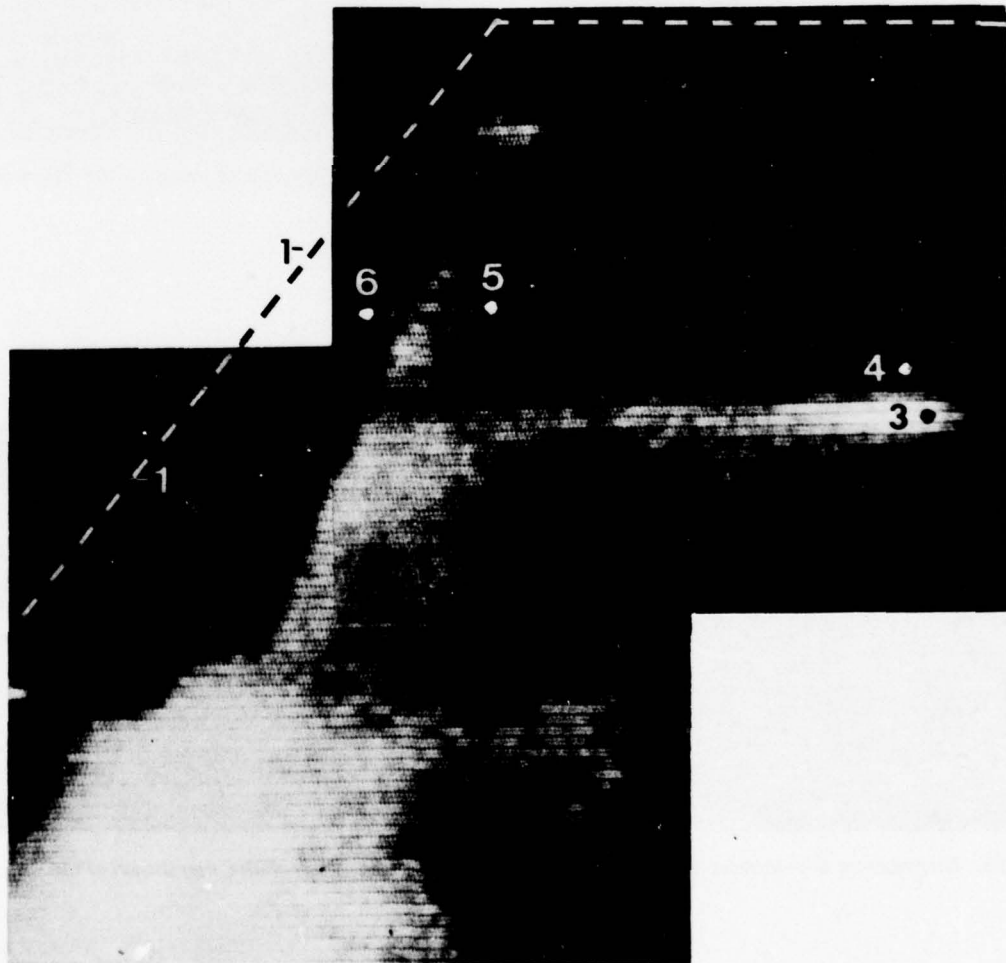
the thermogram (26) were also wet (113% and 68%, respectively). It was subsequently determined that the extra brightness shown in Figure 26 was caused by ceiling-mounted propane-fired heaters that were operating late in the evening when the infrared survey was conducted. On the thermogram, sample 6 is in a long rectangular black area. In that area the insulation was not light-weight vermiculite concrete but 2¼-in.-thick perlite. The perlite was rather dry (5%) and, as the dark area on the thermogram indicates, it was a far better insulator than the light-weight concrete insulation which is present on the remainder of the level 1 roof. A detailed view of the well-defined division between the thermal image of the dry perlite and the wet light-weight concrete is shown in Figures 27 and 28.

Figure 26. Thermogram mosaic of a portion of level 1. Points 3-6 are sample locations (1 - edge of roof).

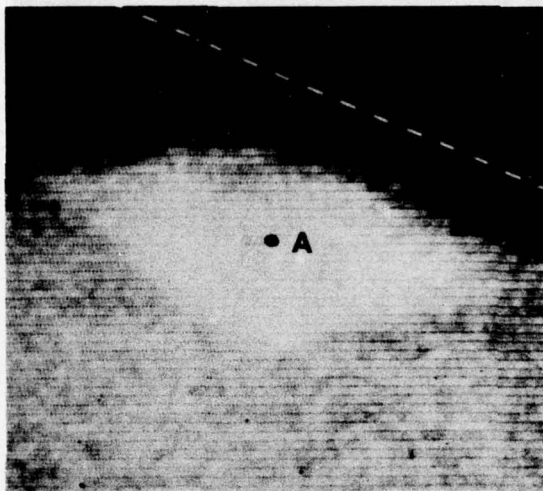
Figure 31. Thermogram of a small white anomaly near the northeast corner of level 4. Sample B was taken just beyond the thermogram's lower right corner.

and compressed to a thickness of about $\frac{1}{4}$ in. At B the insulation was damp, light in color and $\frac{3}{4}$ in. thick. Based on the infrared survey, it is expected that the insulation at B represents the general condition over most of the roof in that area. Since the moisture content at B is rather high (28%), the insulation cannot be very effective thermally.

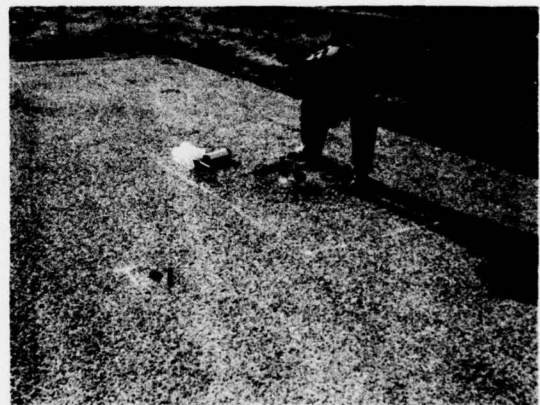
Several wet areas were found along the southerly portion of the west edge of level 4 (Fig. 22). A thermogram and a conventional photograph taken of one of the anomalies in this area are shown in Figures 34 and 35. Sample H, taken within the bright area of the thermogram, had a water content of 227%. Sample I, taken in the darker region nearby (Fig. 35), had a water content of 28%. No visible signs of membrane or flashing distress were evident in this area. Rainwater drains over a gravel stop at the eaves all along the nearby edge. It is speculated that snow meltwater, backed up on the roof by slight icings at the eave during the winter, found

Figure 34. Thermogram of the anomaly in the southwest corner of level 4. Sample I was taken just beyond the lower left corner of the thermogram in the gray area.

rapidly. Although there is apparently no urgency to replace this roof because serious leaks are not present, a new roof and a significant amount of insulation should be considered before long.

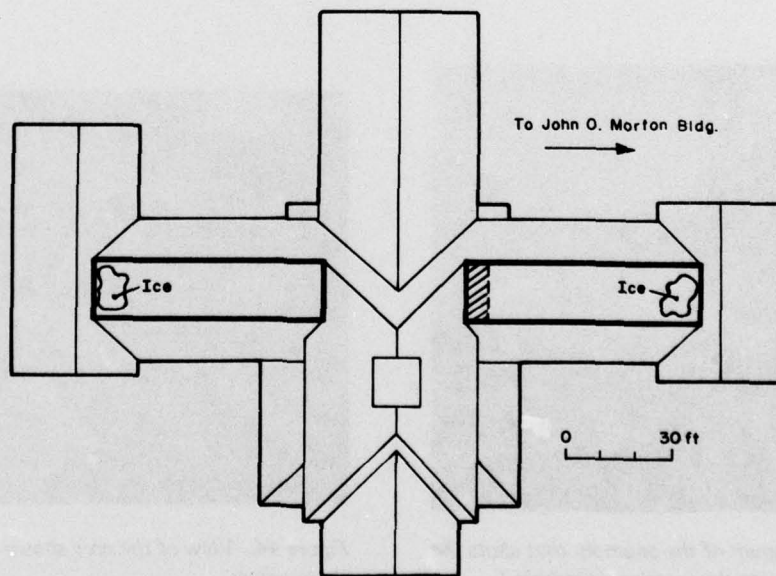
economically feasible to modify the two flat portions of the Supreme Court roof to better facilitate drainage. Since water and ice accelerate the deterioration of roof membranes, ponding should be avoided in future construction by providing adequate slope for drainage even on small areas, such as the two flat roofs of the Supreme Court.

Figure 41. Plan view of the Supreme Court with the outline of the two flat built-up roofs emphasized. The cross-hatched area was bright when viewed with the infrared camera.

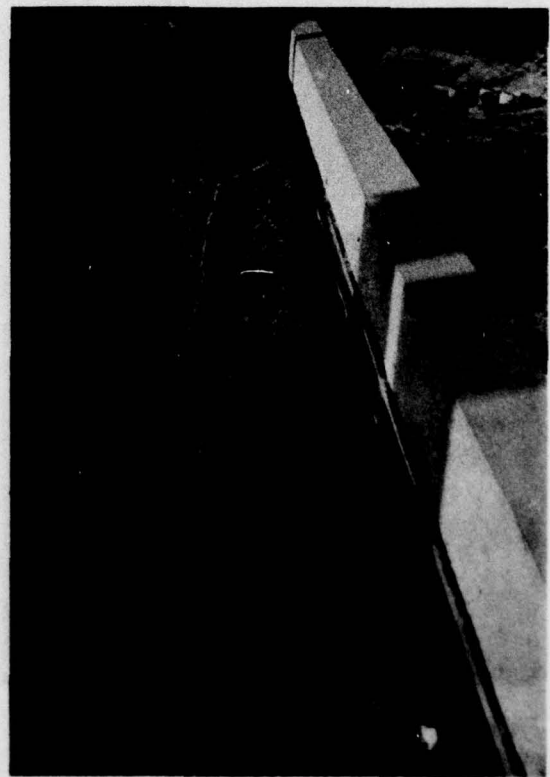
A comprehensive infrared survey of the roof uncovered three potential problem areas as shown in Figure 48. A thermogram and photograph of the first of these areas are shown in Figures 49 and 50. Insulation samples taken at A and B had water contents of 236% and 32% respectively. The perlite board insulation was

Figure 49. Thermogram of an anomaly along the parapet wall.

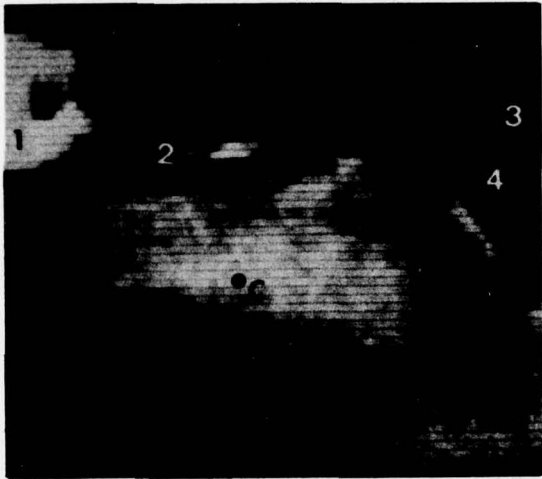
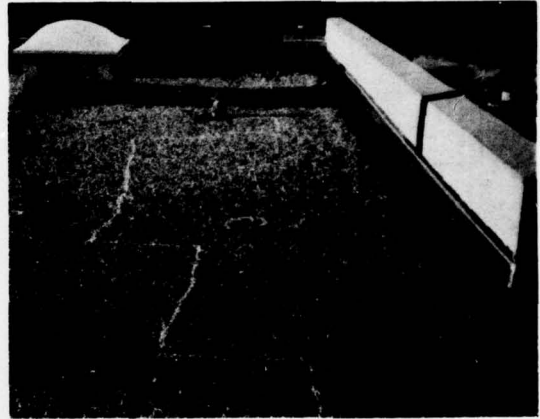
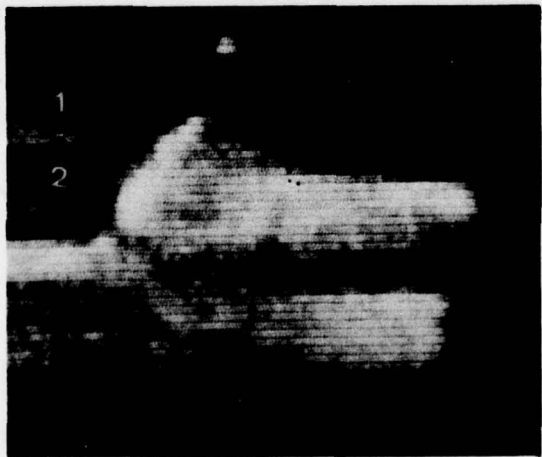
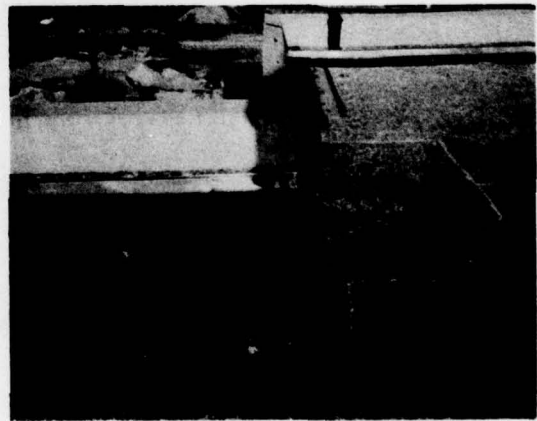
This wet area is also adjacent to the portion of the parapet that had copper counter flashing missing for

Figure 51. Thermogram of another anomaly along the parapet wall (1 - fan, 2 - drain, 3 - parapet, 4 - flashing).

some time. Since new counter flashing is now in place, no additional water should be entering that area. As with the first anomaly, it is recommended that two breather vents be installed in this area in an attempt to dry out the wet insulation.

As an alternative to the above, the membrane, insulation, flashing and drain in the wet area could be removed and replaced as was recommended for the two wet areas of the John O. Morton Building.
