Special Report, 77-39

6
TEMPORARY PROTECTION OF
WINTERTIME BUILDING CONSTRUCTION

Fairbanks, Alaska, 1976-77.

10 F. Lawrence Bennett

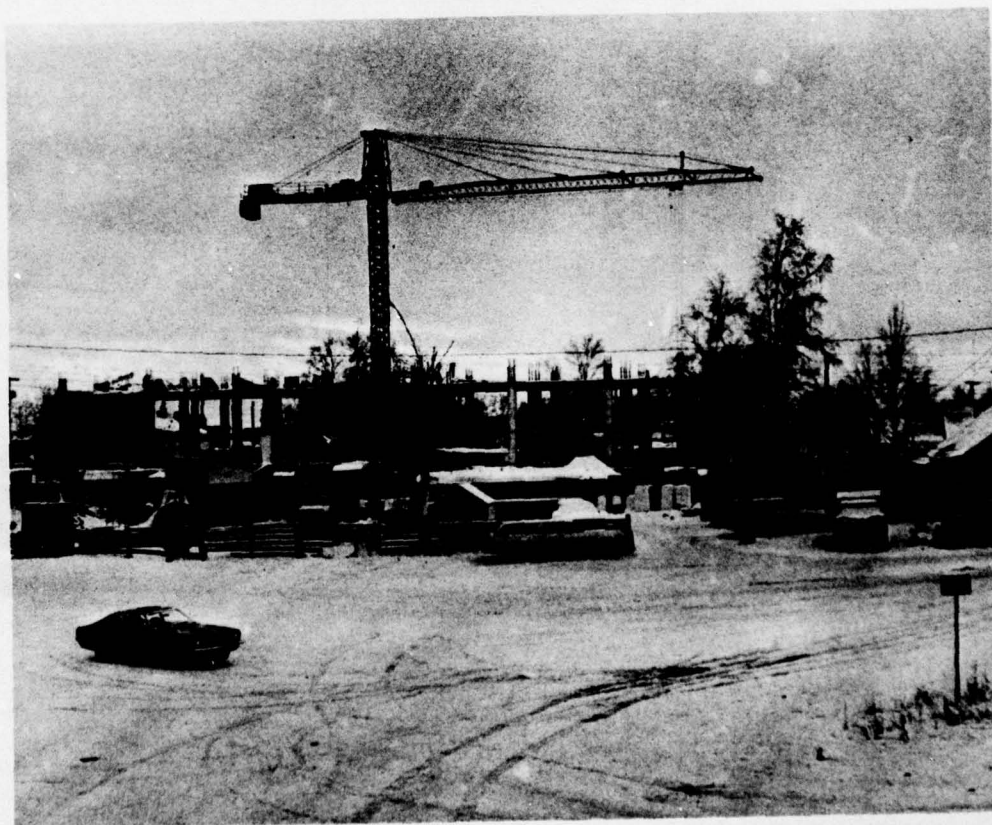
This project, owned by Fairbanks Real Estate Development Corporation and Bering Straits Development Corporation, was not active during the 1976-77 winter. Figure 5 shows this project, with its tower crane standing idle; the idleness was due not to winter conditions, but, instead, to financial difficulties. Contractors on this project, located at 1st Avenue and Hall Street, include O.L.Q. and Sons, and Life Systems Corporation.

5. Fairbanks Plaza Hotel, activities suspended -- not by winter, but by lack of funds. November 28, 1976. +32°F.

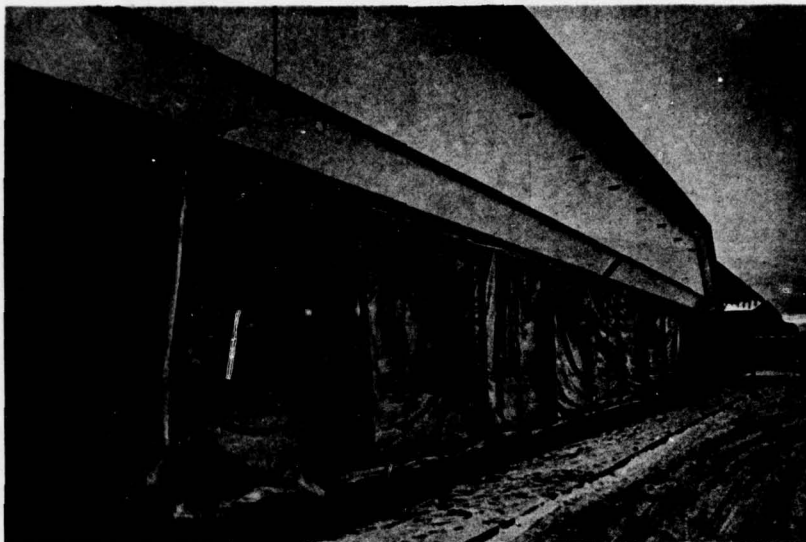
14. Polyethylene window bays at Bentley Mall project. November 28, 1976. +32°F.

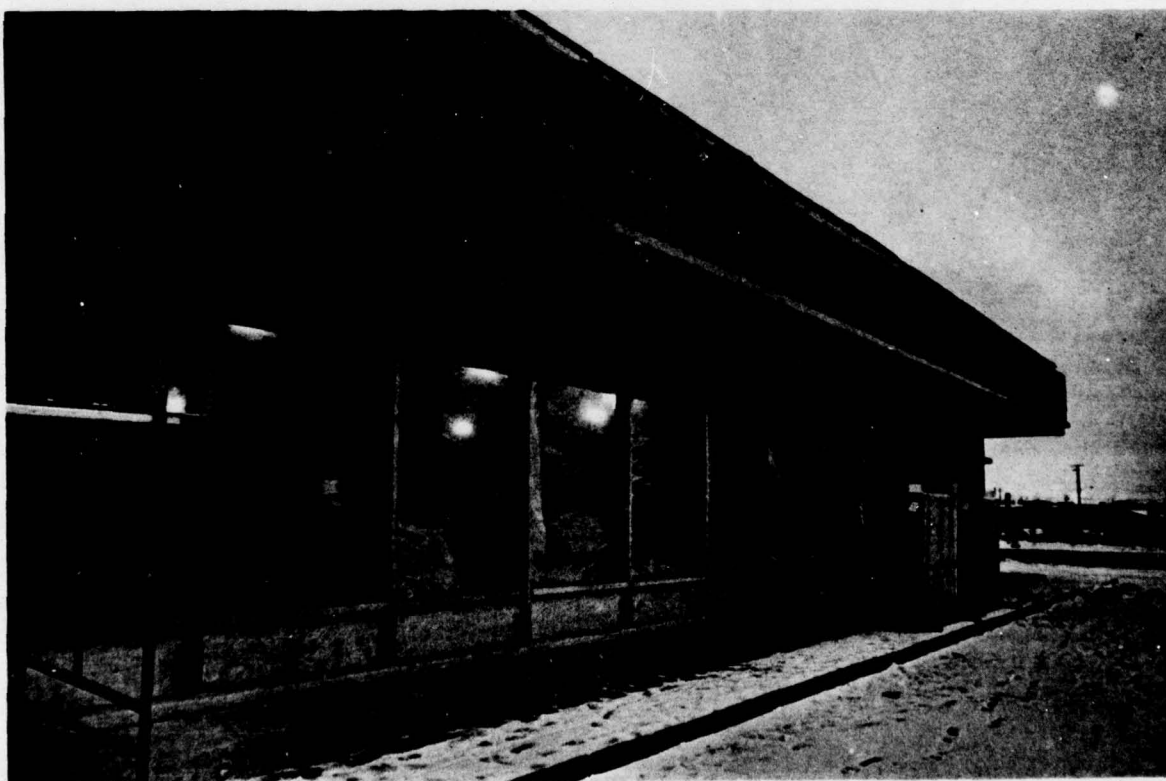
15. Temporary enclosures were window openings, Bentley Mall project. November 28, 1976. +32°F.

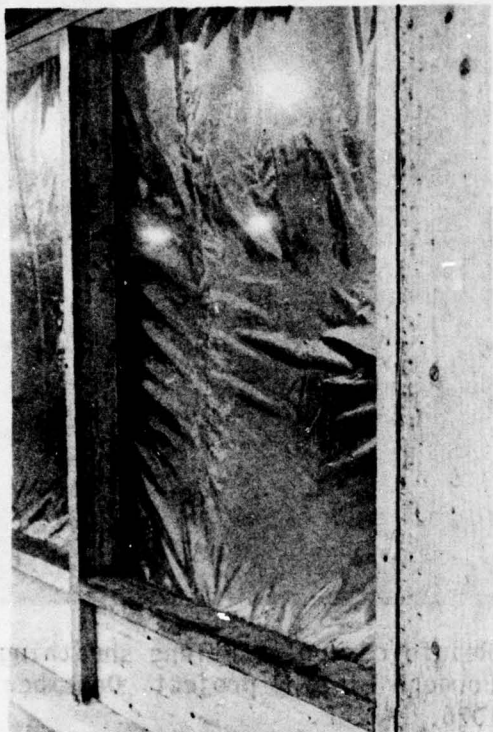
16. Close-up of temporary window coverings, Bentley Mall project. November 28, 1976. +32°F.

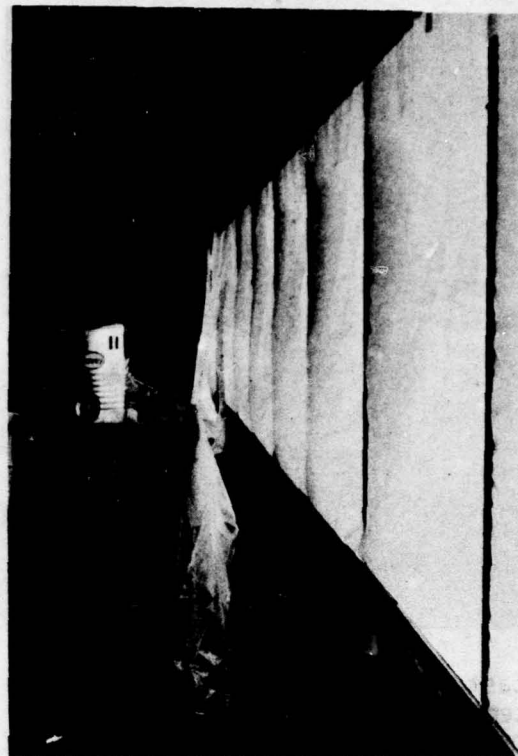
17. Temporary window enclosures at Bentley Mall project, inside view. January 7, 1977. +31°F.

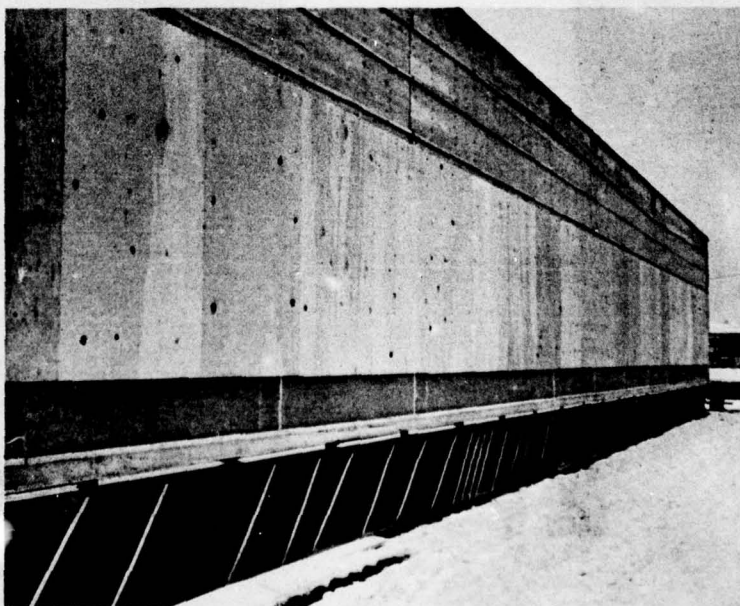
18. North wall, Borough Library project, plywood sheathing protecting window placement activity. November 28, 1976. +32°F.

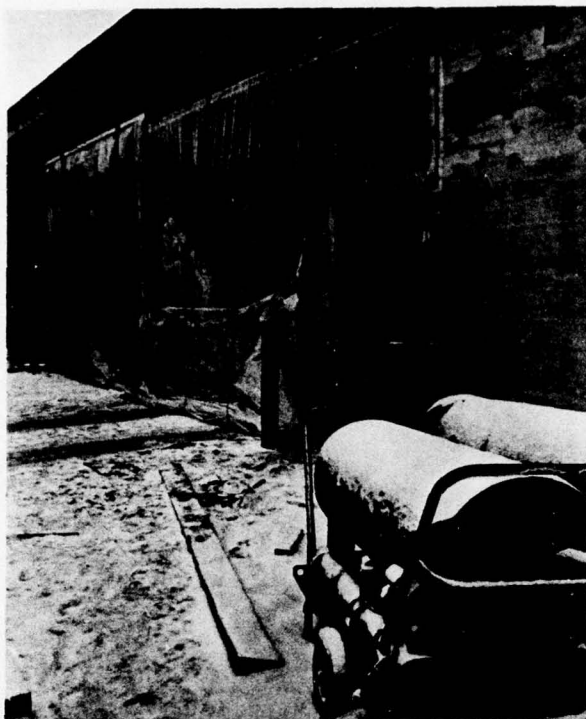
19. East side, Borough Library project, temporary garage door sheltering equipment. November 28, 1976. +32°F.

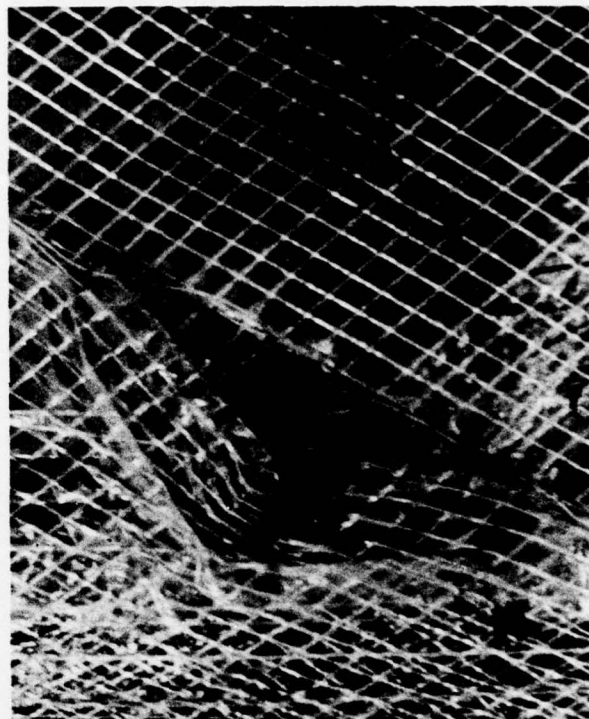
20. Reinforced polyethylene sheathing at Borough Library project. December 30, 1976. -12°F.

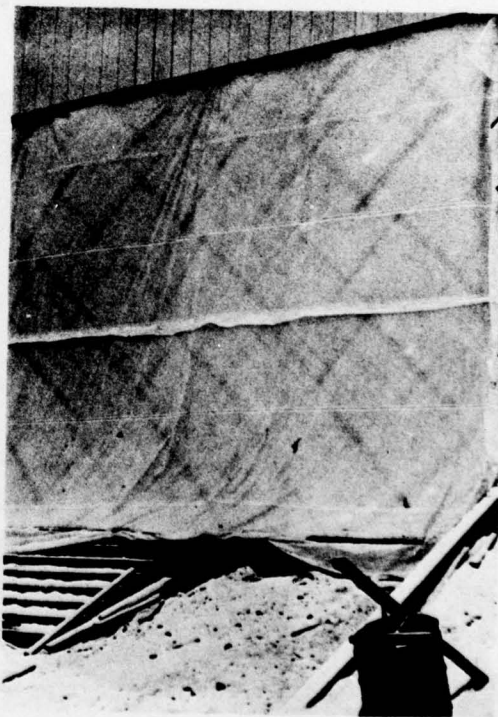
22. Federal Building project. Polyethylene cover on northeast corner. November 28, 1976. +32°F.

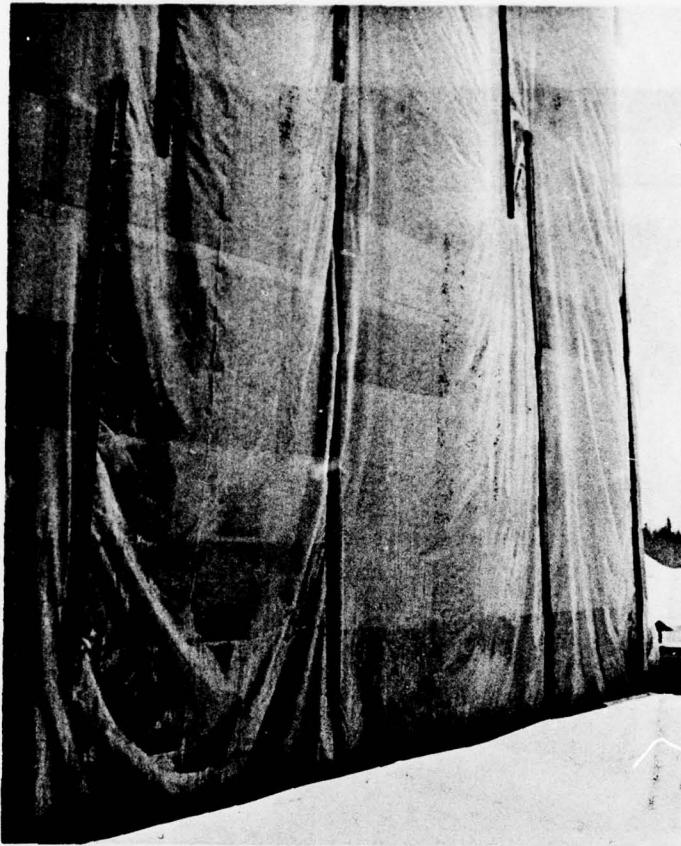
23. Polyethylene cover protecting parking area on southwest corner, Federal Building project. November 28, 1976. +32°F.

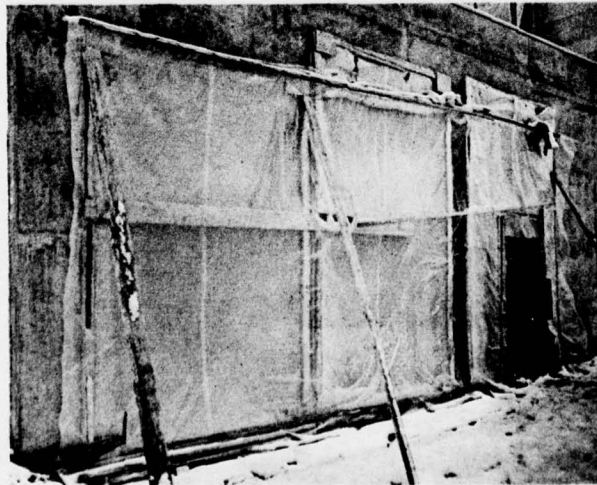
24. Reinforced polyethylene sheathing providing temporary enclosure for garage door at Federal Building project. November 24, 1976. +12°F.

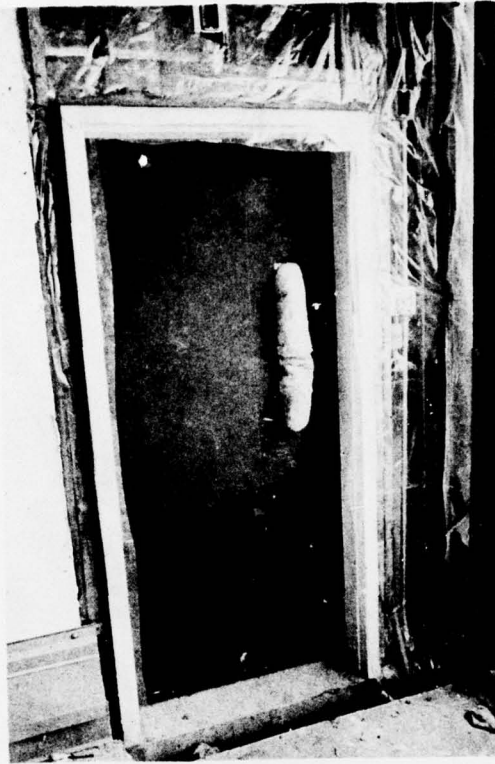
25. Partially installed door protected with insulation, Federal Building project. November 24, 1976. +12°F.

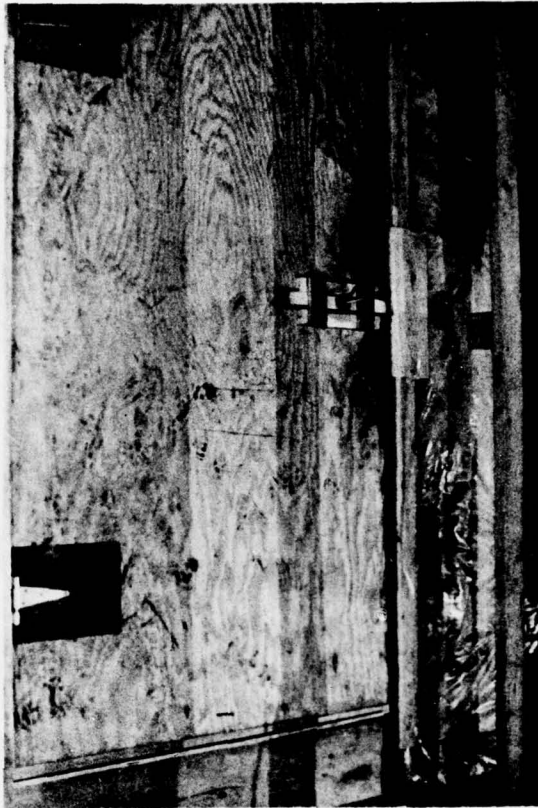
29. Temporary door at Plywood Supply project.
December 30, 1976. -70°F.

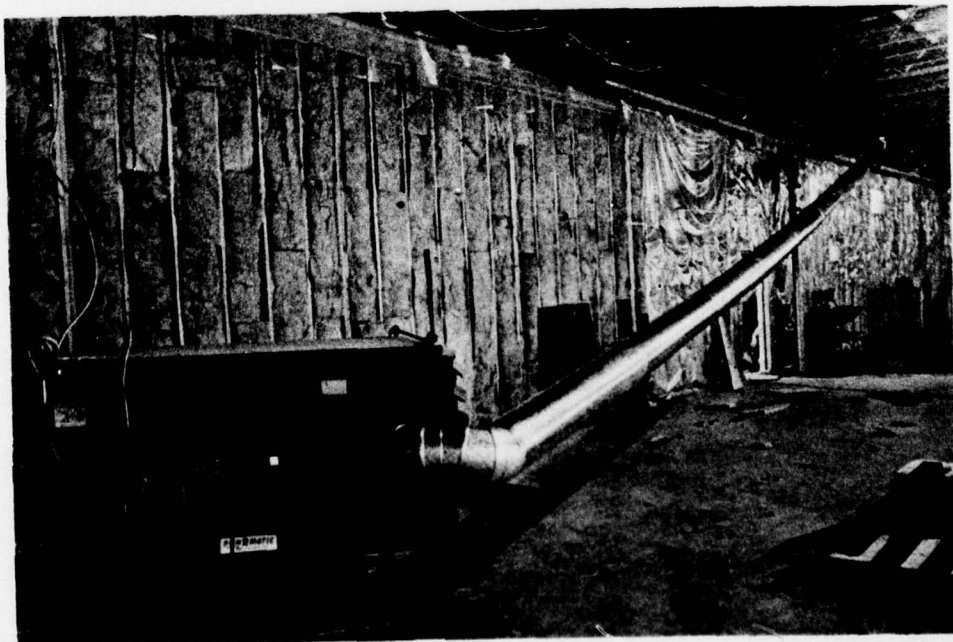
30. "Powrmatic" 450,000 BTU furnace at Bentley Mall project. November 28,
1976. +32°F.

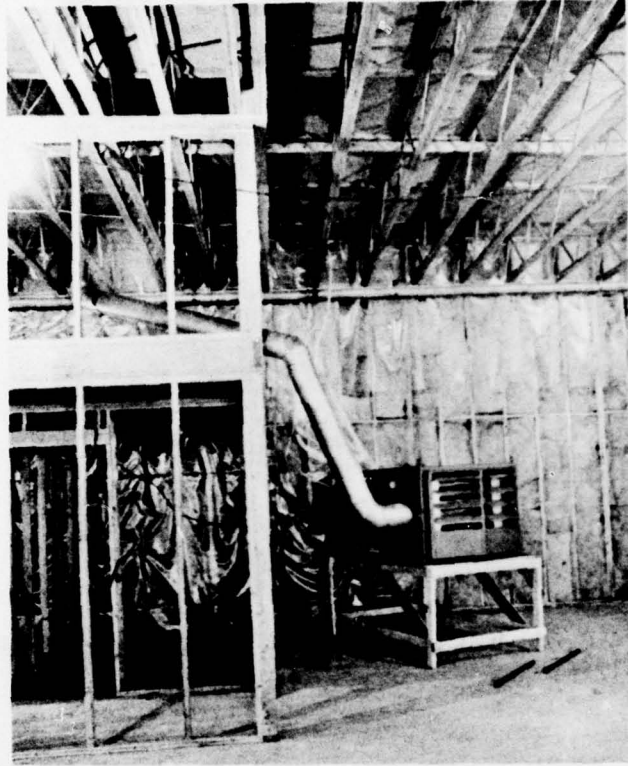
31. Temporary furnace with exterior vent duct, Bentley Mall project. November 28, 1976. +32°F.

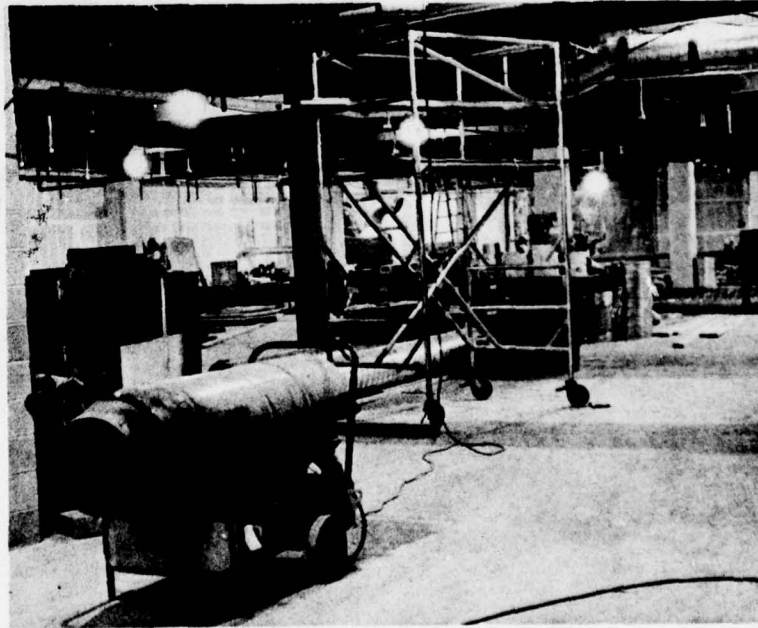
32. "Master" heater, foreground and "Armstrong" furnace, background, at Borough Library project. December 30, 1976. -12°F.

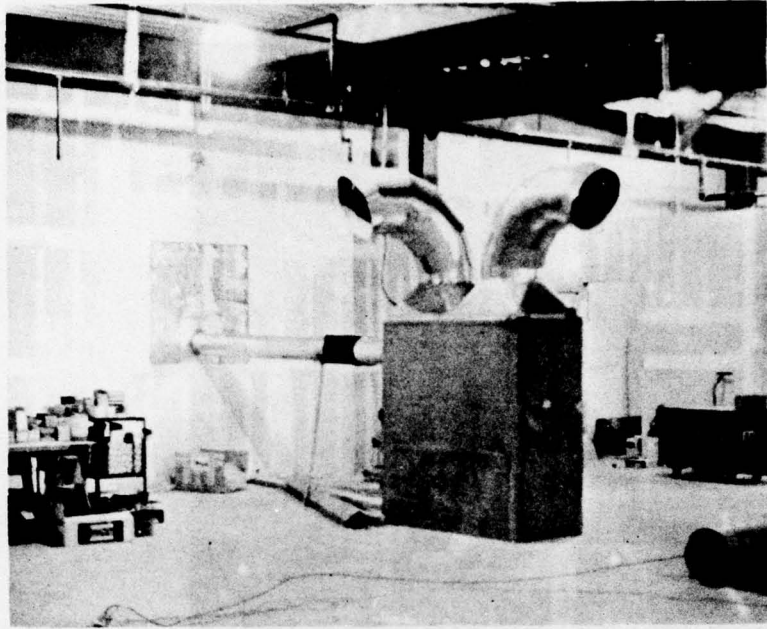
33. "Armstrong" furnace (450,000 BTU per hour) at Borough Library project.
November 30, 1976. -12°F .

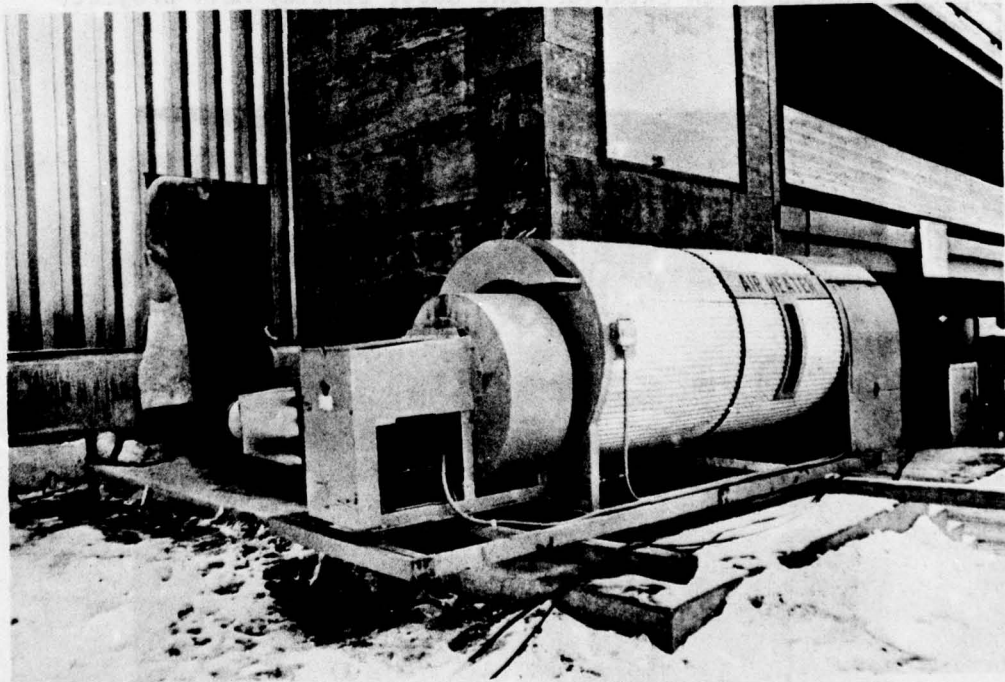
The large volume at the Federal Building project was heated by four large capacity heaters. These units included two "Master" heaters of one million BTU's per hour capacity each and two "Tioga" oil-fired furnaces of two million BTU's per hour capacity each. Figure 34 shows one of the two "Tioga" heaters at the Federal Building, while Figure 35 gives a detail of the ducting that carried heated air from this heater into the building. Figure 36 shows the other "Tioga" heater, which in this case was trailer mounted. It should be noted that both these units were installed outside the building, and heated air was conducted from the heaters into the building.

34. 2 million BTU per hour "Tioga" furnace at Federal Building project.
November 24, 1976. $+12^{\circ}\text{F}$.

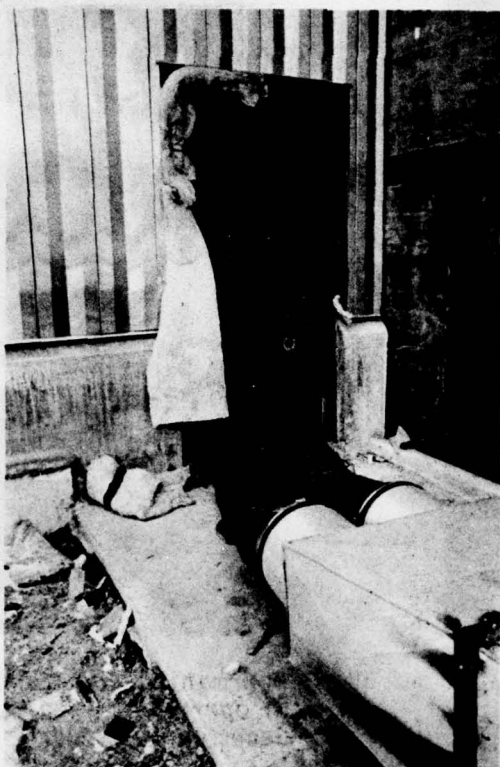
35. Close-up of ducting for Tioga heater,
Federal Building. November 24, 1976.
+120F.

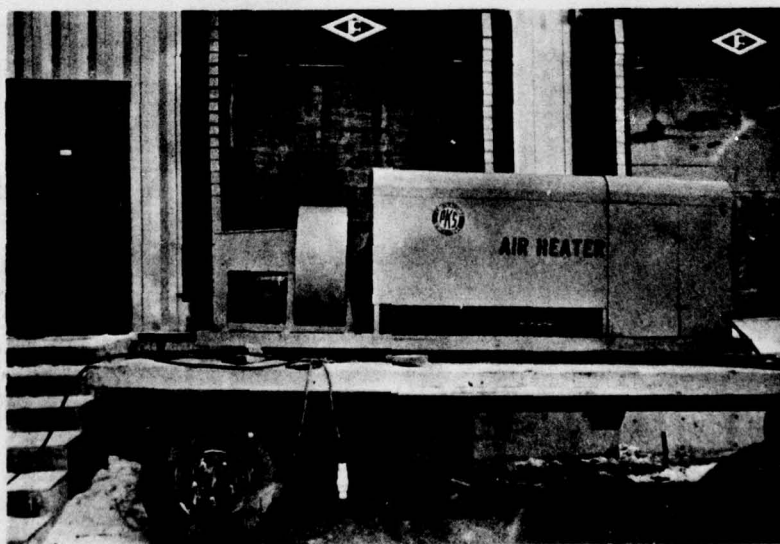
36. Trailer mounted Tioga heater at Federal Building project.
November 24, 1976. +12°F.

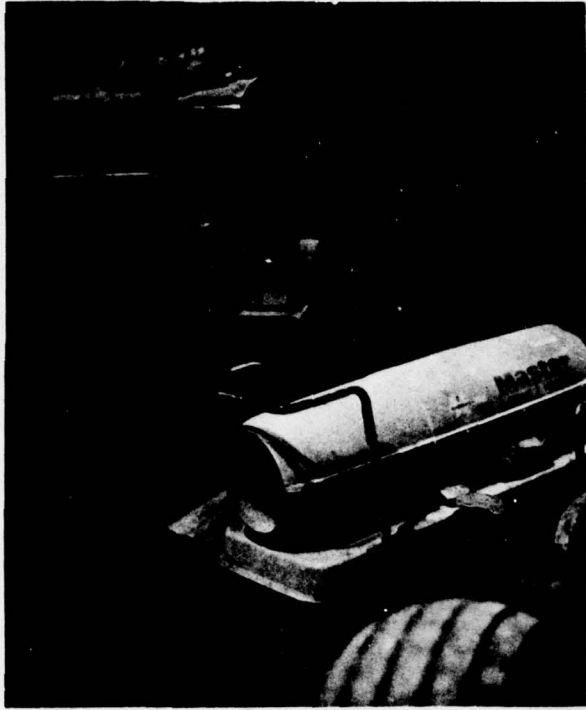
37. Space heater for temporary use at Interior Branch project. November 20, 1976. +7°F.

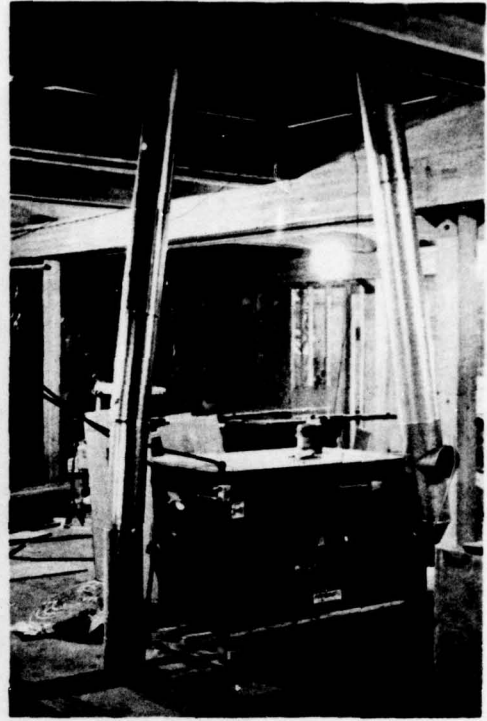
38. "Powrmatic" 450,000 BTU per hour furnace in operation at Plywood Supply project. December 30, 1976. -7°F.

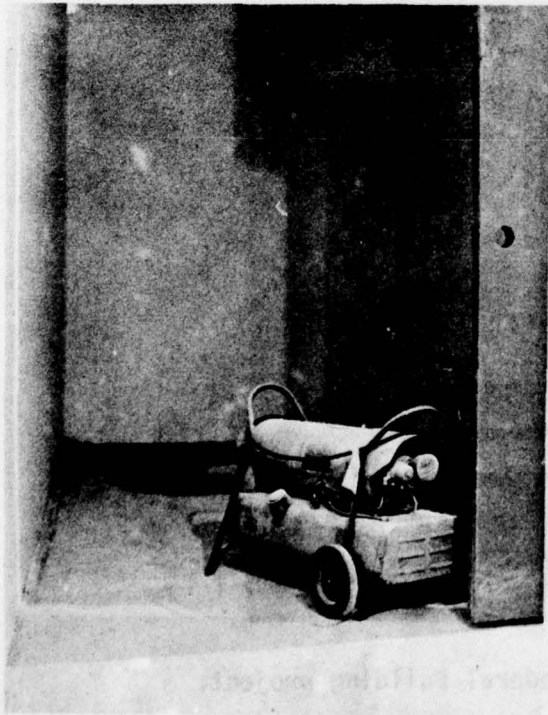
39. "Master" heater drying a damp corner at University Mall project. January 6, 1977. +4°F.

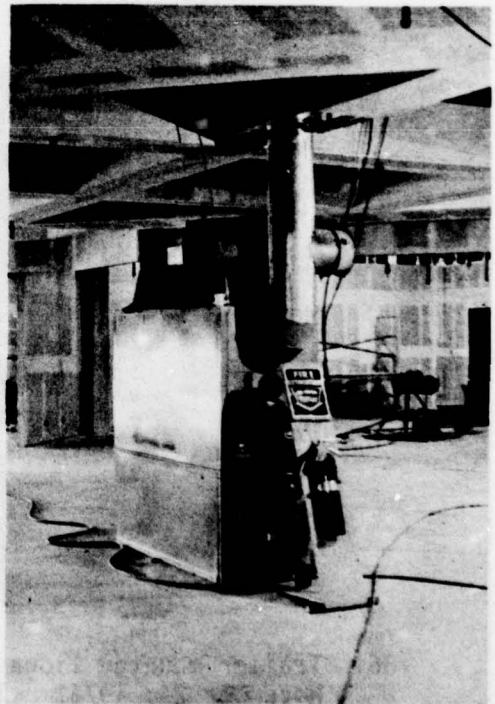
40. "Flexaire" 500,000 BTU per hour furnace in operation at University Mall project. January 19, 1977. -2°F.
