Technical Report

December 1977

**CORROSION PROTECTION OF EXISTING UTILITY
LINES UNDER PIERS AND WHARVES - RESULTS OF
3 YEARS OF MARINE ATMOSPHERIC EXPOSURE**

by E. S. Matsui

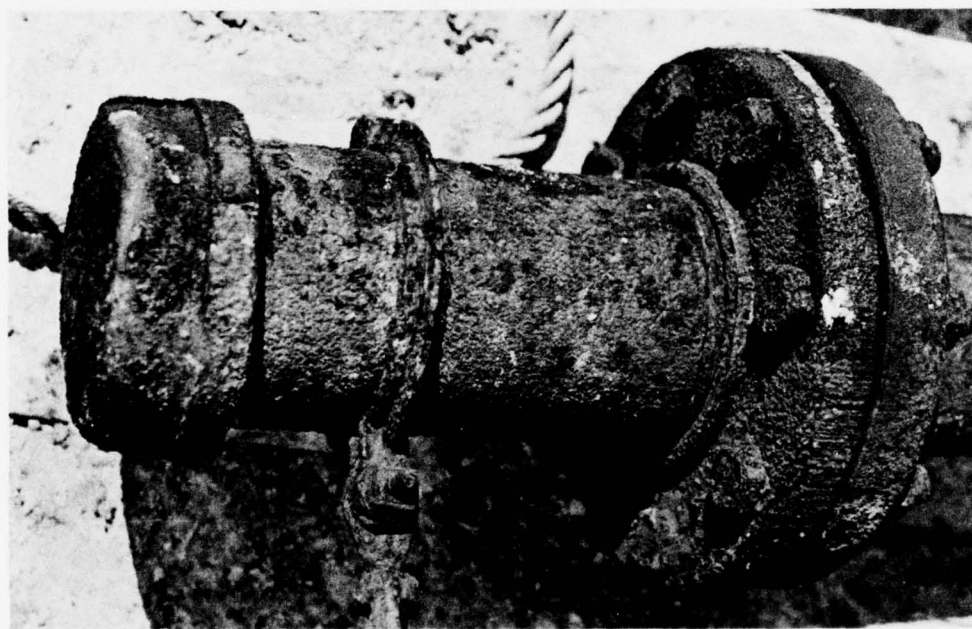
Port Hueneme. The coated pipe specimen suspended from the corrosion dock above the high-tide water level lost its glossy appearance after 6 mo of exposure. Thereafter, the coating rapidly eroded; rust was very much apparent after 12 mo of exposure. By the end of 3 yr of exposure, the coating was completely eroded, and the exposed metal surface was rusted and heavily pitted (Figure 10).

Figure 10. Rusty and heavily pitted pipe specimen coated with Astro RP Extra after 3 yr of exposure above the tidal zone.

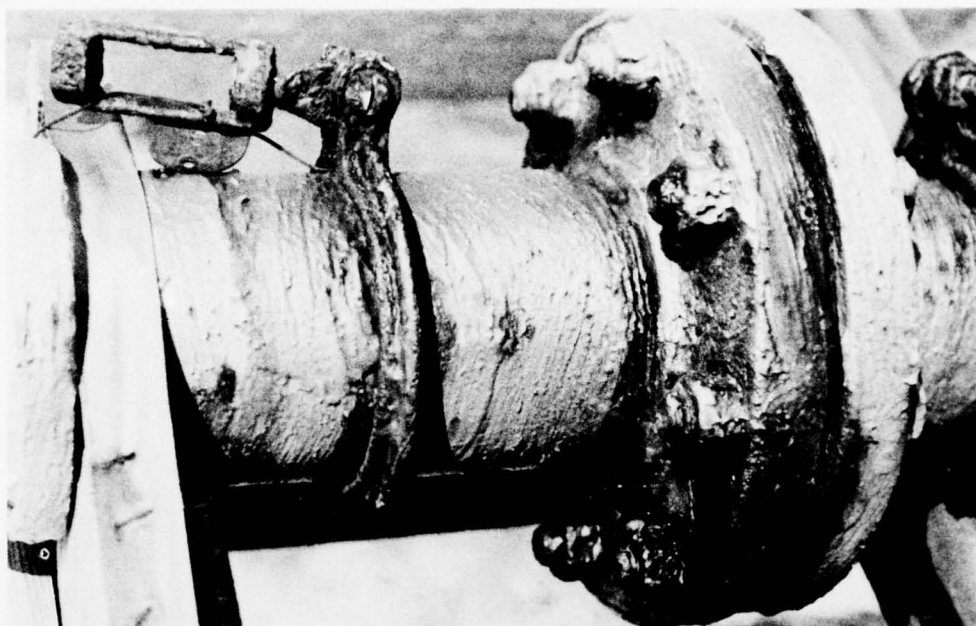
Kwajalein. The Carbomastic X2256-138-coated specimens (Figure 14) began to show rust at irregular surfaces such as bolt heads, nuts, threaded areas, flange joint, and pipe hangers after 6 mo of exposure (Figure 15). The pipe hangers appeared to be particularly vulnerable to the corrosion attack because of the difficulty in obtaining a uniform coating thickness during the coating. Many blisters were found at the flange joint area after 2 yr of exposure. By the end of 3 yr, approximately 50% of the total surface was covered with rust and blisters (Figure 16). The coating showed very little difference in protection between the sandblasted and wire-brushed surfaces. Overall performance of the Carbomastic was rated fair to poor after 3 yr of exposure at Kwajalein.

Figure 15. Carbomastic X2256 coated pipe specimen after 6 mo of atmospheric exposure at Kwajalein.

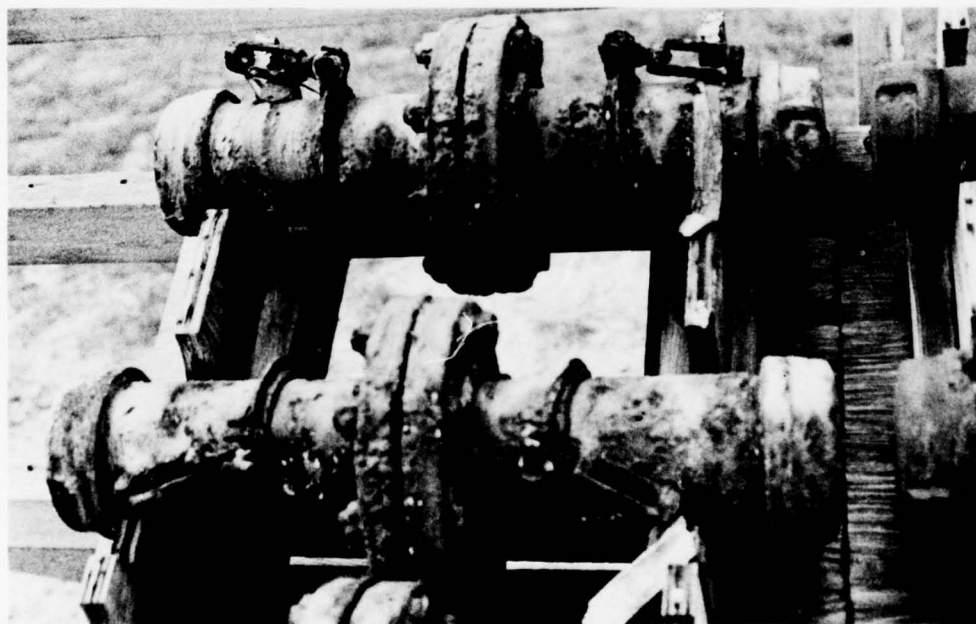
Figure 16. Carbomastic X2256 coated specimens after 3 yr of atmospheric exposure at Kwajalein.

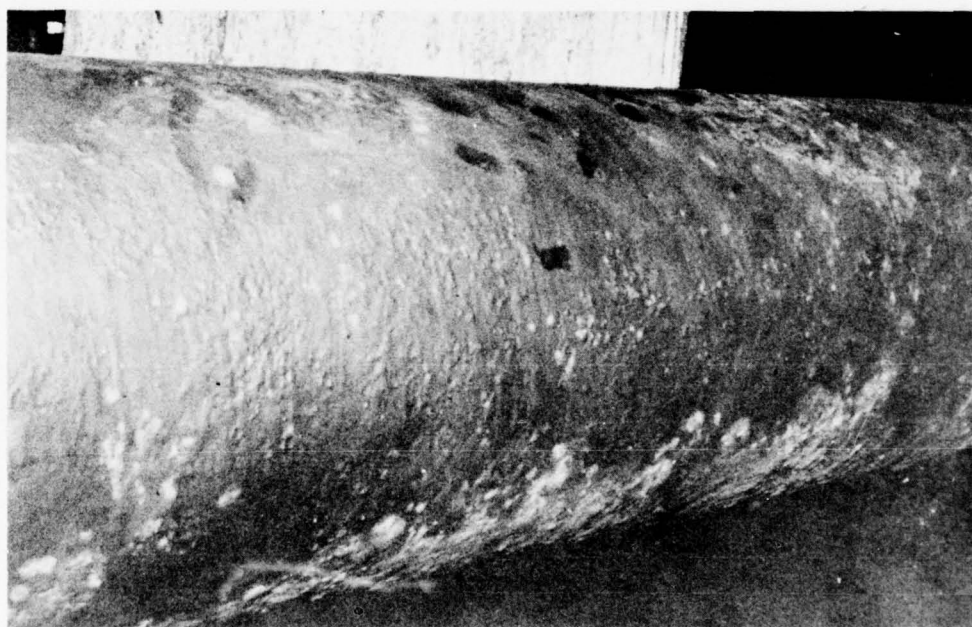
Pearl Harbor. The pipe section coated with Rust-Ban (Figure 19) was protected well during the first 6 mo of exposure. Rust began to appear along the bottom side of the pipeline after 12 mo of exposure. Corrosion along the bottom side of the pipelines appear to be a common problem under piers due to daily condensation of moisture and sea-spray. Upper portions of the coated pipe, however, appeared to be well-protected during 3 yr of exposure (Figure 20).

Overall performance of Rust-Ban was rated fair after 3 yr of exposure at Pearl Harbor.

Figure 20. Rust-Ban after 3 yr of exposure at Pearl Harbor.

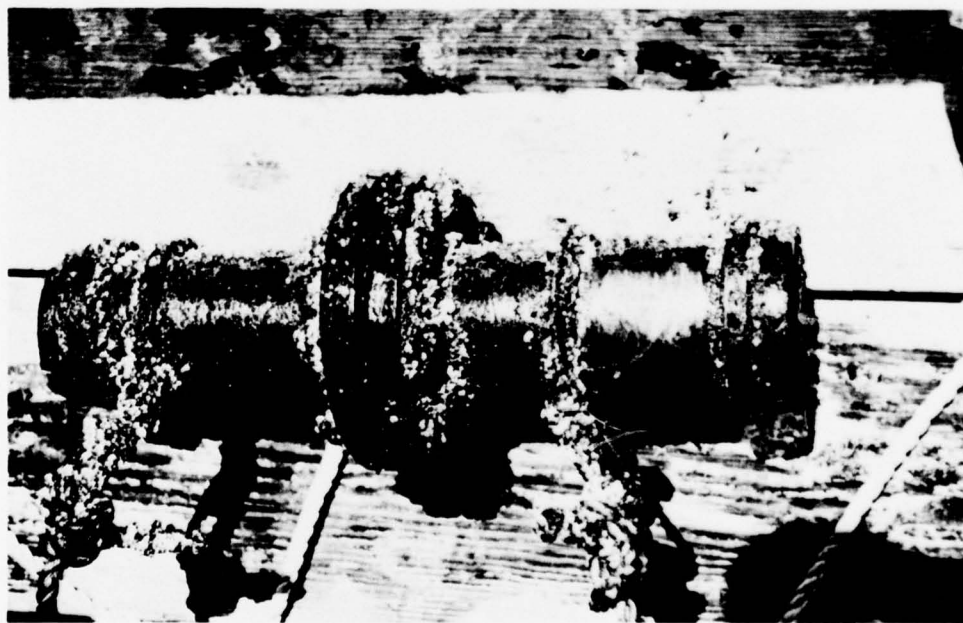
Very few barnacles grew on the specimen suspended below the tidal zone during the first 6 mo of exposure. By the end of 12 mo of exposure, approximately 25% of the surface (mostly at irregular surface areas such as bolt heads, flange joints, and hangers) was covered with barnacle growth. The irregular surface appeared to give better footing compared to the smooth surfaces, for the barnacles to grow (Figure 24). By the end of 3 yr of exposure, however, the entire surface was covered by the barnacles, and the extent of damage to the coating was difficult to determine. Overall performance of the Rust-Ban suspended below the high-tide zone was rated less than fair after 3 yr of exposure at Port Hueneme.

Figure 24. Rust-Ban coated pipe specimen exposed below tidal zone for 12 mo at Port Hueneme.

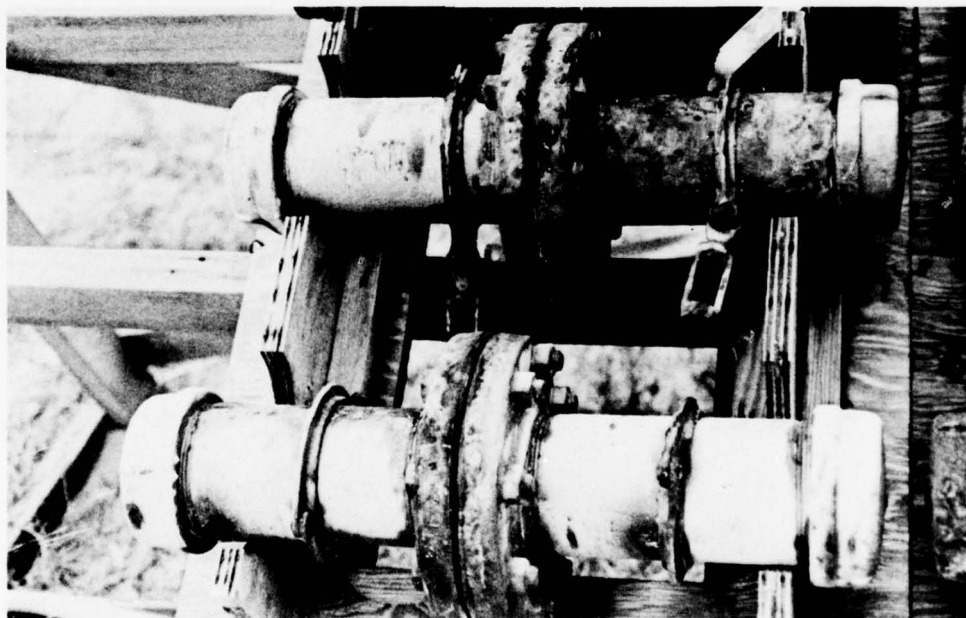
30% to 40% of the surface was covered with rust after 3 yr of exposure (Figure 28). In contrast to other coatings being investigated, MIL-P-24441 appeared to have protected the wire-brushed rusted surface better than the sandblasted surface. Overall performance of the MIL-P-24441 was rated fair to poor after 3 yr of exposure at Kwajalein.

Figure 28. MIL-P-24441 coated pipe samples after 3 yr of exposure at Kwajalein (the pipes on the nut end of the flanges were wire-brushed).

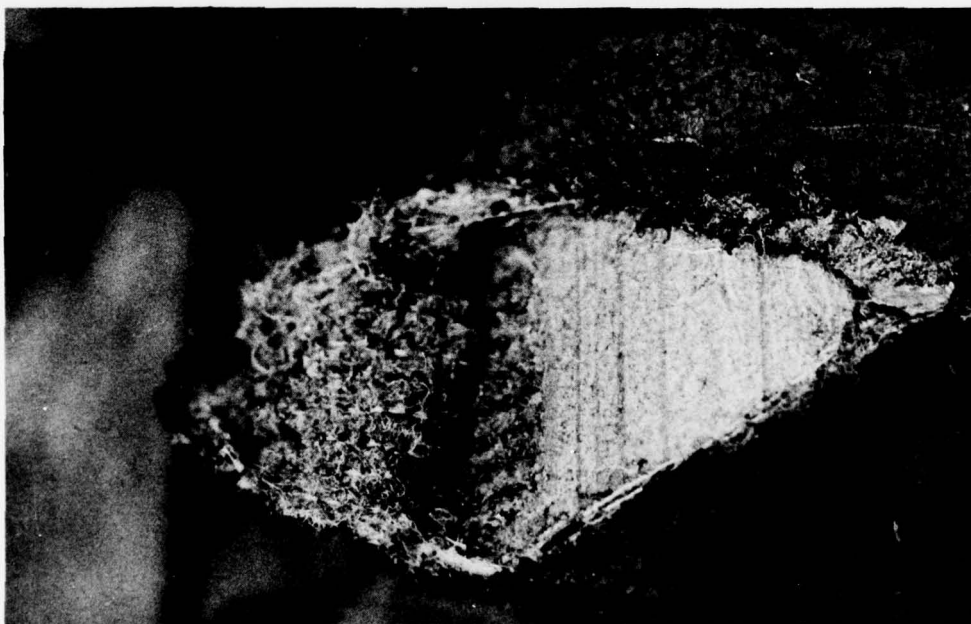
Figure 36. No rust on sandblasted surface under Denso tape after 3 yr of atmospheric exposure at Kwajalein.
