ade 000112  
NRL Memorandum Report 3685

## Fracture Initiation in Irdome Grade $\text{MgF}_2$

R. W. RICE, S. M. MOREY and F. W. FRASER

January 1978

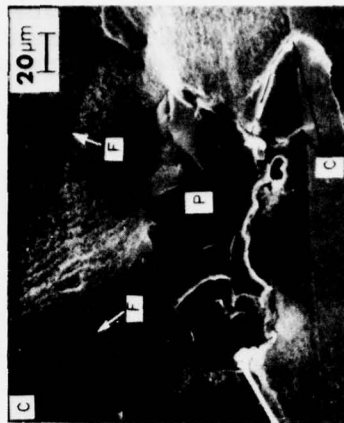
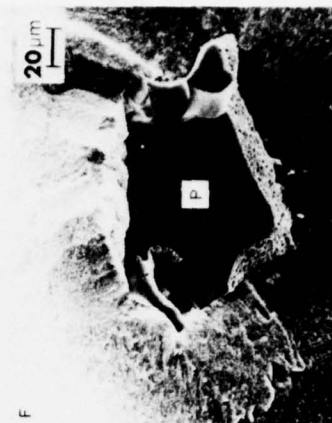
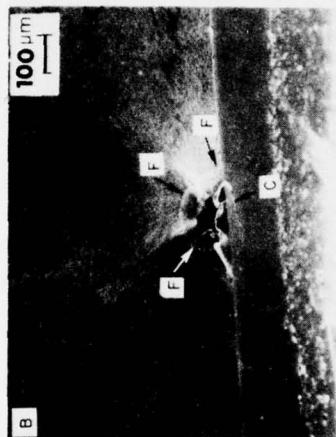
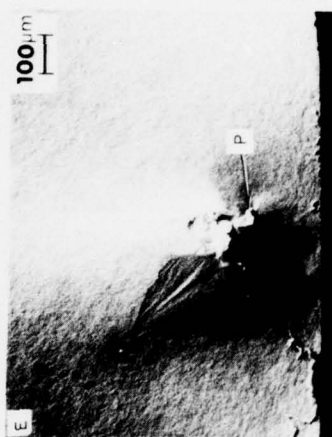
Figure 1

Of 10 particles at fracture origins of the disks analyzed in an electron probe 7 were found to be  $\text{SiO}_2$ , e.g. Figs. 1,4 (see also Fig. 7), by direct comparison of x-ray counts against a  $\text{SiO}_2$  standard. Two however showed no difference from the matrix and hence appeared to be large  $\text{MgF}_2$  grains (e.g. Fig. 3). In one case a particle was found to be a zinc compound (Fig. 2).

Failure of  $MgF_2$  test disks from foreign particles. A and D are low magnification photos of failed disks No. 10 (the weakest one) and No. 12 (intermediate strength) listed in Table 1. Note the amount of cracking correspondingly increasing with the failure stresses. The arrows indicate the approximate location of the fracture initiation. B and C are higher magnifications of the actual fracture surface of disk No. 10 showing fracture initiation from the semi-circular flaw, F, propagating out from the central particle, P. Also, note the associated cracks, C, which had they been completed could have led to surface spalling. E and F are higher magnifications of the actual fracture surface of disk No. 12 showing failure from a foreign particle, P, located somewhat inside of the surface. Note the porosity (black dots) indicated along the bottom periphery of the particle in F. Electron probe analysis of this particle showed the particle to be  $SiO_2$ . Note that in both figures C and F that the fracture character of the particle is consistent with conchoidal fracture of glasses such as fused  $SiO_2$ .

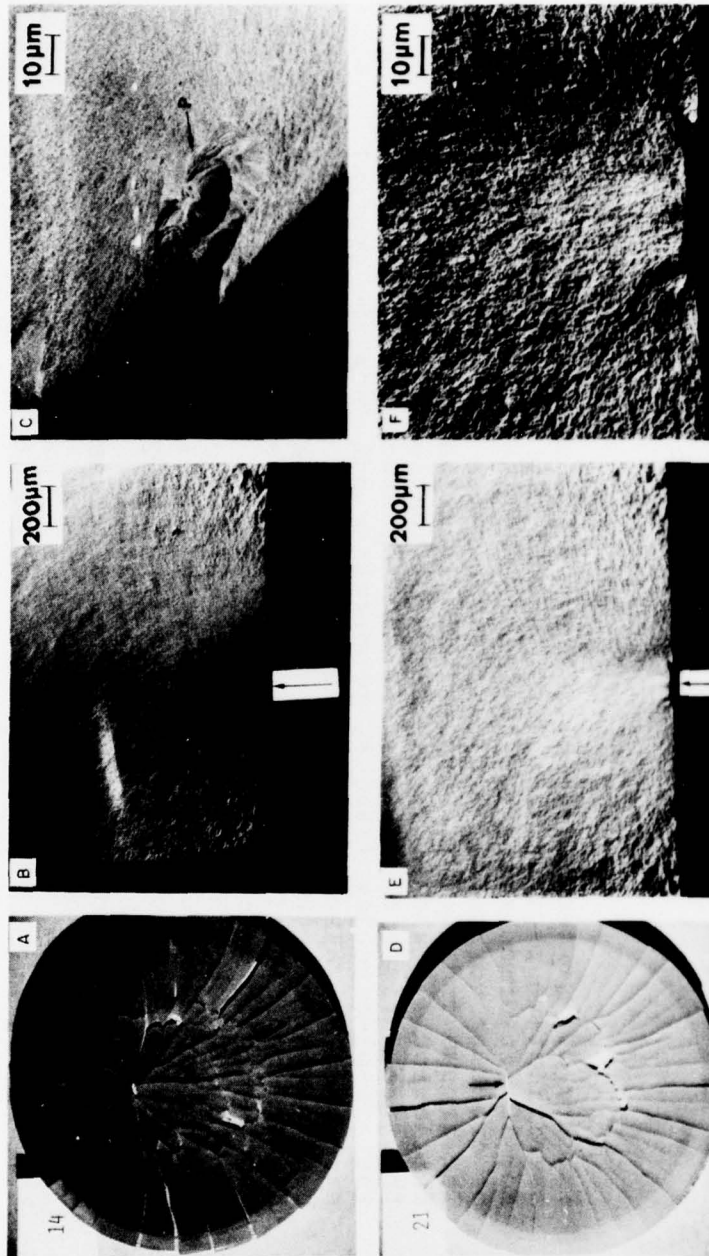
Figure 2

The  $\text{MgF}_2$  manufacturer also stated that occasionally some Zn compounds are hot pressed in the same facilities and possibly the same dies are used for the  $\text{MgF}_2$ . Thus the possible cause of the one Zn containing impurity was a small agglomerate of powder that was either left in the die from a previous pressing, or that fell into the die from some other piece of equipment. Since this appears to be a rather rare occurrence it may not be necessary to take precautions against this. However, if it were to be a significant problem, then separation of the facilities or the dies or greater cleaning of dies would be possible solutions to this problem.

Further examples of fracture initiation in  $MgF_2$  test disks. A and D are low magnification photos of failed disks Nos. 14 and 21 listed in Table 1. The arrows indicate the approximate location of failure initiation. Note the greater amount of cracking in these disks consistent with their higher than average failure stresses. B and C are higher magnifications of the actual fracture surface of disk No. 14 showing failure from a foreign particle (P) very near the surface. Note that the orientation of the sample in C is different from that in B. Note also in C that the foreign particle has a number of steps suggestive of crystallographic character consistent with the fact that electron probe analysis showed this to be a Zn rich particle which would be consistent with the crystallographic character to the surface of the particle. E and F are high magnification photos of the actual fracture surface of specimen No. 21 showing failure from a surface flaw which may represent either surface damage, e.g. from localized contact or impact or could possibly represent spallation from a foreign particle which is not exposed.

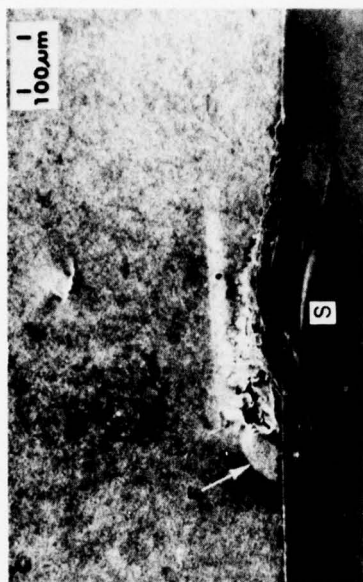
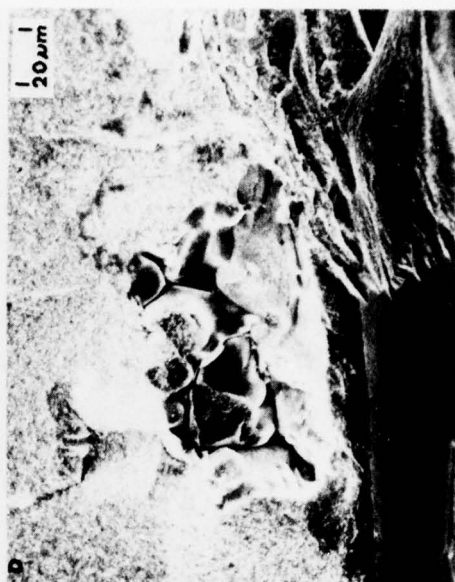
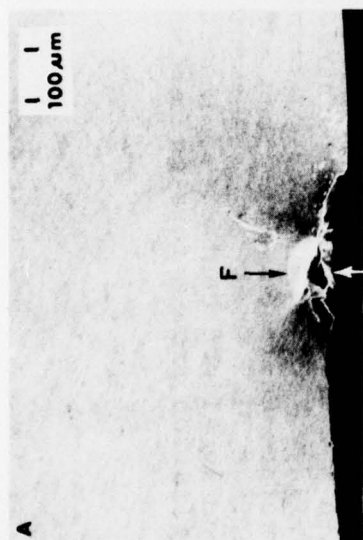
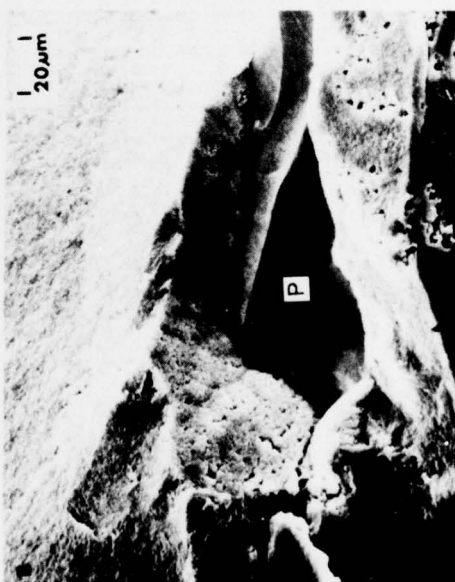
Figure 3

Additional examples of  $\text{MgF}_2$  disks failing from large particles A and B are photos of the actual fracture surface of specimen No. 22 of Table 1. Note the approximately semi-circular flaw having propagated out from the foreign particle, P, which is shown in greater detail in B. Because of the only partially exposed nature of this particle and the flaw propagating out from it, this specimen was first listed as failing from a surface flaw (Table 1). This illustrates the fact that some specimens actually failing from particles were not detected to have such fracture origins by optical examination. C and D are photos of the fracture origin of specimen No. 29 of Table 1. Note a flaw propagating out from the left side of a cluster of particles, shown at higher magnification in D. Electron probe analysis showed to these particles to be of essentially the same composition as the matrix, i.e.  $\text{MgF}_2$ . Note also the surface spallation (labeled S in C) which is believed to have occurred during or after failure.

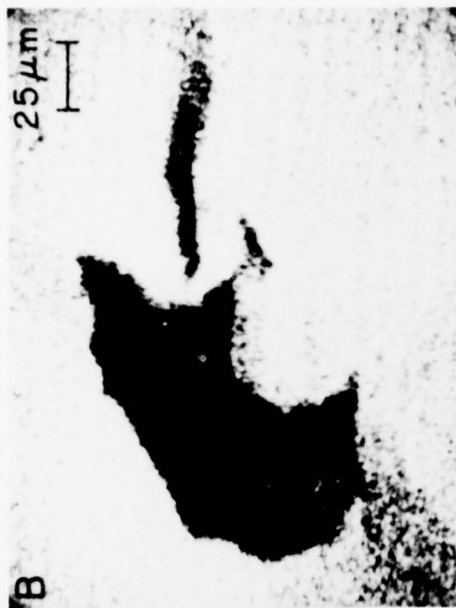
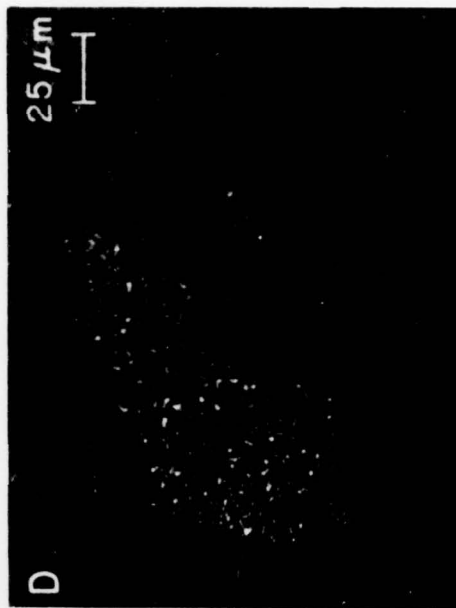
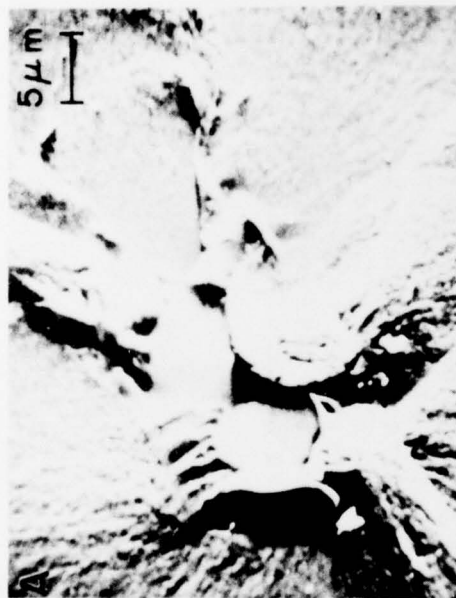
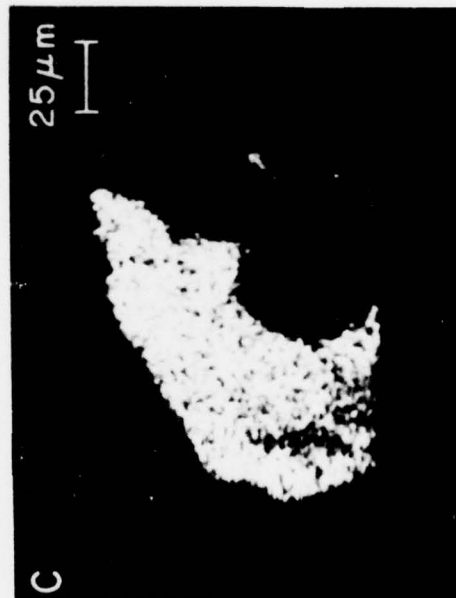
Figure 4

Sample electron probe analysis of foreign particle failure in  $\text{MgF}_2$ . A is an electron backscatter presentation showing a foreign particle at the fracture origin of a specimen (No. 103-2 of Table 2). B is the magnesium x-ray fluorescence showing that the particle is clearly not  $\text{MgF}_2$  while photos C and D are respectively silicon and oxygen x-ray fluorescence showing the particle clearly consists of silicon and oxygen. The relative count rates ( $\sim$  proportional to the density of white dots) are consistent with the count rates obtained off a calibration sample of pure  $\text{SiO}_2$  in the probe. These results are typical of several analysis made in the probe.

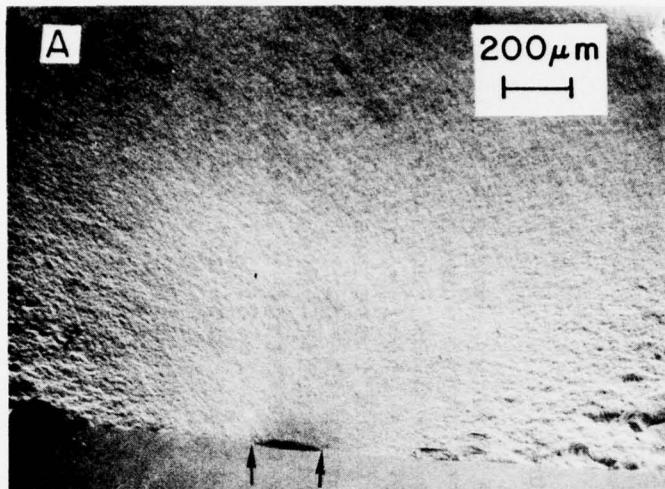
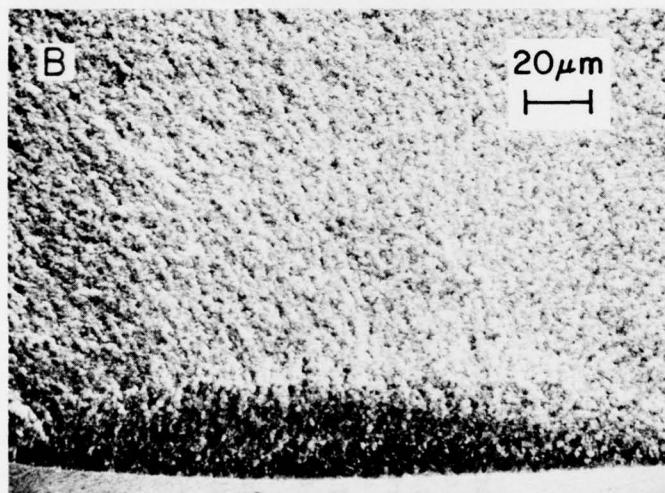
Figure 5

MgF<sub>2</sub> disk failing from a machining flaw. A and B are SEM photos of the actual fracture surface of specimen No. 7 of Table 1 which failed from a surface machining flaw bounded by the arrows in A and shown in higher magnification in B. The elongated shape of this flaw as well as the smooth flaw periphery suggest that this is a flaw from the final stages of finishing the disk, i.e. polishing, rather than a part of coarser flaw left over from earlier grinding.

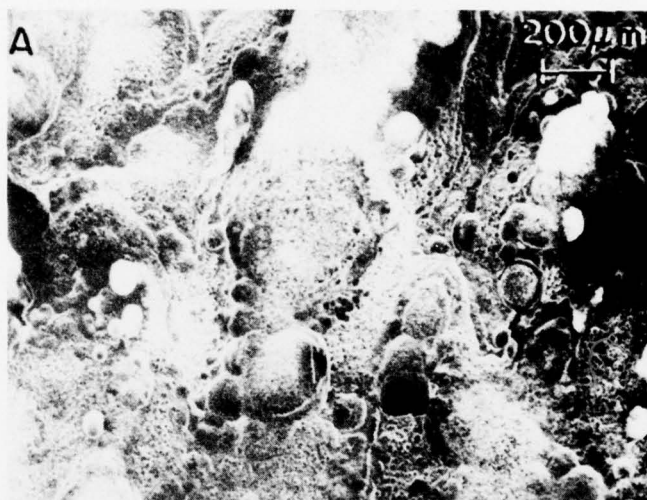
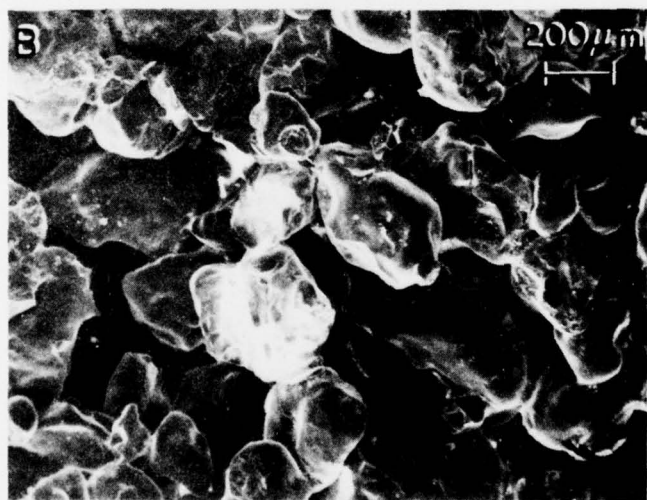
Figure 6

Discussions with the manufacturer revealed the probable sources of all of these failure causing foreign particles with the exception of the large  $\text{MgF}_2$  grains. Thus, for example, the manufacturer reports that coarse finish  $\text{SiO}_2$  crucibles are used for calcining the  $\text{MgF}_2$  powder. Examining sections of these crucibles supplied by the  $\text{MgF}_2$  manufacturer shows that while the interior surface of the crucible is not a likely source of such loose  $\text{SiO}_2$  grains, the outside surfaces of the crucibles are an extremely likely source of such grains of the proper size, e.g. Fig. 6. Thus the major source of failures is attributed to  $\text{SiO}_2$  particles which are readily abraded off the exterior surface of the  $\text{SiO}_2$  crucibles that are used in processing of the powder. Use either of other crucibles or possible subsequent screening of the powder could thus be major steps to the reduction if not elimination of this primary source of foreign particles for failure.

SEM photos of surfaces SiO<sub>2</sub> crucible used for MgF<sub>2</sub> powder processing.  
A) Crucible interior. Note many circular depressions.  
B) Crucible exterior. Note relatively loosely bonded SiO<sub>2</sub> grains of similar sizes to those found in the hot pressed MgF<sub>2</sub>.

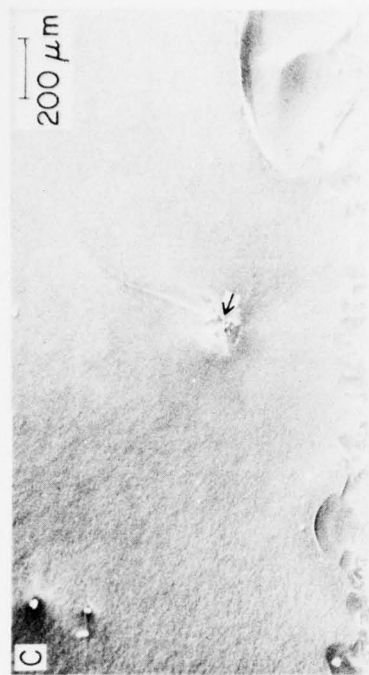
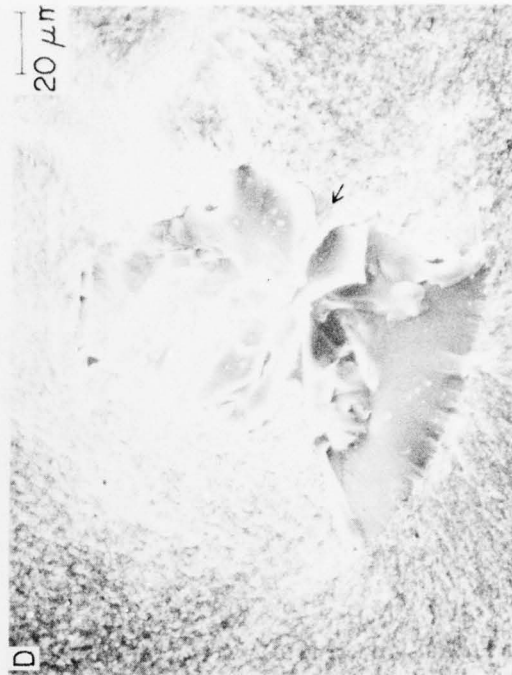
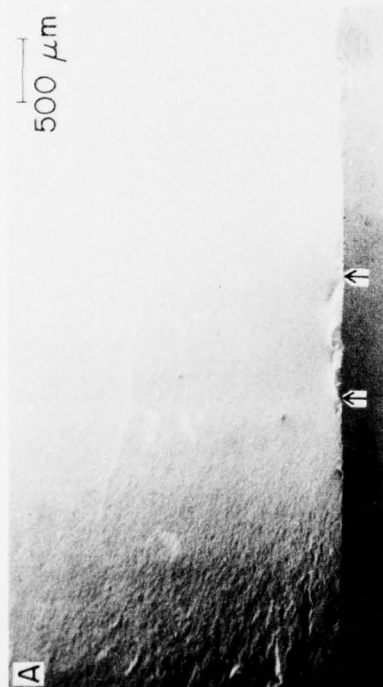
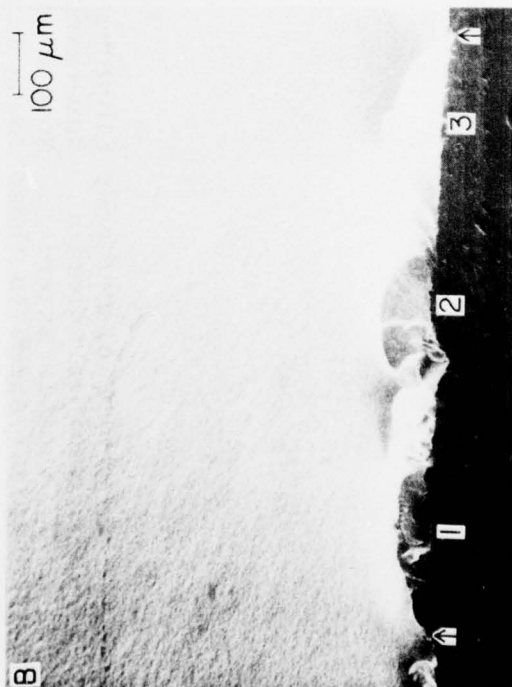
Figure 7

Fracture of large (0.5" x 0.75" cross section) MgF<sub>2</sub> bars broken in 3 point flexure (3.5" span) A and B are progressively higher magnification photos of a bar failing ( $\sigma_f \sim 8.5$  ksi) from an elongated machining flaw (between arrows) from machining perpendicular to the bar axis. Note the flaw consists of at least 3 major crack segments. C and D show the fracture of a bar ( $\sigma_f \sim 13.6$  ksi at the surface,  $\sim 12.2$  ksi at particle) from 1 or 2 particles (arrows) identified by EDAX as having a strong Si, but no Mg, signal and hence assumed to be SiO<sub>2</sub>. Note also the spalling at the intersection of the fracture and tensile surface near the bottom of C due to the intersection of the cracks propagating from the particles and cracks propagating from machining flaws.
