Special Report 77-43

CRREL ROOF MOISTURE SURVEY

Building 208
Rock Island Arsenal

December 1977

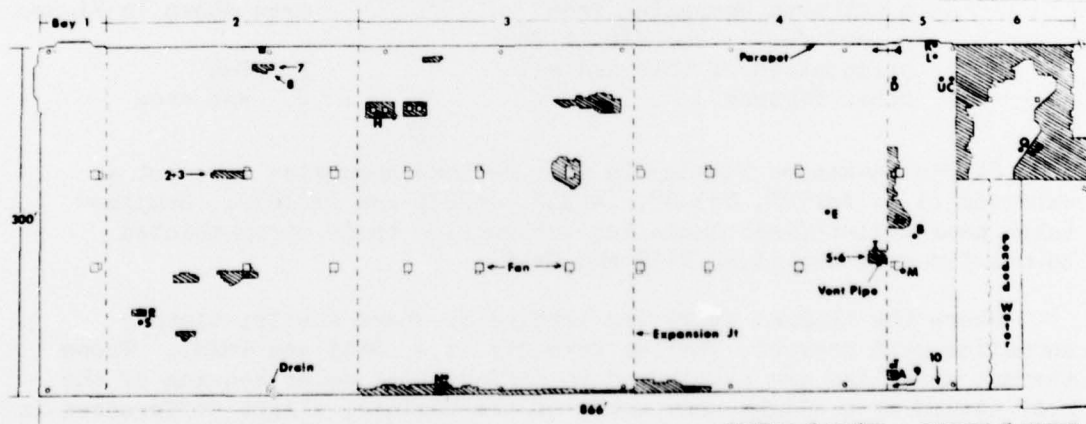
SAMPLE-% WATER		SAMPLE-% WATER	
A	170	L	2
B	3	M	3
C	4	N	3
D	5	O	318
E	2	P	216
G	398	Q	5
H	235	R	155
I	435	S	3
J	223	T	4
K	1	U	2

Figure 1. Plan view of building 208. The cross-hatched areas indicate wet insulation. Arrows indicate the viewing direction of objects in Figures 2 through 10.

The eastern half of the southern portion of Bay 6 was covered by ponded water as shown in Figure 1. Because of the ponded water an infrared survey could not be conducted in this area. Ponding of water is a problem and better drainage should be provided. The western half of this southern portion was not water-covered and appeared to be free of wet insulation as no thermal anomalies were detected.

Much of the northern portion of Bay 6 contains wet insulation. New built-up roofing and insulation are needed there. Careful attention should be directed toward installation of new wall flashings as it is quite likely that flashing flaws destroyed this portion of the roof.

New insulation and a built-up membrane are needed for the northern portion of Bay 6. Better drainage should be provided in the southern portion of this bay.

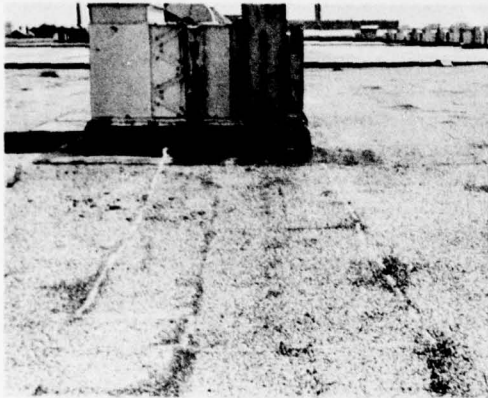
Figure 2. White spray paint outlines a wet area emanating from a roof fan. (See Fig. 1 for orientation of this and all other figures.)

Samples taken on Tuesday in well-defined anomalies were wet as expected (i.e. A=170%, G=398%, I=435%, J=223% and O=318%). Samples taken near well-defined anomalies but outside their spray-painted boundaries were dry (i.e. N=3% and T=4%).

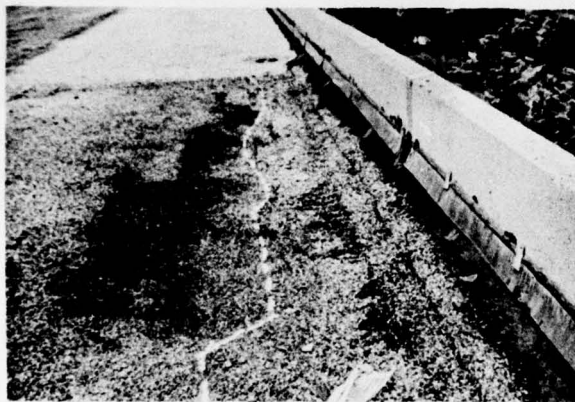
unrelated to moisture are frequently encountered there. The anomalies detected in these areas appeared to be of this nature, except that their inside boundary was quite irregular (Fig. 4), which is uncommon. Since anomalies with irregular boundaries are often moisture-related, samples were taken. All insulation samples associated with these types of anomalies were dry (i.e. C=4%, D=5%, K=1%, L=2% and U=2%). The membrane was thicker within these anomalies. This is believed to be the cause of their thermal signature.

Figure 4. Spray painted boundary of an irregular thermal anomaly along the parapet.

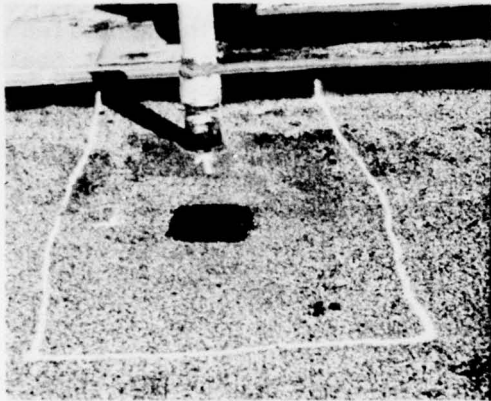
The majority of the wet areas shown in Figure 1 are associated with membrane penetrations. Quite likely water has entered the insulation through the flashings at these penetrations. For example, the flashing collar was loose at the base of a vent pipe. The collar would move relative to the pipe when someone walked nearby. Figures 5 and 6 show the well-defined wet area surrounding this vent pipe. The collar was not loose at an identical vent pipe nearby and the thermal image was

Figure 5. Daytime photograph of a wet area outlined with white spray paint. The arrow points to the loose collar flashing. The built-up membrane contained a 3-in.-diam hole which was subsequently patched (black square).

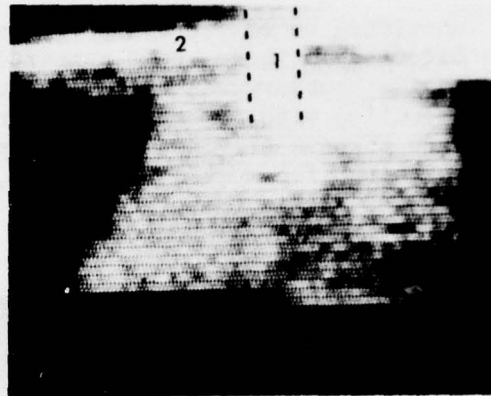
Figure 6. Thermogram of the area shown in Fig. 5. The moisture probably entered around the vent pipe.

1. Vent pipe
2. Expansion joint

uniformly dark there. Within the wet area shown in Figure 6 a 3-in.-diam hole was discovered in the membrane. Sample I, taken from the exposed insulation, had a water content of 435%. Prior to completion of this survey the hole was patched as shown in Figure 5.

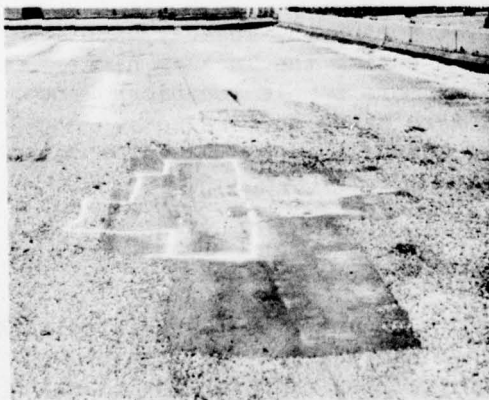
Other wet areas were associated with roof patches as shown in Figures 7 and 8. It's not possible to determine when moisture entered this area - before or after the patches were installed.

Figure 7. Daytime photograph of a patched area with a wet area outlined in white spray paint.

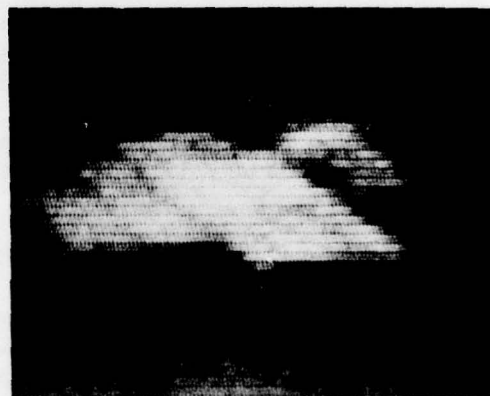
Figure 8. Thermogram of the wet area shown in Fig. 7.

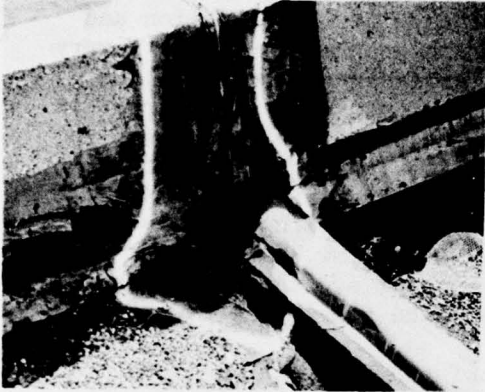
Visual examinations conducted during the daytime (26 and 27 July) revealed that the entire roof membrane contained numerous blisters. Although blisters are potential moisture entry points no wet areas were directly associated with blisters. While the flashings and expansion joints were being examined, defects were marked with white spray paint, as shown in Figures 9 and 10. Repairs should be made in such areas.

Figure 9. White spray paint was used to mark defects.

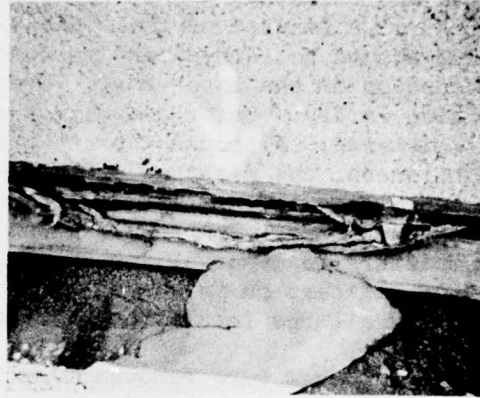
Figure 10. Flashing defect marked with white spray paint.
