# DESTROYER ENGINEERED OPERATING CYCLE (DDEOC)

## System Maintenance Analysis DDG-37 CLASS FIREMAIN AND AUXILIARY MACHINERY COOLING WATER SYSTEMS SMA 37-201-521

### REVIEW OF EXPERIENCE February 1978

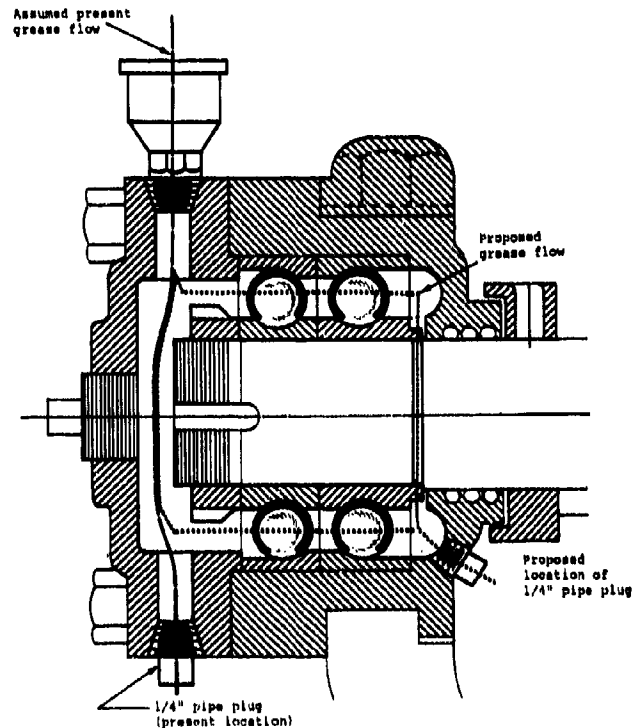
Figure 3-1. TYPICAL FIREPUMP BEARING AND HOUSING

During analysis of the firepumps, it was further noted that the procedure currently used to grease the ball bearings does not ensure that the old grease in the ball bearing is purged and replaced by new grease. This may have contributed to the high bearing replacement rate by not allowing an adequate flow of new grease. The existing drain plug on the bearing housings is directly below the grease cup or zerk fitting, and it is possible that the fresh grease will flow directly out of the drain hole. The lubrication procedure could be improved by moving the drain hole to the opposite side of the ball bearing, thus forcing new grease to flow through the bearing in such a way as to ensure that fresh grease is introduced to the contact points of the ball bearings and the old grease is flushed out. Figure 3-1 graphically describes the proposed change.

It is recommended that a ShipAlt be developed to implement this recommended firepump bearing housing change on both bearings of the installed firepumps of the DDG-37 Class.
