FINAL REPORT  
INVESTIGATION AND IMPROVEMENT OF THE  
RELIABILITY OF THE C-141A AIRCRAFT  
MASTER CAUTION CONTROL UNIT

JULY 1976

ARINC Research Corporation  
a Subsidiary of Aeronautical Radio, Inc.  
2551 Riva Road  
Annapolis, Maryland 21401  
Publication 1904-01-1-1524

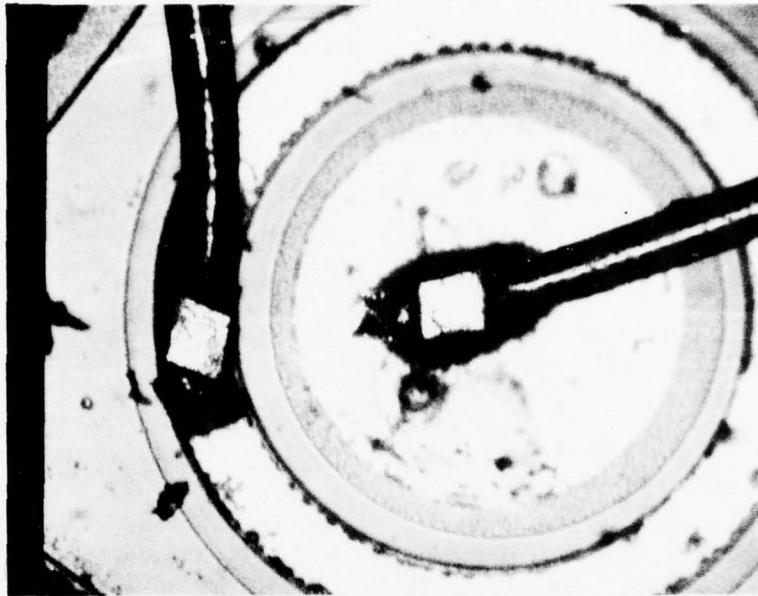
The transistor examination revealed evidence of a failure mode that consisted of concentrated temperature extremes in the emitter contact area. The photographs of Figure 3-6 show the typical failure mechanism seen in the transistors examined.

(a) Hot spot shown just below emitter terminal

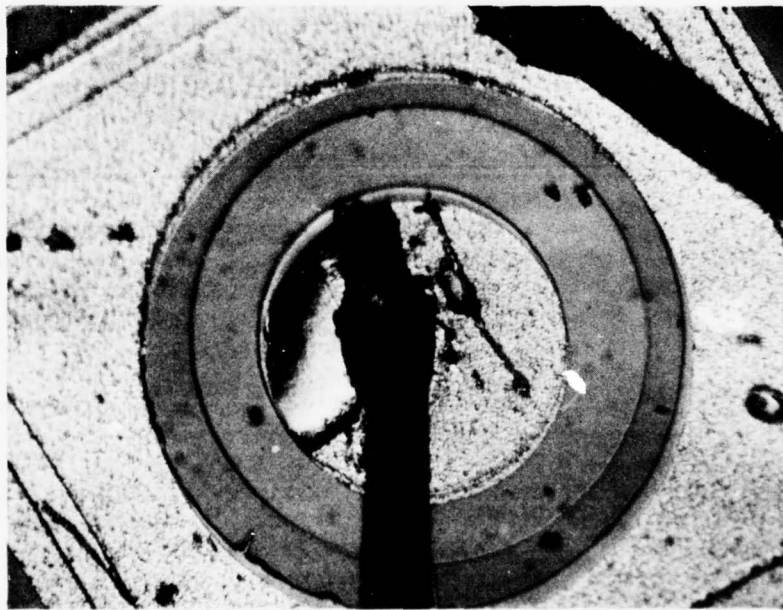
(b) Melted area to left of emitter terminal

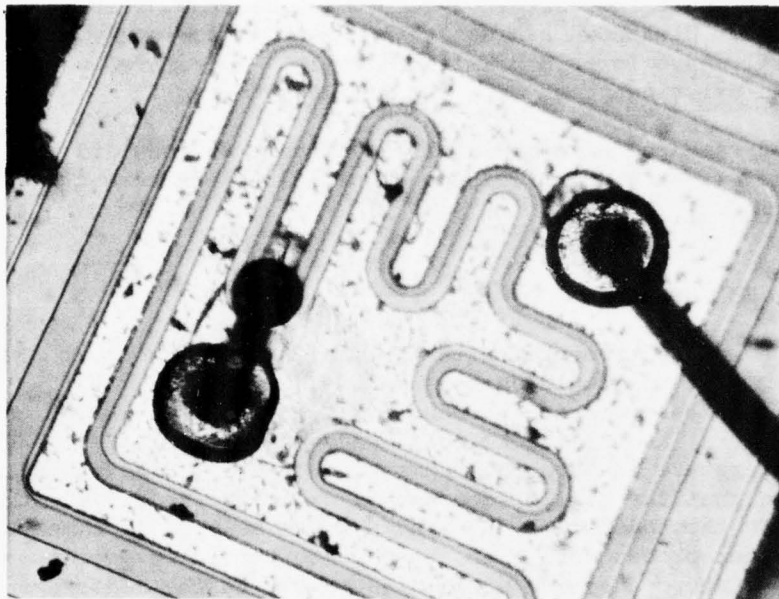
(c) Emitter terminal burned off near semiconductor connection; hot spot shown just above the emitter terminal

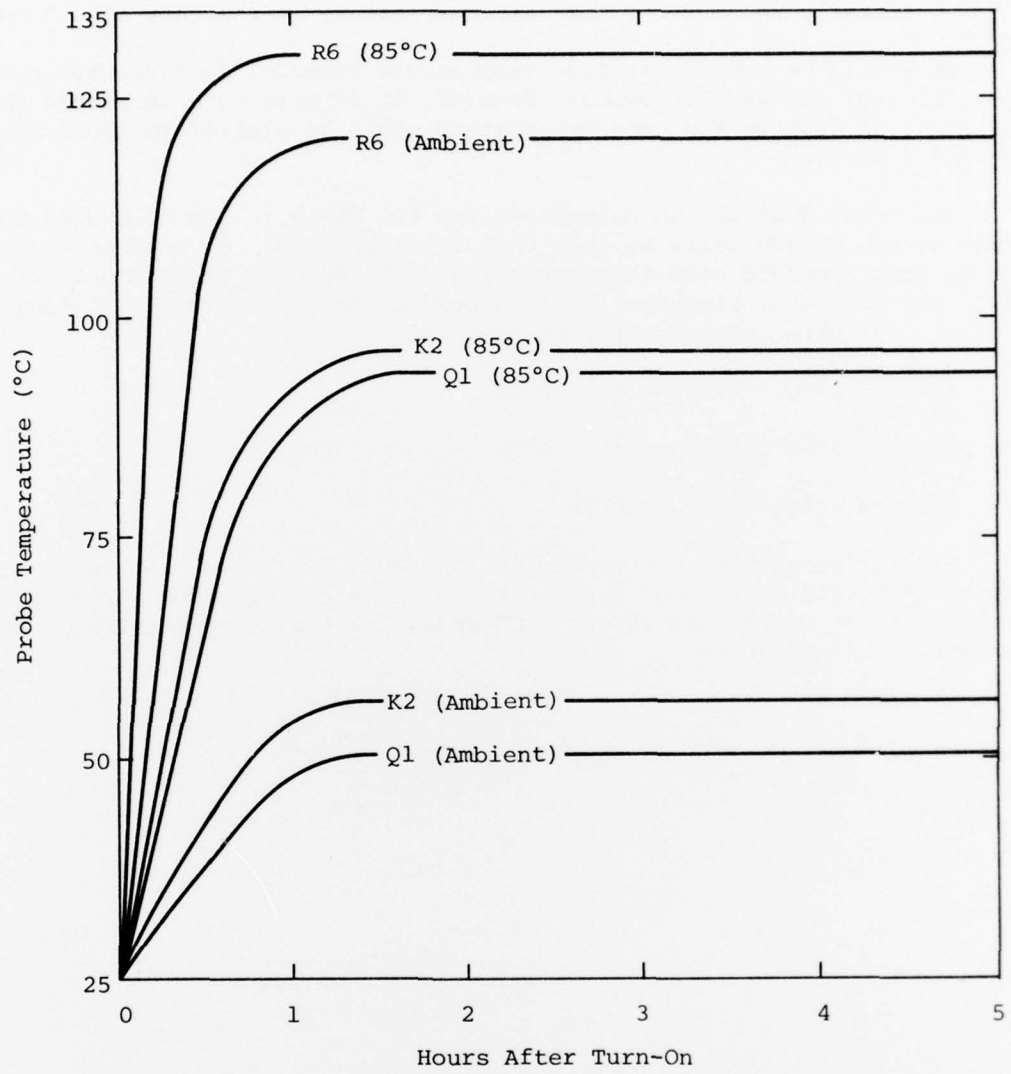
Figure 3-7. THERMAL MEASUREMENTS

Similar results were obtained for the 2N3063 device. The thermal measurements indicated that there were no thermal problems associated with transistors or components in the MCCU under the most severe anticipated conditions of operation.
