HONEYWELL INC HOPKINS MN DEFENSE SYSTEMS DIV
XM587E2/XM724 ELECTRONIC TIME FUZES SYSTEM VERIFICATION TEST PH--ETC(U)
JAN 78 J C RAVIS

HDL-CR-78-157-1

Prepared by
HONEYWELL INC.
DEFENSE SYSTEMS DIVISION
600 SECOND STREET NE
HOPKINS, MINNESOTA 55343

4. TITLE (and Subtitle) XM587E2/XM724 ELECTRONIC TIME FUZES SYSTEM VERIFICATION TEST PHASE,		5. TYPE OF REPORT & PERIOD COVERED Final Report. 31 Mar 1975 - 30 Jun 1977

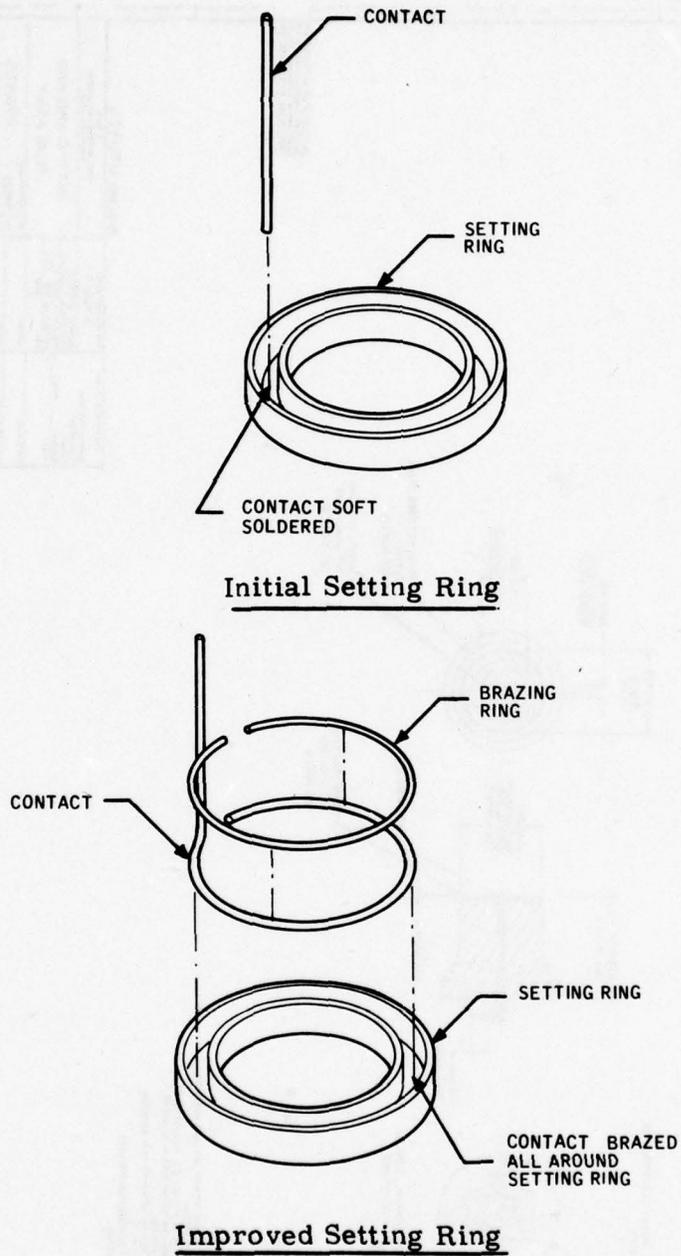
Figure 3. Comparison of initial and improved setting ring designs.

During the prior program (contract DAAG39-73-C-0176), the setting ring and plug assembly had two types of problems. The first was bulging or nonconcentricity of the setting rings. This was caused by the heat and pressure required to install the rings. The grooves provided in the nose plug did not provide for proper alignment. Tooling was fabricated to hold the rings while heat staking them in place. However, this did not improve the concentricity since the tooling could only hold the rings until they started to seat in the plastic nose plug. This problem was not successfully resolved during the program.

The second problem was that of providing a proper electrical connection. The lead wire was soft soldered into the nose ring where heat and pressure used in assembly caused the solder to flow and degrade the connection. In addition, some of the plastic material tended to flow and degrade the connection. Finally, some of the plastic material tended to flow up on the rings from the nose plug, thereby reducing the contact area of the setting ring.

To solve this problem, a three-piece brazed setting ring was used to replace the two-piece soft soldered setting ring. The initial assembly and the improved assembly are shown in figure 3. Along with this change, the plastic nose plug was redesigned to improve self-alignment of the setting ring during the heat staking operation.

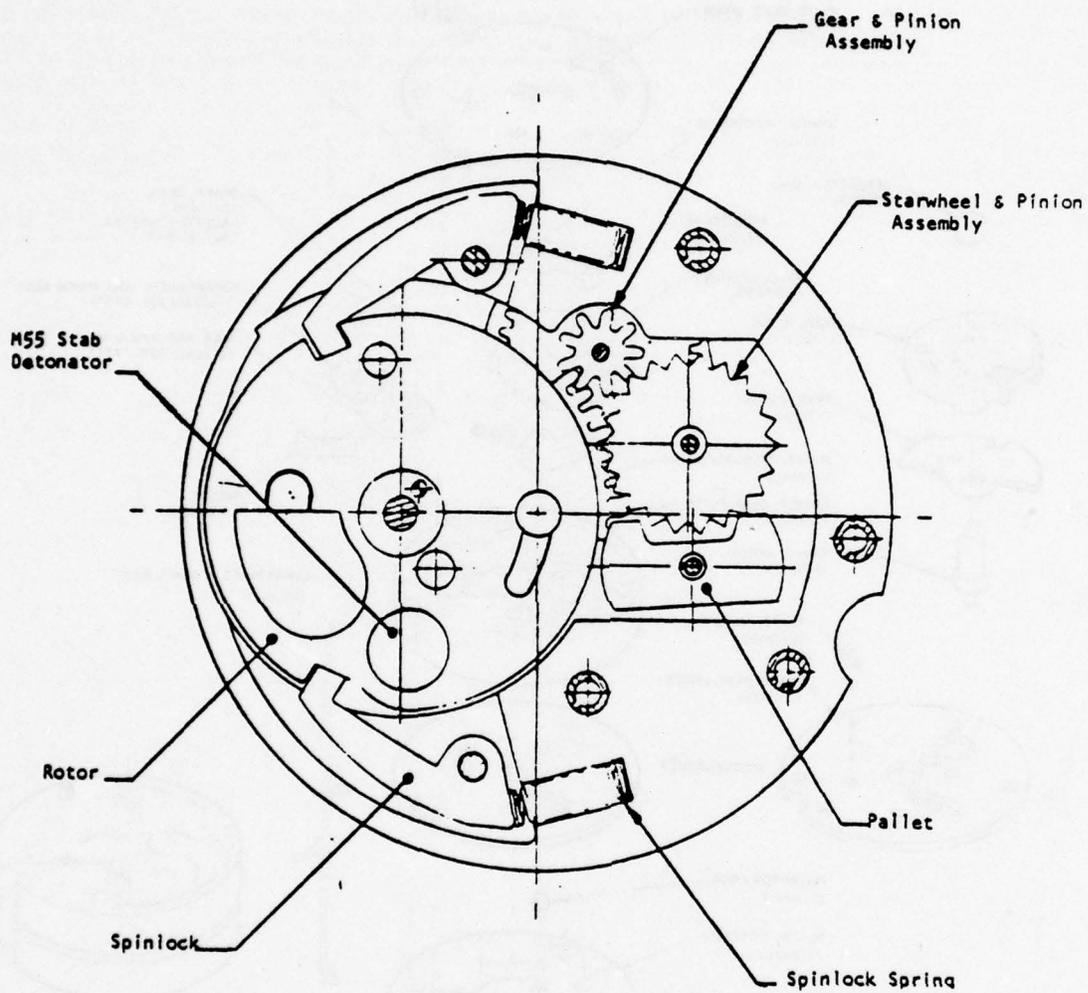
Figure 7. Rotor and gear train of the S&A module of the XM587E2/XM724 fuzes.

2.3.1 S&A Module Gear-and-Pinion Assembly -- The rotor and gear train of the S&A module is shown in figure 7. An exploded view of the major S&A module piece parts is shown in figure 8. The rotor is eccentrically mounted and imbalanced such that the centrifugal forces resulting from spin about the fuze centerline cause it to rotate counter-clockwise. The center of gravity of the rotor is shown in figure 7 close to the pivot at about the 1 o'clock position and is indicated by the symbol

The corrective action taken was to replace the die-cast zinc gear with one machined from wrought aluminum, which does not go through a crystalline transition. This aluminum gear is staked onto a one-piece machined pinion and shaft and, in construction, is similar to what is used in the M732 and M577 fuzes, the M125 booster, and the safety adapter for the M564/M565 fuzes. The functional form of this new assembly is identical to the die-cast zinc version. Laboratory tests were performed to confirm that the new machined gear set is

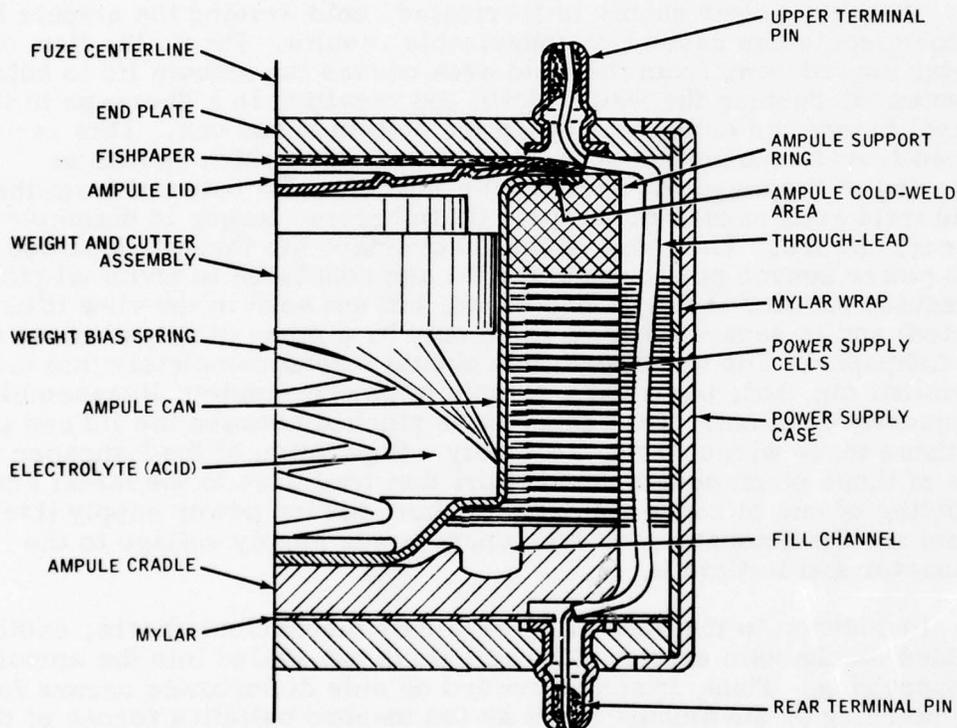
Figure 9. Cross-sectional view of the SVT vintage power supply.

When the power supply is fabricated, cold welding the ampule lid to the ampule can cause two undesirable results. First, the flow of metal inward away from the weld area causes the ampule lid to bulge downward, pushing the weight down and resulting in a decrease in the travel before the cutter tips touch the bottom of the can. This reduced travel reduces the base-down drop height which can cause piercing of the ampule. Second, the flow of metal outward from the cold weld area causes the ampule lid to become larger in diameter and to curl upward. This edge of the lid overlaps the through-lead and the two power source power leads (which are connected to terminal pins in a fashion similar to the through-lead, but not seen in the view illustrated) and is separated from them only by a piece of polyethylene coated fishpaper. The wire insulation should extend completely into the terminal pin, but, based on a sample of power supplies disassembled, frequently does not. The fishpaper is pinched between the lid and each of these three wires during assembly. Separation of the fishpaper and one of these pinch points would short that lead wire to the metal ampule. Shorting of one or more leads could short out the power supply itself, short out the detonator, or even apply power supply voltage to the detonator and initiate it.

In addition to the possibility of purely mechanical shorts, another failure mechanism exists. The ampule is not sealed into the ampule support ring. Thus, if some forward or side disturbance occurs following piercing of the ampule (such as the in-bore balloting forces of the 175mm gun), it is possible for some of the excess acid remaining in the fill channel to be splashed up between the ampule and the support ring and onto the fishpaper. The fishpaper absorbs the acid and becomes conductive, especially in thin sections. Depending on how much acid is splashed in this manner and where, it is possible to short any combination of terminal wires to the ampule lid. This electrolyte splashing and terminal shorting has been demonstrated using a jolt machine. It is also conceivable that the acid could be splashed onto the fishpaper at one point only and would, after a delay of a few seconds, spread through the fishpaper and cause two terminal leads to be shorted to the ampule lid. If the two leads thus shorted were the through-lead

and a power source power lead, then a delayed functioning of the electric detonator would result. This is the only known single failure mechanism which could cause a 4-5 second function of a fuze set to 90 seconds, and it is believed to be the most likely cause of the early burst at YPG during 175mm gun testing.

The design improvements made to remedy the power supply deficiencies are shown in figure 10. It will immediately be noticed that the through-lead is no longer present. It has been replaced by a one-piece strap which extends from the top to the bottom of the power supply and is formed around plastic posts on either end to become the male portions of the connectors. The metal terminal pins are replaced with plastic, and no part of the detonator firing lead conductor is exposed to the inside of the power supply. Between the posts, the strap is laminated between layers of high-strength, high-temperature plastic, and is bonded to the case for ease of handling. The nearest conductor to the strap is the power case, which is grounded, so any shorts to the strap could not be expected to result in functioning of the electric detonator.

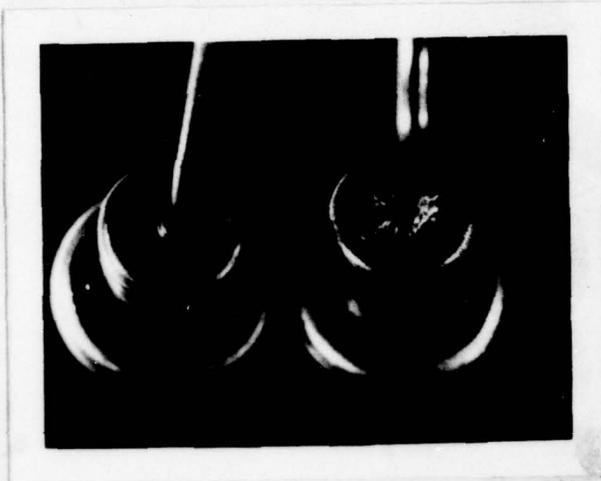
Photo 1 - MAG10X

The Kaupp switch is on the left. The Accudyne switch is on the right. Note the difference in weld appearance.

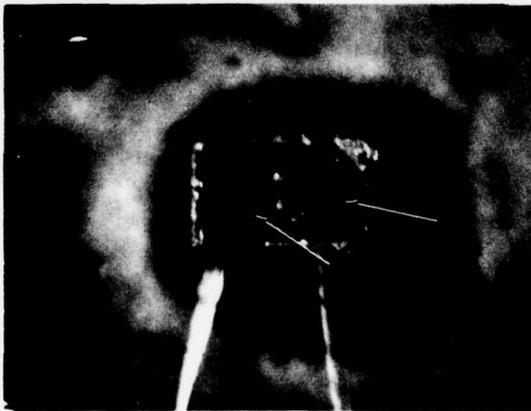
Photo 6 - Mag. 110X

Overall view of the
Q3 die on oscillator
SN 1283. Note the
contaminated bonds.

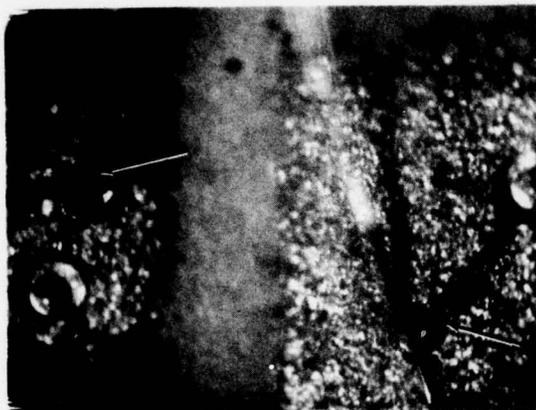
Photo 7 - Mag. 110X

The stitch and safety
bonds on the Q3 emitter
and base leads. Note
the discoloration.

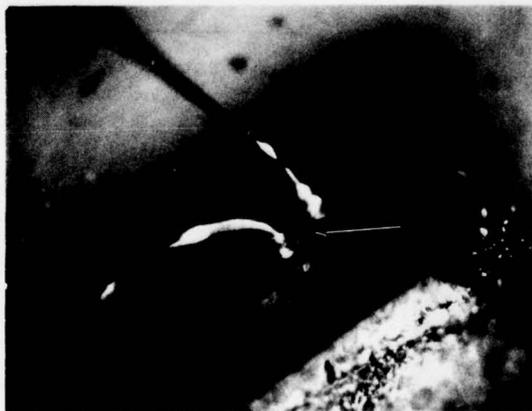
Photo 8 - Mag. 80X

The transistor Q4
emitter bond is lifted
on oscillator SN 680.

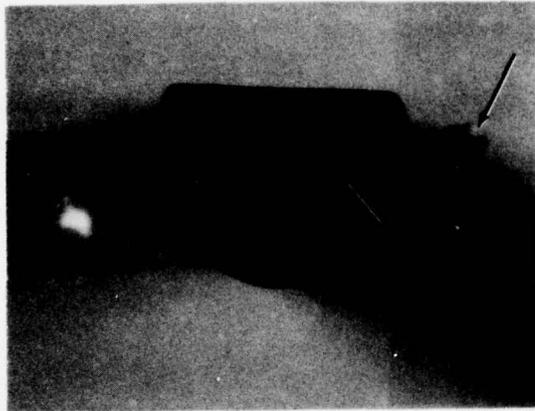
Photo 11 - Mag. 10X

External view of the bottom of transistor 2N6010. Note the crack in the epoxy encasement near the emitter lead. The top arrow identifies the emitter lead.

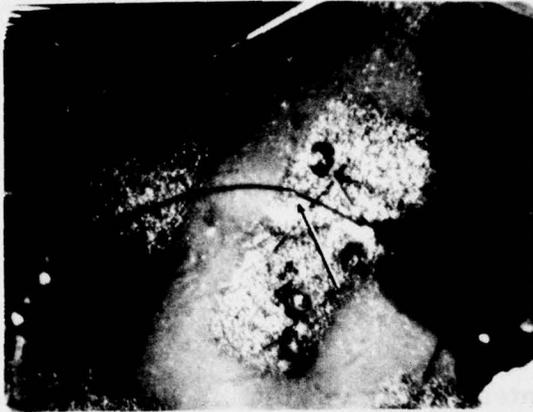
Figure 3 - Mar. 302

Transistor Q1 emitter
lead broken.
