Report No. CG-M-4-78

INFLATABLE LIFERAFT TESTS IN THE PACIFIC OCEAN
OFF THE COLUMBIA RIVER BAR

May 3, 1978

**DEPARTMENT OF TRANSPORTATION
UNITED STATES COAST GUARD**

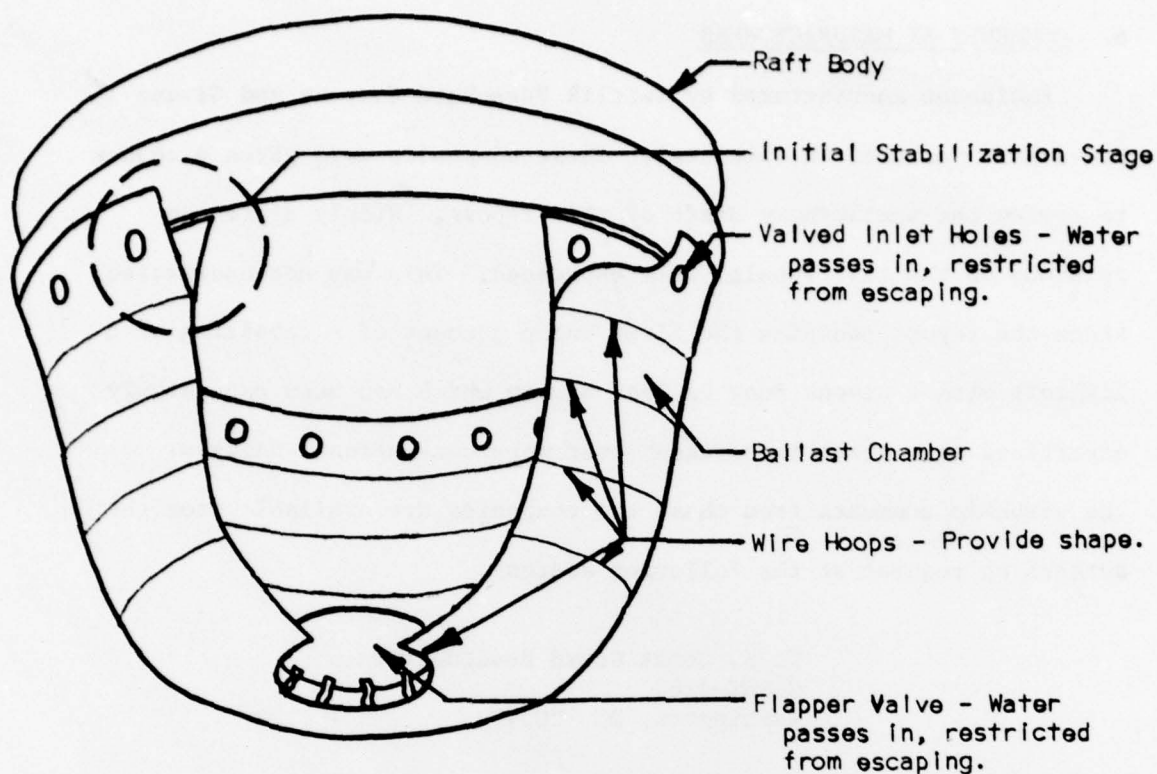
FIGURE 1. Given's Buoy System on Rafts S-G and G-G (Simplified cutaway view of raft bottom: canopy and certain design details not shown).

An incorrect version of Figure 1 appeared in an early printing of this report which is marked "ADVANCE PRINT" on its cover. The incorrect figure showed baffles in the ballast bag of the raft. The raft actually did not have such baffles. Figure 1 is correct as it appears in this report.

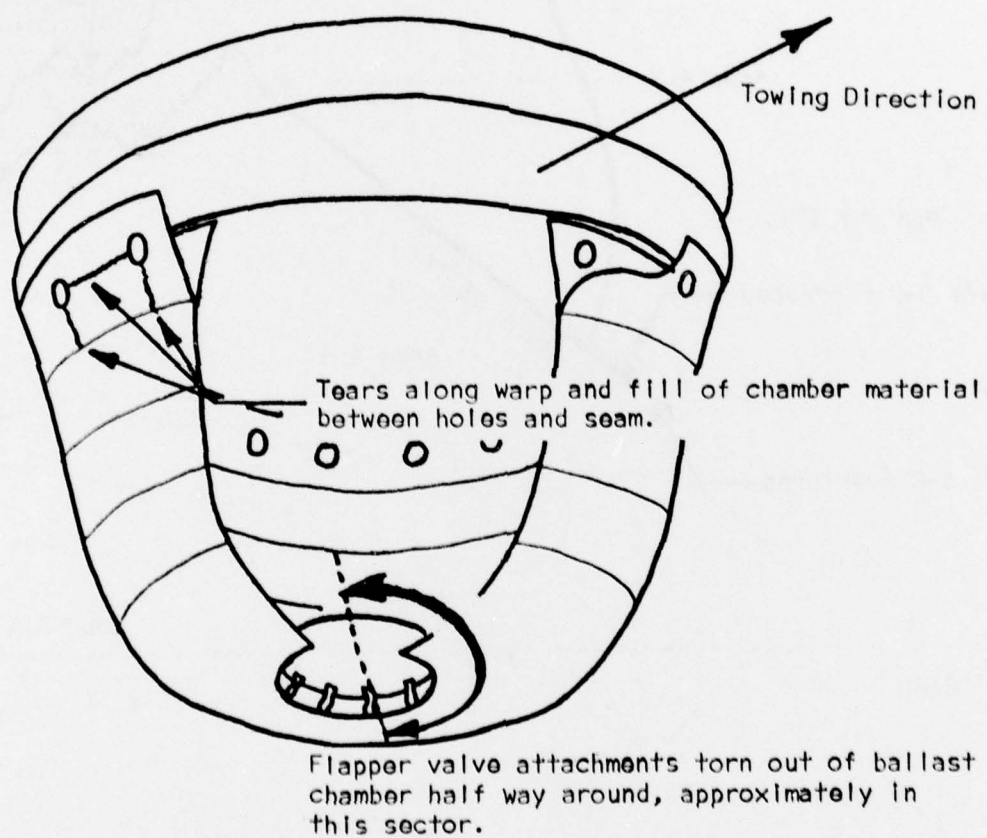
FIGURE 4. Damage to Raft S-G.

Several hours later, Raft S-G washed onto the north side of the North Jetty where it was recovered by land (see Figure 3). By the time it had reached the jetty, it had righted in the surf and the occupant area was filled with water and one or two small logs. No one saw the raft reright. The raft had been caught for some time in an eddy just north of the jetty with a large amount of floating debris including logs 8 to 12 inches in diameter and several sea otters and sea lions. When the raft was recovered, it was discovered that several of the attachments of the flapper valve had broken, indicating that movement of the raft and the resulting pressure on the ballast chamber had broken them. There were also tears radiating from two holes for filling the initial ballast stage. These tears were located about 90° around the raft from the towing point. One of the tears was horizontal, parallel to the waterline and connected the two holes. The other tears extended downward from the same two holes

and stopped at a seam. This damage is illustrated in Figure 4. Other than this, the raft was in good shape. There was no noticeable loss of pressure in the tubes including the canopy support tubes which were upright and firm. The similarity of the damage to this raft and the damage that occurred to raft G-G as reported in Section 4.2 should be noted.

(d) The tearing of the initial ballast stage between filling holes would probably not have affected the stability of the raft significantly when the ballast chamber was full. This damage could have possibly been caused by the floating debris in the area where the raft was recovered, but the similarity of this damage to the damage sustained by Raft G-G indicates that the tears probably occurred earlier. It is noted that the holes could be high stress points when the body of the raft is twisted and the ballast chamber has not had a chance to move, such as would

occur when the slack is taken up on a towing line and the raft is not aligned in the direction of towing. Since rip-stop material was not used in construction of the ballast chamber, small rips could easily propagate into long ones.

(e) A different choice of materials and design detail could possibly prevent the kind of damage that occurred to the ballast chamber.
