REPORT NO. NADC-77328-60

6 GALVANIC CORROSION FATIGUE TESTING OF 7075-T6 ALUMINUM BONDED WITH GRAPHITE-EPOXY COMPOSITE

10 S. R. Brown and J. J. De Luccia  
Aircraft and Crew Systems Technology Directorate  
NAVAL AIR DEVELOPMENT CENTER  
Warminster, Pennsylvania 18974

11 10 JAN 1978

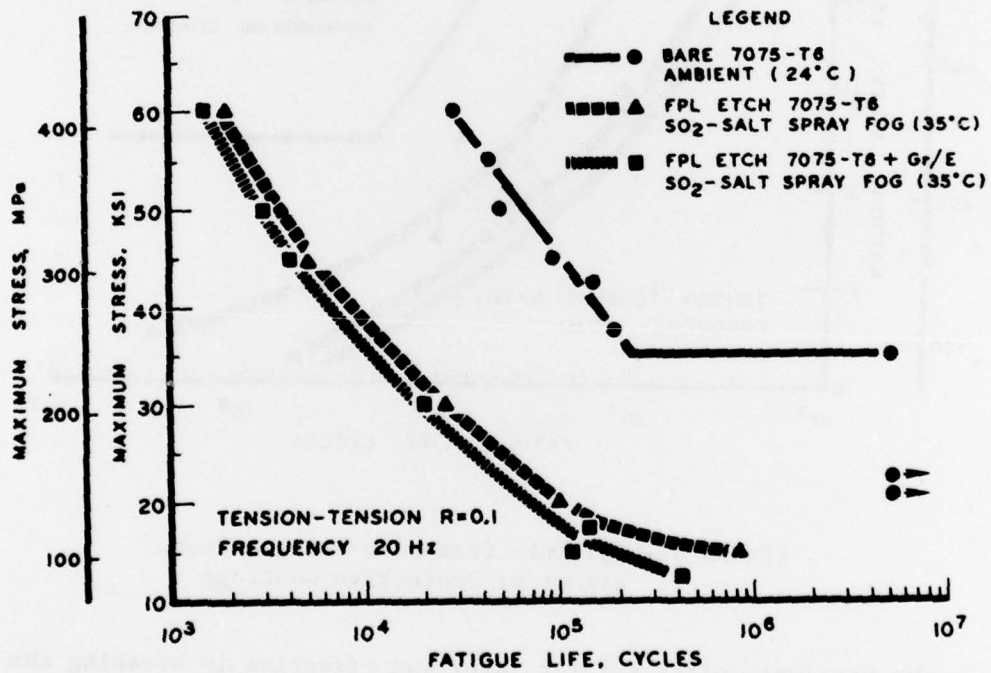
Figure 3 - Galvanic Corrosion Fatigue Tests Without Protective Coatings

Fatigue life of bare 7075-T6 was reduced from 150,000 cycles at the 40 ksi stress under ambient conditions to 8,400 cycles (FPL etched) under the same stress when exposed to sulfur dioxide-salt spray as given in Table I. A further reduction to 6,400 cycles was experienced with bonded graphite-epoxy tabs due to the galvanic coupling effect. This is shown in Figure 3.

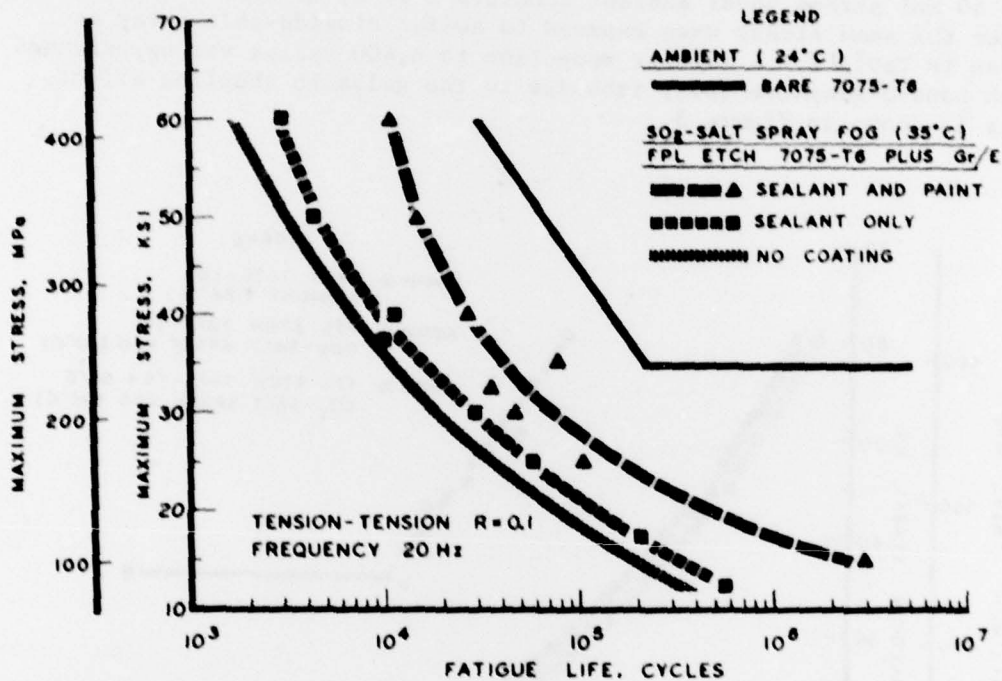
Figure 4 - Galvanic Corrosion-Fatigue Tests  
Effect of Protective Coatings

A degree of baseline fatigue life (bare 7075-T6 at ambient conditions) was recovered by applying protective coatings of polysulfide sealant to the coupled edges and overcoating with inhibited epoxy primer-polyurethane topcoat. This protective scheme provided an additional 20,000 cycles of fatigue life at 40 ksi over the uncoated condition as shown by the "sealant and paint" curve in Figure 4.

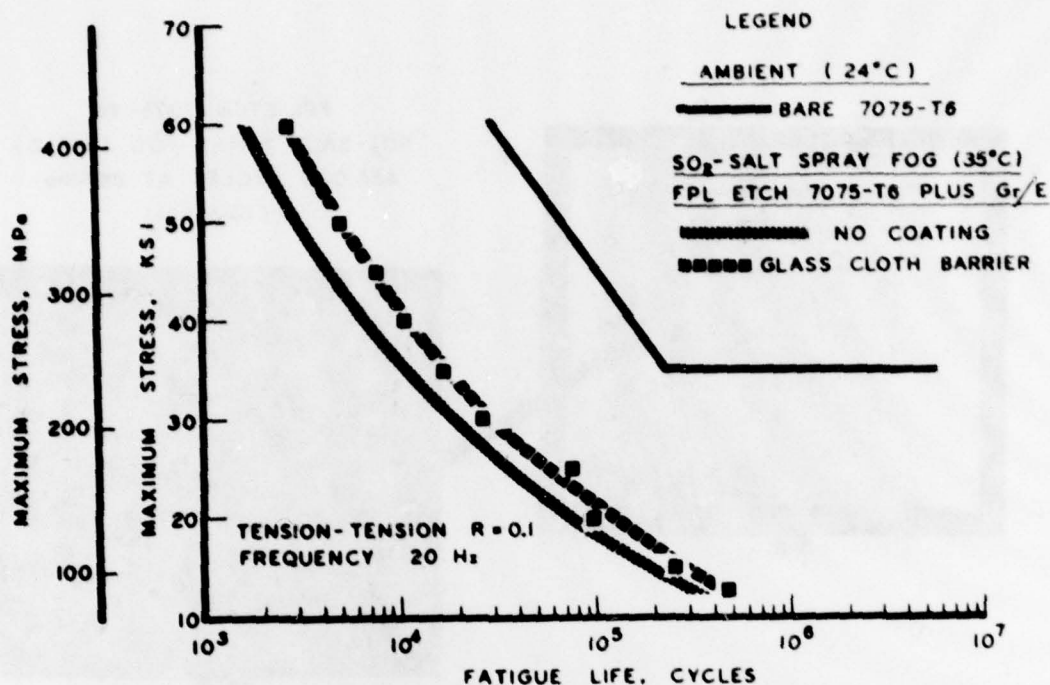
Figure 5 - Galvanic Corrosion Fatigue Tests with Glass Cloth Barrier

The Scotchply glass barrier layer was effective in breaking the galvanic couple between the graphite-epoxy tabs and aluminum fatigue specimens. Resistance across regular adhesively bonded graphite-epoxy to aluminum was measured as 60-100 ohms. With the glass barrier cloth acting as an insulator, resistance was 100 megaohms, a 10<sup>6</sup> - fold increase. The S-N curve for specimens with the glass cloth barrier bonded between the graphite-epoxy and aluminum, exposed to the corrosive environment, is shown in Figure 5.

It should be noted that the glass cloth restored fatigue life to the aluminum to the same extent as the use of sealants. In both cases, the galvanic circuit between the aluminum and the composite is eliminated.

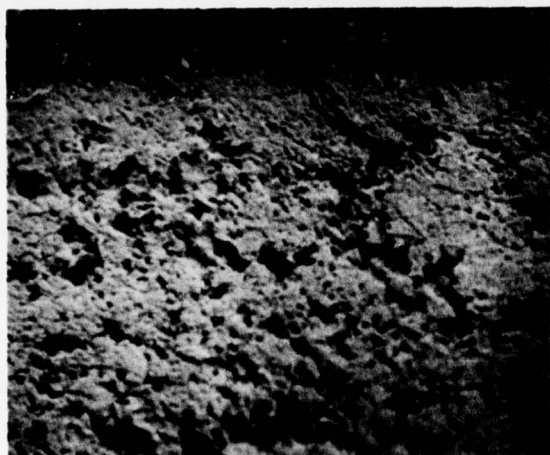
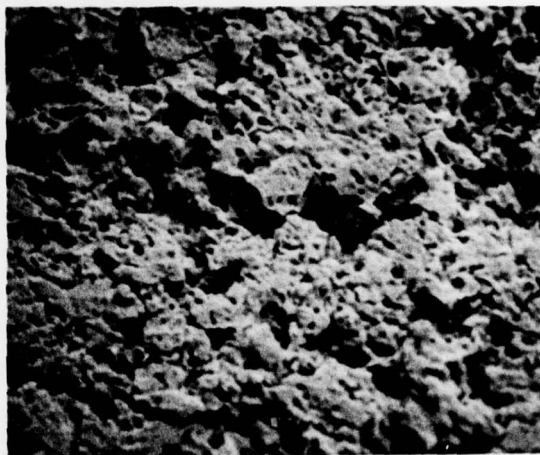
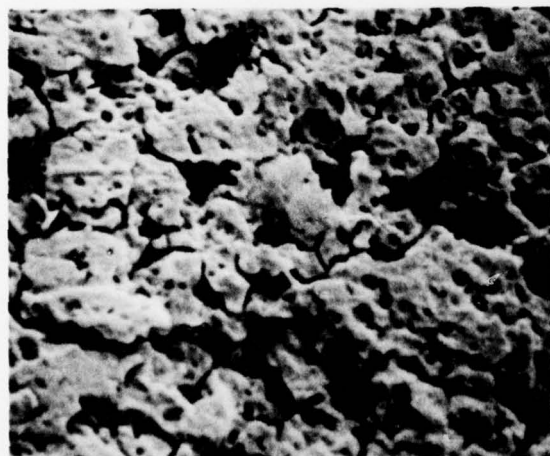
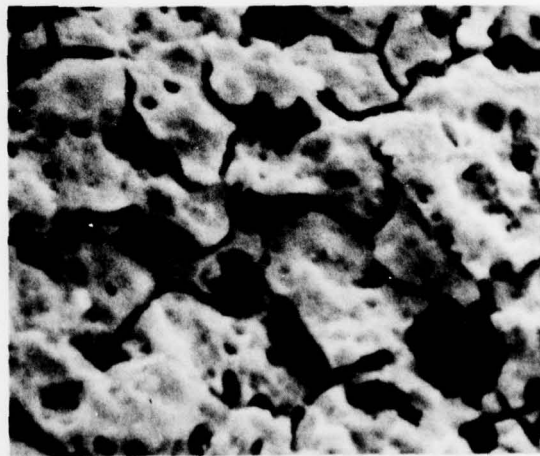
Figure 7 - Scanning Electron Micrographs of FPL Etched 7075-T6 Surface Near Graphite-Epoxy Composite, Specimen Exposed to  $\text{SO}_2$  - Salt Spray and Fatigued at 86MPa for 465,000 Cycles

Figure 7 is a SEM study of a corroded aluminum surface area from Figure 6. Intergranular corrosion is quite evident in the magnified views and was accelerated by the proximity of the graphite-epoxy to the aluminum.

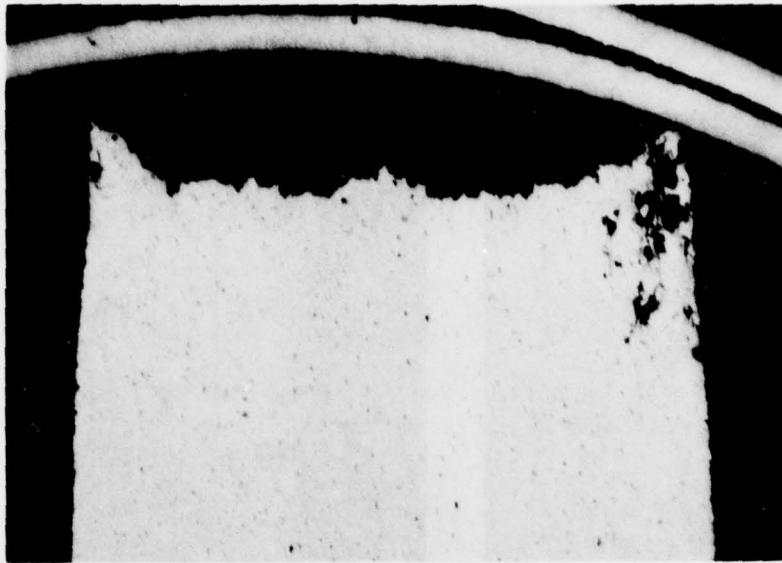
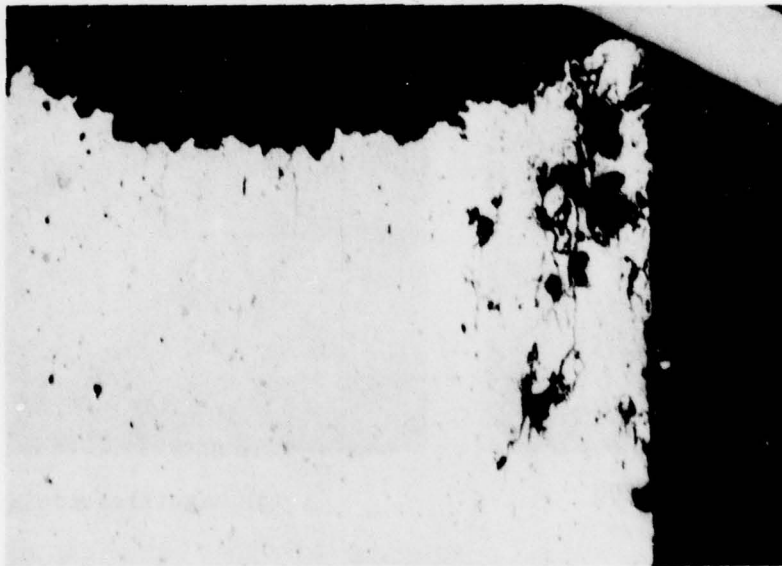
Figure 8 - Cross Section of 7075-T6 Fatigue Failure After Tension-Tension Fatigue Corrosion Test. Fatigued at 86 MPa for 465,000 Cycles.

The photomicrographs of Figure 8 are of the same specimens as shown in Figures 6 and 7, but were taken at the opposite end of the graphite-epoxy tab where the fatigue failure occurred. The cross-section was made across a deep pit that developed in the aluminum at the end of the graphite-epoxy tab. This pit, or a similar pit, served to initiate fatigue failure of their specimen. Mount supports shown in the upper portions of the Figure 8 (a) and (b) are not part of the specimen.

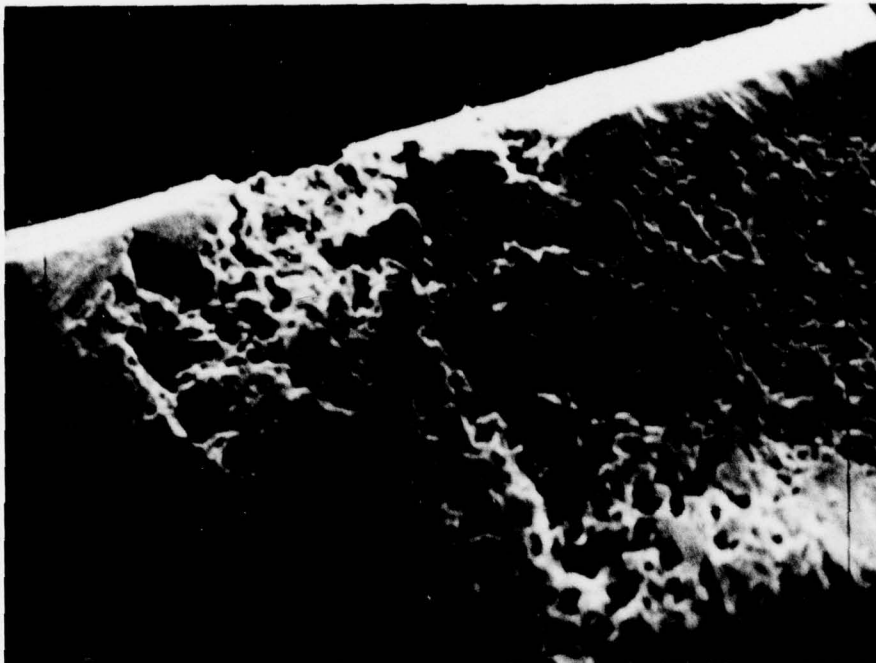
Figure 9 - Scanning Electron Micrograph of Pitting Corrosion in 7075-T6 Aluminum at Graphite-Epoxy/Aluminum Interface (Original Magnification - 100X)

Fatigue failures originated from pitting sites at graphite-epoxy and aluminum intersections. Figure 9 shows an isometric view of an aluminum specimen in the vicinity where the graphite-epoxy tab was attached. Note the severe pitting of the aluminum. These pits act to concentrate stress and initiate fatigue cracking.

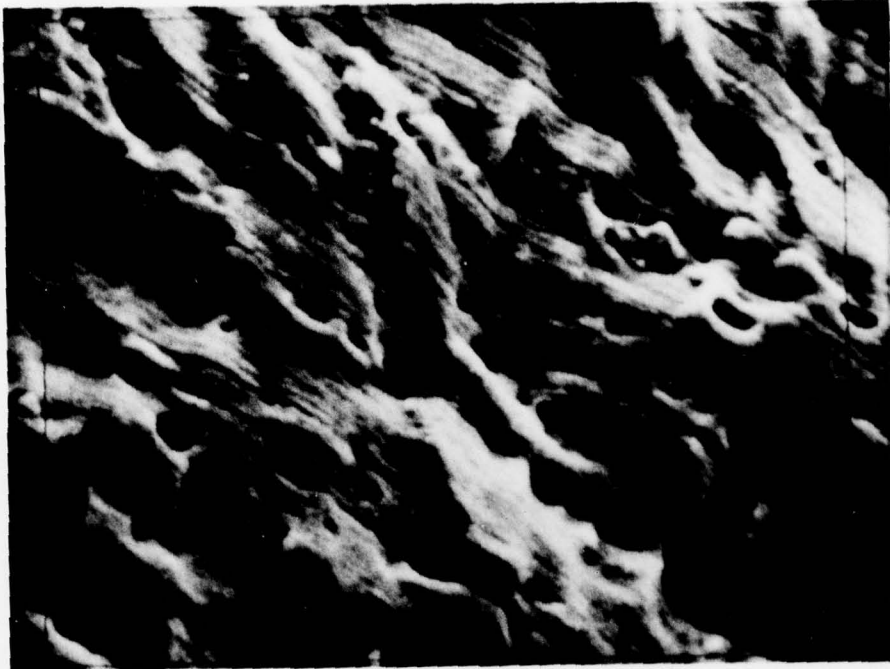
Figure 10 - Scanning Electron Micrograph of Galvanic Corrosion  
Fatigue Fracture Surface (Original Magnification 500X)

An examination of a fracture surface (Figure 10) reveals fatigue striations as well as pits (circular dark areas) after failure in the sulfur dioxide-salt spray test environment.
