USARTL-TR-78-11

**ENGINE/AIRFRAME/DRIVE TRAIN DYNAMIC INTERFACE
DOCUMENTATION**

Boeing Vertol Company
P.O. Box 16858
Philadelphia, Pa. 19142

April 1978

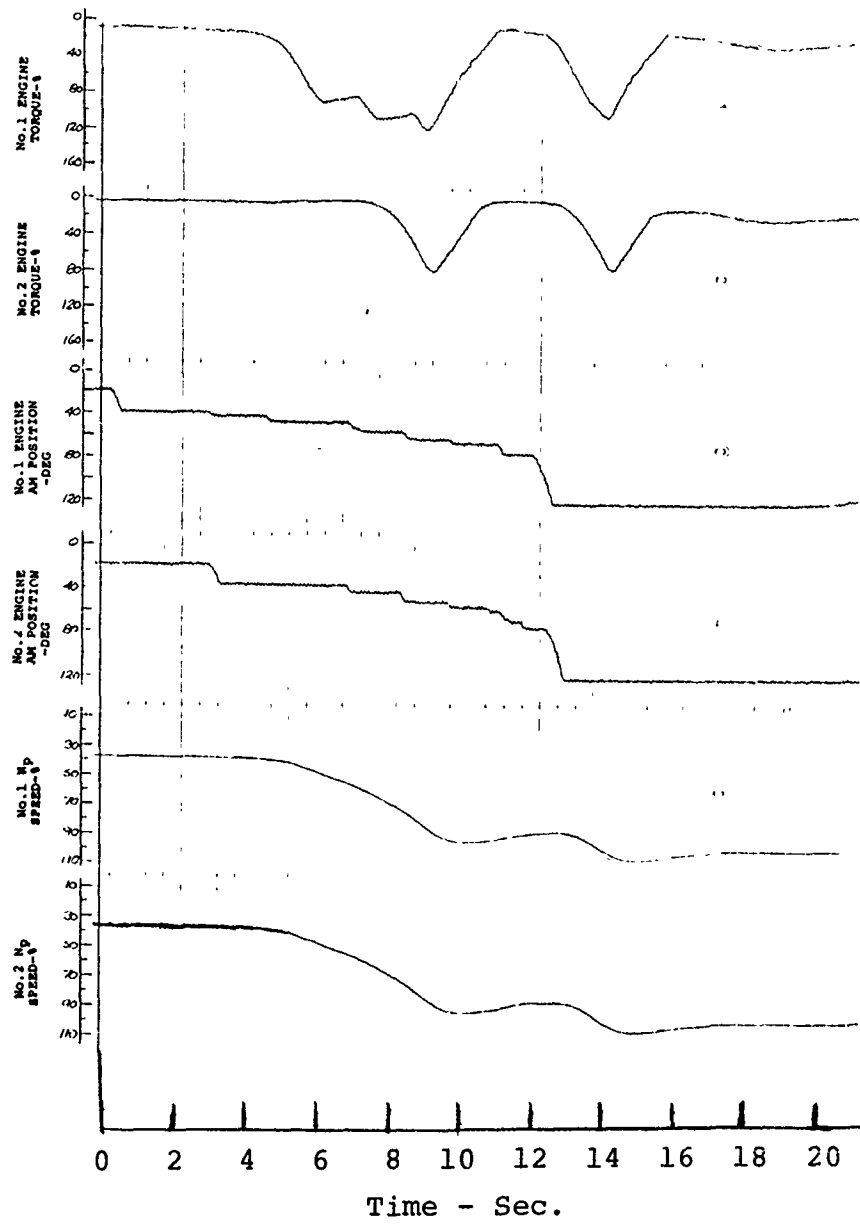
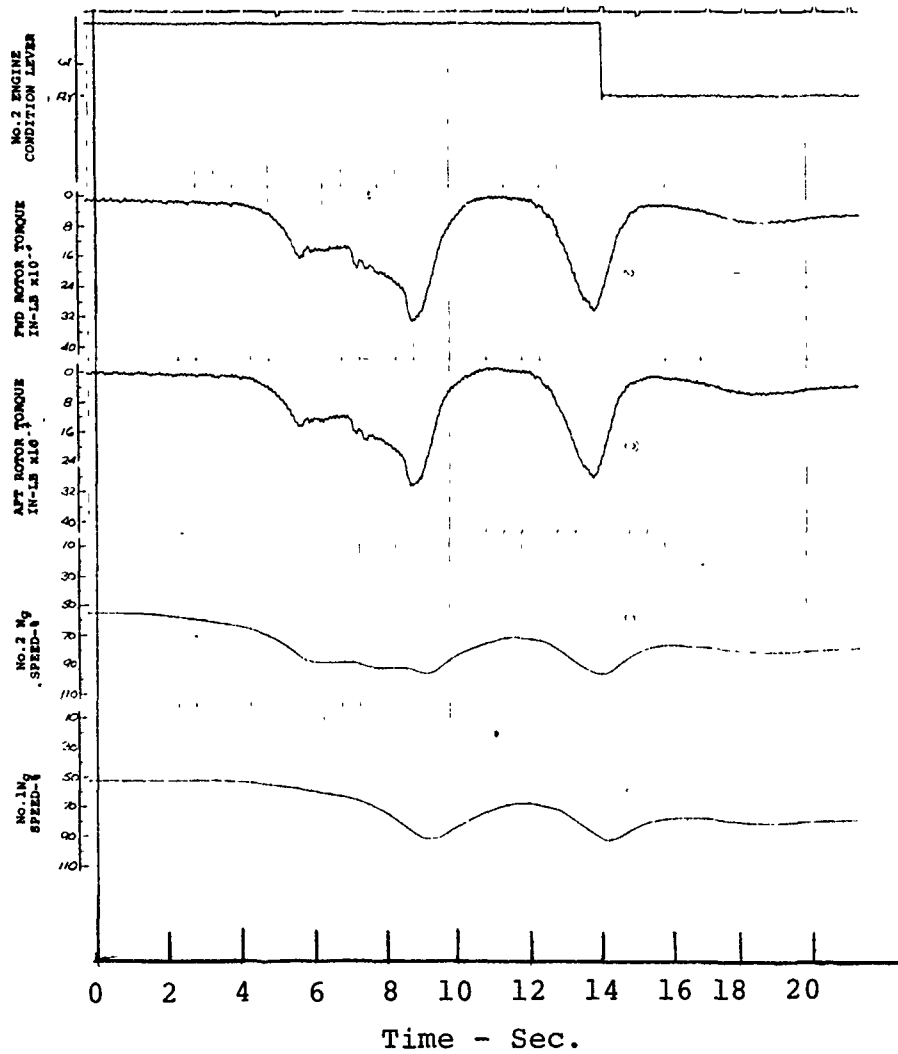
Figure 26. Rotor Startup.

A startup transient during which the condition lever is advanced from ground idle (GI) to FLY in about 15 seconds is described on Figure 26. The AM position was stepped from 16° to 34° because of a nonlinearity within the quadrant, rendering low power modulation ineffective. The engine acceleration characteristic provides very little torque for about 4 seconds following a condition lever advance, as shown in the same figure. This typical lack of response off GI indicates there is no need for modulation between GI and minimum speed governing power, since during the 4-second deadzone the condition levers would have most likely been advanced through the 16° to 34° range.

When the minimum power turbine governing speed (about 85%) is reached, the engines cut back in power. This creates an undesirable second deadband with no engine response to condition lever inputs prior to the increase in speed request from 72° to 120° AM position.

A revision to the aircraft quadrant schedule could provide results similar to those noted above. Bending the straight line schedule of AM position with condition lever travel to allow greater AM movement prior to attaining governed speed will decrease the second deadband.

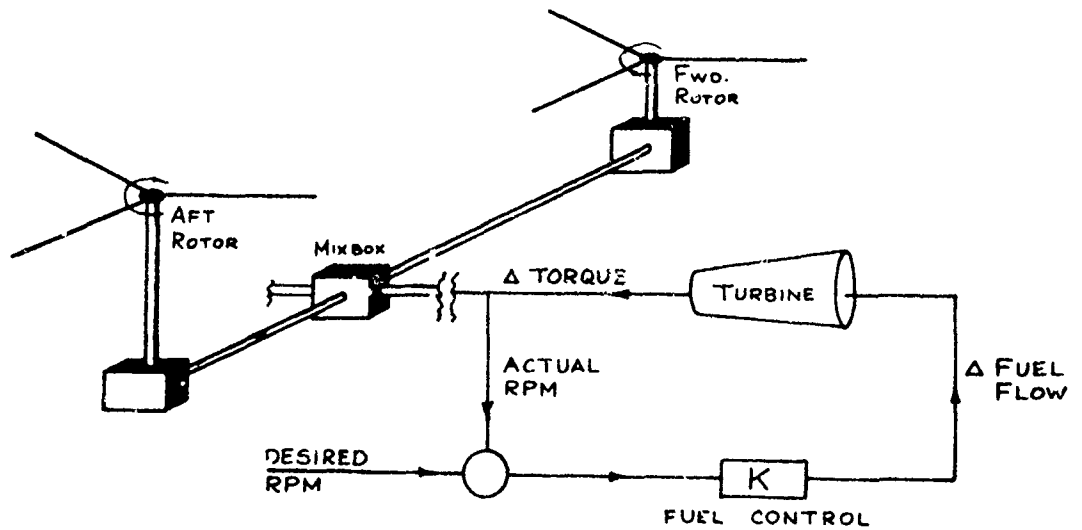
Figure 29. Drive System/Fuel Control/Engine Schematic.

Starting in 1969, when CH-47 C-model helicopters (with T55-L-7C engines) were converted to the full "C" model by incorporating T55-L-11 engines, variations in engine and rotor shaft torque were observed. These torque oscillations, at a frequency of 4.1 cycles per second (dual engine) and 4.7 cps (single engine), were audible and disconcerting to the pilot and crew. The significant differences between the -7C and -11 engines were a 50% increase in inertia and a new fuel control configuration. Figure 29 shows a schematic of the drive/fuel control/engine arrangement.

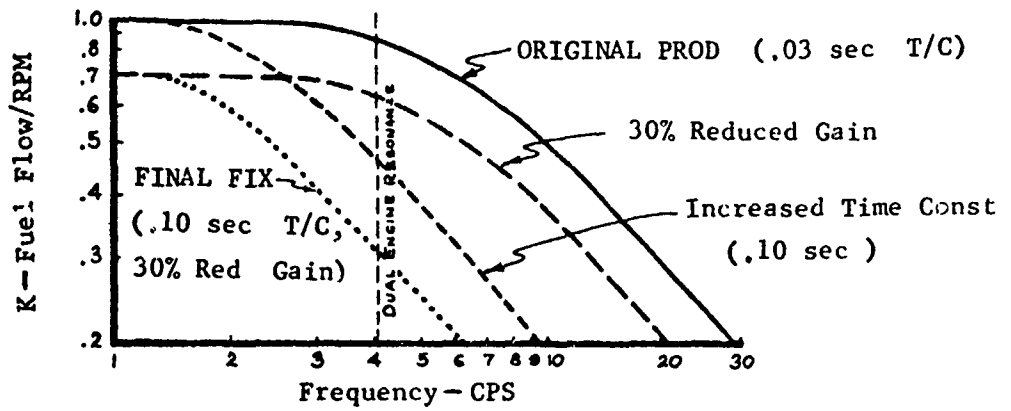
Figure 31. Fuel Control Frequency Response.

One way to improve attenuation would be to simply reduce the change in fuel flow per unit change in N_2 at all frequencies. As shown in Figure 31, this amounts to a frequency response curve parallel to the curve of the original fuel control. Assuming a steady-state gain of unity for the original control, a 30% reduced gain control would have a steady-state gain of around .7; hence, for most normal maneuvers, engine response is slightly degraded. Changing fuel control gain has an effect on the engine droop rates, as shown in Figure 32. Engine droop is defined as the reduction in power turbine speed accompanying an increase in engine power. Steady-state droop is defined as the percent reduction in N_2 as power is increased from zero to maximum power. Original production fuel controls yielded a steady-state droop of approximately 7.5%. Reducing the fuel control gain by 30% has the effect of increasing steady-state droop to approximately 10%.

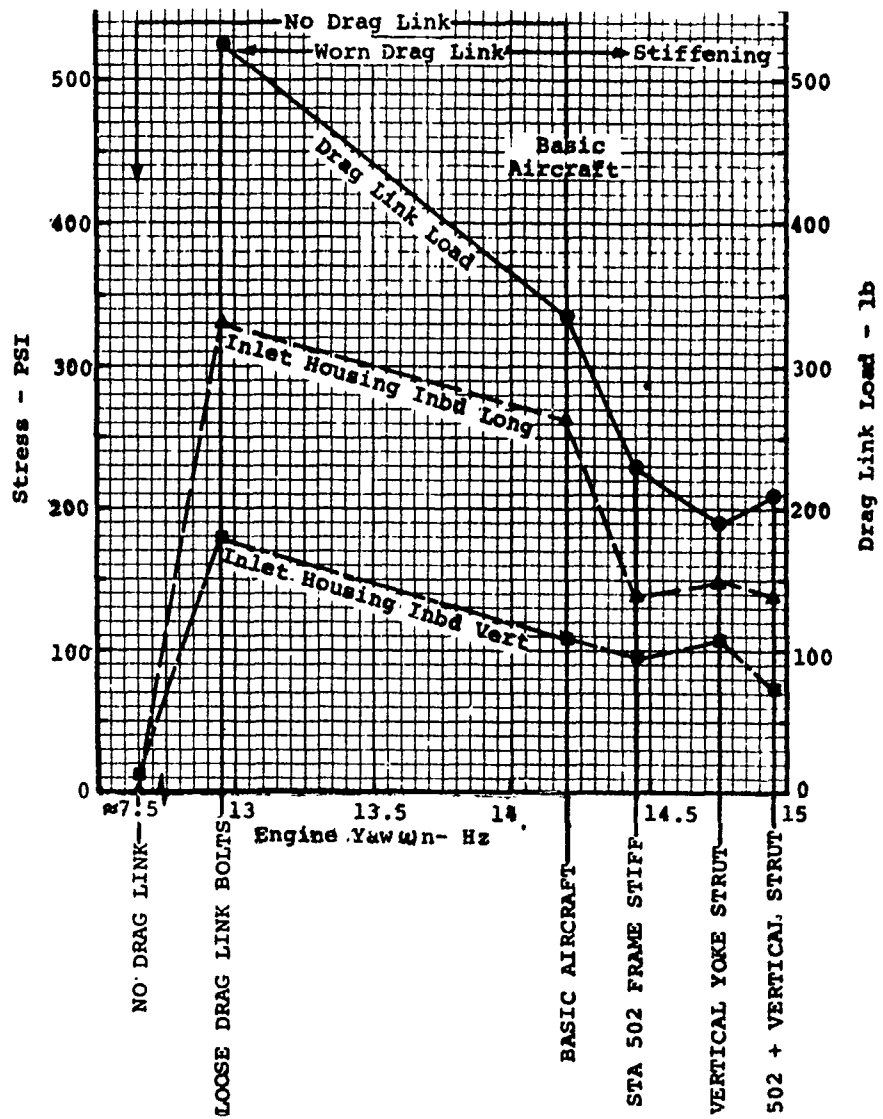
Figure 41. Configuration Effect on Yaw Frequency.

Graphic presentation of the engine yaw mode frequencies, inlet housing strains and drag link loads shows the basic levels, the increase in loads with loose parts, the moderate reduction in strains with engine mount stiffening, and the dramatic reduction in levels with the removal of the drag link (Figure 41).
