CONCRETE AND ROCK TESTS  
REHABILITATION WORK, BRANDON ROAD  
DAM, ILLINOIS WATERWAY  
CHICAGO DISTRICT

Richard L. Stowe

May 1978

Final Report

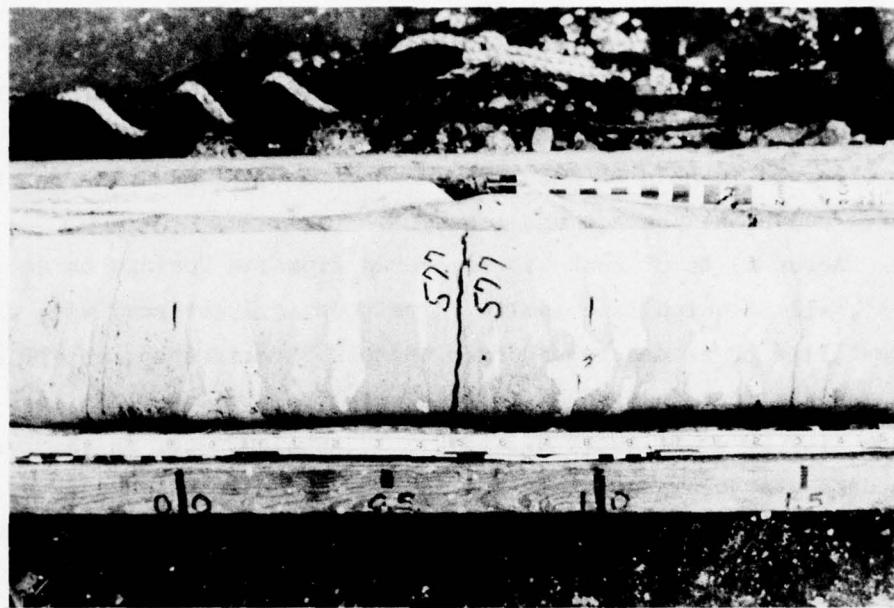
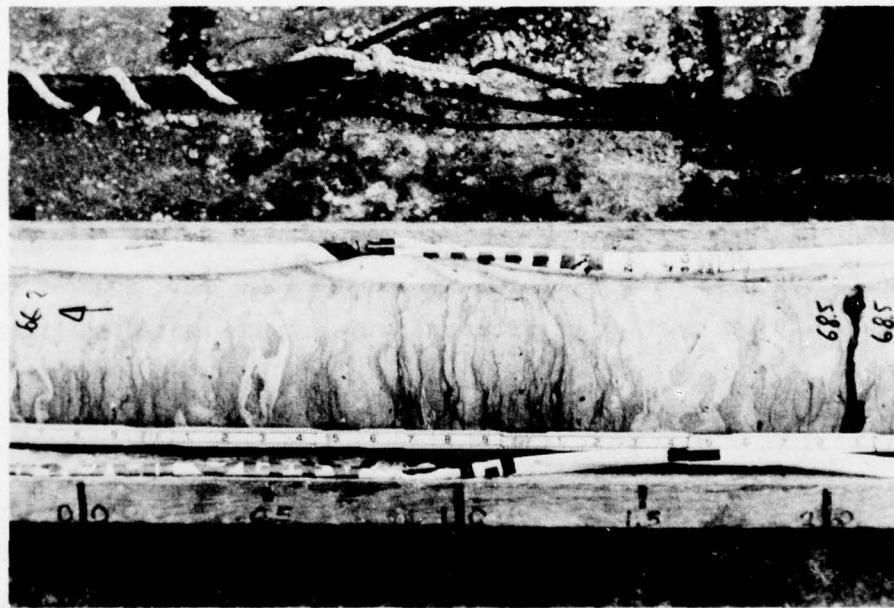
Figure 5. Typical bedrock samples

30. The bedrock is considered competent and massive. No appreciable dip could be measured on the bedding surfaces, therefore bedding is assumed to be horizontal over the foundation. The bedding surfaces are irregular with a nominal 1-in. differential between the peaks and valleys both of which are generally rounded (Figure 5).

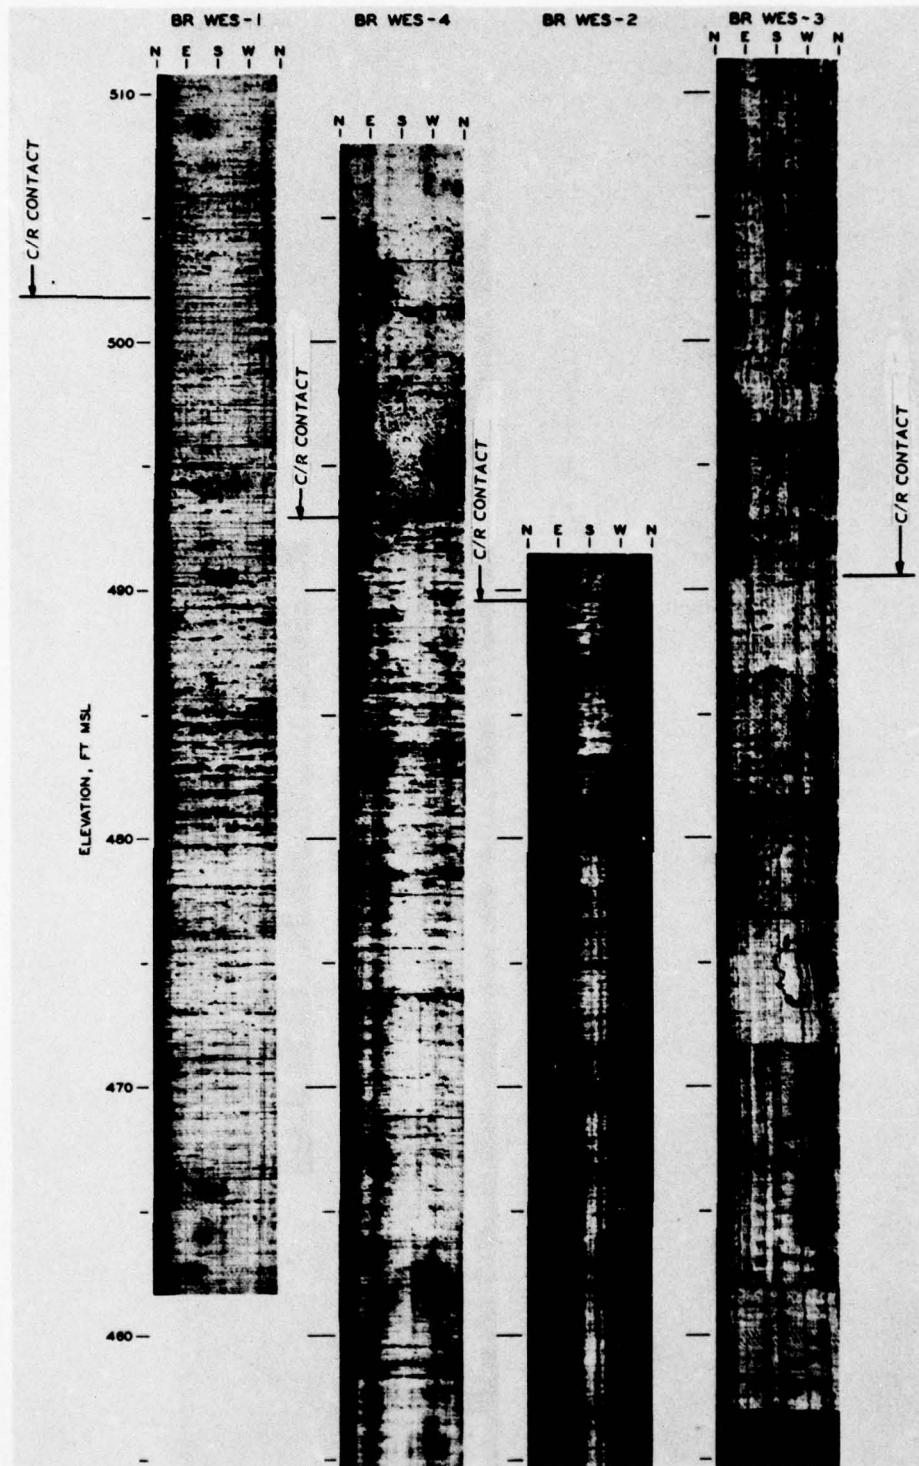
Figure 6. Televiewer logs, section A'-A'

52. Prior to analysis of the televiwer logs, core logs and core photos were consulted with the result that very little geologic structure was indicated in the subsurface to the depths explored in this investigation. The geologic structure considered important for purposes of stability analysis includes joints or bedding planes dipping greater than 10 degrees. Only 15 fractures in rock, most of which were short discontinuous fractures, were described in the core logs of the five borings. Of those 15, only 4 were sufficiently continuous and distinct in the core to be considered joints. These four were also discernible on the televiwer logs and are tabulated below.

<u>Drill Hole No.</u>	<u>El, ft</u>	<u>Strike and Dip</u>
BR WES-1-76	491.0 to 488.8	N 50° E, 75° NW
BR WES-3-76	476.1 to 473.3	N 45° W, Vert.
BR WES-3-76	458.9 to 457.4	N 45° W, Vert.
BR WES-6-76	489.6 to 486.6	N 90° E, 78° S

53. The majority of the other features visible on the televue logs are probably horizontal bedding-related structures such as vugs, primarily solution cavities, zones of soft material such as clay and shale that washed out during drilling, and light and dark banding by clay and shale interbeds. The fractures occurring in the boreholes were too scattered to establish the existence of joint sets or set orientations. Deere's rock quality designation<sup>11</sup> (RQD) classifies rock as excellent if the RQD is between 90 and 100 percent. On this basis, the rock at Brandon Road would be rated excellent because all breaks in the core were classified as mechanical.

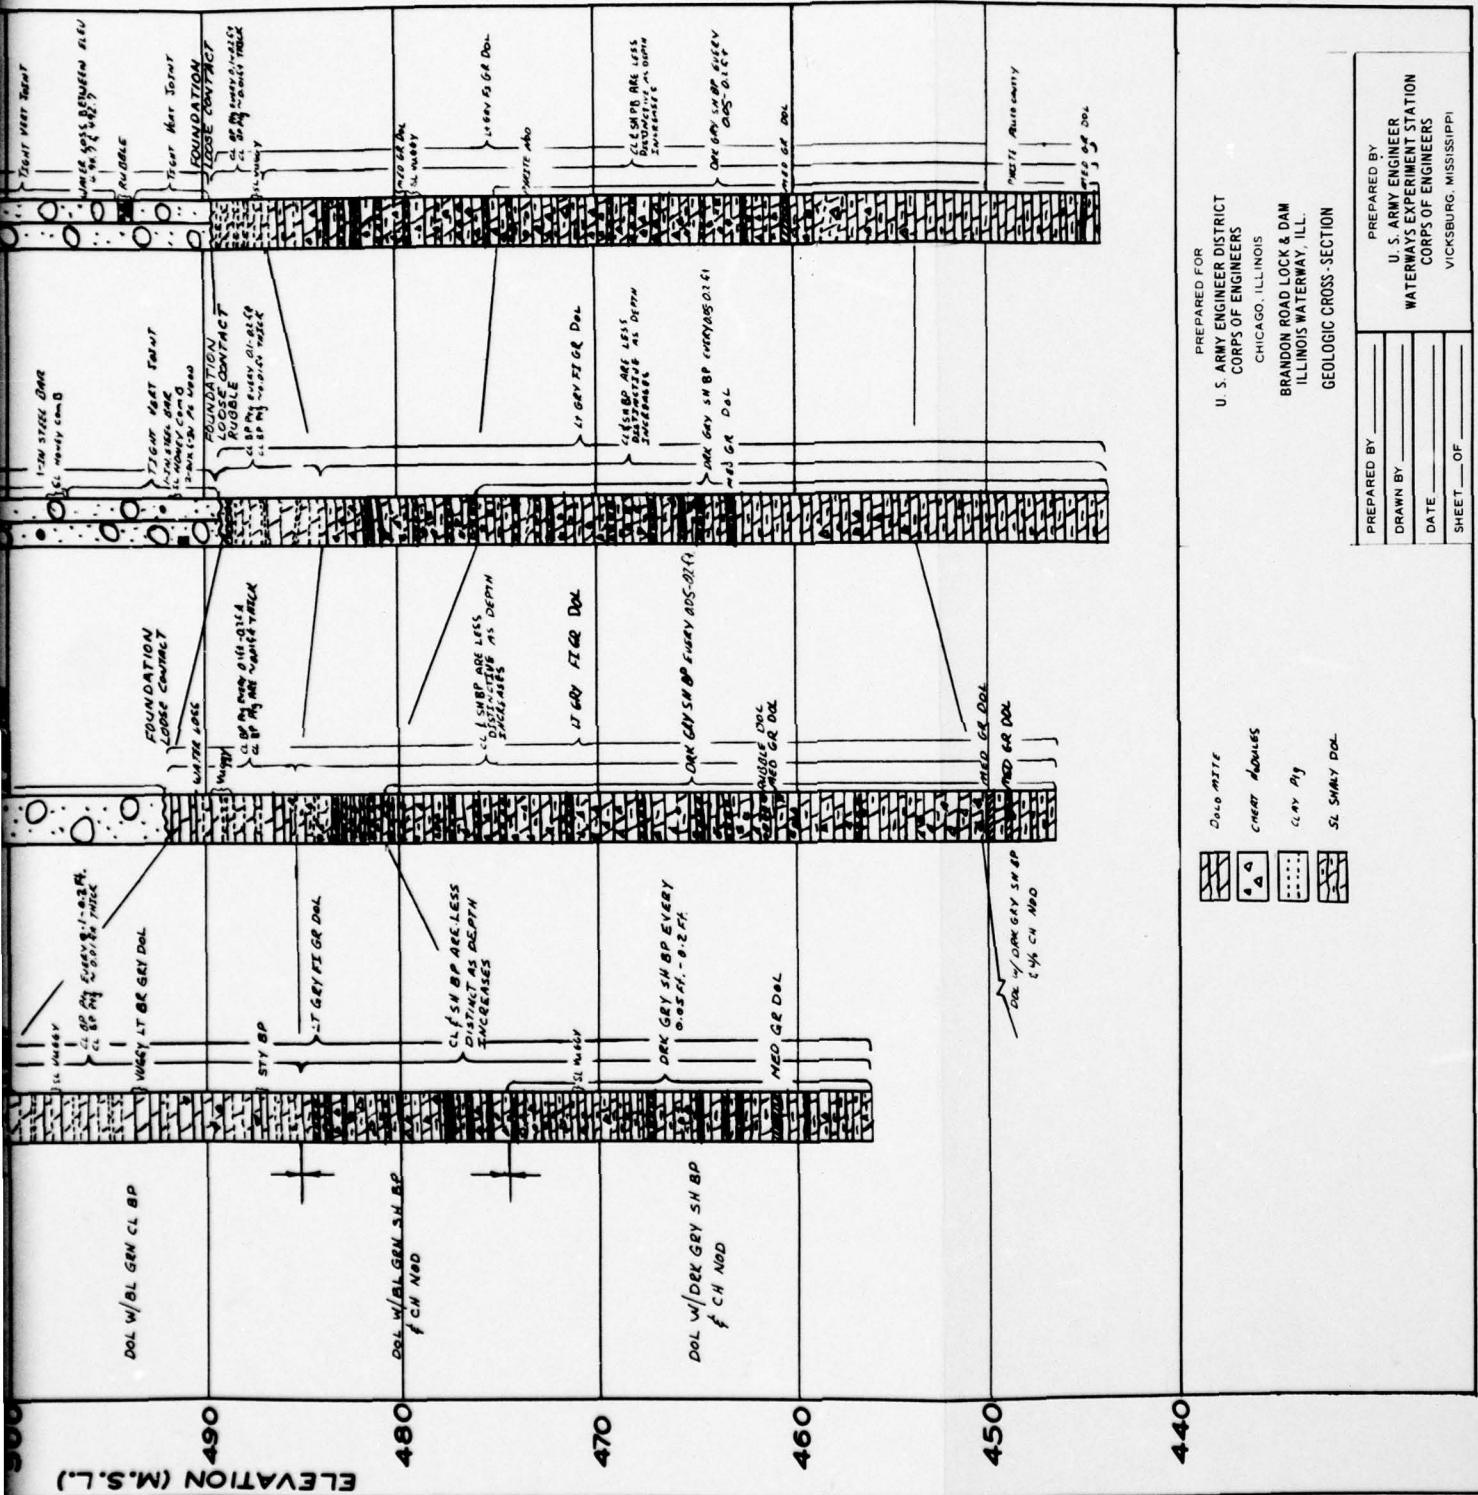
Geologic Cross-Section, Section A-A'

26. Section A'-A' shows the thickness of concrete and the depth of the bedrock recovered from each borehole. The concrete is considered to be in good condition having been adequately consolidated during placement. The top 4 ft of concrete in the tainter-gate piers section shows the results of frost action; however, compressive strengths within this zone are in excess of 3550 psi. Both tight and loose horizontal construction joints were encountered during drilling. Portions of borings BR WES 2- and

3-76 were drilled parallel to vertical pier construction joint; some portions were tight while others were loose. Both of these holes were drilled in tainter-gate piers. A tight contact between the concrete and the bedrock was observed in hole BR WES-1-76 (head-gate section) while in the other three holes the contact was loose.

56. Some alkali-silica gel reaction product was observed in the concrete. The occurrence of this reaction product was not believed to be extensive enough to affect the concrete. The description of the cores are given in the geologic cross section A'-A' (Plate 5).

57. The foundation material was essentially made up of one rock type with only a variation in color and some texture differences within each hole. Very little variation between the holes was noted. The near-surface rock contained soft blue-green clay. The clay was easily dug out from the BP and the BP could be separated with little or no effort. The extent of this feature and the color differentiation are noted in geologic cross sections A'-A' and B'-B' (Plates 5 and 6). The remaining rock contained shale with occasional clay-filled partings.

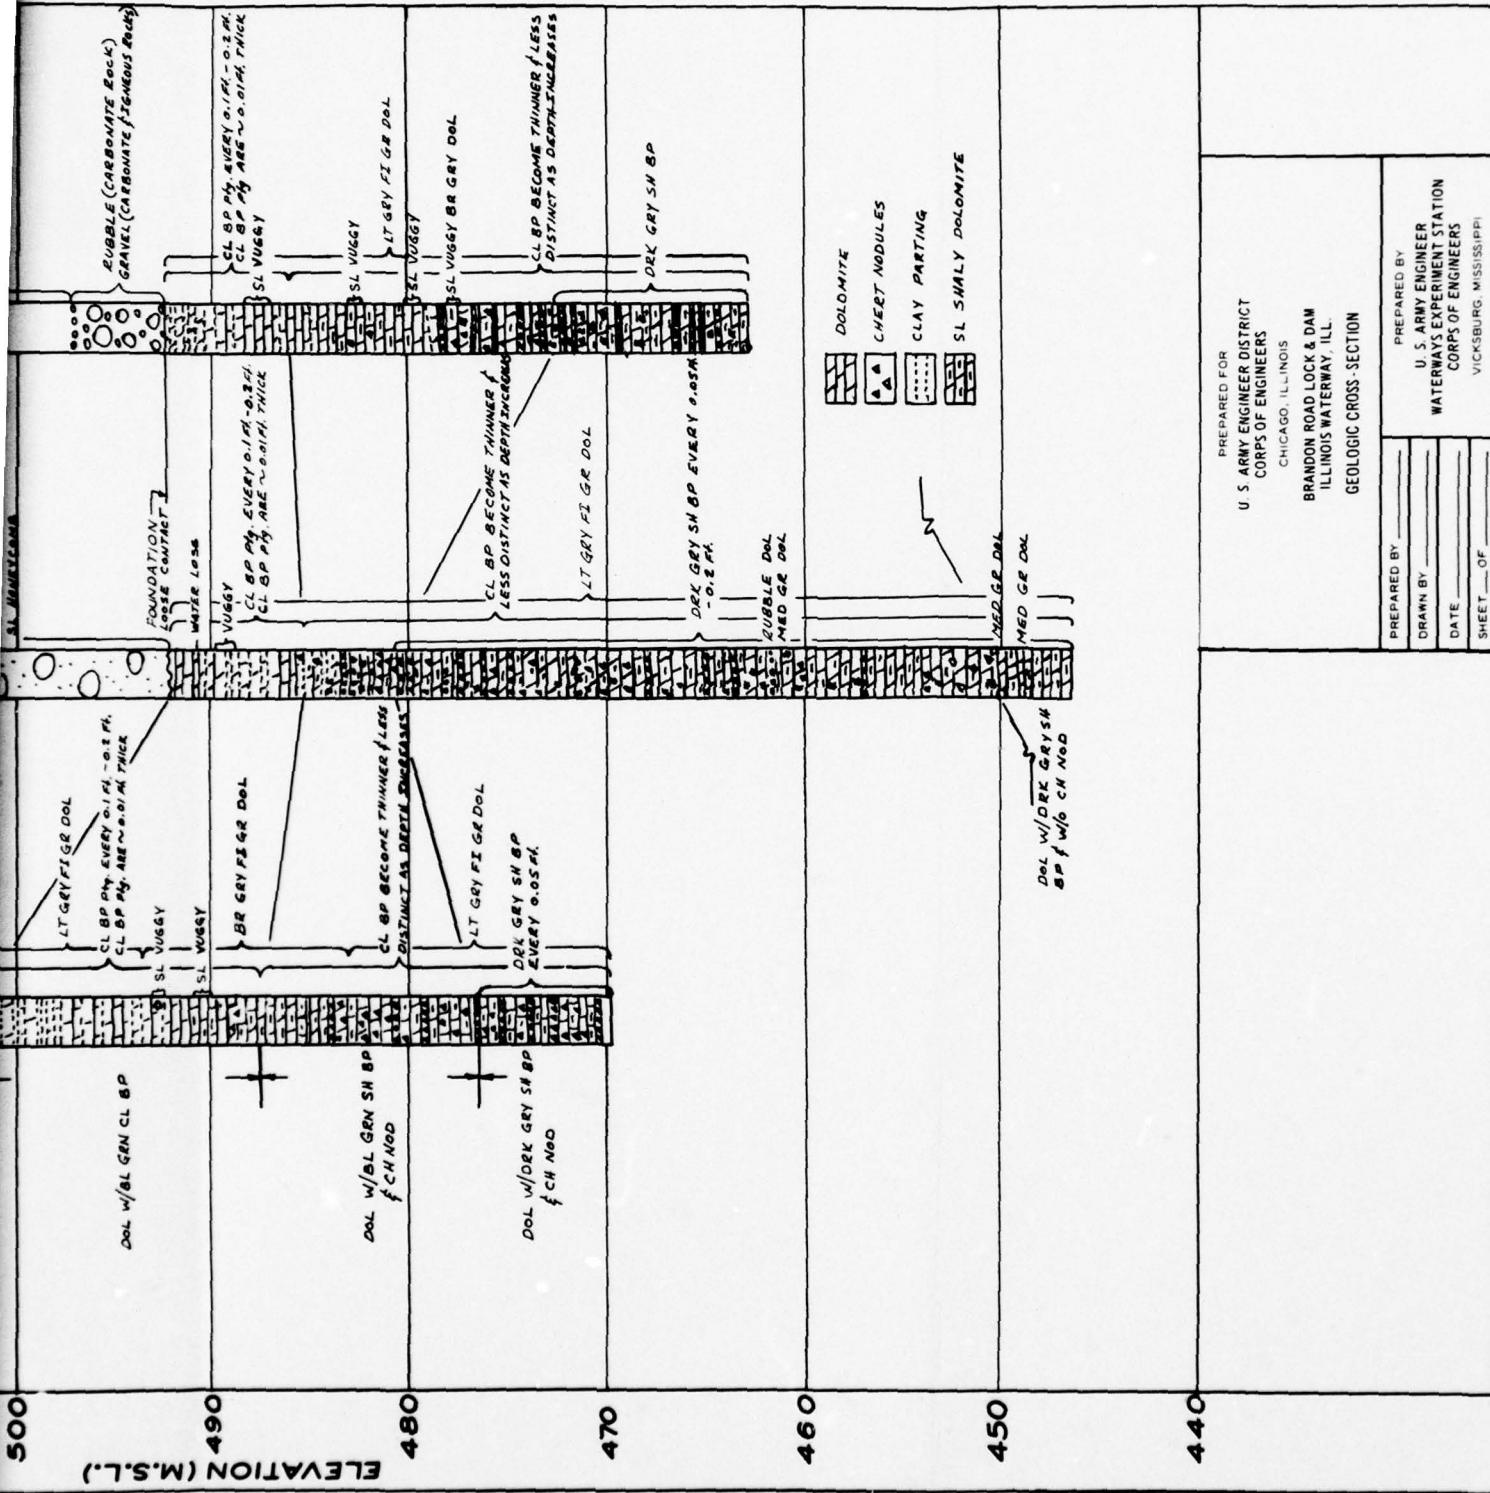
Geologic Cross-Section, Section B-B'

28. The bedrock in sections A'-A' and B'-B' has been subdivided into three units as seen in Plates 5 and 6. The subdivisions were made based upon the color and composition of the filled BP. The units are continuous across the dam foundation and consist of dolomite with the blue-green clay BP, dolomite with blue-green shale BP, and dolomite with dark gray shale BP. The overburden abutting the tainter gates of the dam consists of about 9 ft of organic silt with large amounts of fibrous organic matter and about 6.5 ft of gravel-to-boulder size rock; these depths apply to the area just behind the sluice-gate pier adjacent to tainter-gate 1. The section of silt and gravel is presented in Plate 6.

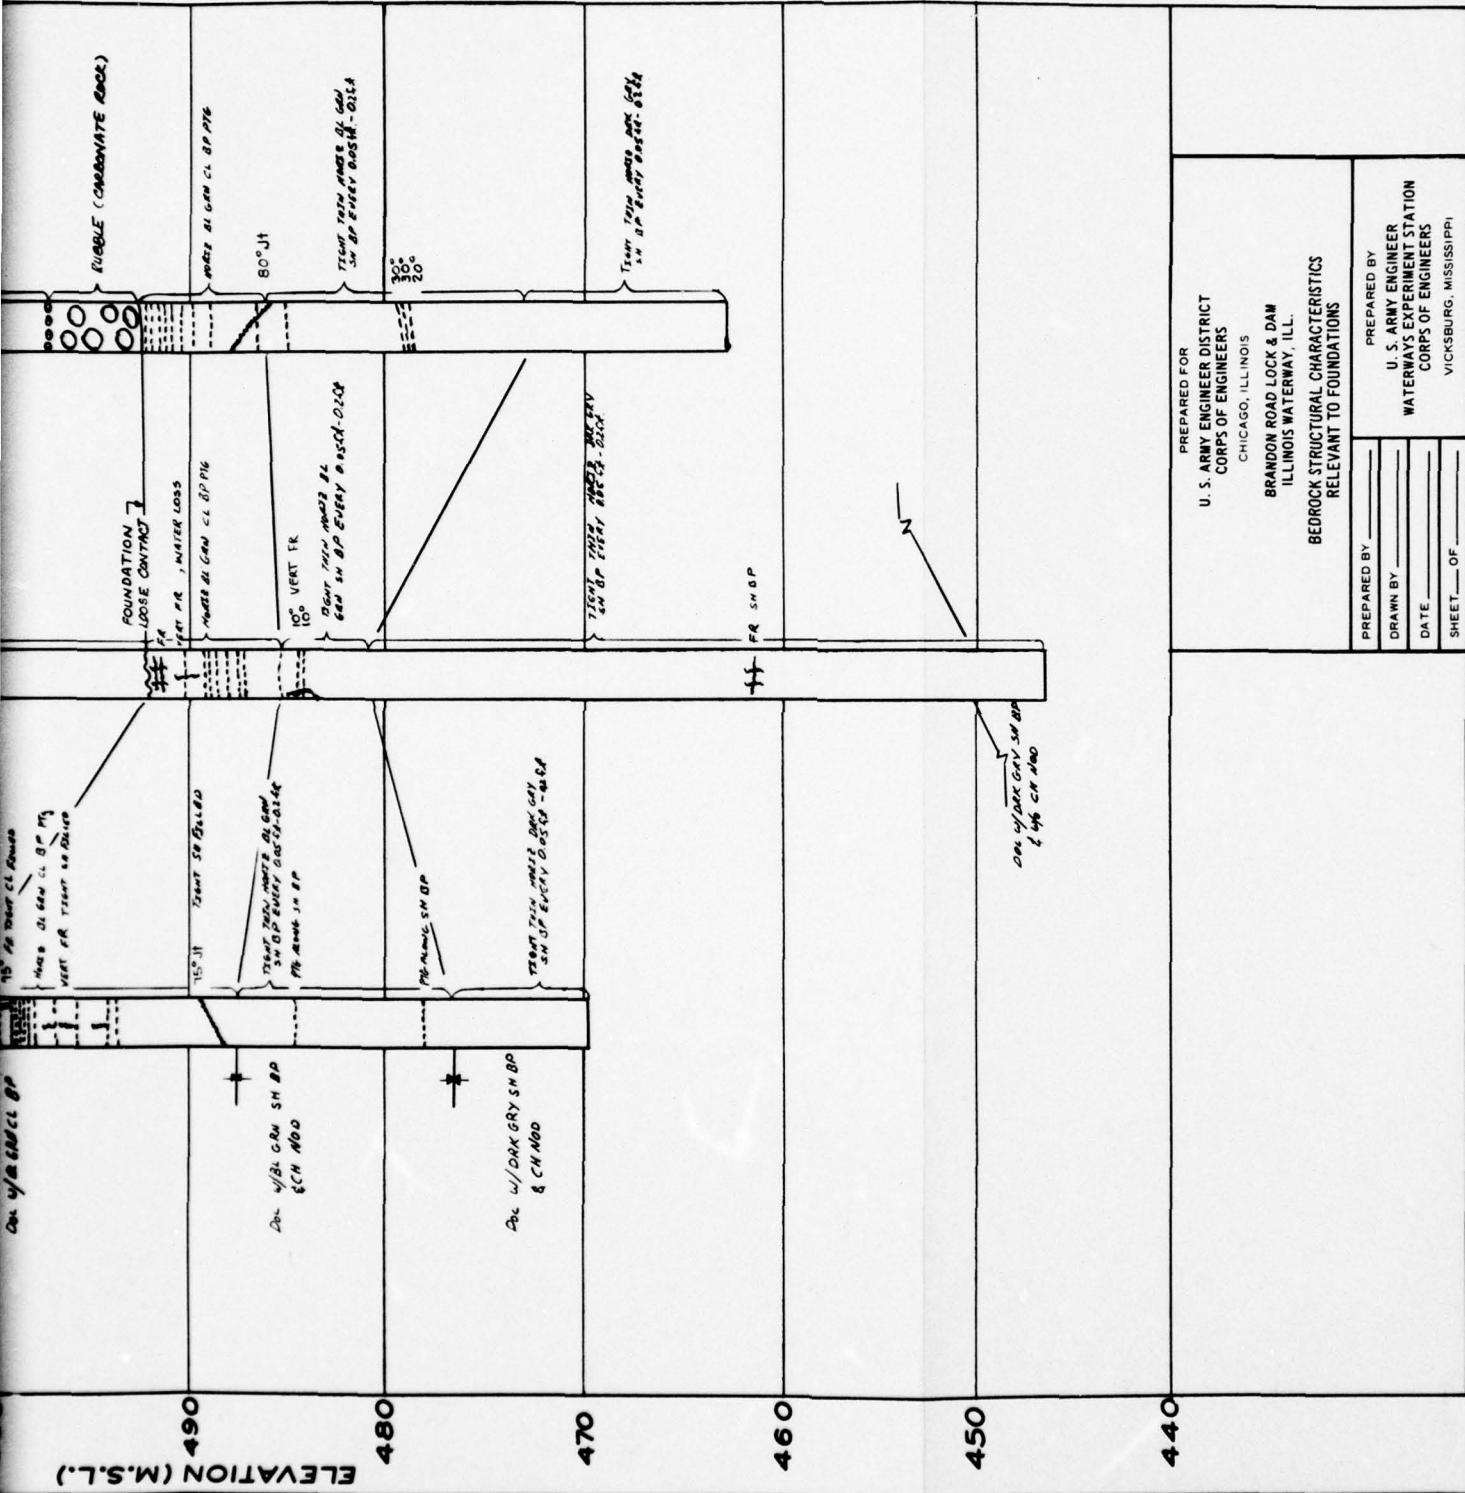
Bedrock Structural Characteristics, Section B'-B'

29. The bedrock structural characteristics relevant to foundations are presented in Plates 7 and 8 and represent the same sections (A'-A' and B'-B') as described in paragraphs 25-28. These sections and the core logs from borings BR WES-1-76 through BR WES-6-76 were used for fracture evaluation.

59. There were only a few structural features and they are shown in structural cross sections on Plates 5 and 6. The most notable feature was the high-angle fracture in holes BR WES-1, 3, 5 and 6-76 at elevations 490 ft, 475 ft, 488 ft, and 487 ft, respectively.
