**FINAL REPORT
FOR
TF30 THIRD-STAGE COMPOSITE FAN BLADE
SERVICE PROGRAM
Contract No. F33657-70-C-0624**

David G. Randall
Pratt & Whitney Aircraft Group
United Technologies Corporation
East Hartford, Connecticut 06108

15 May 1978

Final Report for Period 1 July 1970 - 31 December 1977

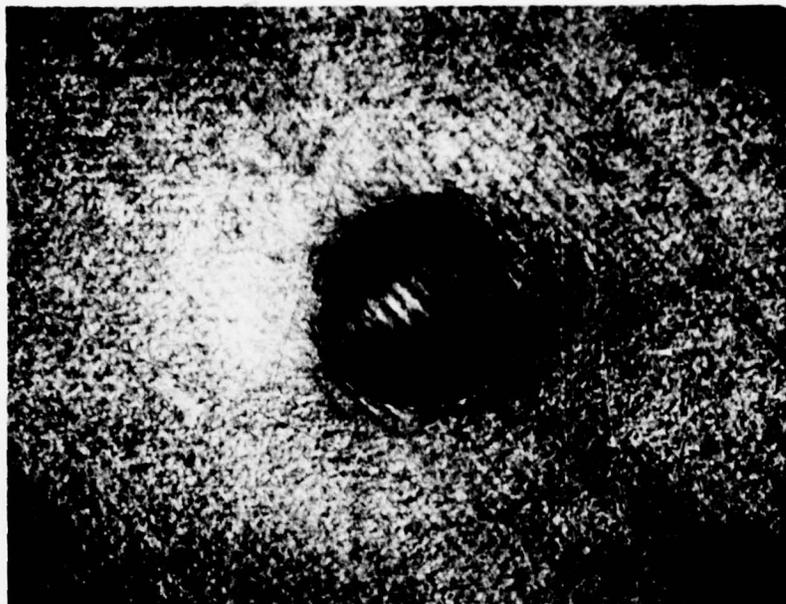
Figure 9.2-3 Ballistic Impact Damage on a Unidirectional Borsical[®] Test Panel Specimen, SAR-Bs/A-3A/u-H2

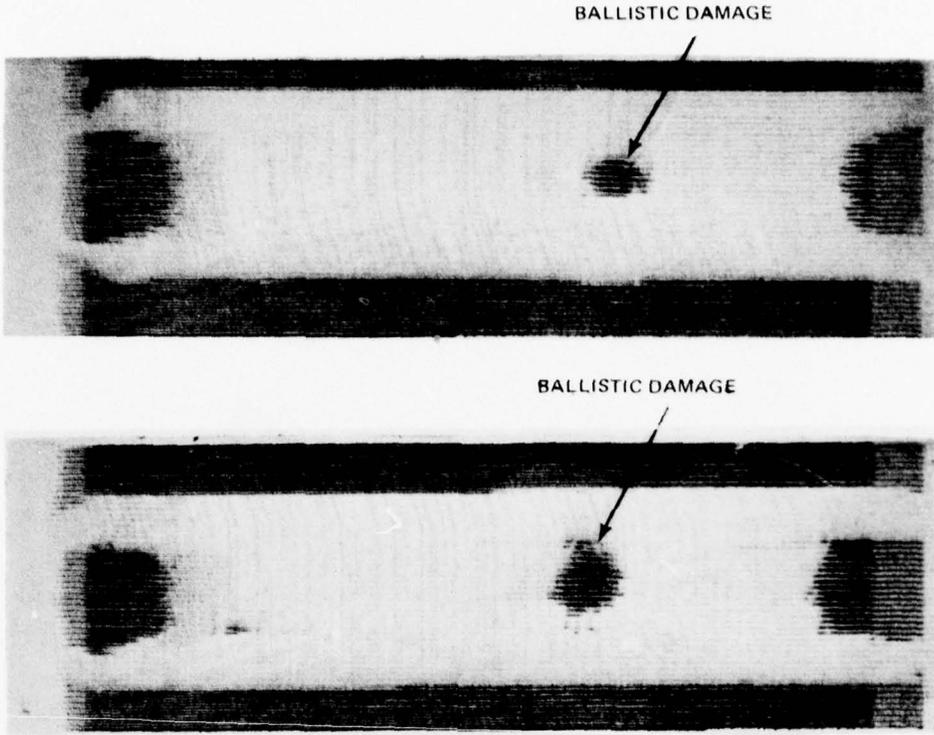
Figure 9.2-4 Ballistic Impact Damage on a Component Borsical[®] Test Panel Specimen, SAR-Bs/A-7B/B-H3

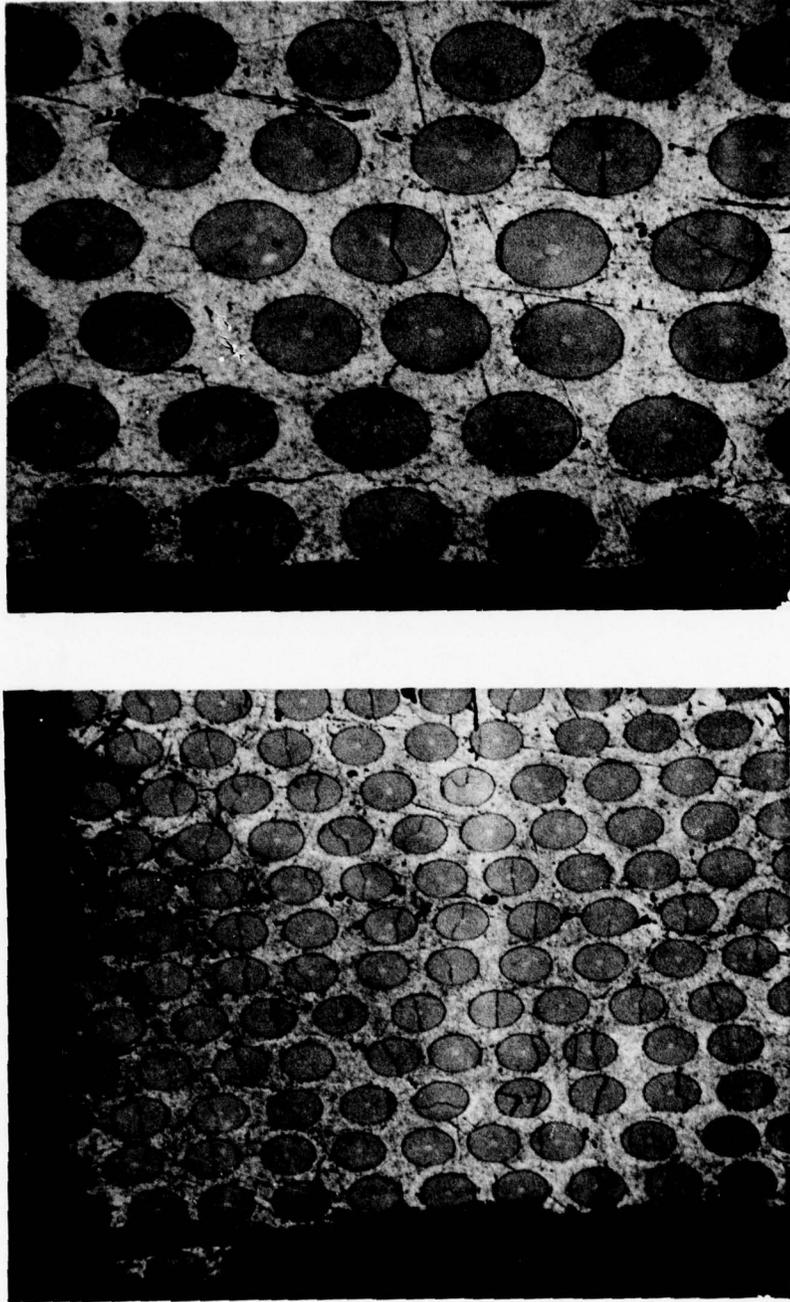
Cross-ply samples that were HFF tested at 450°F contained numerous fatigue cracks which appeared to originate at split fibers (see Figure 9.4-9). The orientation of the splitting which occurred in the fibers of the cross-ply laminate was normal to the plane of the specimens rather than parallel as found in the component specimens. Stress analysis of cross-ply samples during HFF testing indicated that the tensile stresses in the plane of the samples could result in fiber splitting due to the low transverse strength of Borsic[®] filament. During fatigue testing, a ten percent drop in natural frequency occurred prior to delamination, and apparently the fiber splitting, as well as the growth of fatigue cracks in the matrix, produced that frequency drop. The orientation of fiber splitting directed the fatigue cracks into the specimen, preventing visual delamination.

Figure 9.4-9 Microstructure of Cross-Ply Borsical[®] Specimen (12D/C-H4) that was High Frequency Fatigue Tested at 450°F and 1265 μ in./in. for 10^7 Cycles

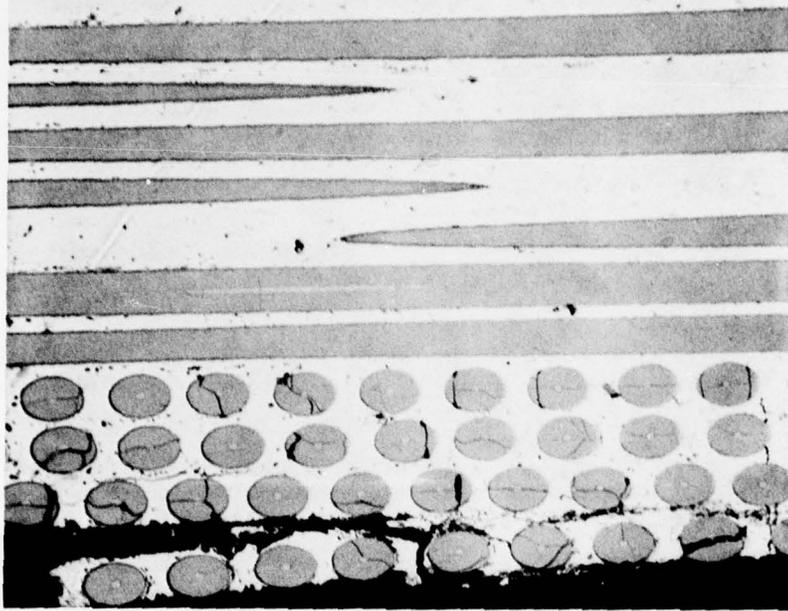
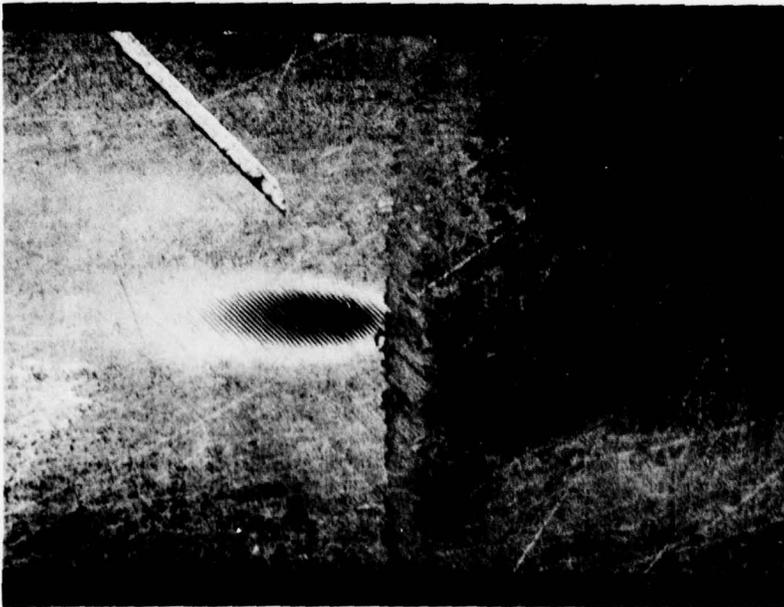
Figure 9.5-4 Surface Appearance and Microstructure of Eroded Component Specimen (7A/B-H2) After 450° F High Frequency Fatigue Testing at 1575 μ in./in. for 5×10^6 Cycles

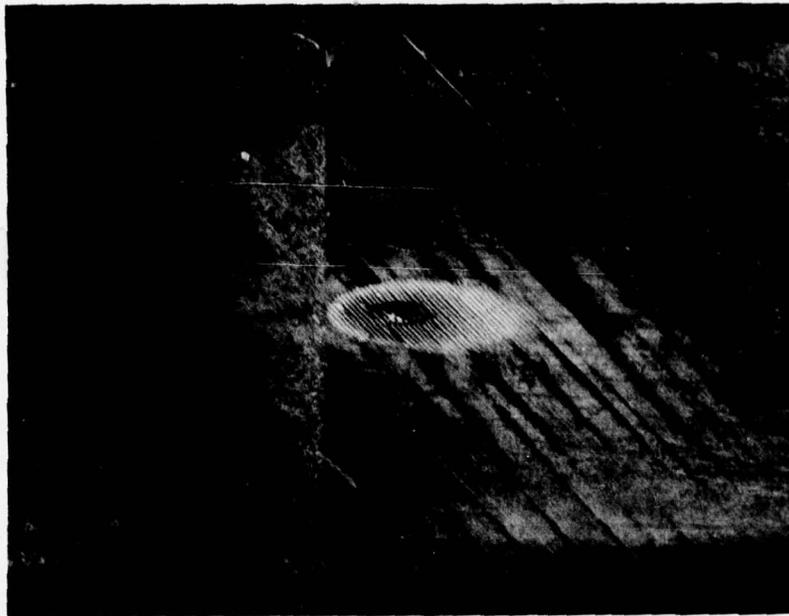
The microstructure of eroded (exposed fibers) 70°F HFF-tested unidirectional specimens was similar to that for undamaged specimens. As shown in Figure 9.5-2, failure takes place by surface delamination with no internal fatigue cracks. Eroded unidirectional specimens HFF-tested at 450°F also looked identical to the undamaged specimens. The delamination did not occur preferentially at the eroded region even when cycled to 100 percent of life expectancy at either room temperature or 450°F. A deeply eroded sample with broken fibers was HFF tested at 450°F and did delaminate from the damaged area as shown in Figure 9.5-3. Erosion damage also did not alter the failure mode for component specimens. As with undamaged specimens, the 450°F HFF test resulted in splitting of the cross-ply layers and surface delamination as shown in Figure 9.5-4. It should be noted that, again, delamination did not originate in the eroded area of exposed fibers. A deeply eroded component specimen (fibers broken during erosion) behaved in a 450°F HFF test as though there were no broken fibers, and specimen delamination did not begin at the eroded area, as shown in Figure 9.5-5.

Figure 9.5-5 Surface Appearance of Deeply Eroded Component Specimen (4D/B-H4) After 450°F High Frequency Fatigue Testing at 1710 μ in./in. for 5×10^6 Cycles

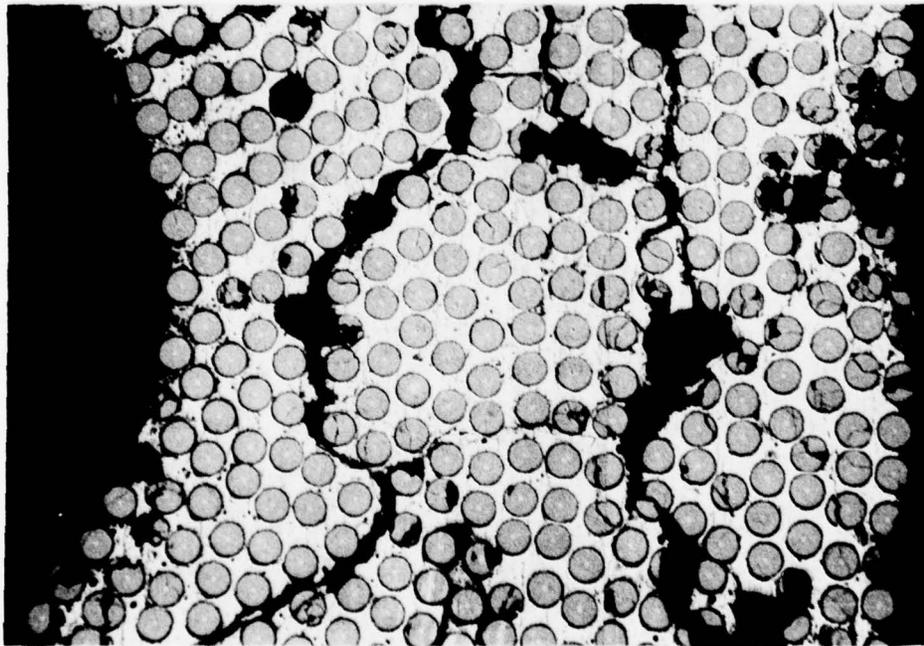
A large amount of matrix cracking was found in the unidirectional specimens after impact, plus 70°F or 450°F HFF testing, as shown in Figure 9.6-4. In contrast, the component specimens which were impacted and HFF tested at 450°F did not contain as much matrix damage as the unidirectional specimens, as shown in Figure 9.6-5. Note that although the cross-ply layers suffered extensive fiber breakage, the unidirectional core fibers remained intact and little matrix cracking occurred. At locations away from the immediate impact area, fiber splitting and surface delamination took place in these component specimens similar to the undamaged specimen behavior, as shown in Figure 9.6-6. Impact plus 450°F HFF damage of cross-ply material is illustrated in Figure 9.6-7. The excessive fiber and matrix damage shown are probably the cause of the early frequency drop observed.

Figure 9.6-4 Typical Ballistically Impacted Unidirectional Specimen After High Frequency Fatigue Testing Showing Extensive Matrix Cracking

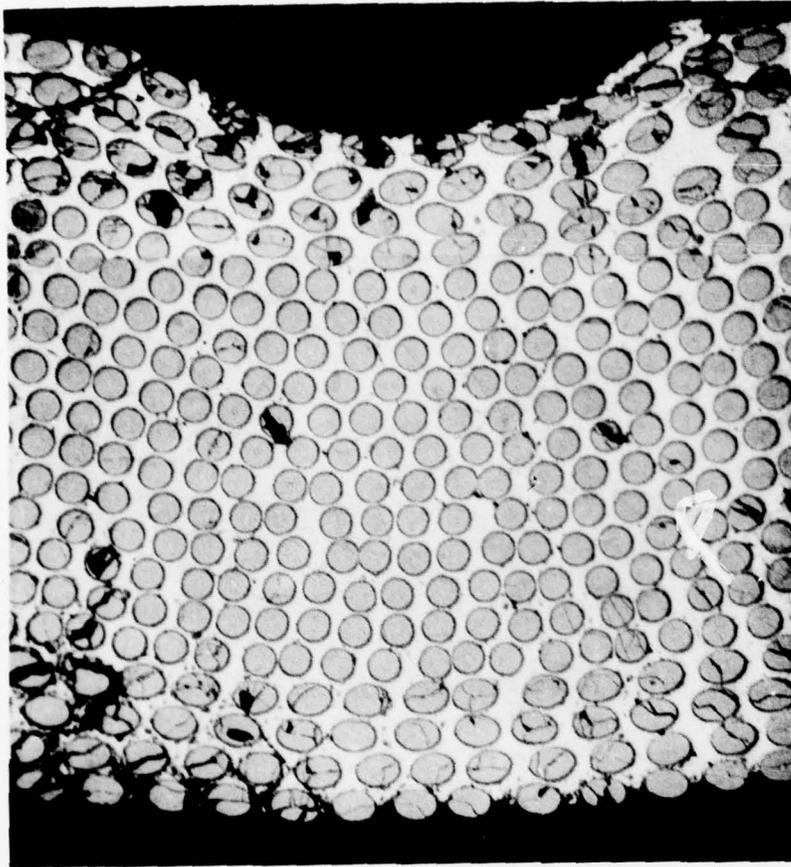
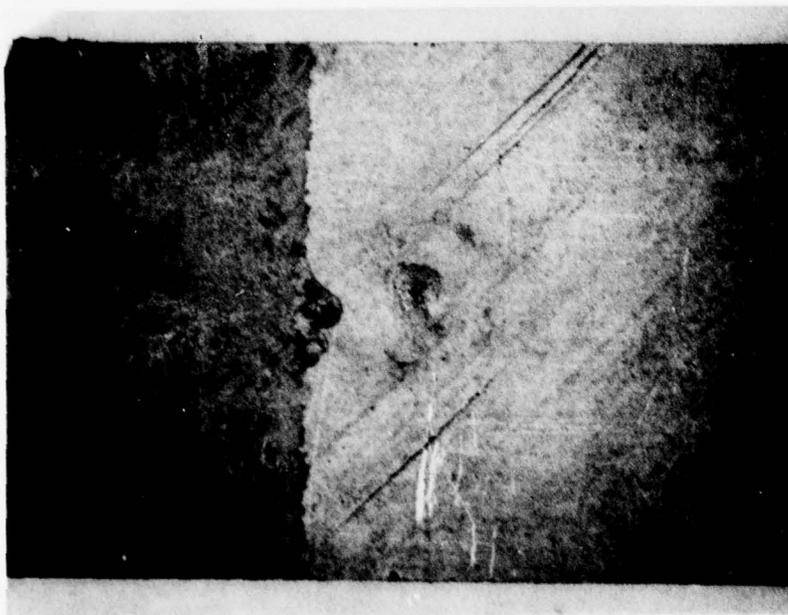
Figure 9.6-5 Typical Ballistically Impacted Component Specimen (7B/B-H4) After High Frequency Fatigue Testing at 450°F Showing Only Limited Matrix Cracking

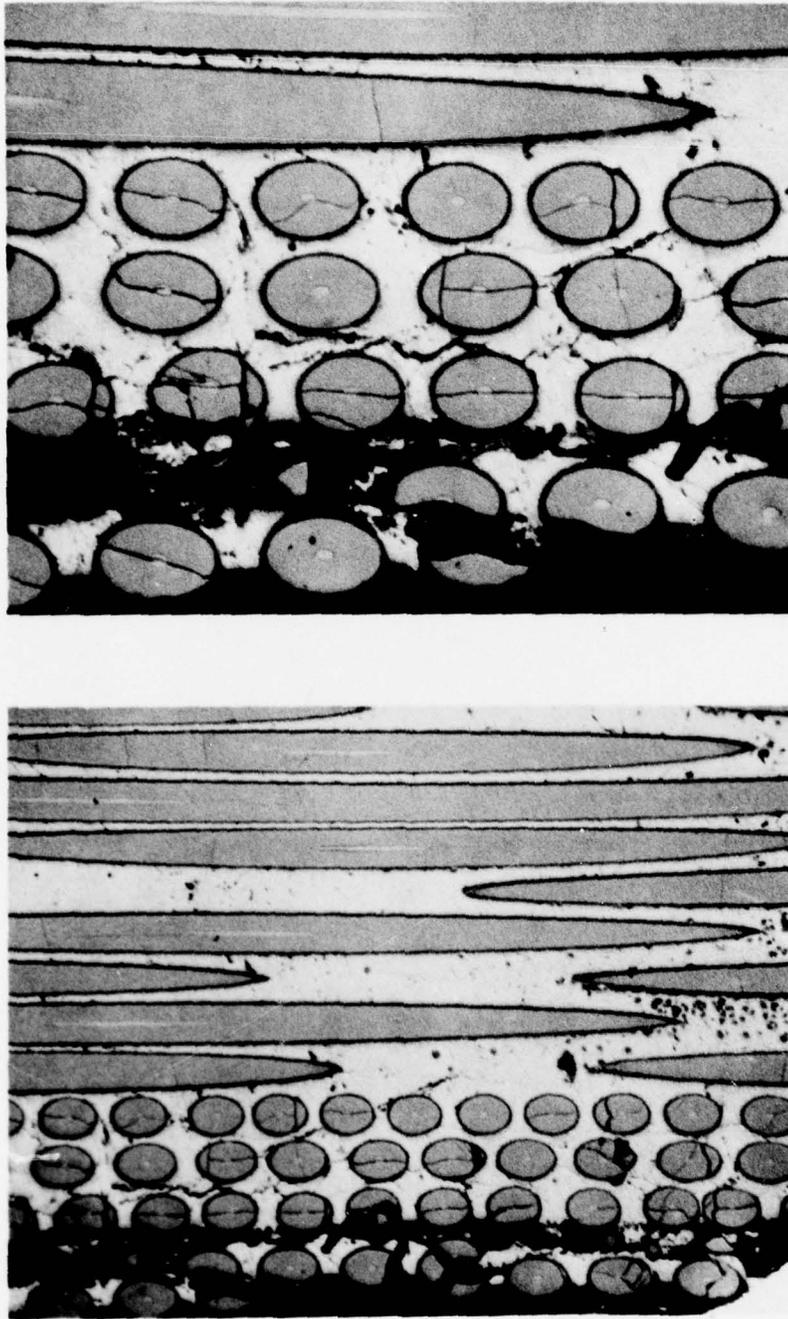
Figure 9. 6-6 Microstructure of Ballistically Impacted Component Specimen (7D/B-H2) After 450°F High Frequency Fatigue Testing

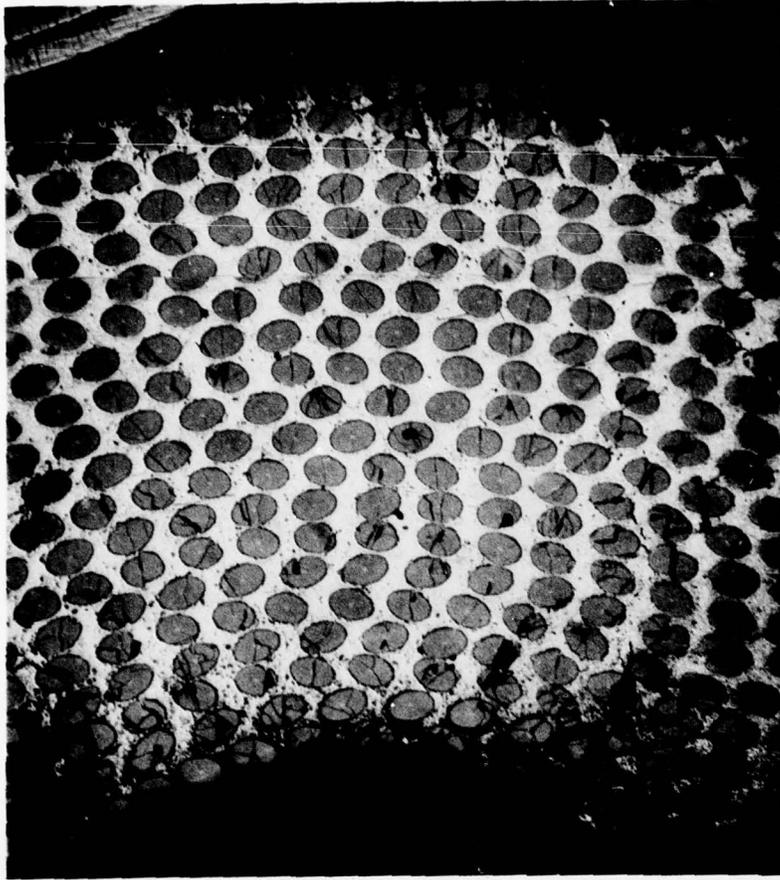
Figure 9.6-7 Ballistically Impacted Cross-Ply Specimen (9E/C-H4) After 450° F High Frequency Fatigue Testing

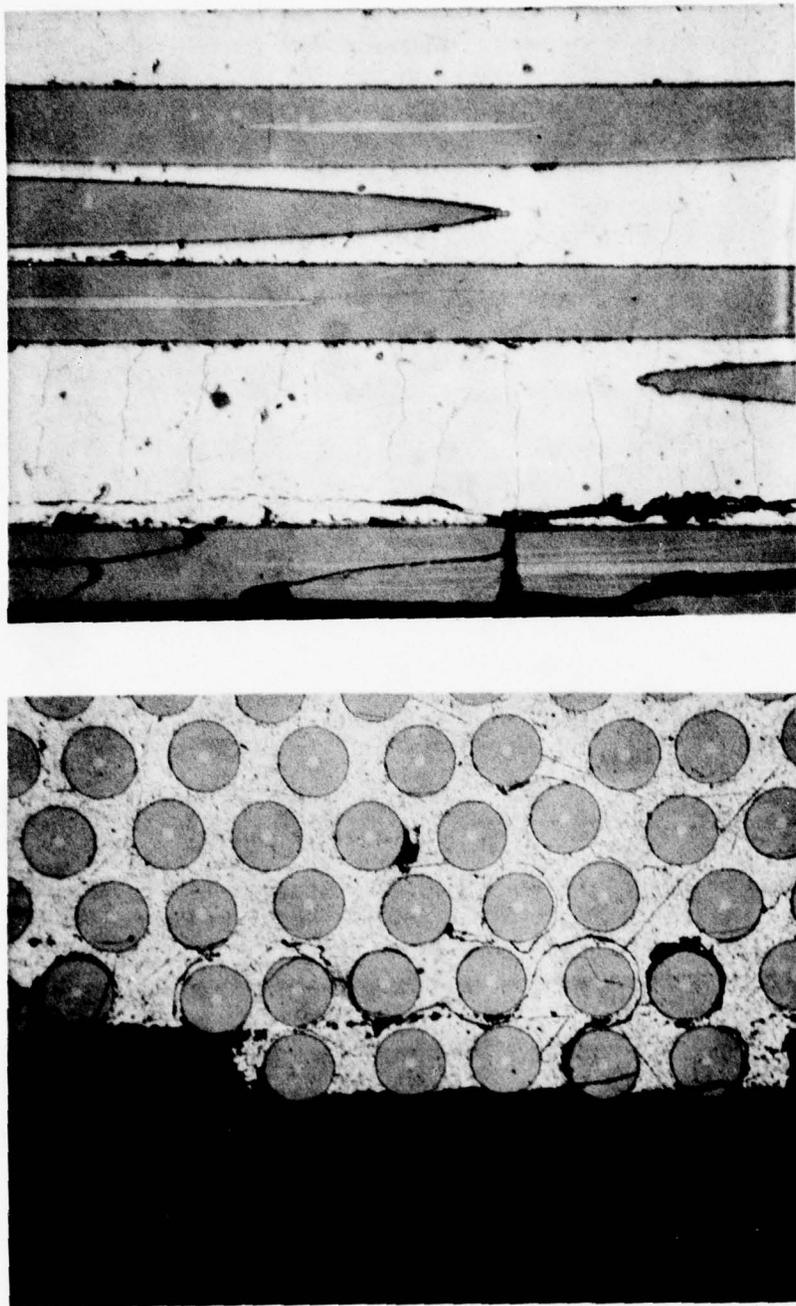
Figure 9.7-2 Microstructure of Thermal Fatigue Damaged Unidirectional Specimen (11A/ μ -H2)
After 70° F High Frequency Fatigue Testing

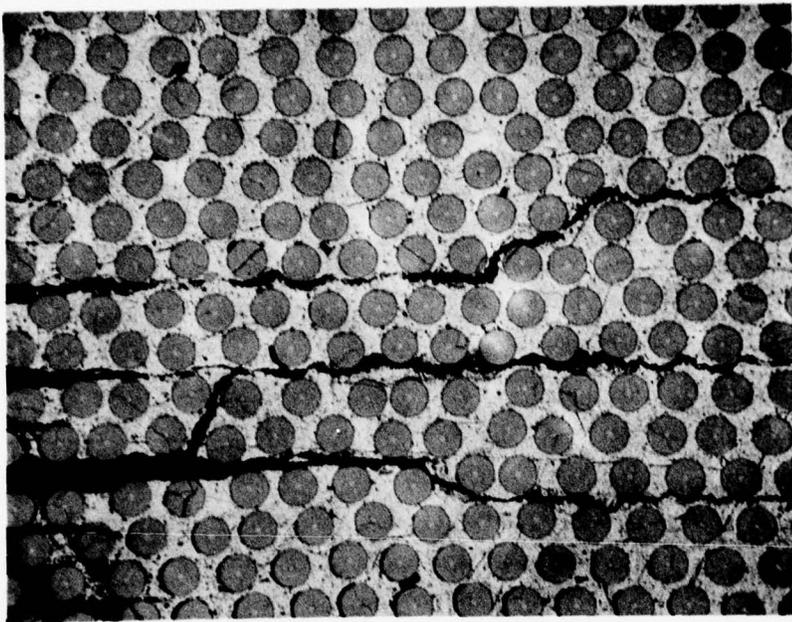
Figure 9.7-3 Surface Appearance and Microstructure of Thermal Fatigue Damaged Unidirectional Specimen (11D/u-H2) After 450° F High Frequency Fatigue Testing

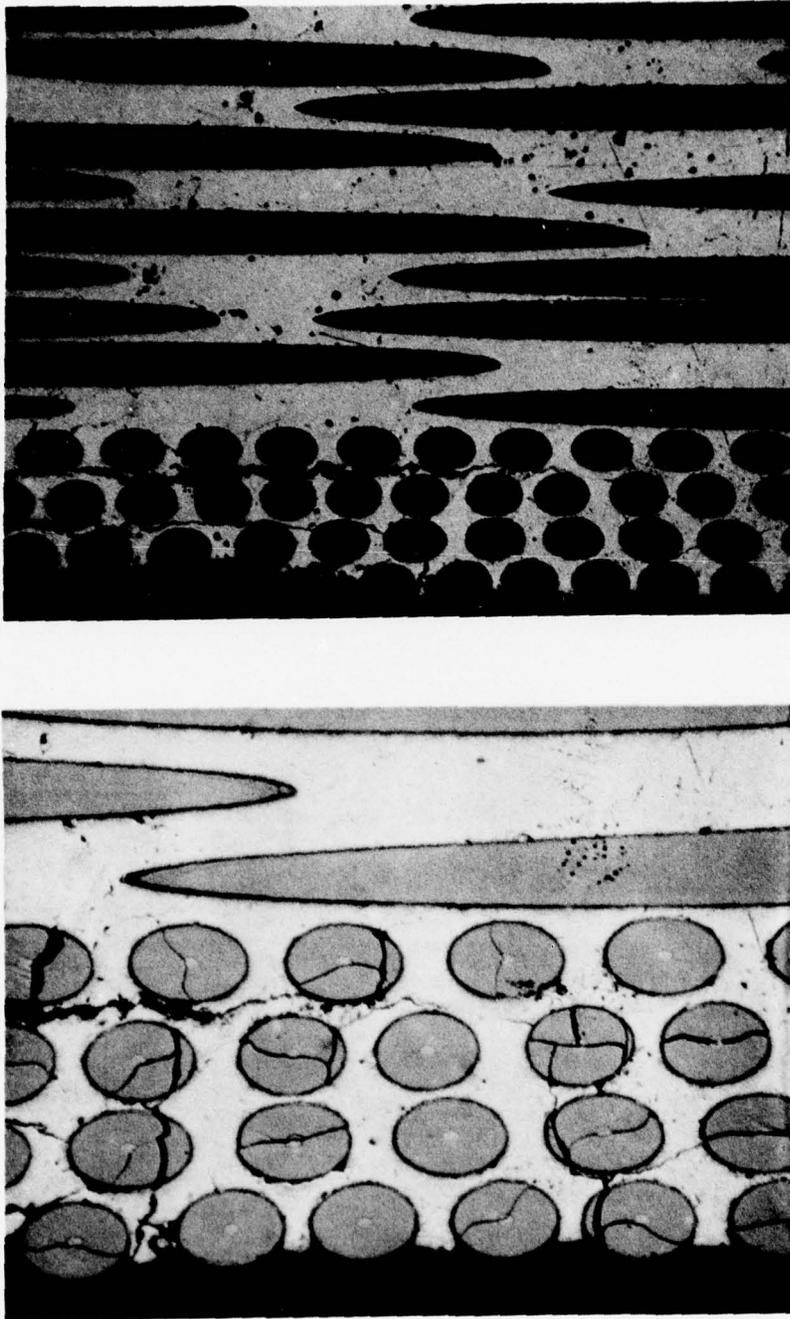
The microstructure of thermal fatigue component specimens looked no different from undamaged specimens after a 450°F HFF test. Failures were characterized by splitting of the cross-ply fibers and surface delamination (Figure 9.7-4) with interconnected fatigue cracks. Cross-ply samples also appeared similar to undamaged specimens with fiber splitting normal to the specimen surface.

Figure 9.7-4 Microstructure of Thermal Fatigue Damaged Component Specimen (8B/B-H1)
After 450°F High Frequency Fatigue Testing

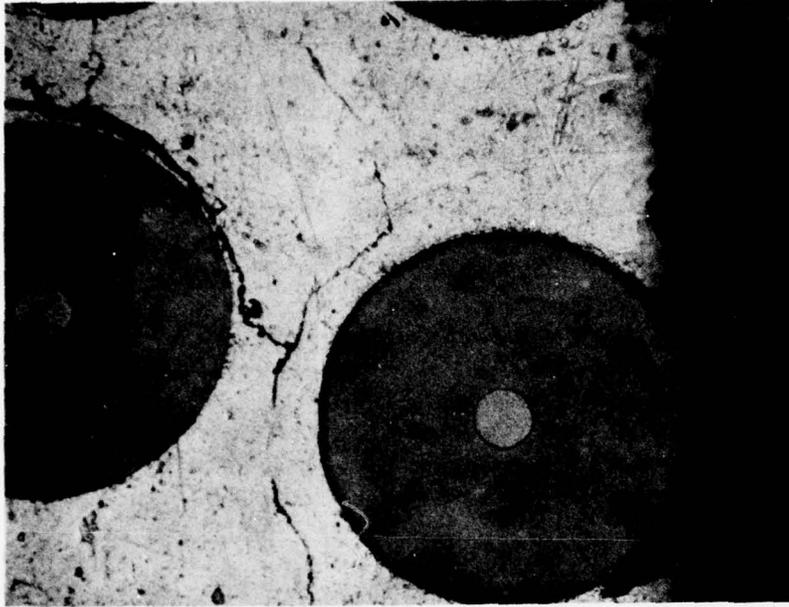
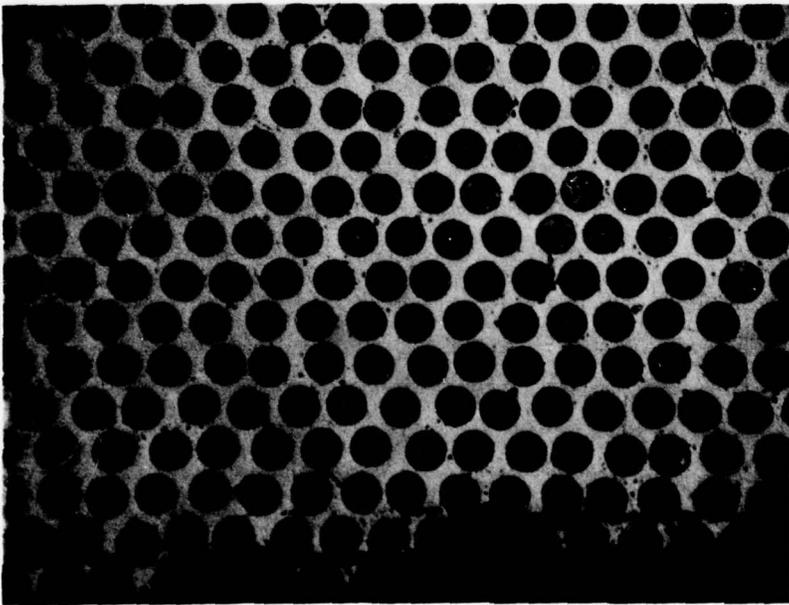
Figure 9.8-2 Microstructure of Salt Stress-Corrosion Damaged Unidirectional Specimen (6B/u-H2) After 70° F High Frequency Fatigue Testing

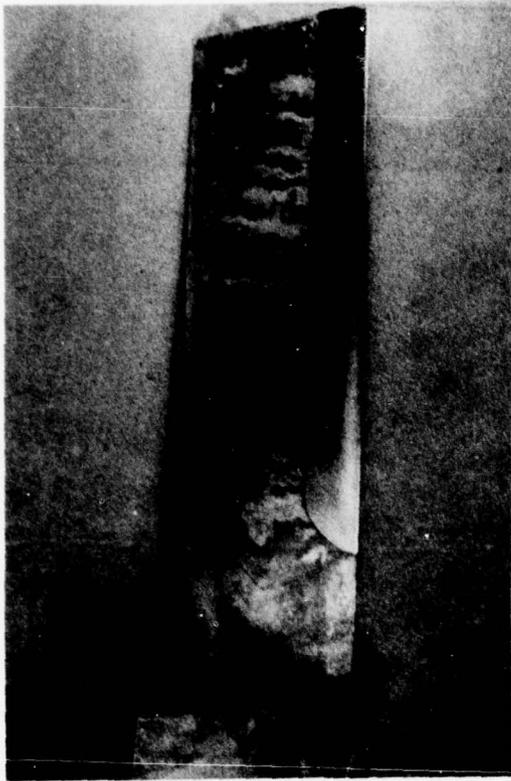
Figure 10.2-1 The BORSIC[®]/Aluminum Blade Showed No Evidence of Significant Salt Corrosion After an Elevated Temperature (500°F), 100-Hour Salt-Stress-Corrosion Test

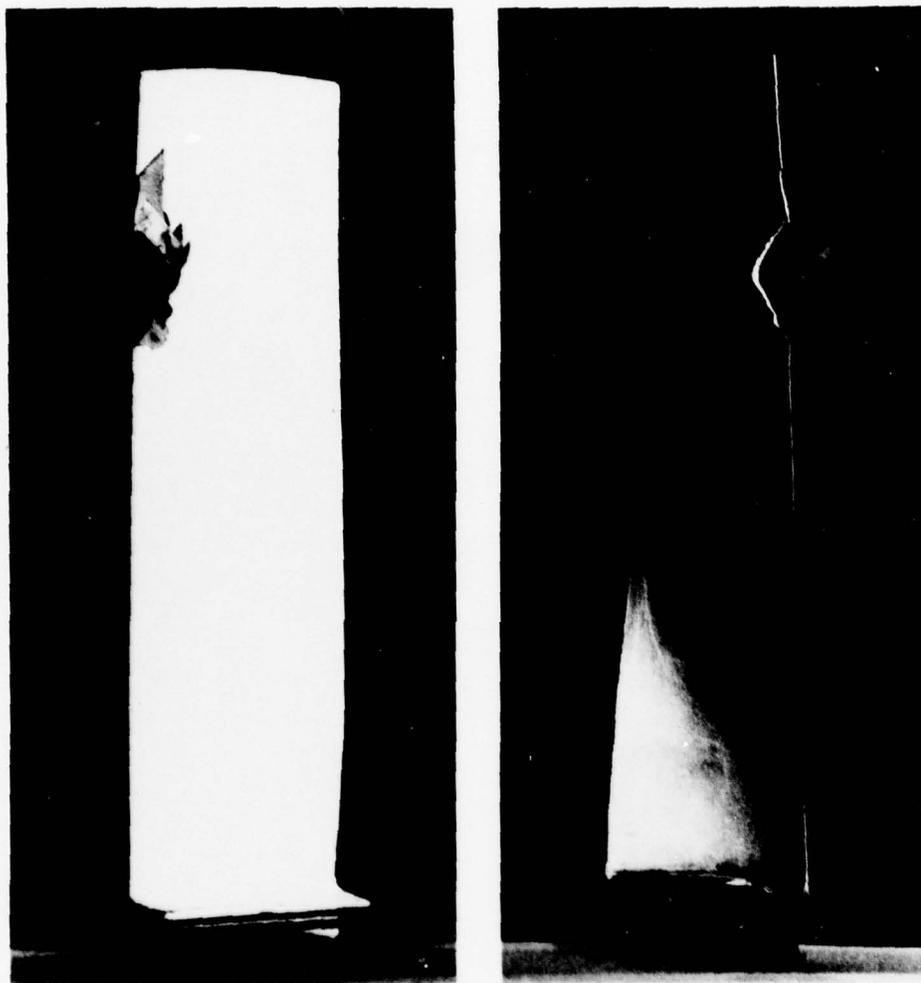
Figure 10.2-17 Damage Sustained by Blade F-216 After Being Impacted With a Single One-Inch Tempered Ice Ball

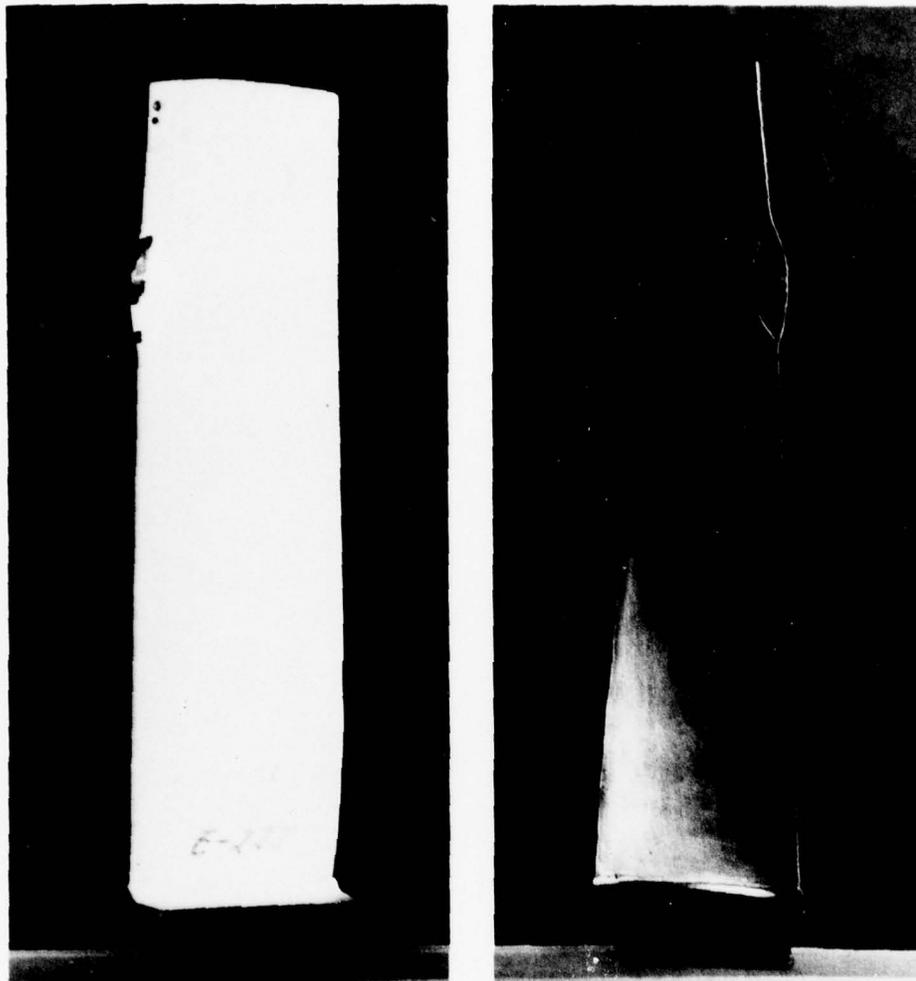
Figure 10.2-18 Blade E-227 Sustained This Damage After Three Impacts of One-Inch Tempered Ice Balls

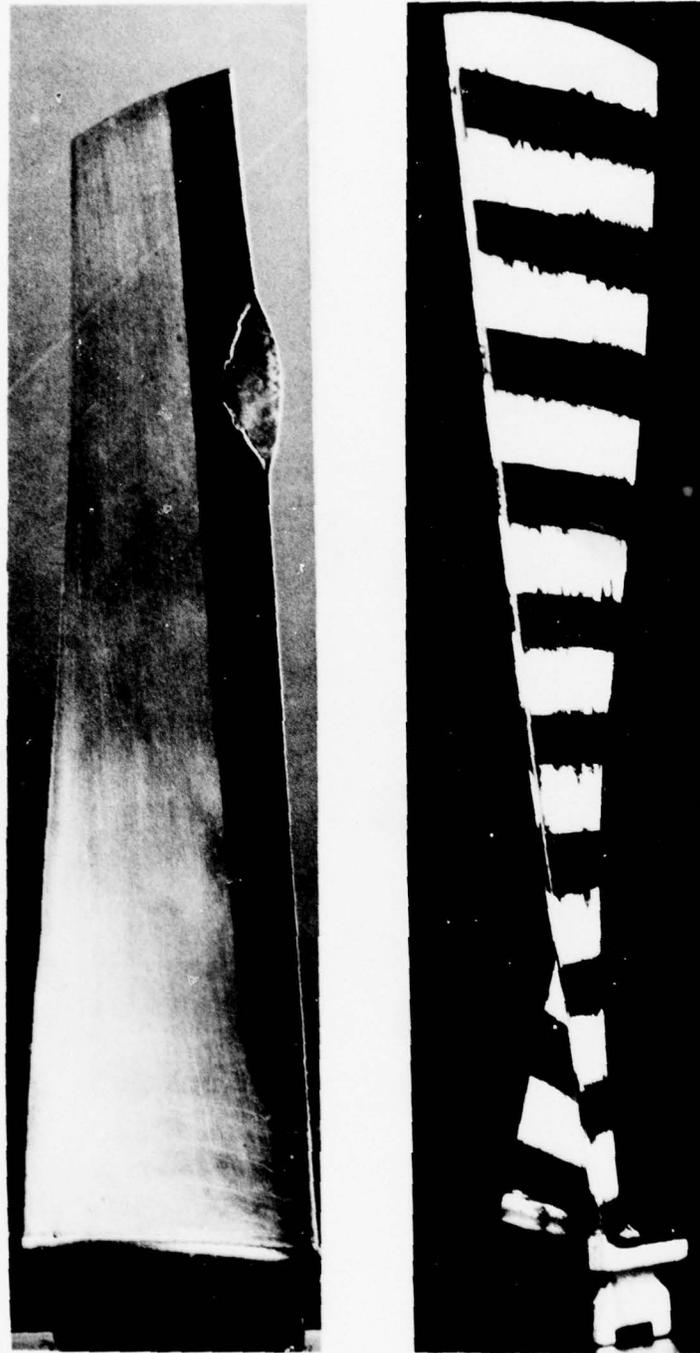
Figure 10.2-19 The Effect of Leading Edge Thickness on FOD, Blade at Right Had 0.025-Inch L.E. Radius and Sustained Only Slight Dents When Impacted by Six One-Inch Tempered Ice Balls. Blade at left had 0.015-inch L.E. radius and sustained damage shown after three such impacts.

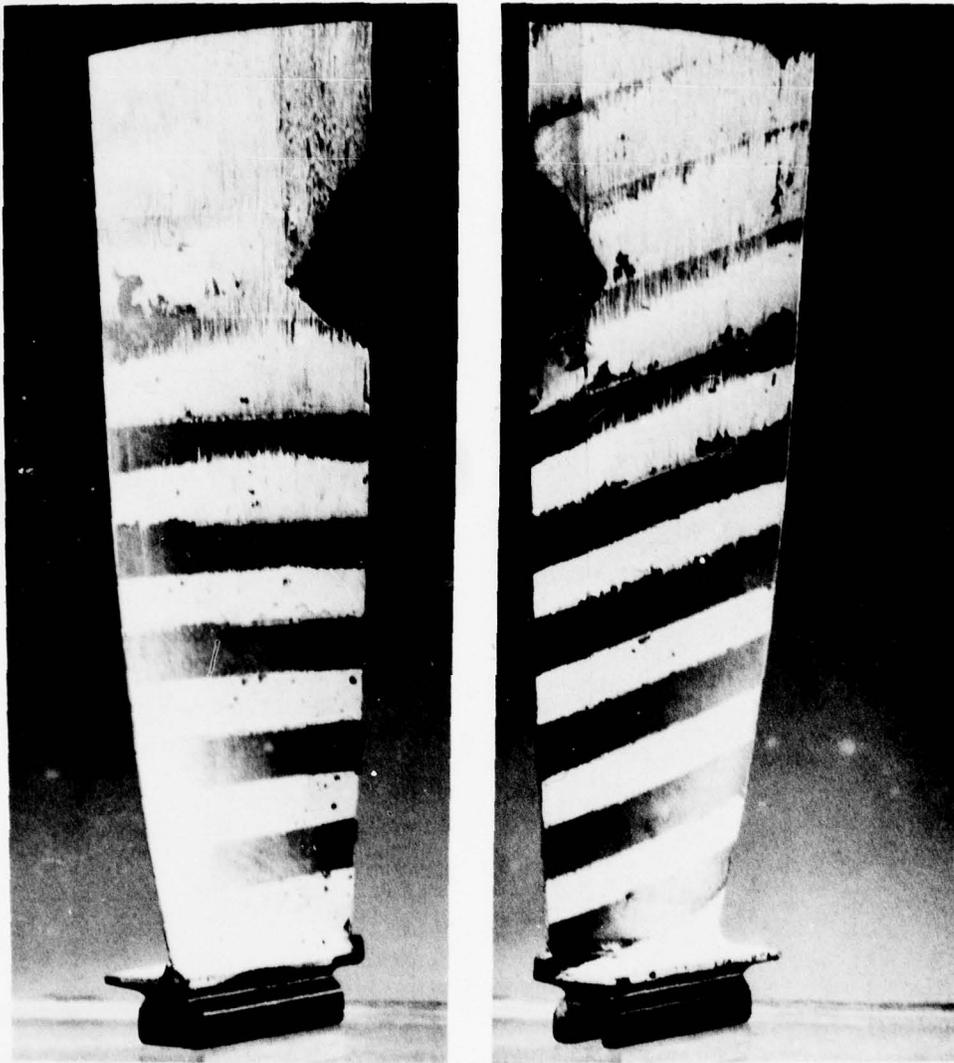
Figure 10.2.21 Damage Sustained by RORSIC^(R) Aluminum Blade in Massive FOD Test. Projectile was 6-oz. jelly ball.

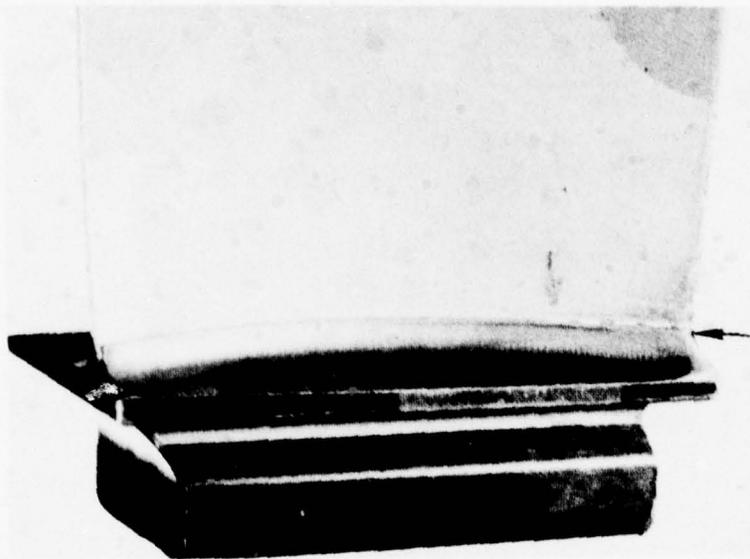
Figure 11.2-12 Location of Crack at Concave Side of Airfoil Root

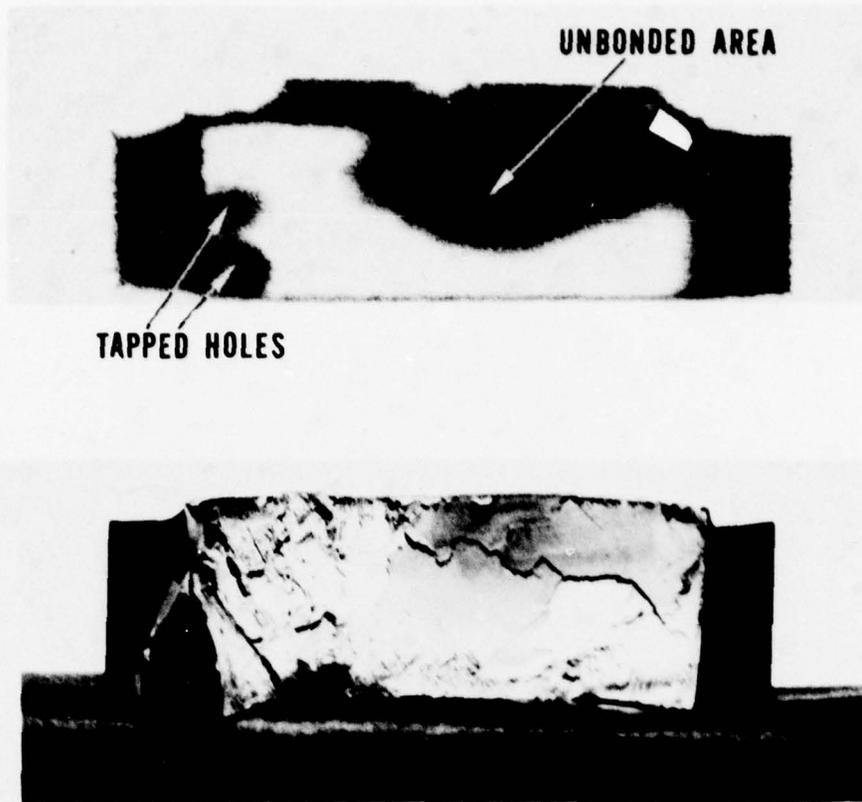
Figure B-4 *Example of Root Bond Defect Readily Detected By C-Scan Inspection*
