SPRUCE RUN DAM

PHASE I INSPECTION REPORT
NATIONAL DAM SAFETY PROGRAM

NJ 00132

DEPARTMENT OF THE ARMY
PHILADELPHIA DISTRICT, CORPS OF ENGINEERS
CUSTOM HOUSE - 2D & CHESTNUT STREETS
PHILADELPHIA, PENNSYLVANIA 19106
25 APRIL 1978

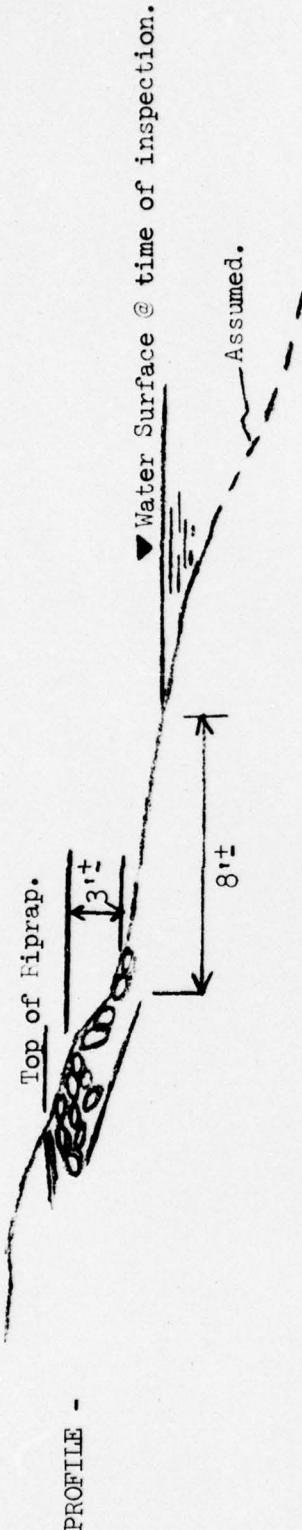
VISUAL EXAMINATION OF	REMARKS
RIPRAP (CONTINUATION)

Although it is believed the surface is capable of protecting the random fill section for the next 3-5 years, the owner should program a reworking of the stone surface in his maintenance budget within that period to assure that rehabilitation work can be performed when needed. The several areas where slumps or other deficiency of protective cover where noted should be repaired as soon as possible. Further suggest that a number of profiles be run to determine existing shape of slope down to El. 255 and compare with as-built surveys if available. Also determine if photos of slopes as-built are available and, if so, compare with present conditions.

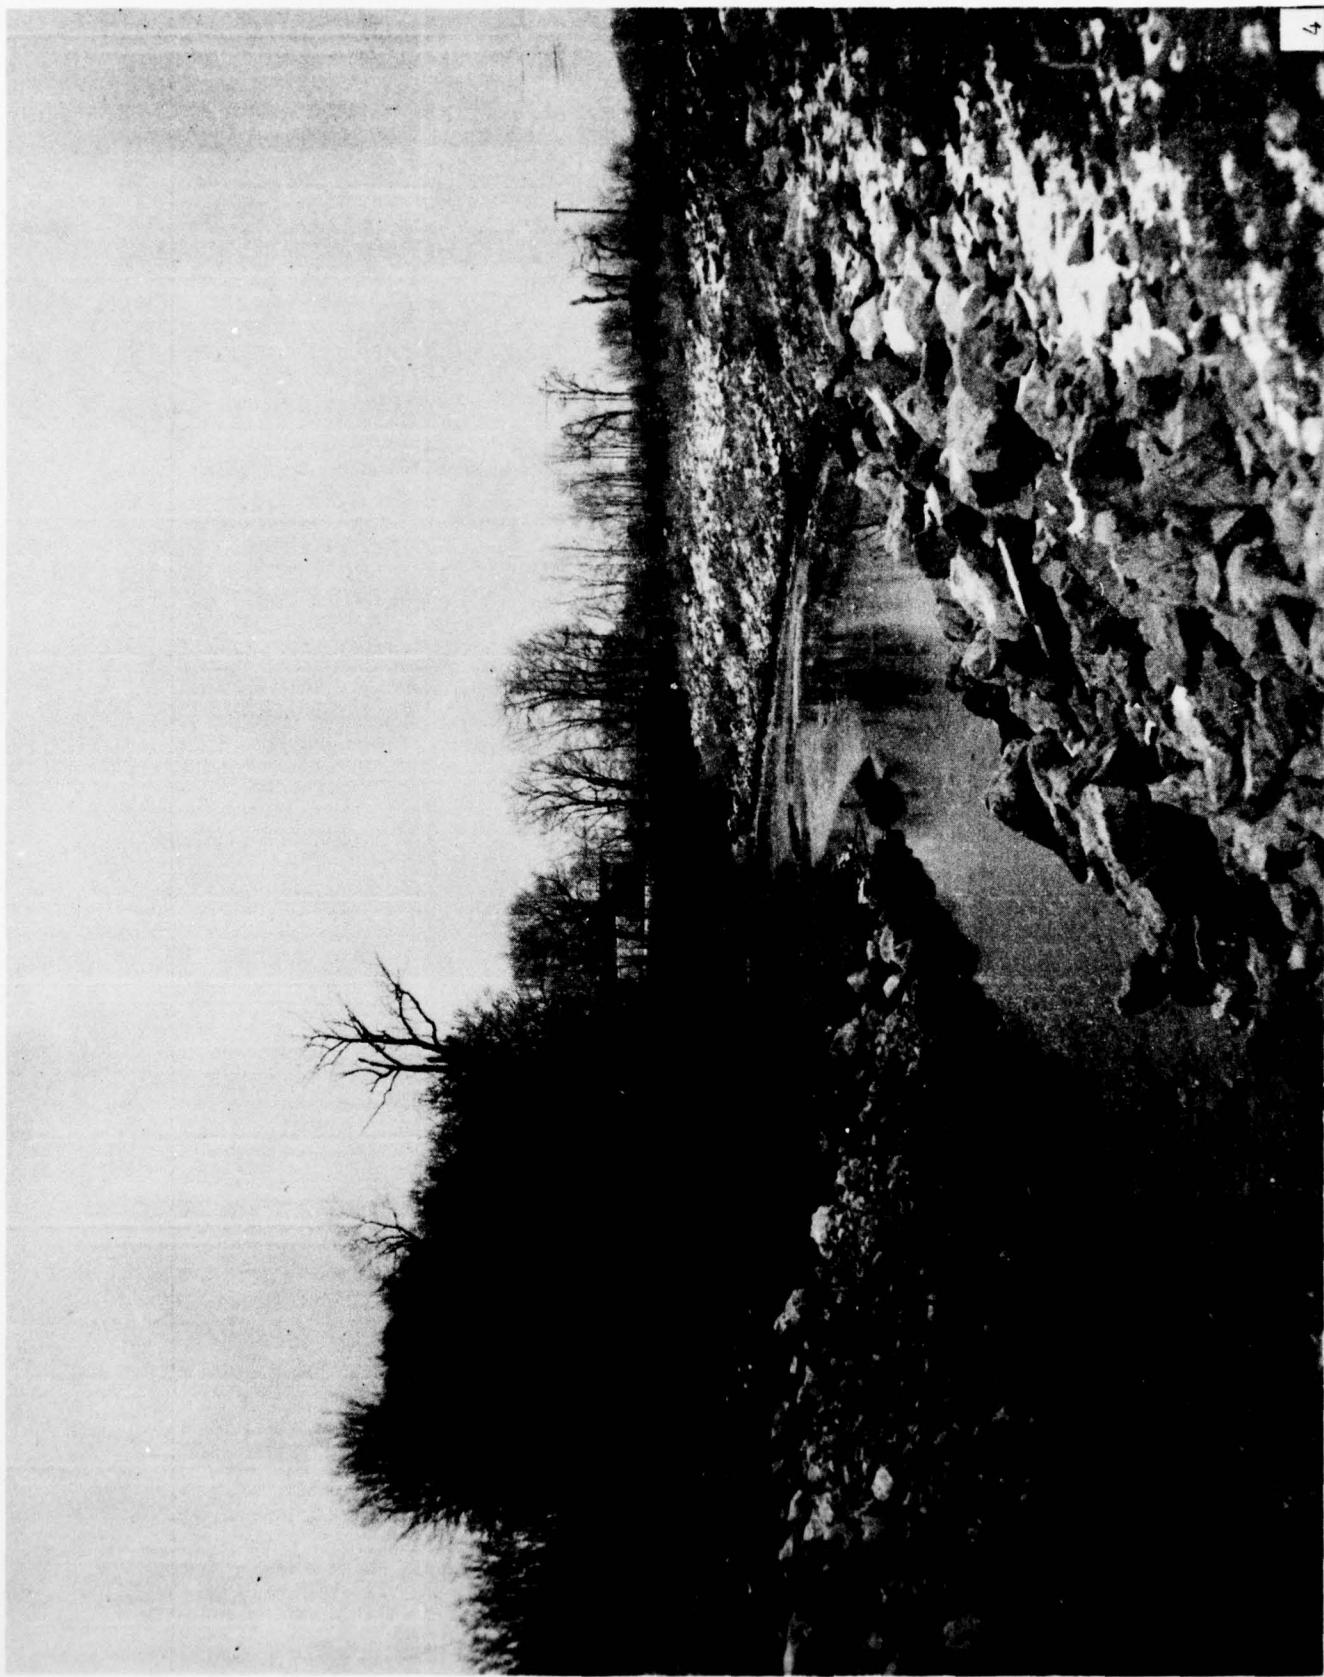
Photo 4 - 12 December 1977

View of downstream channel looking downstream from a point approximately 100 feet downstream of outlet control vault.
