ROUND VALLEY SOUTH DAM

PHASE I INSPECTION REPORT

NATIONAL DAM SAFETY PROGRAM

NJ 00015

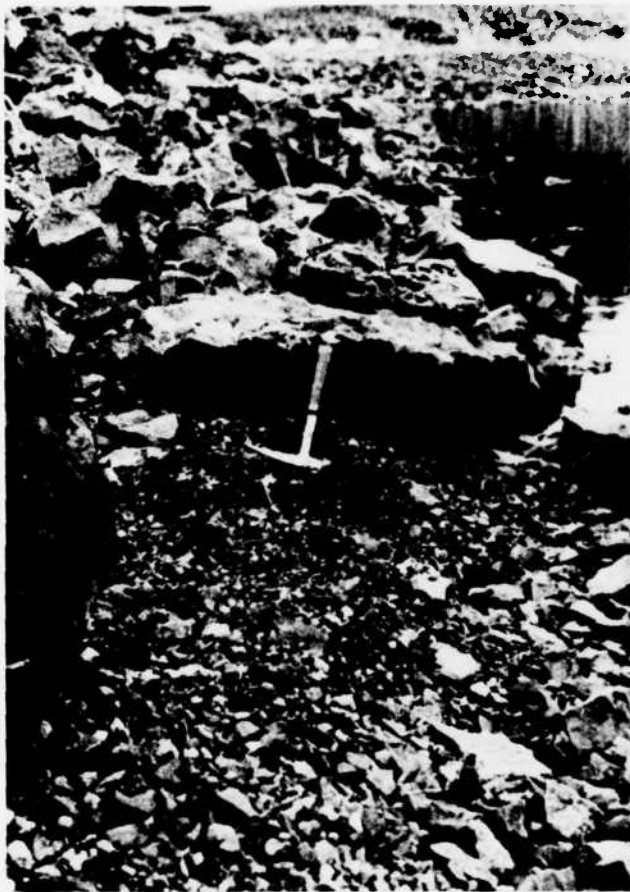
The riprap on the upstream slope is poorly graded and inadequate to provide the necessary protection against erosion due to wave action. The riprap stone appears to have been susceptible to stress release or frost-wedging against fracture planes. According to Mr. Chase, considerable deterioration of the rock has occurred since its placement at the time of construction. Subsequent wave action has left portions of the embankment unprotected.

VIEW OF RIP RAPPED SLOPE
SHOWING POOR GRADATION

(1) The upstream slope protection should be repaired to provide a suitable well graded riprap layer.

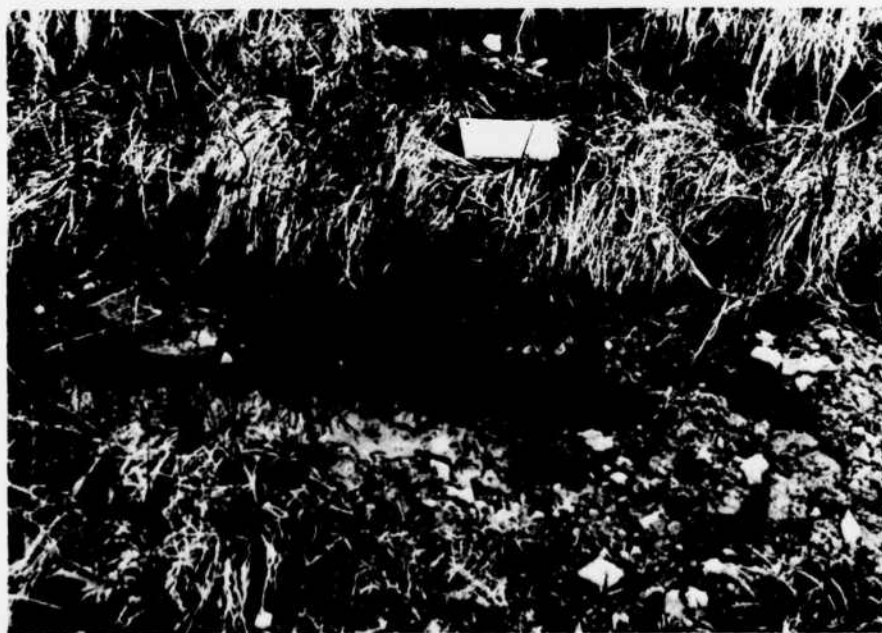
The South Dam embankment appears to be stable. However, the signs of moisture and wetness on the downstream slope, especially at the lower third of the east side, indicate that the phreatic line may intersect the embankment slope at a point well above the filter blanket or rock toe. However, it is possible that the rainfall that occurred previous to the inspection may have been partially responsible for this condition. Since there are no piezometers installed in the embankment, the magnitude of pore pressures cannot be assessed.

Seepage was noted at several locations, and much of the embankment was moist or saturated. The seepage appeared to be most prevalent near the east abutment.

STANDING WATER ABOVE BOTTOM BERM NEAR
EAST ABUTMENT

The embankment of the South Dam should be monitored continuously for signs of increased seepage rates and/or turbid water.

The cause of seepage and areas of saturation should be determined.
