ABSECON CREEK WEST BRANCH, ATLANTIC COUNTY

# DOUGHTY POND UPPER

## PHASE I INSPECTION REPORT NATIONAL DAM SAFETY PROGRAM

NJ 00081

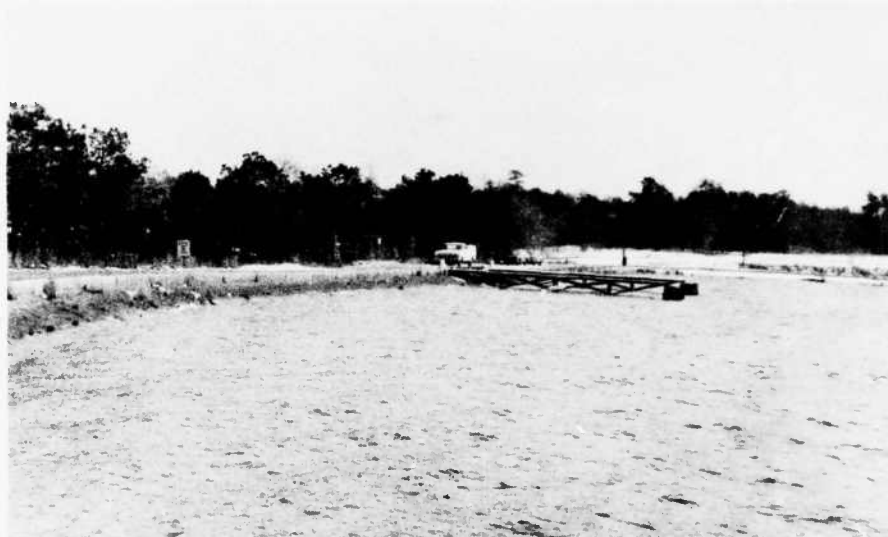
OVERALL VIEW OF DAM

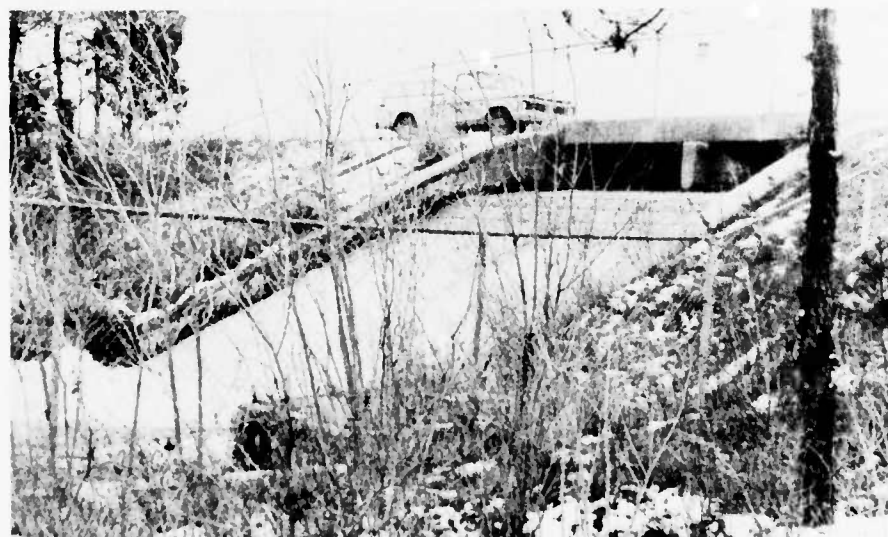
SPILLWAY

The spillway is a concrete weir 25 feet wide with a pier in the center supporting a bridge constructed over the spillway. The spillway abutments are cracked and spalled. Differential settlement of up to 3 inches was observed at the abutments. The channel directly downstream of the spillway is about 60 feet wide and conveys flow under the Garden State Parkway bridges. The bridge openings are approximately 80 feet wide and about 20 feet high.

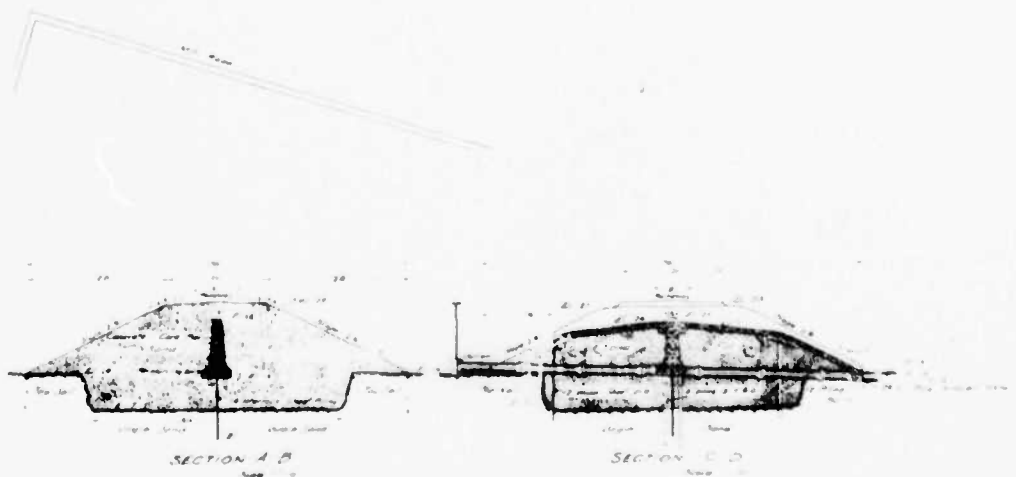
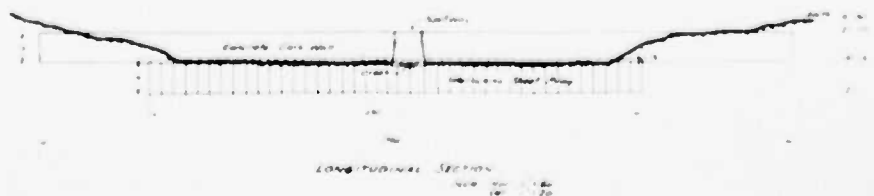
**FIGURE 4**

NOTE: THE EMBANKMENT WAS NOT  
CONSTRUCTED WITH A CONCRETE  
CORE AS INDICATED ON THIS  
DRAWING.

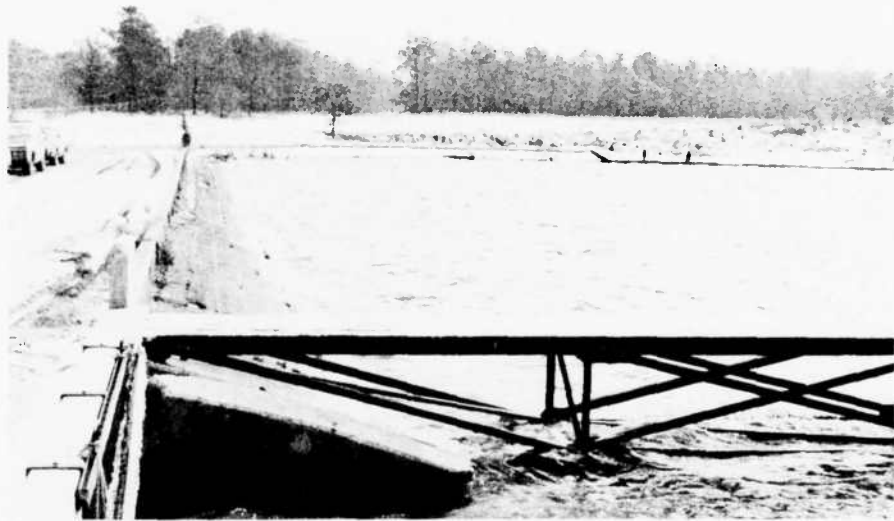
UPSTREAM FACE OF DAM

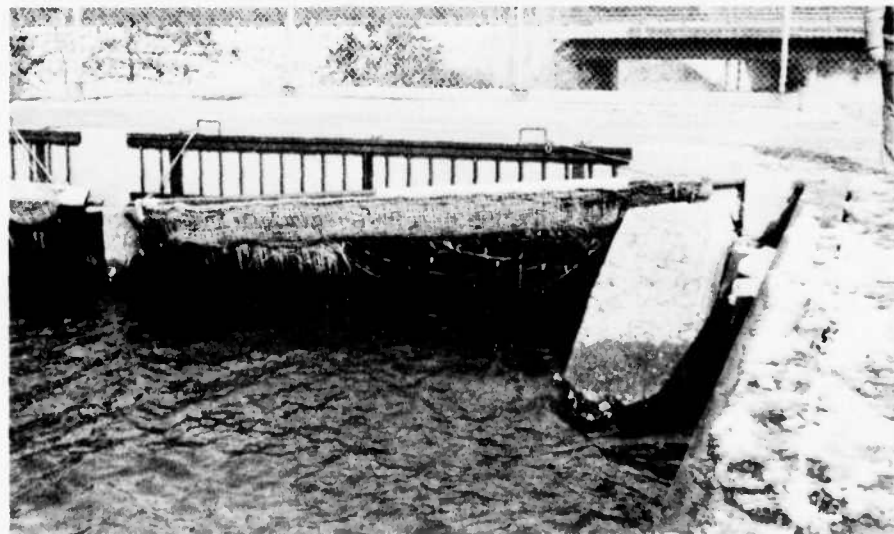
CRACKING AND DIFFERENTIAL SETTLEMENT OF  
CONCRETE ALONG THE SPILLWAY

Differential settlement of up to 3 inches was noted at the junction of the spillway and embankment at both the left and the right sides.

- (1) Protection of the downstream seepage area to prevent migration of fine material from the embankment.
- (2) Removal of trees and brush from the embankment and replacement thereof with suitable ground cover.
- (3) Repair of the seriously spalled portions of the concrete wingwalls and access walkway planking.

(1) Investigate and determine the cause of the settlement in the embankment adjacent to the spillway.

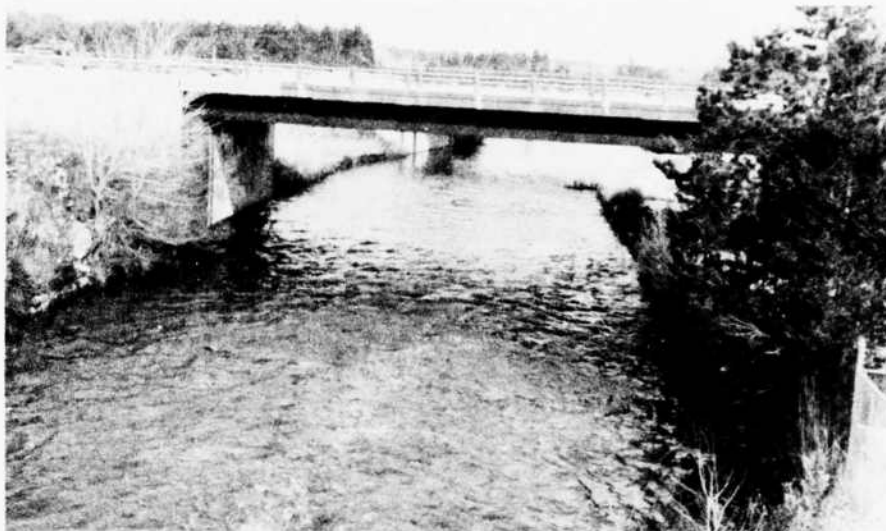
CHANNEL DOWNSTREAM OF SPILLWAY

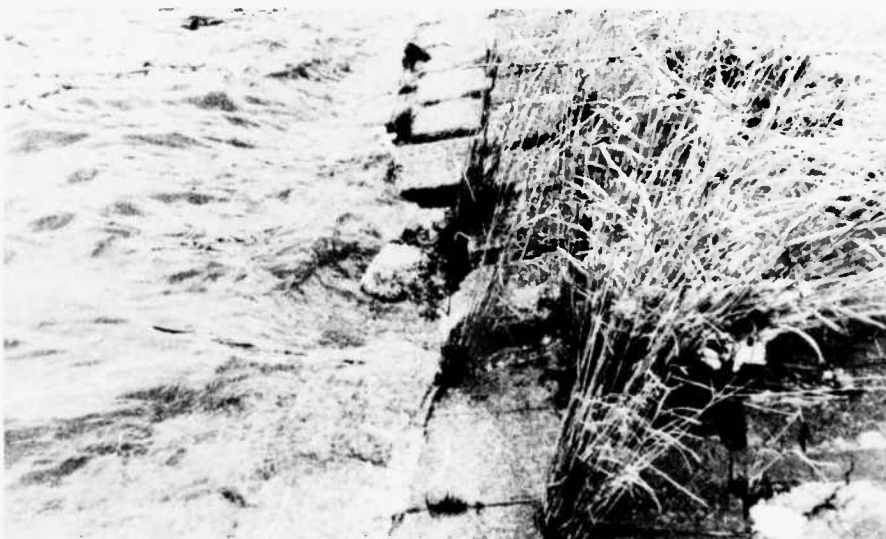
SLOPE PROTECTION ALONG UPSTREAM FACE

| VISUAL EXAMINATION OF | OBSERVATIONS | REMARKS OR RECOMMENDATIONS |
|---|---|---|
| POND FAILURES | One foot square concrete blocks mortared<br>into place. Some displacement and minor<br>spalling has occurred. | The spalling appears to be<br>superficial. |
