# WHITE'S POND DAM

## PHASE I INSPECTION REPORT

## NATIONAL DAM SAFETY PROGRAM

NJ00233

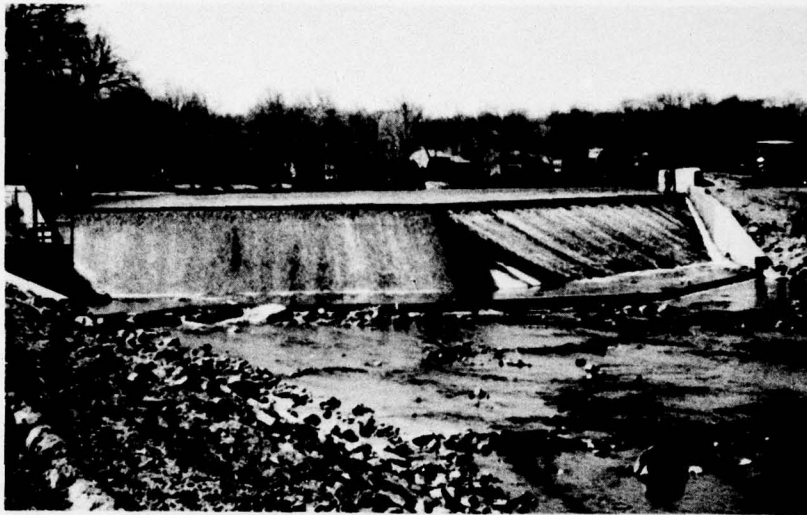
Photo 1 - View of dam from downstream; low level outlet facilities are on the left side of picture (right abutment)

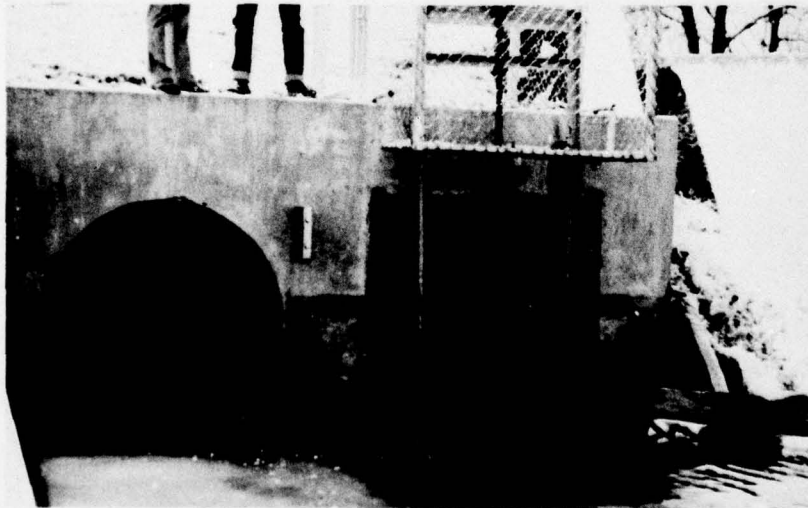
There was a leak of approximately 10 gpm coming from between the sluice gate frame and the face of the concrete spillway training wall extension to which the frame was anchored. No structural failure of anchor bolts or concrete could be found. The leakage is most likely due to failure of grouting or caulking compound.

Photo 2 - Close-up of downstream face of right abutment wingwall showing plugged 54-inch dia. diversion pipe used during construction, and face mounted 36-in. dia. low level outlet gate

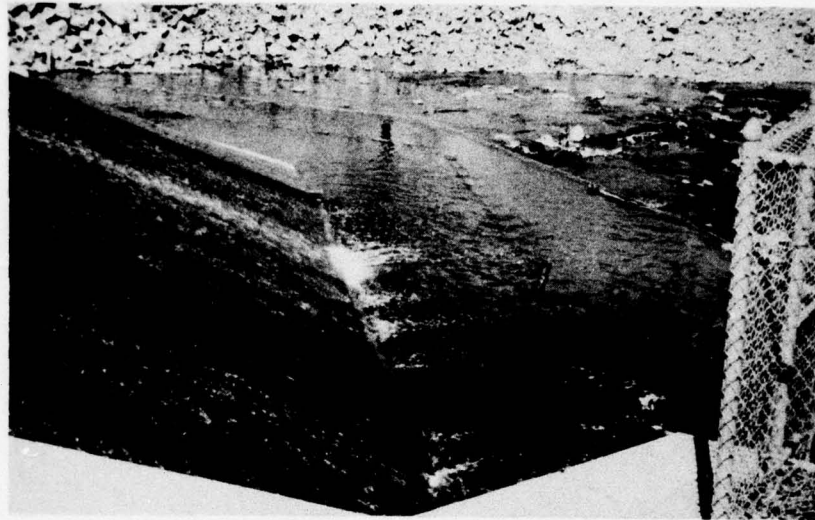
Photo 3 - View of the toe of the spillway and the stilling basin; the view is toward the left downstream channel bank; the 36-inch dia. low level outlet discharges into the stilling basin

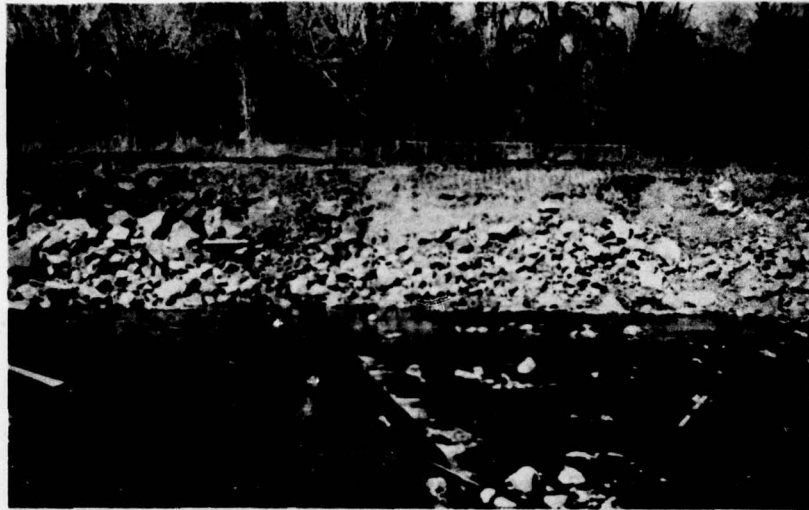
auxiliary spillway when the dam was overtopped, eroding the downstream channel bank riprap by undermining it. The resulting sloughing and slumping can be noticed in a local area 10-foot long. The poor geometric orientation of the left spillway training wall causes spillway water at high discharges to jump over the wall and erode the fill behind it. This action is potentially dangerous to the stability of spillway section and left abutment, if left uncorrected.

Photo 5 - View of damaged and slumping channel bank protection at the left channel bank caused by overtopping of the left abutment area by storm of November 7, 1977; the damaged area is at end of the stilling basin end sill visible in this picture

- Heightening of the left spillway training wall to prevent overtopping during high spillway discharges.
- Regrade and protect the present eroded areas in back of this wall.
- Repair sloughed riprap bank protection downstream of the left spillway training wall damaged by the November 8, 1977 overtopping.
- Anchor the 36-inch dia. low level outlet gate frame firmly in order to eliminate presently observed leakage.

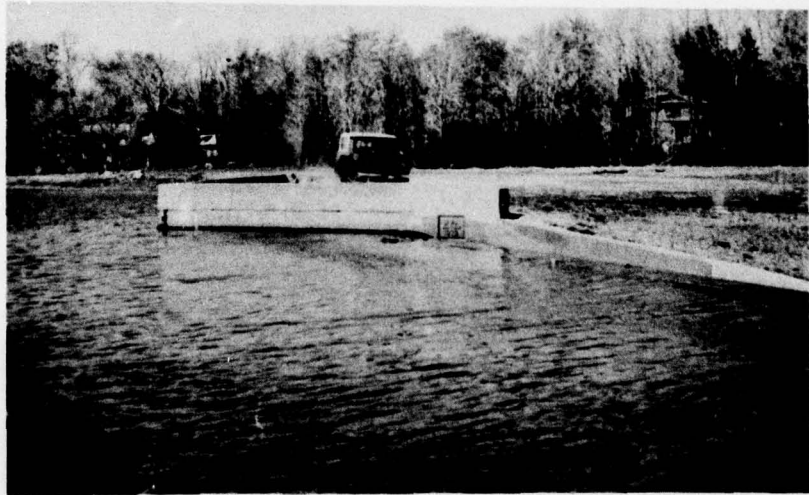
Photo 6 - View of the right abutment area overtopped on November 7, 1977, looking across the ungated weir crest and at the upstream abutment wing-walls

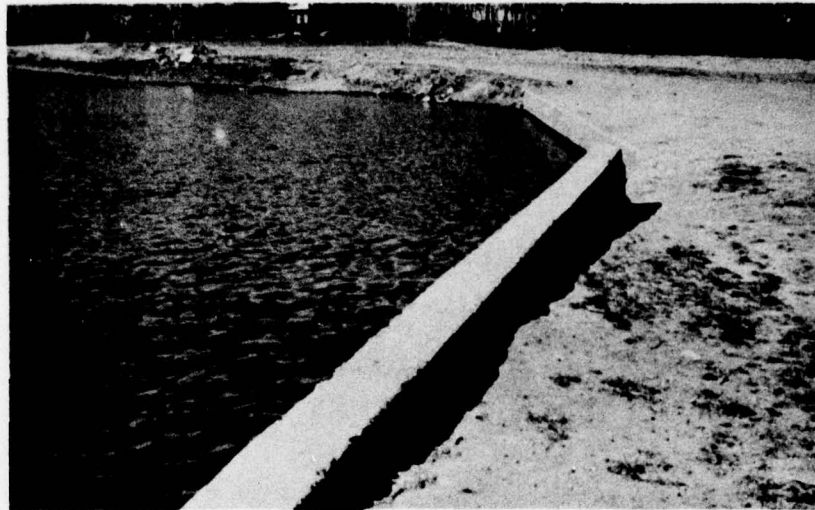
Photo 7 - View of left abutment upstream wingwall topped on November 8, 1977. The upstream shore of White's Pond can also be seen

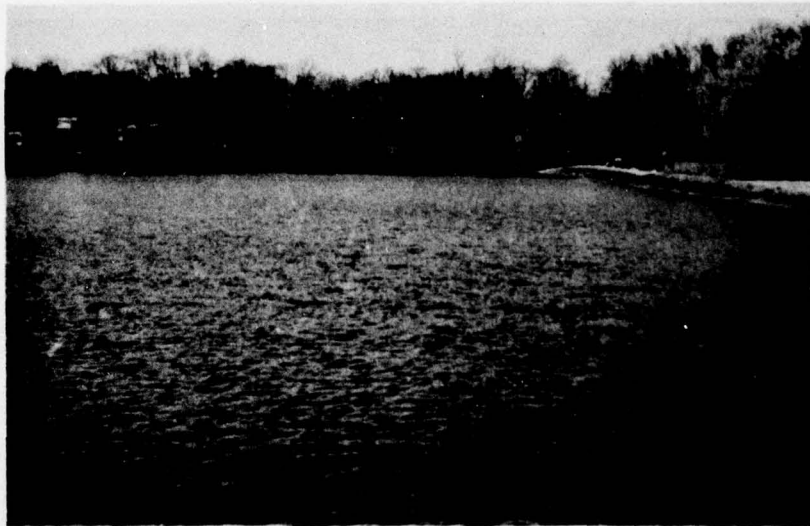
Photo 8 - View of White's Pond, looking toward the left shore line upstream of dam

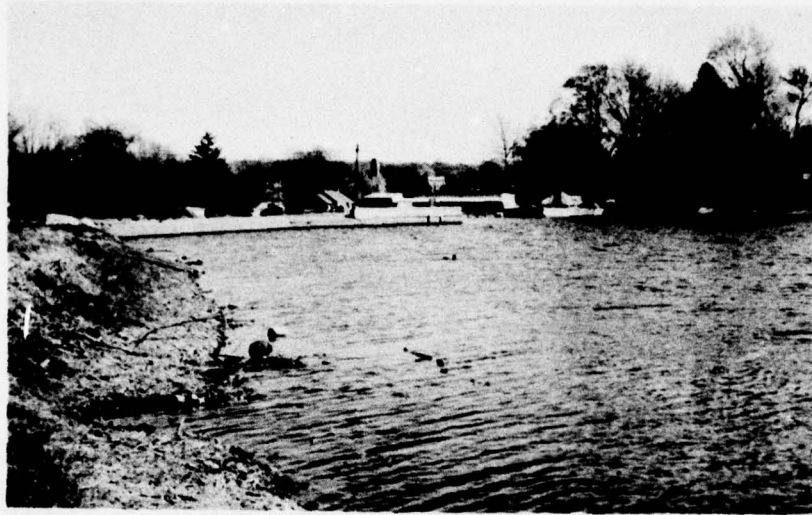
Photo 9 - Upstream face of the dam from left shore of White's Pond Dam

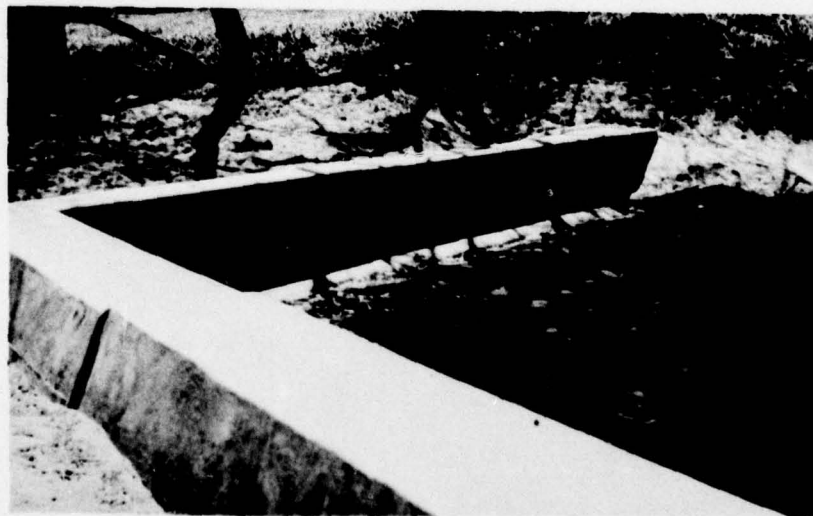
Photo 10 - Right abutment gravity cap wall added in the 1976 reconstruction; this wall was topped by one inch on November 7, 1977

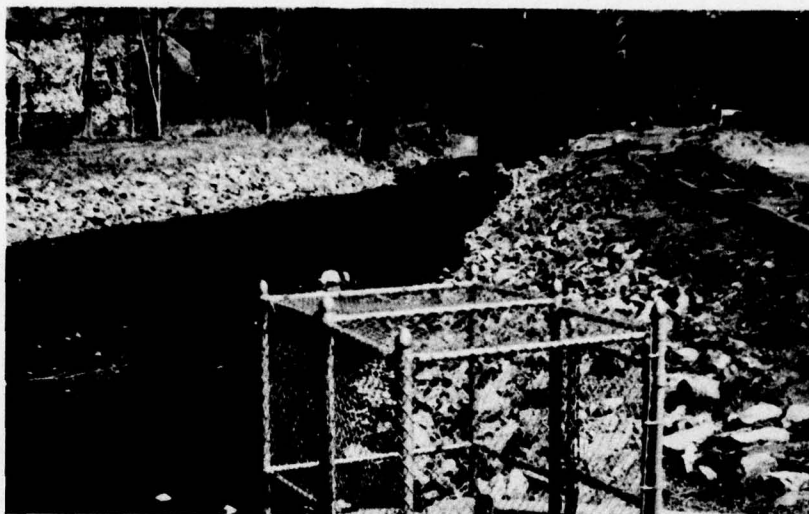
Photo 11 - View of downstream channel of Hohokus Brook; looking from right abutment area toward Hopper Avenue. The fenced enclosure in the foreground is to protect the 36-inch slide gate hoist stand on the low level outlet conduit.
