DUNDEE LAKE DAM

PHASE I INSPECTION REPORT
NATIONAL DAM SAFETY PROGRAM

NJ 00243

JUNE 1978

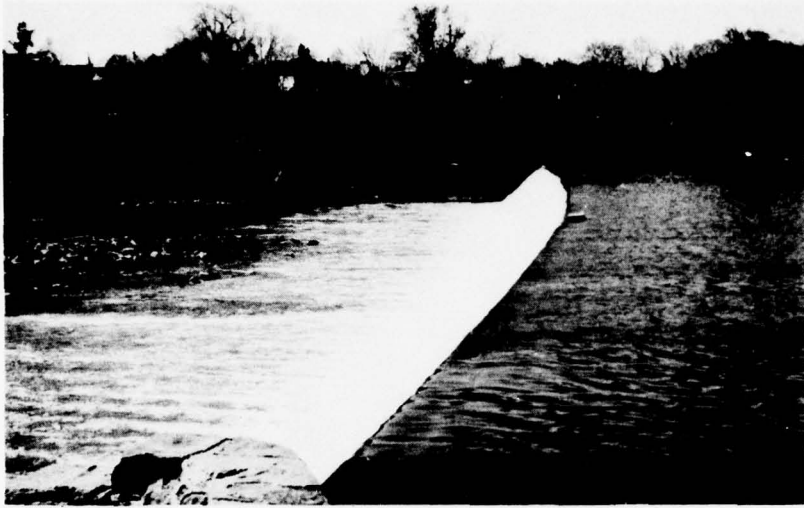
Photo 1 - General view from left bank toward right abutment and canal intake on right bank

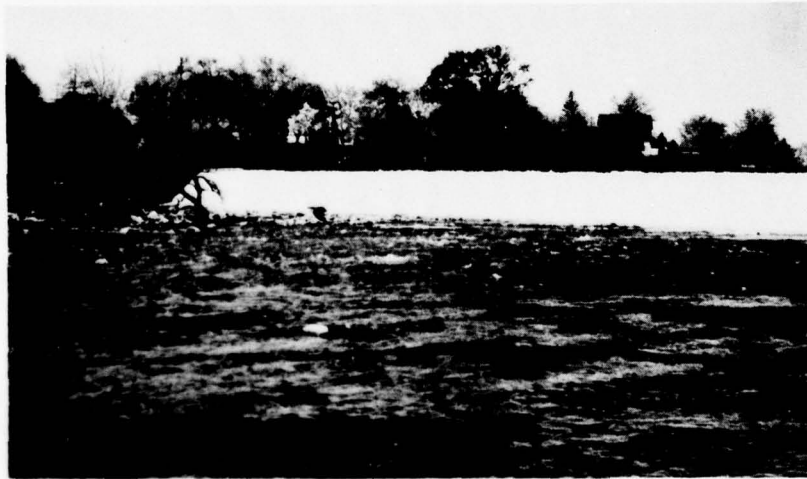
Photo 2 - View from downstream left bank looking toward right abutment

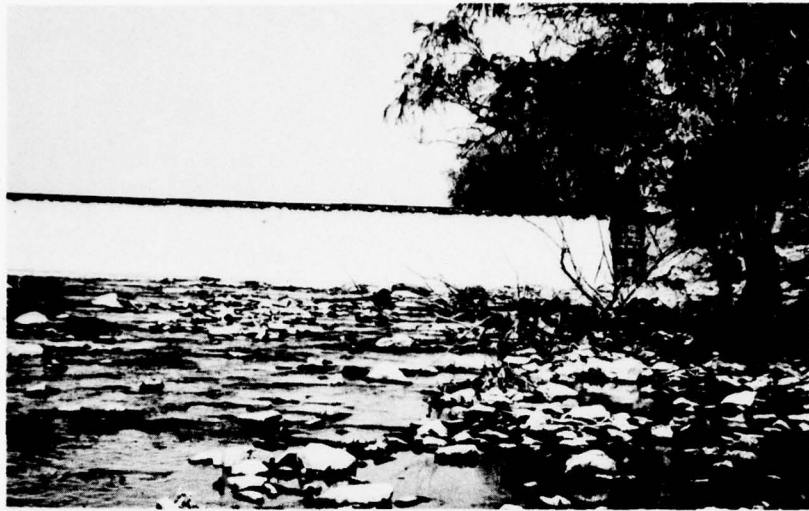
Photo 3 - View from downstream left bank at left abutment

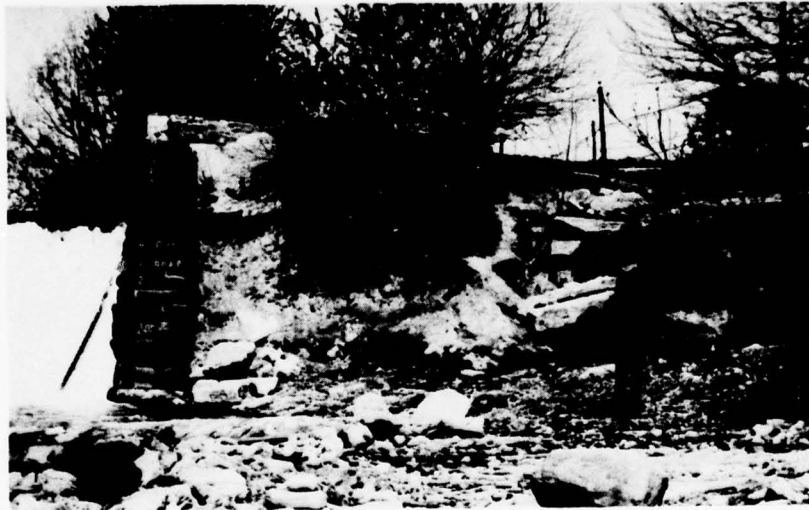
Seepage was observed in two areas, 3 to 5 feet in length, above the toe of the left abutment, approximately 12 to 15 feet from the spillway wingwall. The seepage was estimated to be about 1 gpm at the time of the inspection, and the source is believed to be the reservoir.

Photo 4 - Close-up view of left abutment; seepage is coming out at a point half way between the figure and the spillway training wall

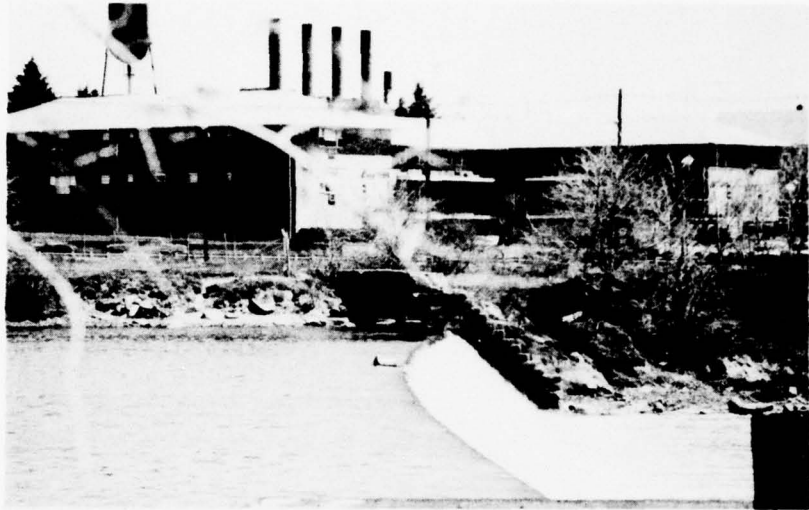
There was no evidence of structural cracking. The left abutment has been partially destroyed or vandalized at the top courses of masonry. The downstream area of the left abutment is severely eroded by drainage

Photo 5 - View of left abutment and left spillway training wall from right abutment

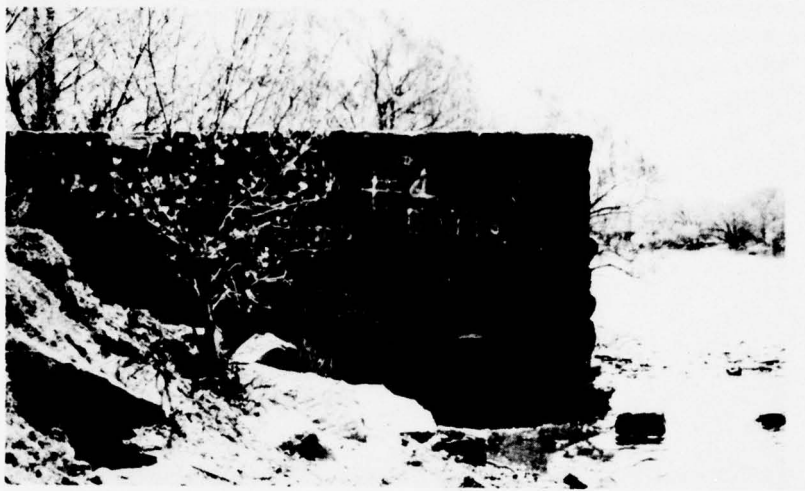
Photo 7 - View of left abutment from upstream side of dam

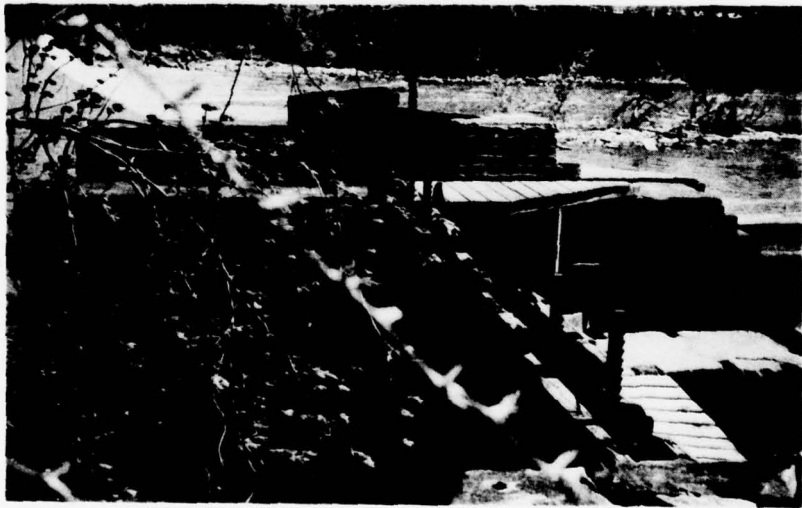
The canal intake is in an advanced state of deterioration. The miter lock gate on the riverward pass is inoperative in the closed position. The paddle valves, originally meant to equalize water levels on both sides of the miter-gate for ease of operation, are still operable and are adjusted to control water levels in the Dundee Canal. The downstream lock gate on this pass has been removed.

The landward pass is blocked by a timber wall which contains four manual operated sluice gates. This timber wall separates the reservoir from the canal. The sluice gates were originally operated by a handwheel and a spur gear reduction drive. All the operating mechanisms have been partially dismantled and the sluice gates have been abandoned, and at one point in the past, were set on fire by vandals in an attempt to burn them down.

Photo 8 - View of right bank and Dundee Canal intake. The vertical lift gates in the landward pass are inoperative. The Mitre gate in the riverward pass has vertical axis paddle gates that permit water to enter the canal for industrial use. This installation is in an advanced state of dilapidation

These structures (the lock gates and timber wall) should be replaced by a more durable structure, and this new structure should contain facilities for by-pass and emergency reservoir draw-down.

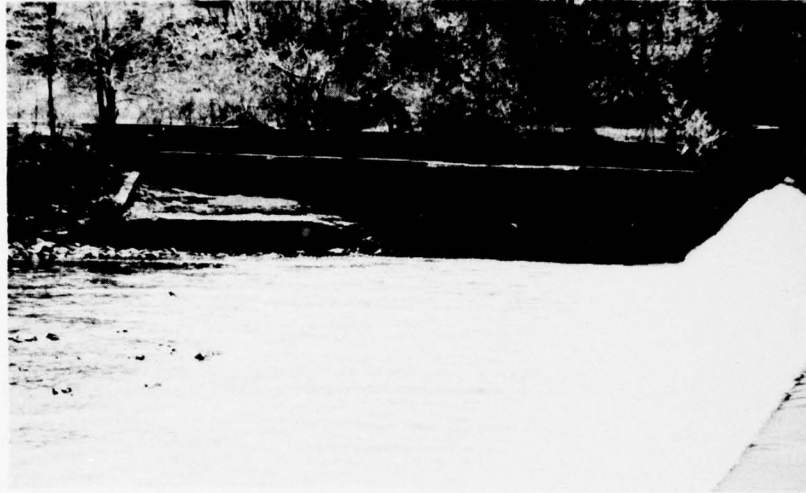
Photo 9 - River wall of Dundee Canal intake; the wall has been lowered to act as a water level control weir for the Dundee canal at high flow rates of the Passaic River; wall is leaking at places through masonry joints

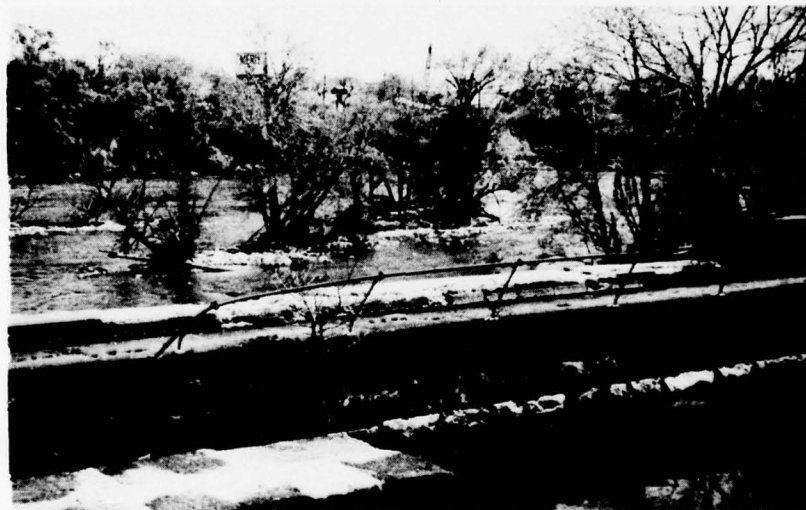
Photo 10 - View of Dundee Canal intake center wall (with railing) and cut down river wall acting as a sideweir beyond it

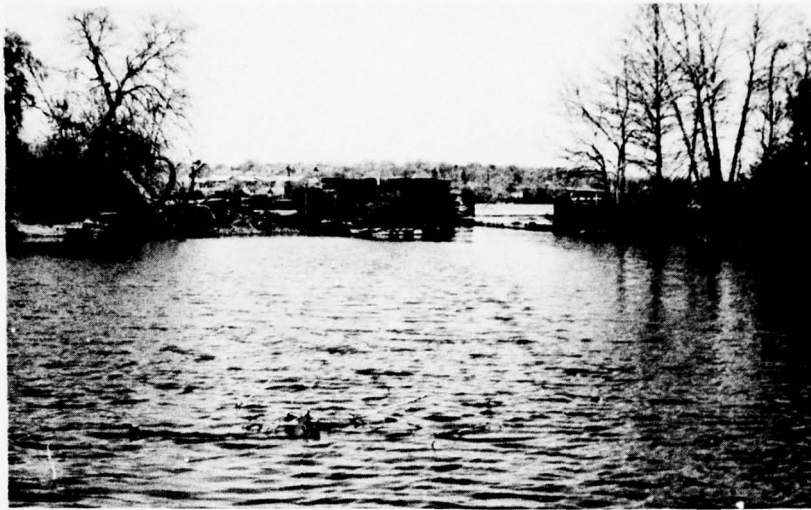
Photo 11 - General view of Dundee Canal intake from right canal bank looking upstream

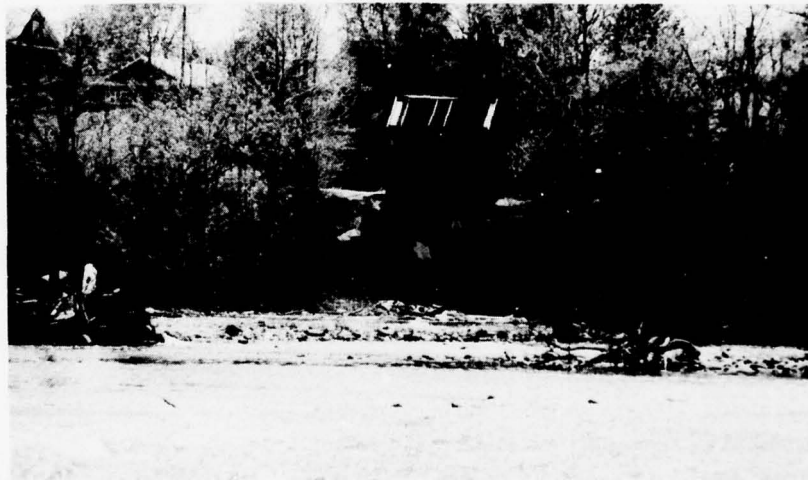
Photo 12 - View of right abutment downstream of dam axis from left bank showing canal bank and gate house used originally for emptying of canal and as low level outlet

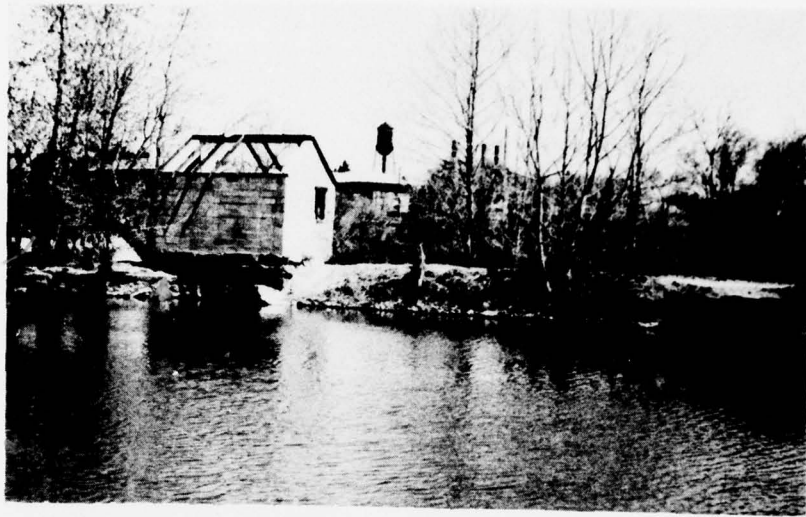
Photo 13 - View of gate house looking across Dundee Canal toward left abutment

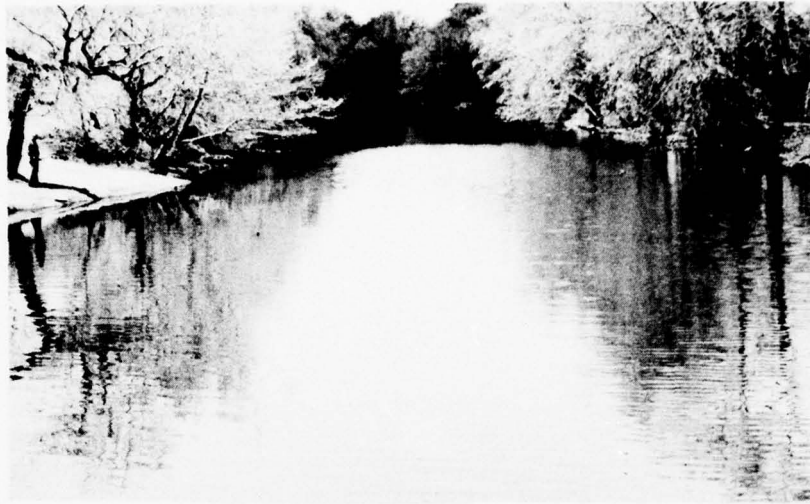
Photo 15 - View of Dundee Canal looking upstream of crossing at Ackerman Avenue, Clifton, NJ

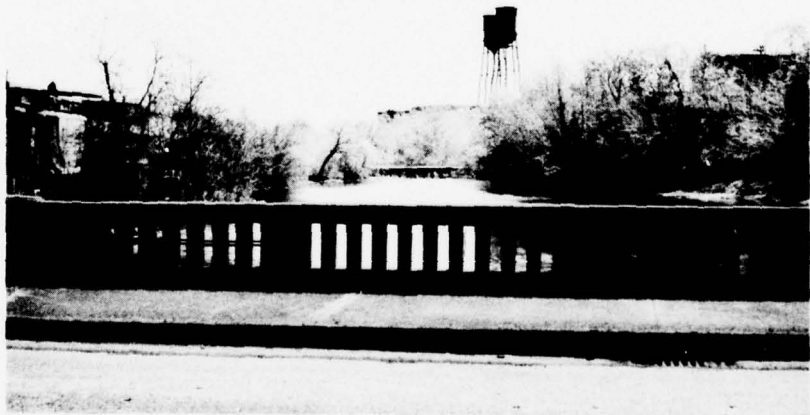
Photo 16 - View of Dundee Canal looking downstream of crossing at Ackerman Avenue, Clifton, NJ
