CHARLOTTEBURG DAM

PHASE I INSPECTION REPORT

NATIONAL DAM SAFETY PROGRAM

(NJ00316)

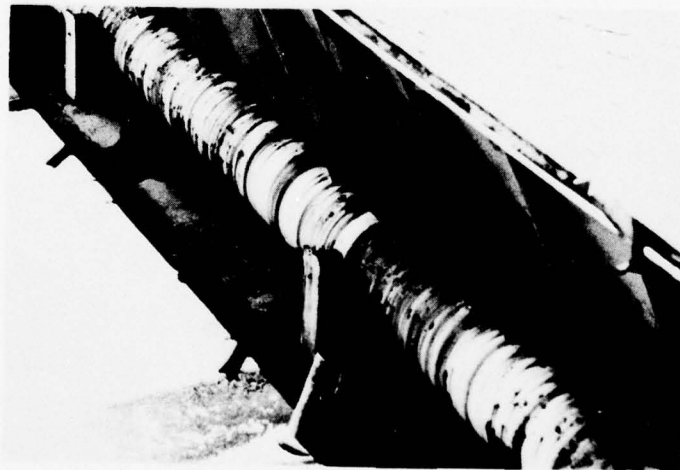
The bascule gate shows minor surface corrosion occurring over approximately 10 percent of the visible surface area. At the next available opportunity the entire gate should receive a coat of protective paint.

The bascule gate seals in the closed position leak a considerable amount of water on the right half of the spillway. This condition, while not objectionable in the summer, could lead to excessive ice build-up on the ogee and gate in a severe winter which would exceed the ability of the heaters to control the problem. This would reduce the spillway capacity. This leakage would make dewatering of the stilling basin difficult. The cause for leakage should be ascertained and corrective measures taken.

Photo 2 - Close-up of bascule crest gate in fully
closed position

- (4) The bascule gate should be repainted. The gate's operating piston rod seal should be repacked to prevent loss of hydraulic fluid. The scales on the right side of the gate should be checked and repaired to eliminate large volume leakage water when the gate is closed.

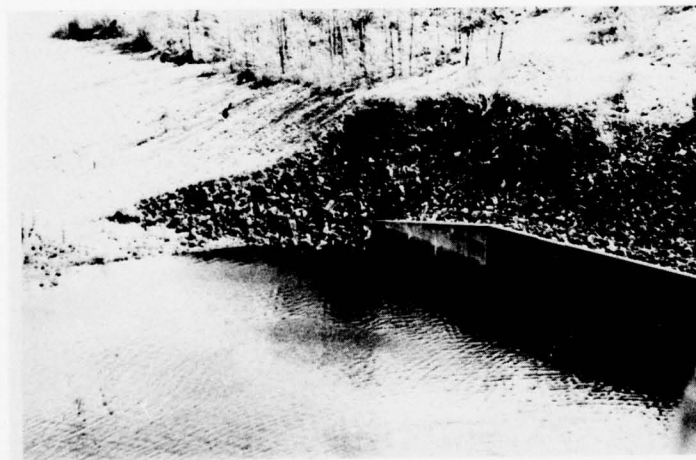
Photo 4 - Downstream end of right stilling basin wall; end sill and baffle blocks are submerged by normal tailwater

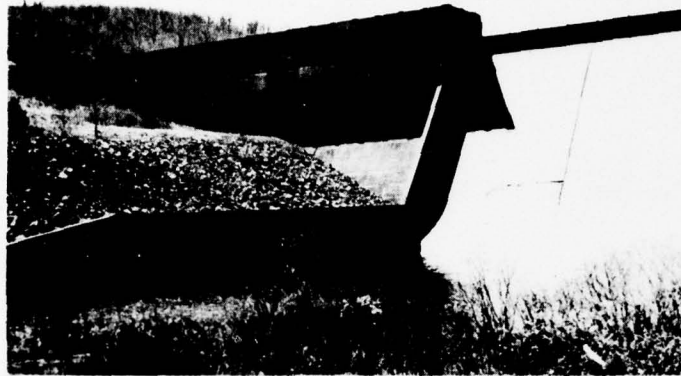
In Monolith 11, there appears to be a defective horizontal lift joint which exhibits through-the-dam leakage for about a 10-ft. width. This location is in the right bulkhead (non-overflow) section at approximately elevation 738. The low head on this joint at the time of inspection, (approx. 3 to 5 feet) indicates that the defect must be fairly wide spread in order to leak right through the whole thickness of the concrete, which is 15-ft. thick at this level.

Photo 5 - Spillway, right abutment and right stilling basin retaining wall. Note wet spot on downstream face of non-overflow monoliths indicating poor lift joint

- (1) Investigate through dam leakage in horizontal lift joint in non-overflow monolith No. 11 and formulate plan for repair. Repair of this joint should be initiated in calendar year 1979.

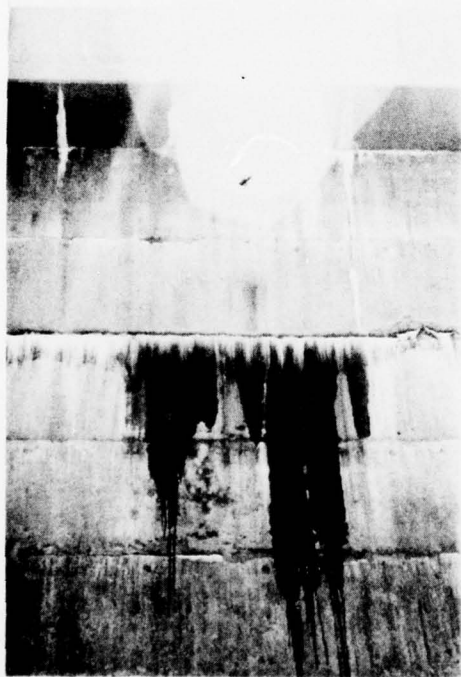
Photo 6 - Close-up of wet spot on monolith 11 indicating leakage through bad horizontal lift joint

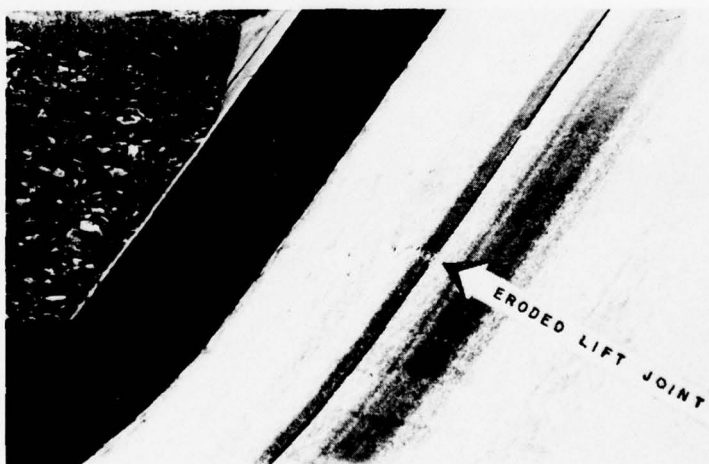
Photo 10 - Spillway looking toward right abutment showing poor lift joint in monolith 9

- (2) Repair lift joint in overflow monolith No. 9 at elevation 685 to 690 ±.
- (3) Dewater stilling basin and inspect floor, chute blocks and end sill for erosion of concrete surfaces. Repairs, if required, should be initiated in calendar year 1979.

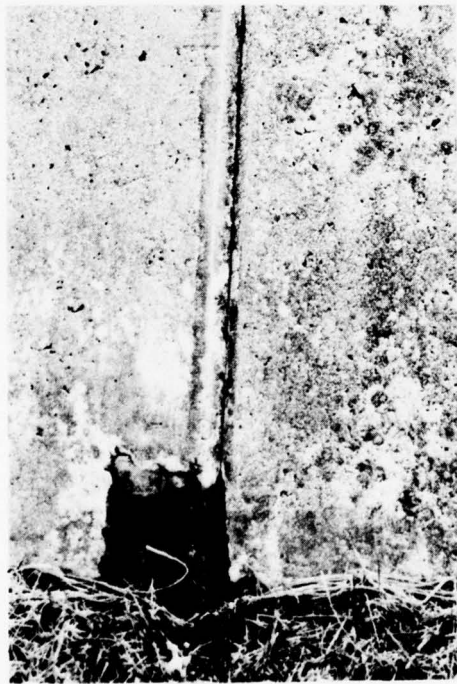
Photo 12 - River Wall - Leaking
vertical monolith joint
at base of monolith

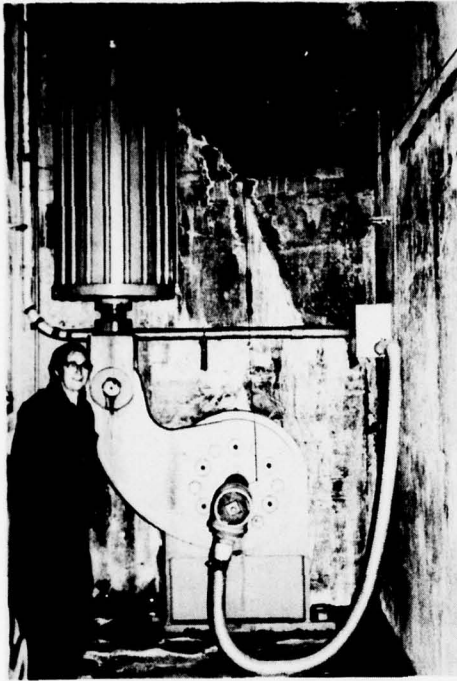
Prior to this inspection, the hydraulic cylinder on the east end of the bascule gate had developed a small leak at the piston rod seal. Operation of the gate was not affected, and the leak eventually stopped. The local operator stated that Allis Chalmers, the original manufacturer of the gate, was scheduled to replace the piston rod seal during July 1978 (when the reservoir level is down below the concrete crest).

Photo 13 - Spillway bascule gate
actuating cylinder on
left abutment
