PASSAIC RIVER BASIN
RAMAPO RIVER, BERGEN COUNTY
NEW JERSEY

LAKE VREELAND

PHASE I INSPECTION REPORT NATIONAL DAM SAFETY PROGRAM

JULY 1978

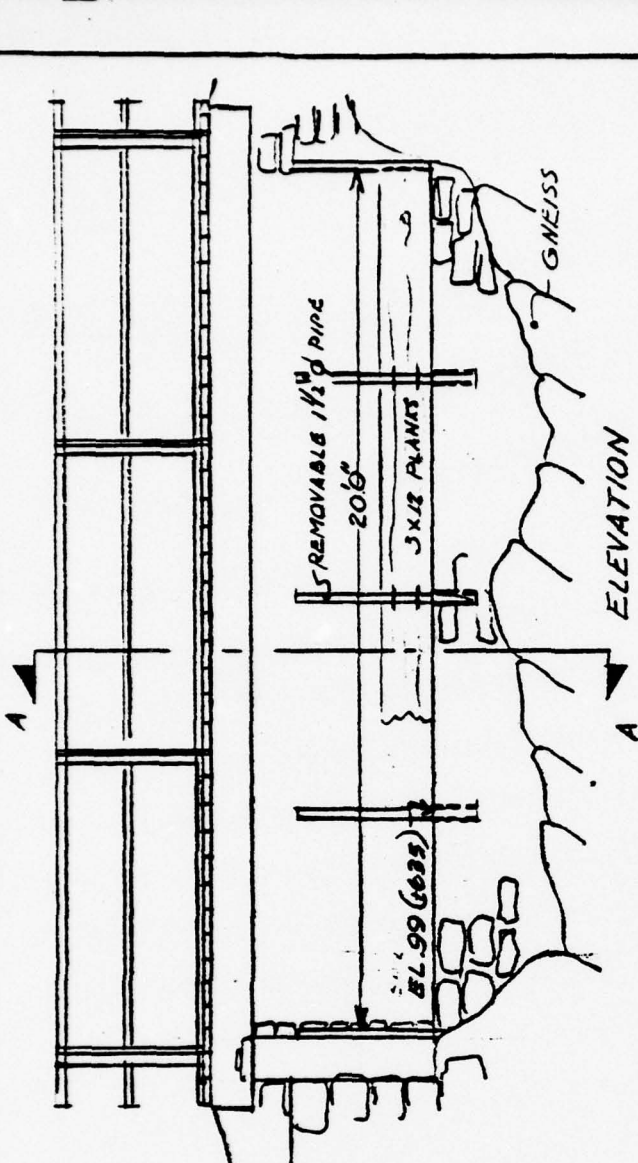
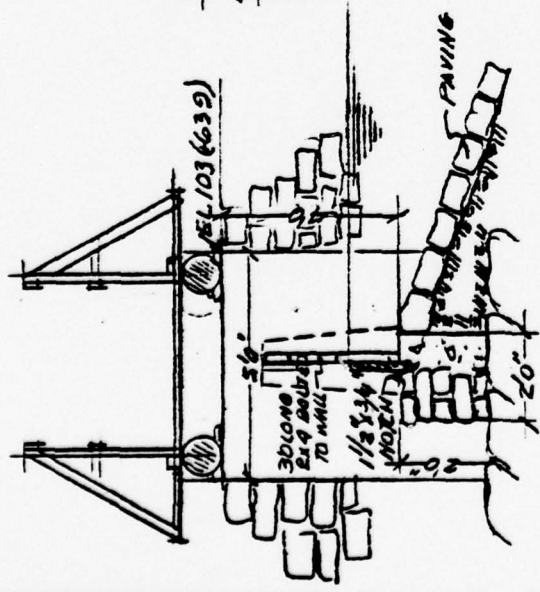
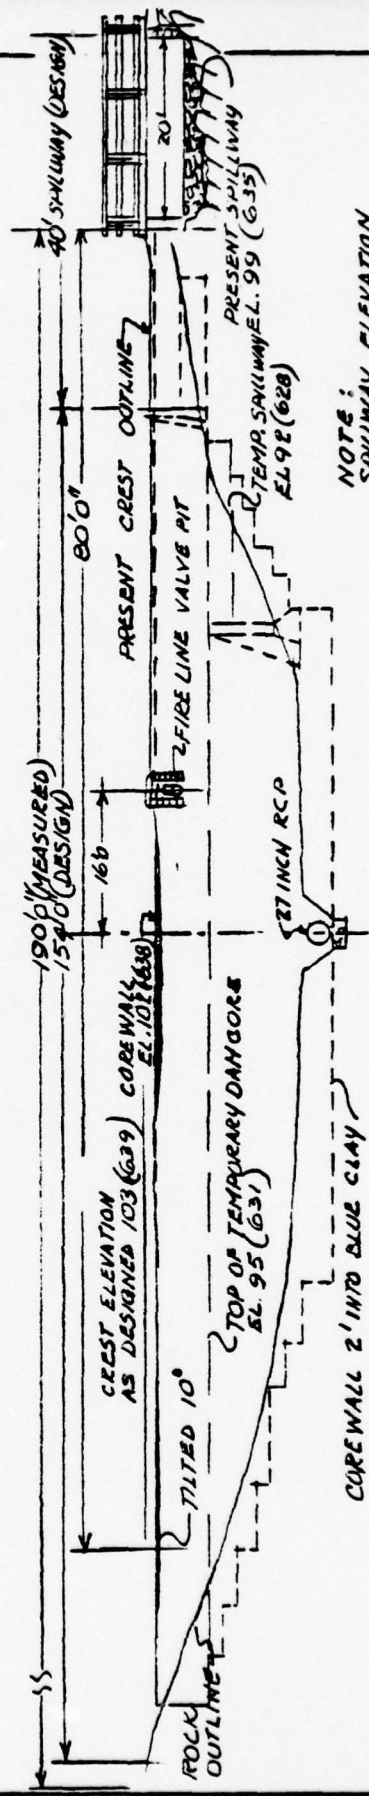
FIGURE 3
LAKE VERBENA DAM

6.1.4 Post-Construction Changes: Since the inspection by the State of New Jersey on May 10, 1955 (See Figures 3 and 4), the dam cross section has changed greatly from the original design. These post-construction changes might have been necessary to repair the damage caused by the overtoppings of the dam.

ITEM	REMARKS
SPILLWAY PLAN	Present spillway does not conform to 1917 construction drawing
SECTIONS	(See Figures 3 and 4)
DETAILS	
OPERATING EQUIPMENT PLANS & DETAILS	Not Available Not Available
MONITORING SYSTEMS	None
MODIFICATIONS	None
HIGH POOL RECORDS	None
POST CONSTRUCTION ENGINEERING STUDIES AND REPORTS	Letter dated 5/17/56 by Norman Wittwer - Describes inadequacy of spillway, not large enough to pass flood of 8/19/55 without overtopping. Recommended raising crest of dam 1 foot or not more than 5.0 feet above spillway crest.
PRIOR ACCIDENTS OR FAILURE OF DAM DESCRIPTION REPORTS	None
MAINTENANCE OPERATION RECORDS	None

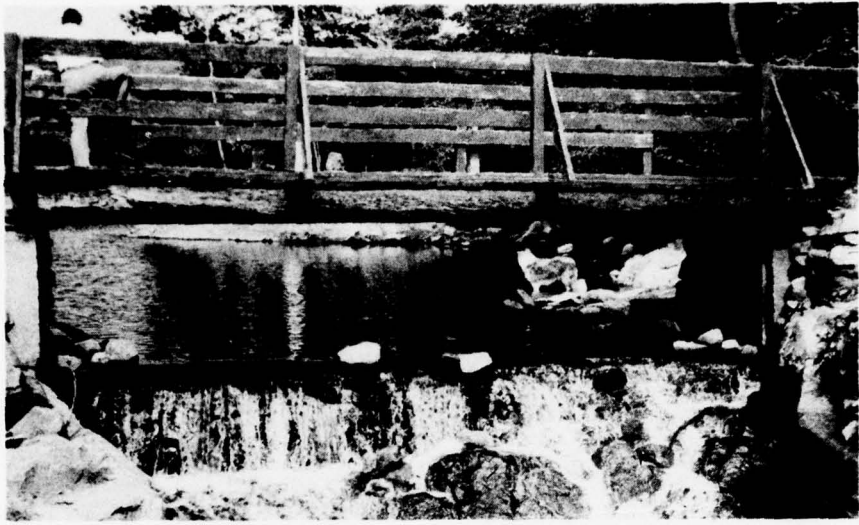
SPILLWAY

3.1.2 Appurtenant Structures: Concrete surfaces of the spillway wall show some aggregate but do not appear to be detracting from the overall stability of the structure. The wooden bridge and handrail over the spillway were in good condition. The right spillway abutment is of concrete and in good condition (see Appendix H). The left spillway abutment is of fieldstone and needs some touching up with mortar.

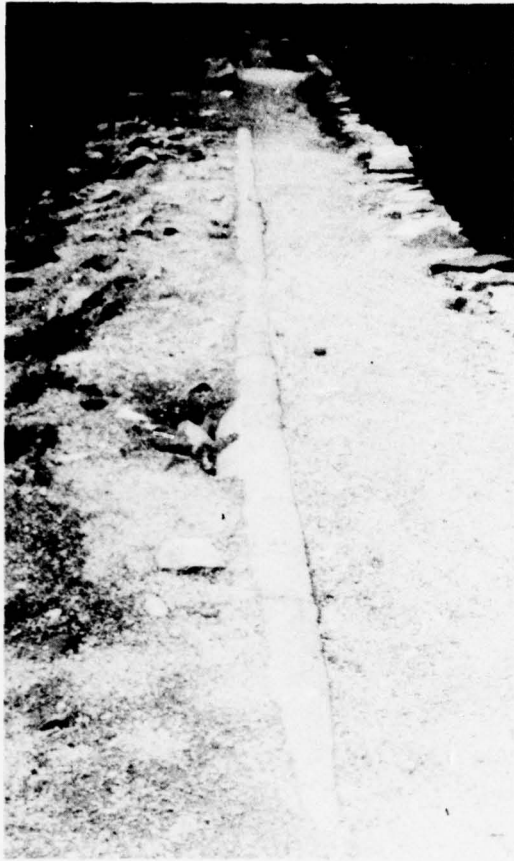
The riprap is stacked vertically and the corewall is exposed over 50 percent of its length. The tilt of a portion of the corewall as evidenced at the crest cast doubts with respect to the integrity of the concrete corewall. The foundation of the concrete corewall may have experienced excessive differential settlement if the wall is founded partially on blue clay and bedrock.

EXPOSED CONCRETE CORE

d. Engineering investigations and studies should be made of the condition of the tilted concrete corewall as well as determination of the properties of the embankment as it pertains to the structure's stability. These investigations and studies should be completed within six months from the date of approval of this report. Any remedial measures found necessary as a result of these investigations and studies should be initiated within calendar year 1979.

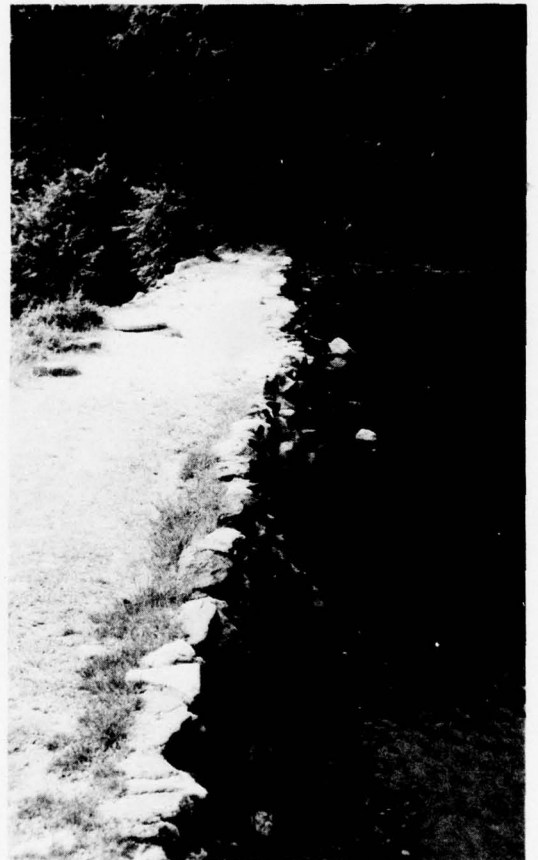
VISUAL EXAMINATION OF	OBSERVATIONS	REMARKS OR RECOMMENDATIONS
RIPRAP FAILURES	Three feet of riprap visible, stacked vertically resting on gently sloping shelf of soil (± 3.5 feet wide) on wet side.	The upstream slope was constructed to 2 horizontal: 1 vertical and the entire slope was protected with paving 9 inches thick.
CORE WALL	Visible in two locations, about 25-foot sections. The section nearest the right abutment shows a $10^{\circ}\pm$ angle with the vertical, and the top of the wall section is not level, but slopes towards the downstream side.	Possibility exists that the core wall has cracked, and that water is seeping through said crack with resultant piping etc.
JUNCTION OF EMBANKMENT AND ABUTMENT, SPILLWAY AND DAM	No distress or seepage noted	
ANY NOTICEABLE SEEPAGE	1 Minor seepage located at the foot of the slope about 70 feet downhill from the toe of the slope. 2 A series of springs flowing at estimated 15-20 gpm is visible in the middle of the parking area, and 220 feet below the toe of the dam.	The Boy Scout Camp Ranger did not remember if this spring was flowing during deepening of lake in 1976. Lake was drained at the time.

VIEW OF UPSTREAM RIPRAP
AND VERTICAL DAM FACE

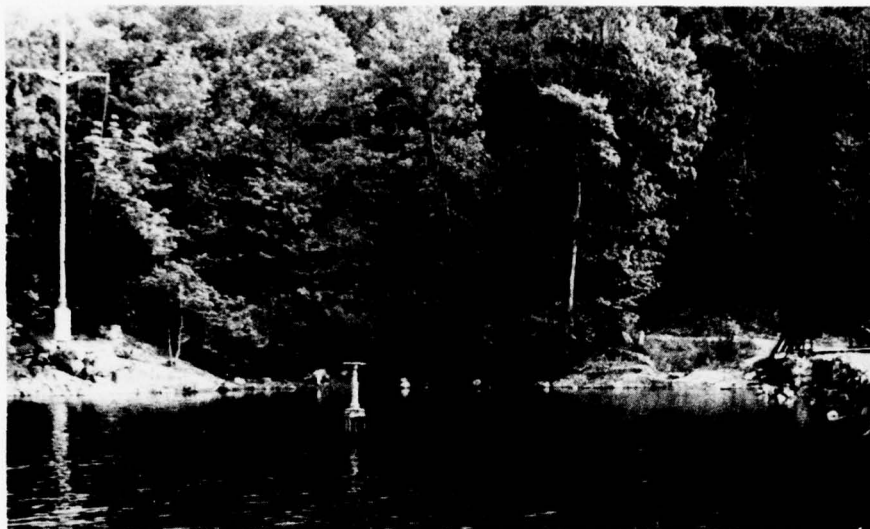
VIEW OF LEFT ABUTMENT
NOTICE PEDESTAL FOR BOTTOM RELEASE GATE

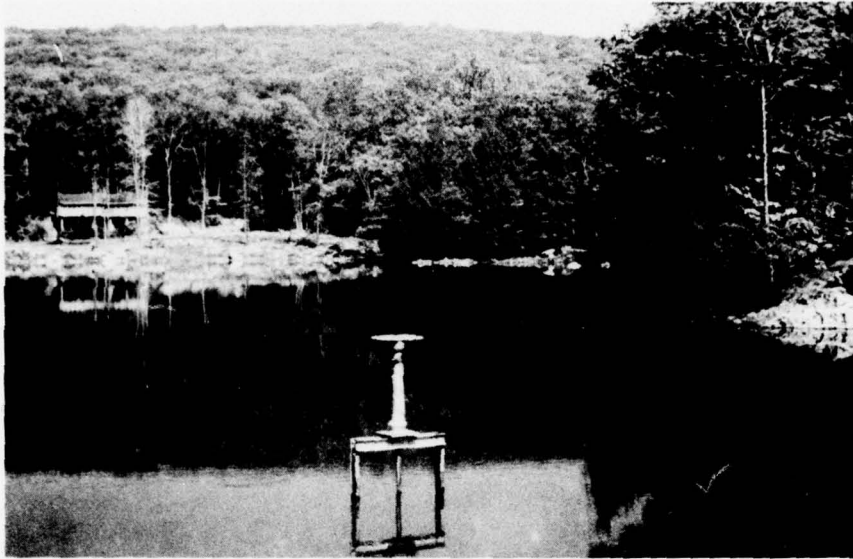
VIEW OF RESERVOIR

3.1.3 Reservoir Area: Considerable fine sediments composed chiefly of silty clay to clayey silt were laid in and around the upper reservoir area. Vegetation cover in some areas near the shore is very poor. No serious problems were observed in the reservoir area.

NOTE: THERE IS NO BRIDGE TO CONTROL GATE

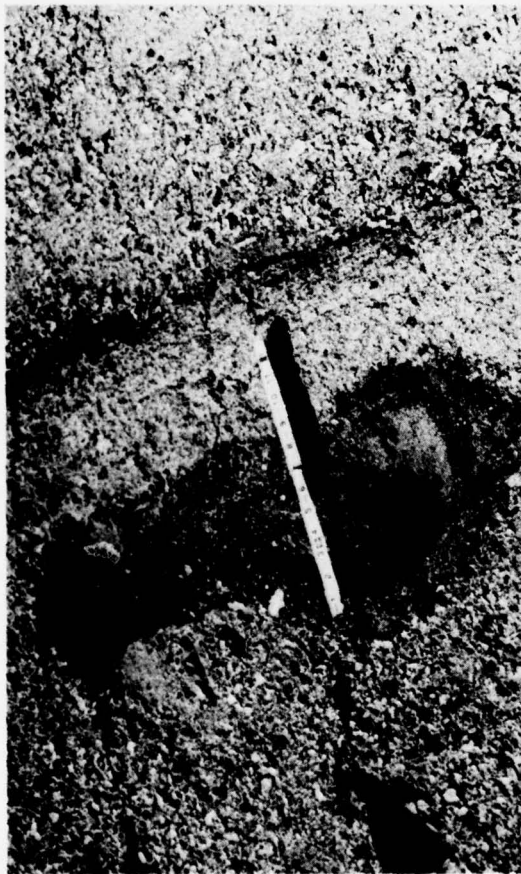
3.1.1 Dam: Some sink holes as large as 9 inches in diameter were observed along the top of the dam. These sink holes were present chiefly along the downstream side of the concrete corewall and the upstream edge of the crest. A section of the exposed corewall on the south side was tilted about 10 degrees toward the downstream. The ground surface at the crest and the top of the corewall were not uniform, which may indicate the results of differential settlements. The downstream embankment varied considerably in slope, material composition and gradation, and method of construction. The material exposed along the downstream slopes is composed chiefly of silty sand, gravel, and boulders. The junction of the embankment and abutment did not show any seepage at the time of inspection. Seepage was not observed along the embankment slopes and toes. There is a small wet ditch located along the toe of the right valley wall at the distance of about 20 feet downstream from the toe of the embankment. A group of intermittent springs with estimated flow of 15-20 gpm at the time of inspection has developed 220 feet downstream from the toe of the embankment at the center of the access roadway. Small amounts of leakage reported (see letter Page E-4, Appendix E) coming out of downstream toe along the concrete culvert pipe at the time of initial reservoir filling, was not discovered at this time of inspection. At a subsequent site visit by the inspection team on June 27, 1978, neither springs nor wet spots were visible.

No cracks visible; localized sinkholes up to nine inches in diameter on the dry side of the concrete corewall along the dam top, along the wet side of the dam, and along the edge of the top. An attempt was made by the Boy Scout Camp Ranger to fill some of the holes with sand.

SINKHOLE ON DAM CREST

f. Sinkholes in dam's downstream crest should be filled with an imperious, stable material within two months from the date of approval of this report.

Recommend filling the holes with sand-cement mix
