PASSAIC RIVER BASIN

ESSEX COUNTY

CEDAR GROVE WEST, NORTH, AND SOUTH DAMS

PHASE I INSPECTION REPORT NATIONAL DAM SAFETY PROGRAM

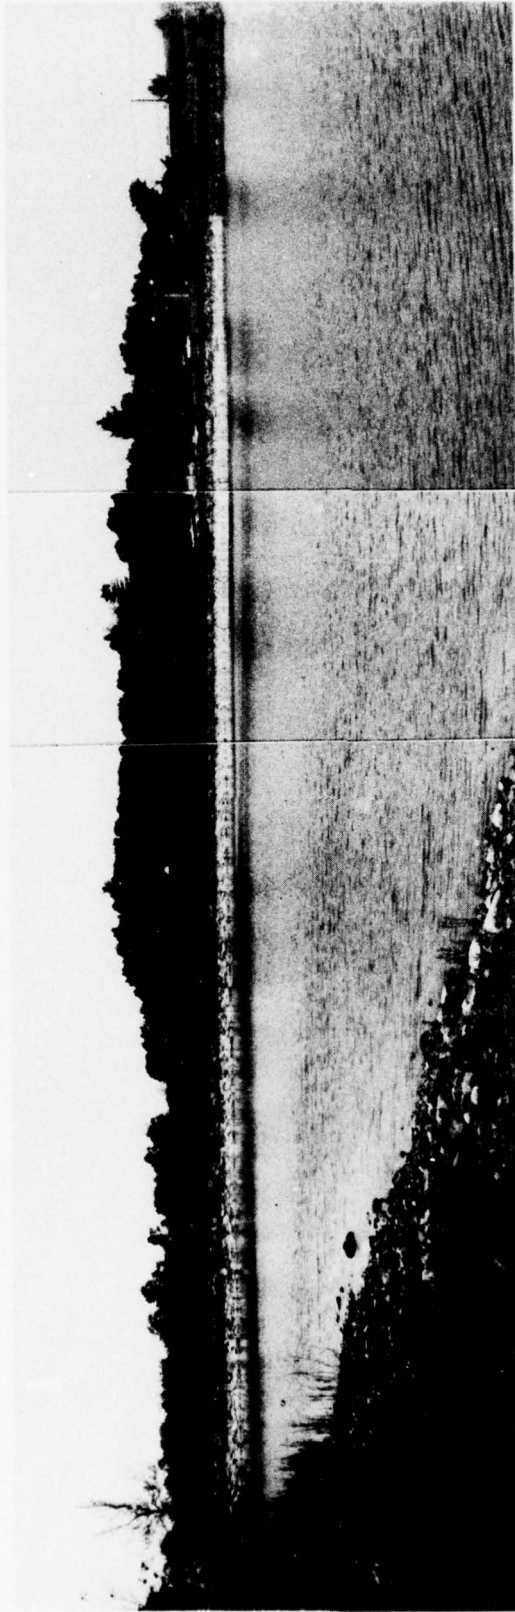
SOUTH DAM

The dislodged and disturbed riprap on the upper portion of the upstream slope of the South Dam was apparently caused by a slope failure or movement of the embankment. This condition should be further studied to evaluate the stability of the dam and to recommend corrective measures.

7.2.1 Alternatives: No alternatives to the studies outlined in paragraph 7.1.4 have been identified. Riprap on the upstream face at the South Dam should be realigned, and the failed slope inspected by a qualified engineer after the repairs have been made.

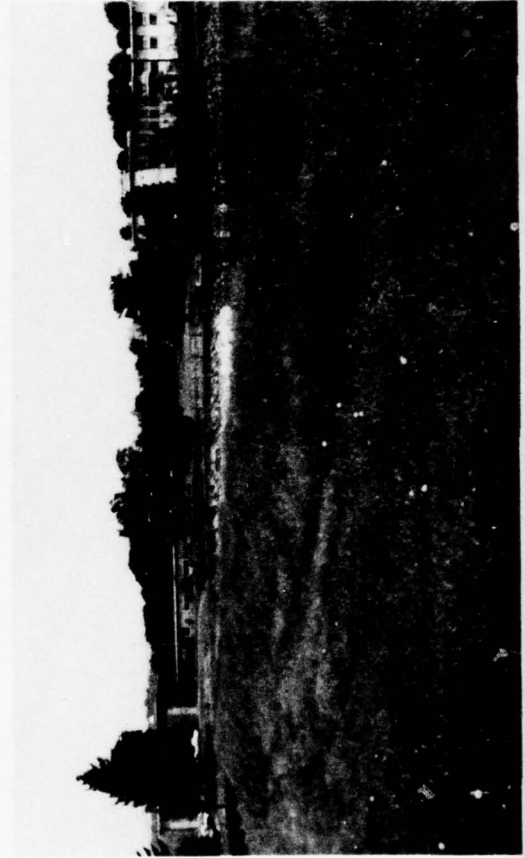
DOWNSTREAM VIEW OF
SOUTH DAM

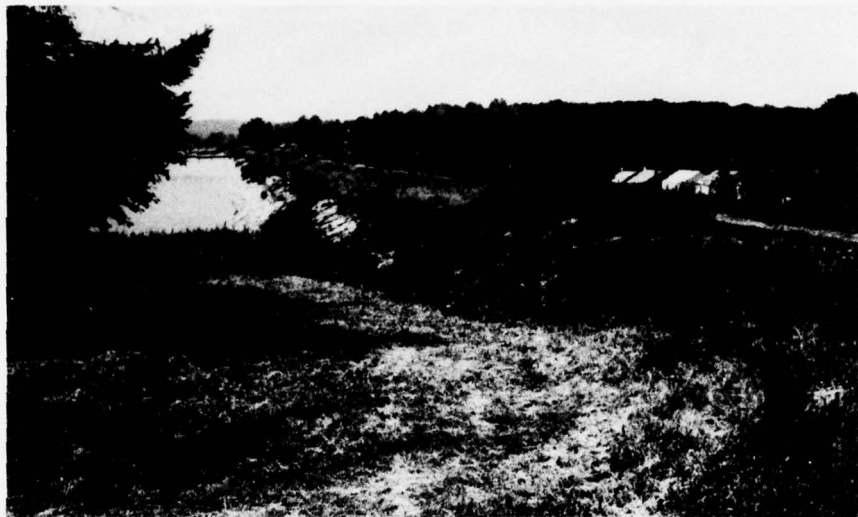
UPSTREAM VIEW OF CREST DAM

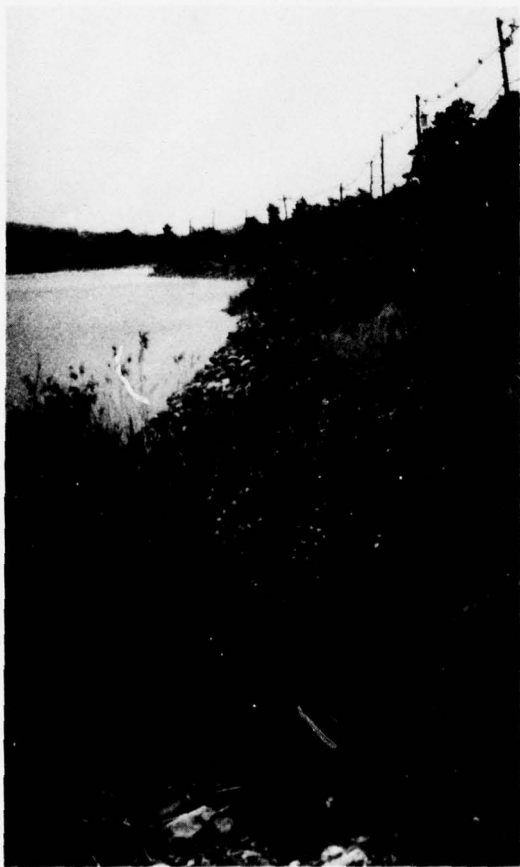
WEST SHORELINE OF RESERVOIR
BETWEEN WEST AND SOUTH DAM

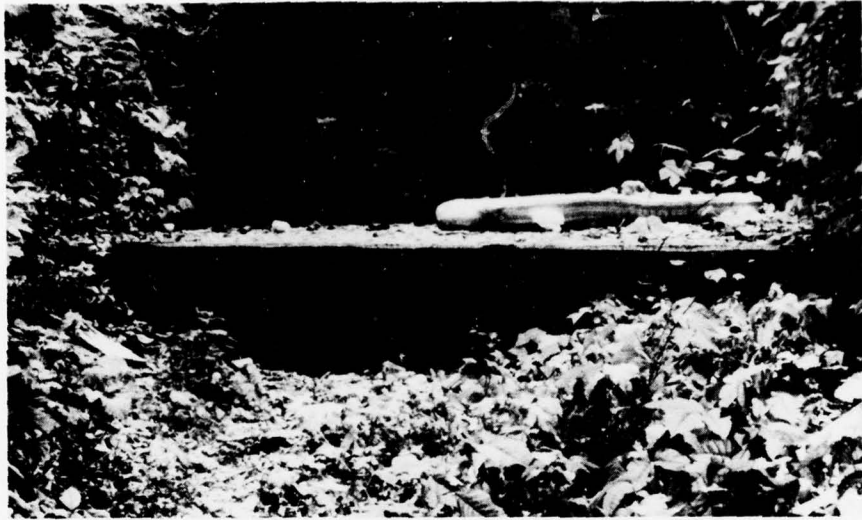
OVERFLOW WEIR

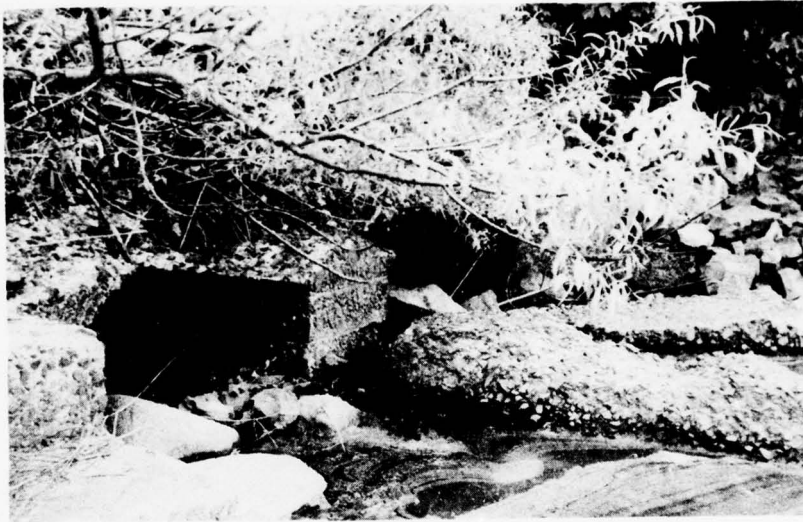
3.1.3 Appurtenant Structures: (a) Spillway - The only spillway for the reservoir is located at the east end of the North Dam. The entrance portion of the twin concrete ducts has been badly damaged, and is partially blocked by debris. The twin 28.5-inch high by 56-inch wide ducts are still serviceable. The spillway section itself appears in good condition, and has been modified since the record drawing was made in 1905.

INLET TO EMERGENCY SPILLWAY

The entrance section of the twin concrete ducts of the spillway on the east end of the North Dam should be repaired. Debris accumulated in front of this intake should be removed.
