MISPILLION RIVER, KENT COUNTY
DELAWARE, MD

(2) HAVEN LAKE DAM (DE 00042)

(4) PHASE I INSPECTION REPORT

(1) NATIONAL DAM SAFETY PROGRAM

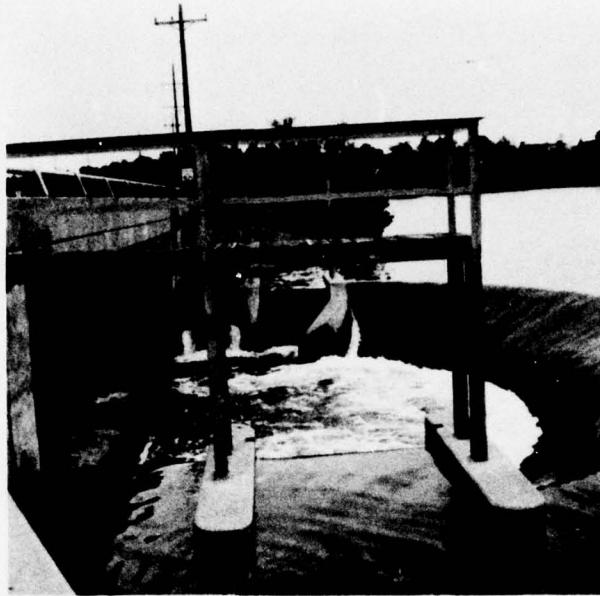
OVERALL VIEW OF SPILLWAY AND ACCESS WALKWAYS

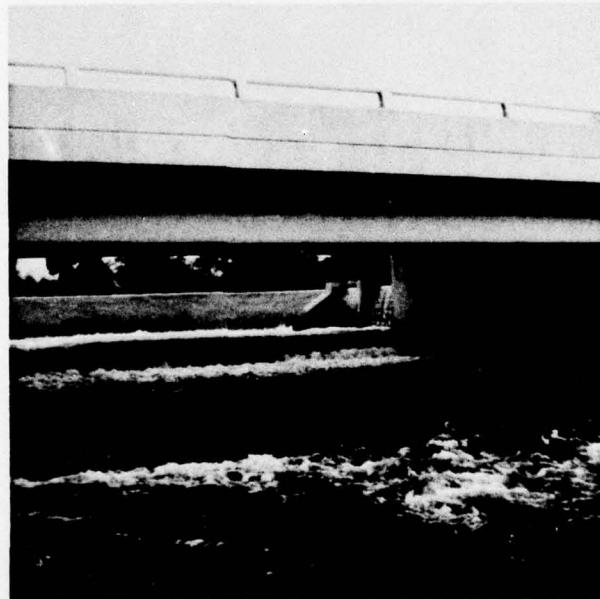
DOWNSTREAM VIEW SHOWING SPILLWAY, SLUICeway,
WIER, CONCRETE APRON AND SOUTHBOUND BRIDGE SPAN

2) Downstream Weir and Concrete Apron - Water was flowing over the 1.5 feet twin-notched concrete weir at the upstream face of the southbound bridge span. A complete investigation was not possible. It was evident, from the flow pattern, that one of the notches was clogged. The concrete apron, downstream of the weir, seemed to be good condition as evidenced by the uniform well-defined flow pattern.

c. At the next time of no flow over the spillway and low downstream flow the spillway structure should be further examined for any signs of distress. The downstream weir's notches should also be checked for clogging and cleared if required.

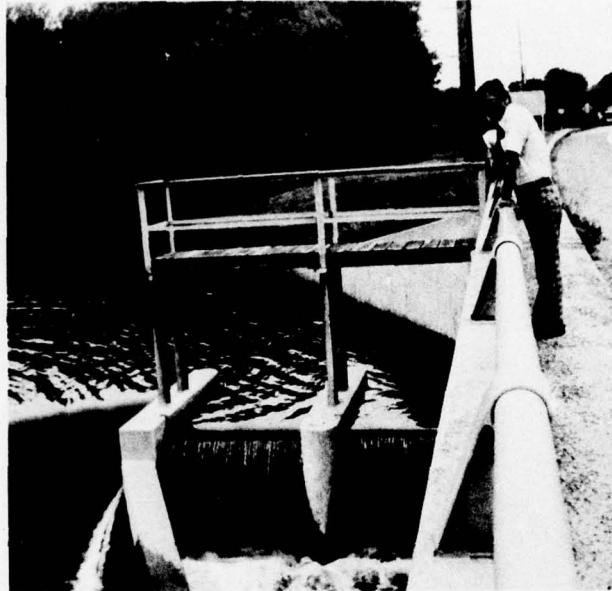
2) Sluiceways - The four sluiceways provided for drawdown appear to be in good condition with no serious deficiencies visible.

SLUICeway AND ACCESS WALKWAYS

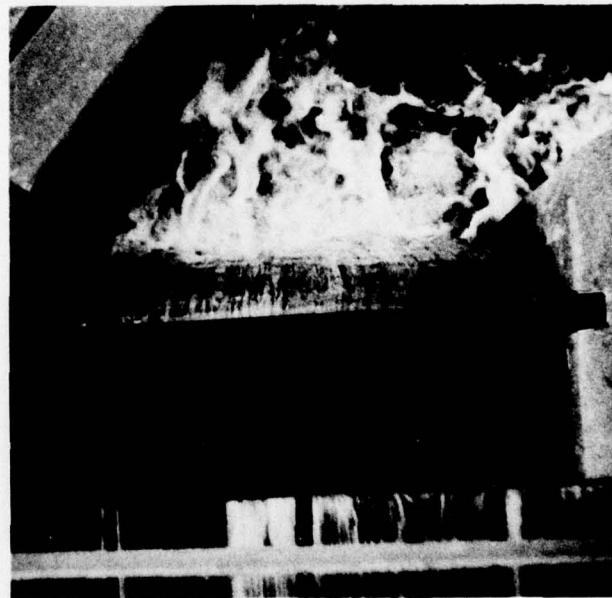
3) Stop Logs - Each sluiceway is fitted with timber stop logs. The stop logs are manually positioned to control pool elevation. The stop logs in the sluiceway immediately adjacent to the southbound lanes of Route #113 (right bank) showed leakage about three feet below the top of the upper stop log.

SLUICeway WITH STOP LOGS IN PLACE

VISUAL EXAMINATION OF	OBSERVATIONS	REMARKS OR RECOMMENDATIONS
SEEPAGE OR LEAKAGE	No seepage observed through the spillway section. However, leakage was occurring through the stoplogs in the right bank sluiceway (looking downstream) immediately adjacent to the bridge abutment.	Reservoir pool elevation should be lowered below spillway crest in the Fall to allow for inspection.
STRUCTURE TO ABUTMENT/EMBANKMENT JUNCTIONS	Abutments and wing walls in very good condition with the exception of minor concrete temperature cracking.	None.
DRAINS A-8	4" weep holes shown on plans, not observed in field inspection (See Figure #3).	Drawdown below spillway crest will allow for inspection of weep holes.
WATER PASSAGES	None.	None.
FOUNDATION	Unobserved.	None.

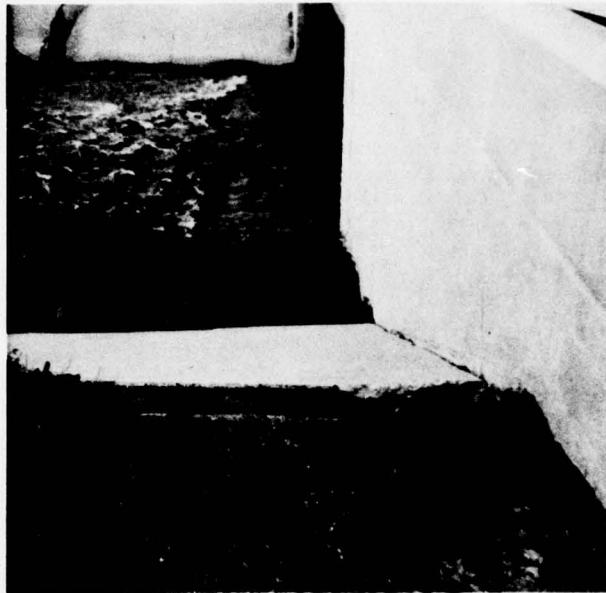
3) Miscellaneous Concrete - Undermining of the concrete lined left bank was observed between the north and southbound bridge spans. Settlement of the concrete lined right bank was also observed on the downstream face of the northbound bridge span. Cracking was noted in the south end of the southbound bridge span sidewalk.

UNDERMINING OF CONCRETE LINING BETWEEN BRIDGE SPANS ON LEFT BANK

b. Within one year of the date of approval of this report the undermining of the downstream concrete lined left bank should be investigated and any necessary corrective action taken. In addition the pool should be temporarily lowered at a convenient time to allow inspection of the leakage of the stop logs adjacent to the right bank, corrective measures should be taken if found necessary.

b. O&M, Maintenance and Procedures - The undermining of the concrete lining between the bridge spans on the left bank (looking downstream) should be rectified. The cavity should be filled and surface drainage routed to eliminate the problem. Surrounding soil could be sodded to eliminate erosion.

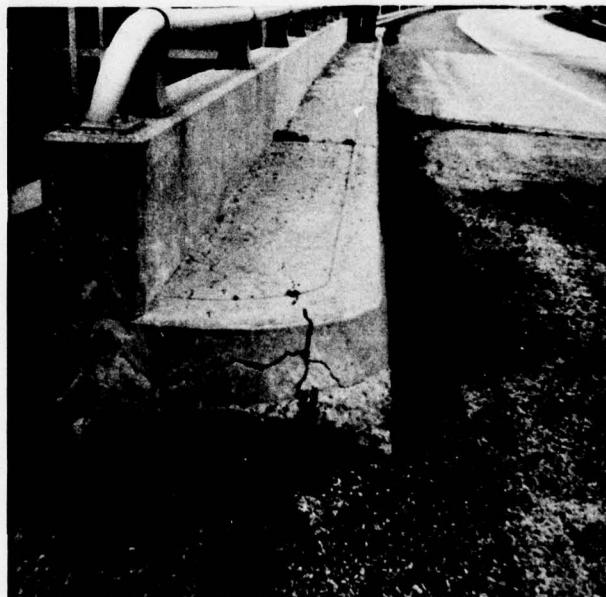
CONCRETE DETERIORATION OF SIDEWALK ON SOUTHBOUND BRIDGE SPAN
