POMPTON LAKE DAM

PHASE I INSPECTION REPORT

NATIONAL DAM SAFETY PROGRAM

NJ 00249

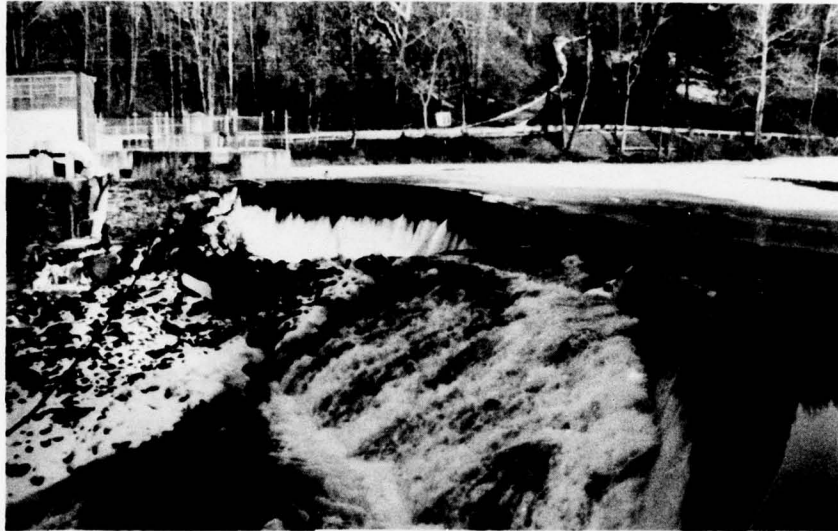
VIEW LOOKING TOWARD RIGHT BANK

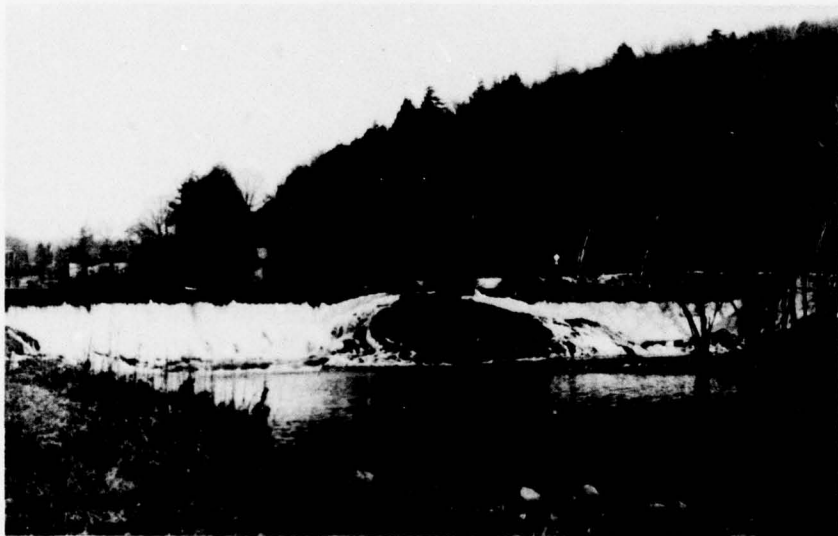
During the inspection, sloughing of the Route 202 highway embankment was observed at the east end of the spillway. Consideration should be given to the construction of a wall at this location to protect the highway and the spillway. It was also reported that an 18 foot deep scour hole exists in the stream channel downstream of the dam. This scour hole could not be examined during the field inspection due to the flow in the river. The location of this scour hole should be determined by a field survey and monitored periodically to determine if it affects the dam foundation.

VIEW LOOKING UPSTREAM SHOWING ROCK OUTCROP
AT CENTER AND EROSION OF HIGHWAY EMBANKMENT

Sloughing of the embankment of U.S. Route 202 could be prevented by construction of a retaining wall. The wall could be built outside of the limits of the spillway at the east end of the dam to protect the highway and to improve flow conditions over the dam.

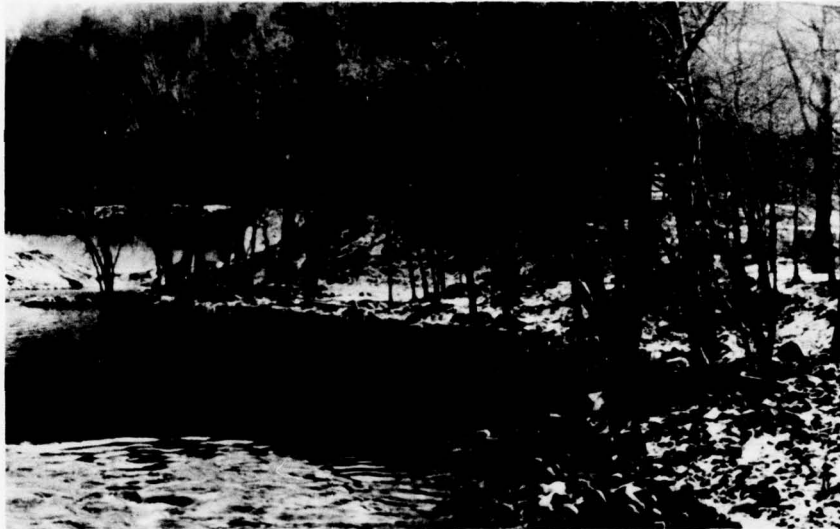
VIEW SHOWING LEFT BANK DOWNSTREAM OF THE DAM

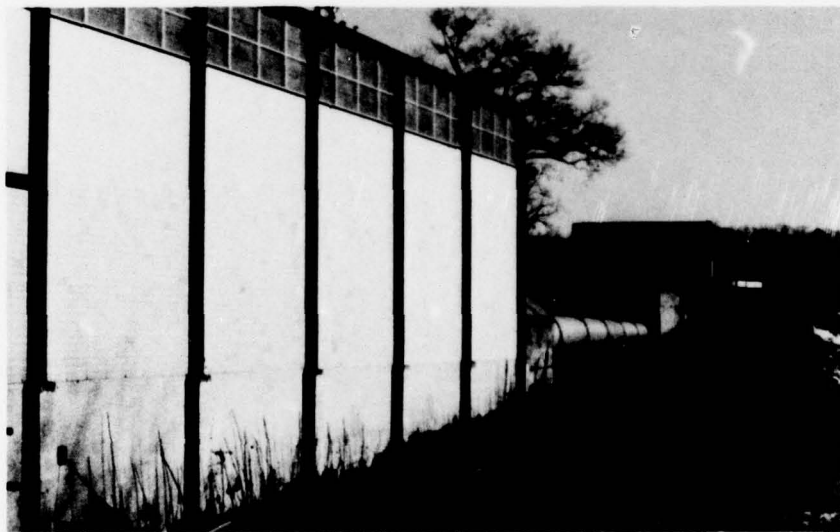
VIEW OF RIGHT BANK DOWNSTREAM OF THE DAM
SHOWING PUMPING STATION IN FOREGROUND AND
SCREEN CHAMBER IN BACKGROUND

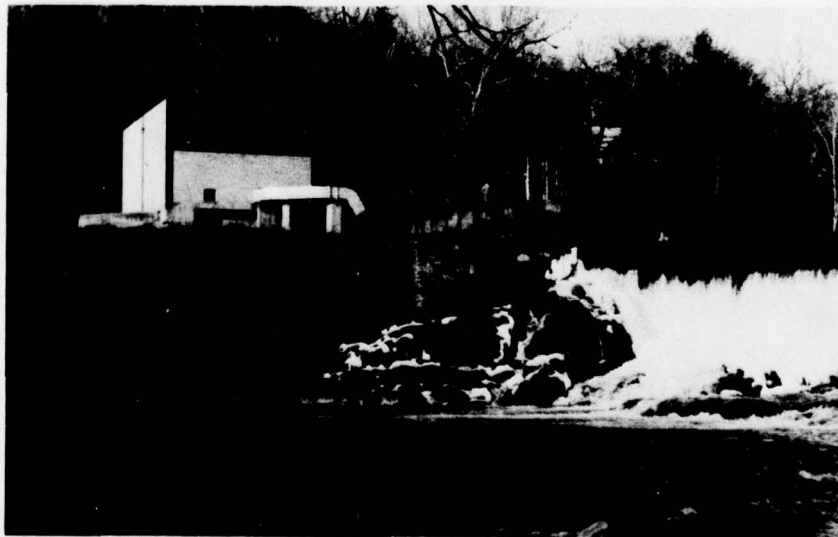
RIGHT BANK SHOWING INTAKE AND SCREEN CHAMBER

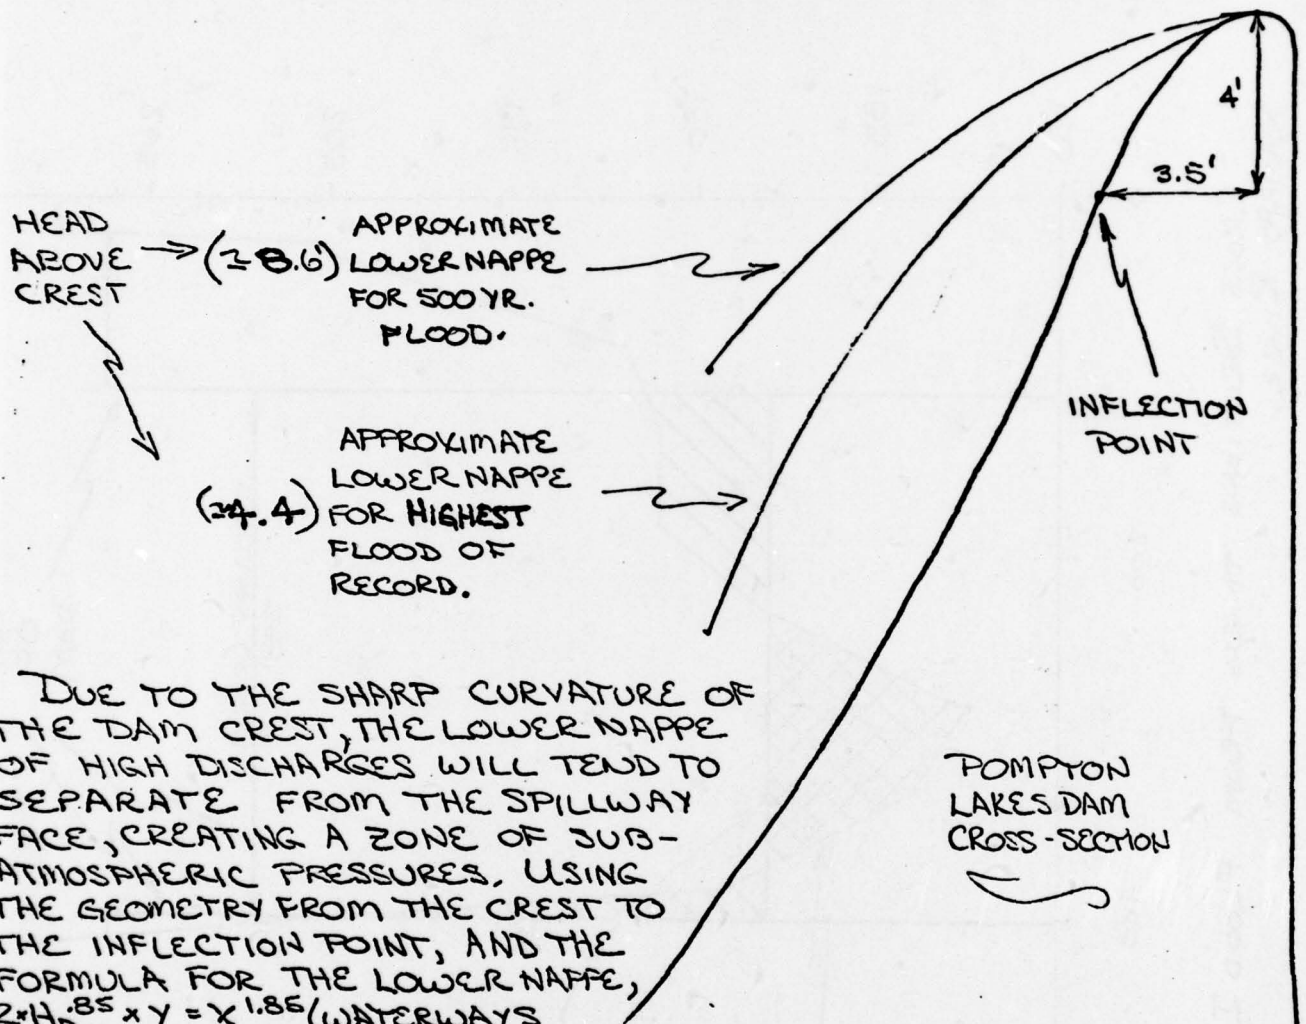
DUE TO THE SHARP CURVATURE OF THE DAM CREST, THE LOWER NAPPE OF HIGH DISCHARGES WILL TEND TO SEPARATE FROM THE SPILLWAY FACE, CREATING A ZONE OF SUB-ATMOSPHERIC PRESSURES. USING THE GEOMETRY FROM THE CREST TO THE INFLECTION POINT, AND THE FORMULA FOR THE LOWER NAPPE, $2 \cdot H_D^{0.85} \cdot y = x^{1.85}$ (WATERWAYS EXPERIMENT STATION), H_D FOR POMPTON LAKES DAM IS 1.32 FEET. HIGHER HEADS WILL PRODUCE SUB-ATMOSPHERIC PRESSURES.
