MISPILLION RIVER BASIN

SILVER LAKE DAM

PHASE I INSPECTION REPORT NATIONAL DAM SAFETY PROGRAM

JUNE 1978

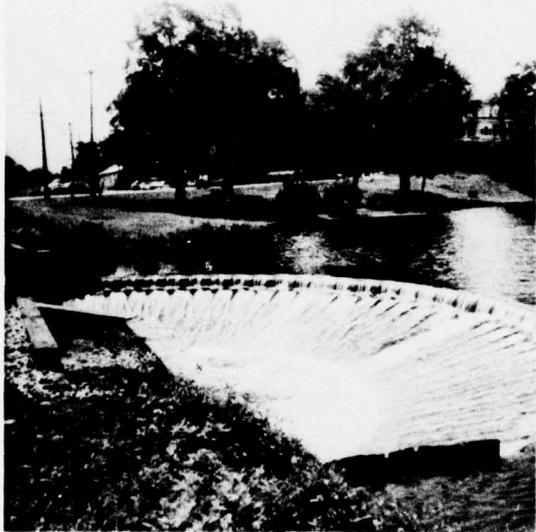
OVERALL VIEW OF DAM

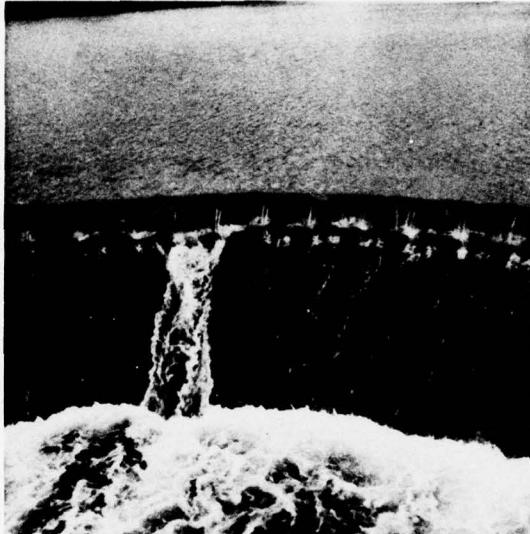
a. Visual Observation - No indications of structural stress were evident during the inspection of the sheet piling spillway. A depression in the apron downstream of the center of the sheeting was noted, but it could not be determined whether this was by design or due to foundation settlement.

DEPRESSION AT CENTER OF DAM

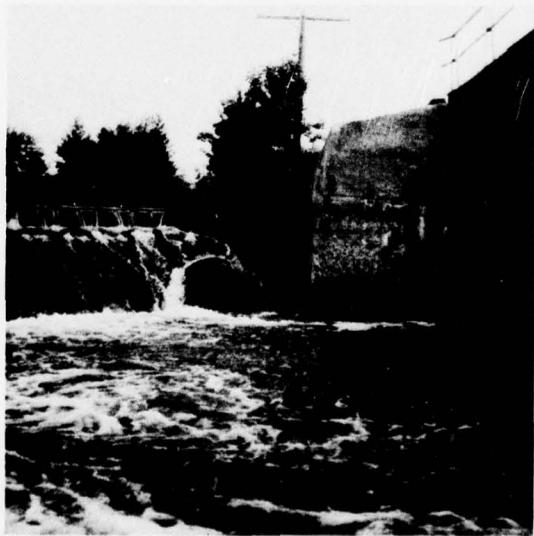
The 48-inch diameter pipe located on the left side of the spillway was not discharging at the time of inspection. The baffle boards which control flow through this pipe could not be observed due to the water level.

DISCHARGE PIPE AT LEFT ABUTMENT OF DAM

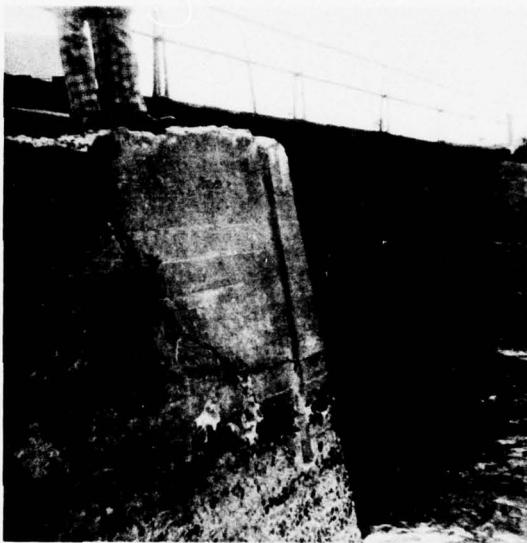
The wing walls of the railroad bridge show significant deterioration and structural stress. Concrete aggregate is exposed on the top surface of the wing walls and major horizontal and vertical cracks extend throughout the wing walls and endwalls of the concrete abutments. Aggregate is exposed in the walls in the lower half of the vertical height.

The concrete walls of the railroad bridge abutments which anchor the spillway sheet piling appear to be in poor structural condition.

CRACK IN RAILROAD BRIDGE WINGWALL (LEFT ABUTMENT)

- b. Monitoring of any changes in the structural condition of the railroad bridge abutments, which anchor the dam, should commence within three months of the date of approval of this report.

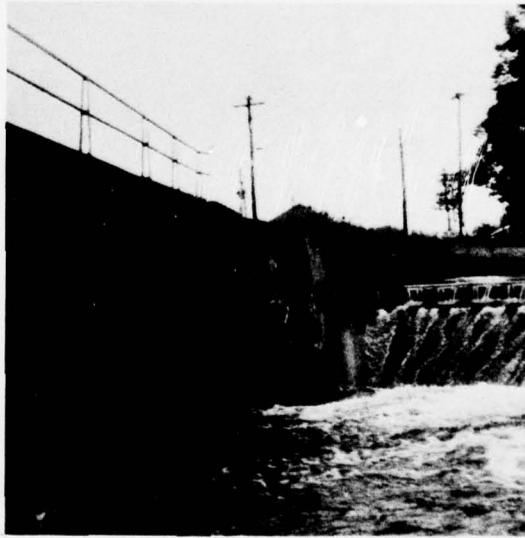
**VIEW OF CRACK AND EXPOSED AGGREGATE IN RAILROAD
BRIDGE ENDWALL (RIGHT ABUTMENT)**

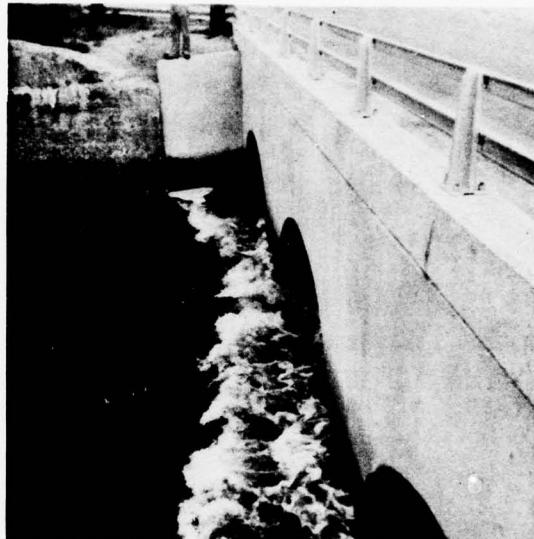
A new concrete highway bridge, which appears to be in excellent condition, is located immediately downstream of the railroad bridge. Three corrugated metal pipe arches, each with a span of about fifteen feet, form the waterway under this bridge.

FLOW AT DOWNSTREAM HIGHWAY BRIDGE

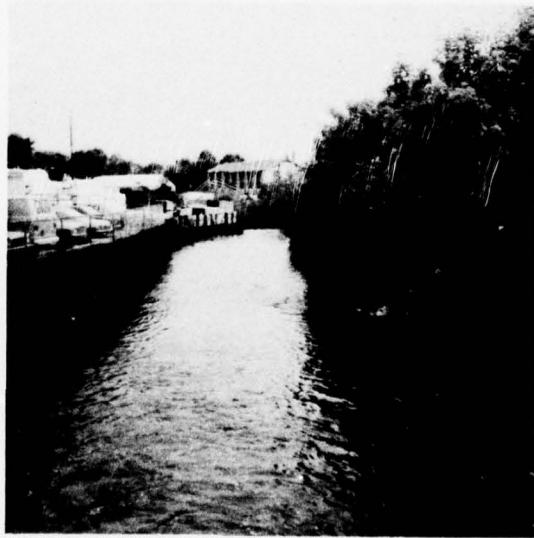
e. Downstream Channel - The left bank of the outlet channel downstream of the highway bridge is lined with steel sheet piling for a distance of about three hundred feet. The right bank in the same area is protected with broken concrete slabs which serve as riprap slope protection. Commercial establishments are located on the property adjacent to both banks. Further downstream, the channel continues through the community of Milford.

VIEW OF DOWNSTREAM CHANNEL
