ABSALOM DOUGHTY DAM

PHASE I INSPECTION REPORT NATIONAL DAM SAFETY PROGRAM

NJ 00080

Date: April 17, 1978

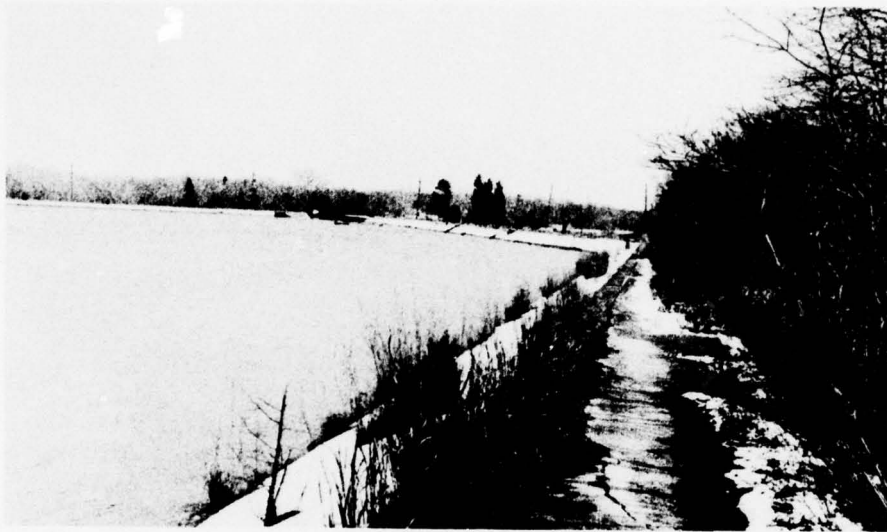
OVERALL VIEW OF DAM

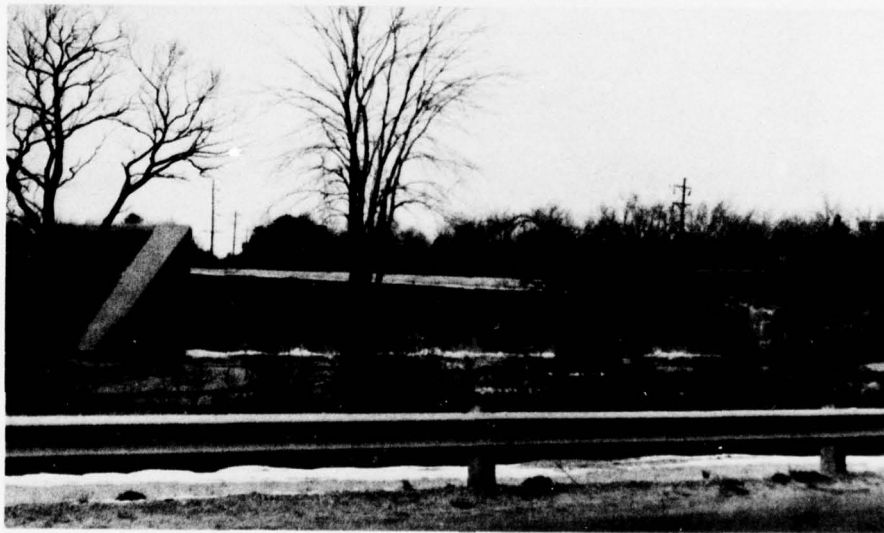
SPILLWAY

c. Appurtenant Structures - The spillway is a concrete ungated overflow structure that appeared to be in good condition at the time of inspection. The adjoining concrete abutments have noticeable age cracks, but appear to be sound.

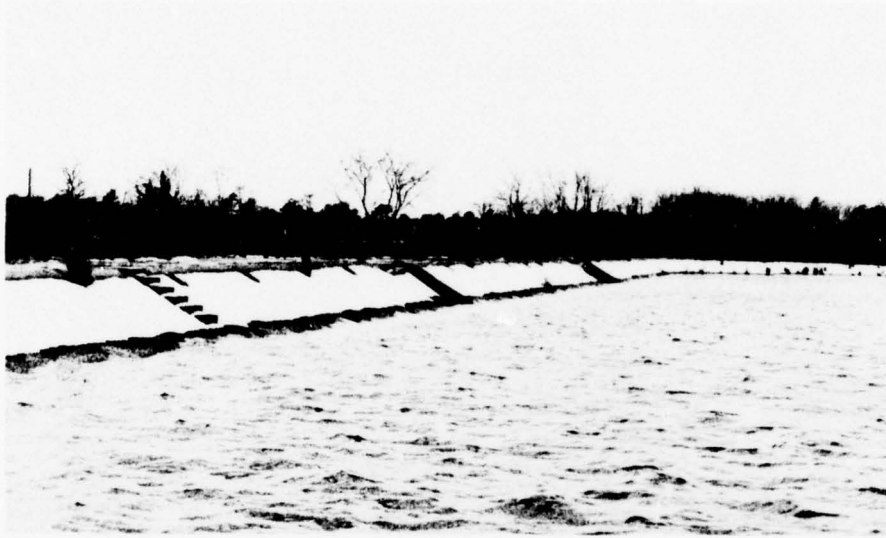
The present condition of Absalom Doughty is poor. A considerable amount of settlement or erosion has occurred along the upstream face of the embankment. Where the concrete slab slope protection has collapsed, the effects of the erosion or settlement are most severe. Strong westerly winds could generate waves of up to 3 feet that could wash away the cohesionless embankment material.

VIEW OF UPSTREAM FACE SHOWING AREAS OF SLOPE FAILURE

Local embankment erosion up to 3 feet was noted where the concrete slab slope protection has been dislodged. At one point, the remaining top width is less than 2 feet. An unknown amount of settlement and erosion has occurred where the slabs are intact.

- a. Remove concrete slabs on the upstream slope which have been displaced.
- b. Fill the eroded areas under the slabs with suitable earth materials.
- c. Replace concrete slabs. Graded filter material or filter fabric should be placed over the earth before the slabs are constructed. Expansive filler should be used in the joints of the new slabs.

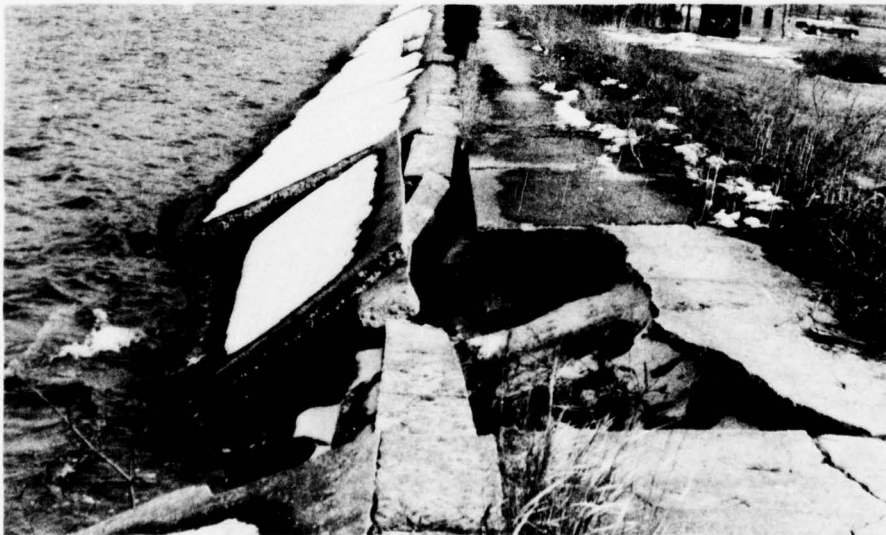
CLOSEUP OF UPSTREAM SLOPE FAILURE

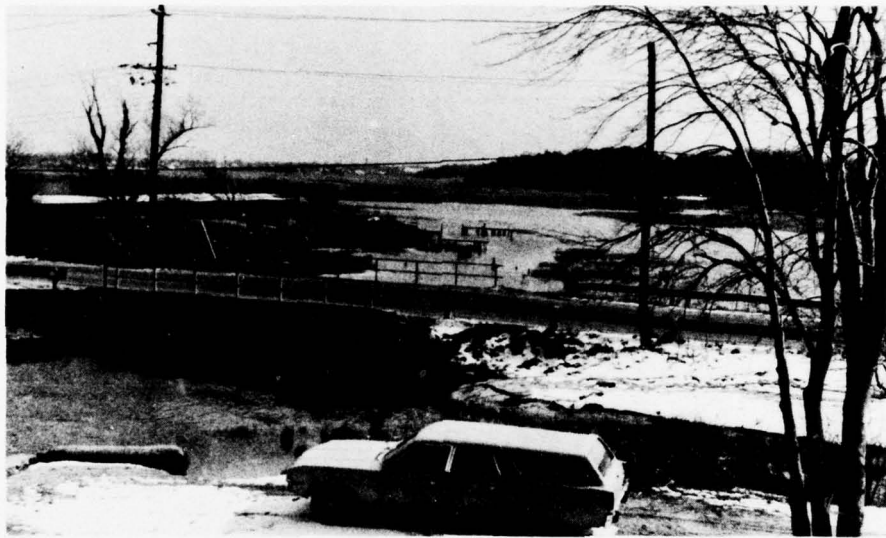
CHANNEL DOWNSTREAM OF SPILLWAY

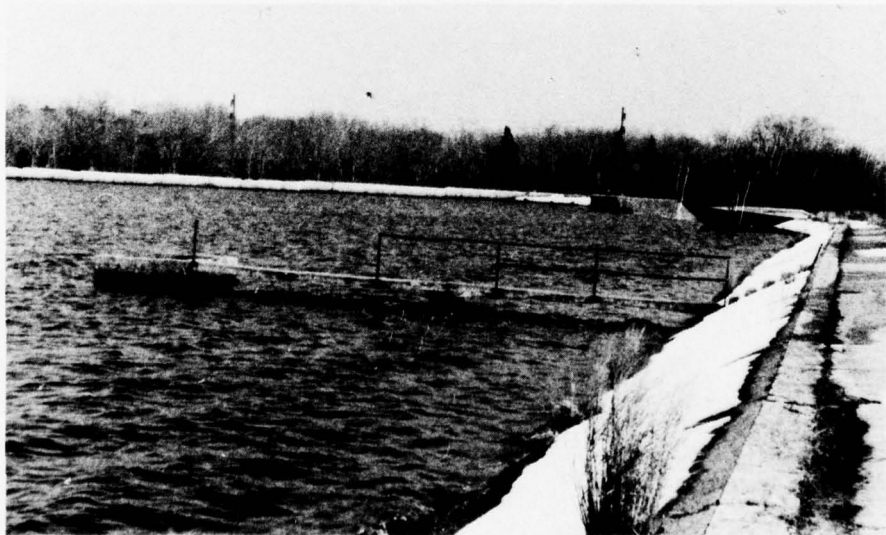
WATER SUPPLY INTAKE

VISUAL EXAMINATION OF	OBSERVATIONS	REMARKS OR RECOMMENDATIONS
CRACKING AND SPALLING OF CONCRETE SURFACES IN OUTLET CONDUIT	Conduit is subsurface.	None
INTAKE STRUCTURE	Water supply intake structure and the walkway to the structure are badly cracked and spalled. Some lengths of the hand railing are missing.	Repair or replacement of the structure should be implemented as merited.
OUTLET STRUCTURE	Thirty-inch blowoff lines are located under the spillway near each abutment. The operating assemblies for these lines are not in place.	The operating assemblies should be permanently in place to allow emergency operation.
OUTLET CHANNEL	Same as spillway discharge channel.	None
EMERGENCY GATE	None	None
