NRL Memorandum Report 3795

Shock and Vibration Performance of an Epoxy Chocking Compound Chockfast Orange, PR-610CF (Philadelphia Resins Corp.)

June 1978

NAVAL RESEARCH LABORATORY
Washington, D.C.

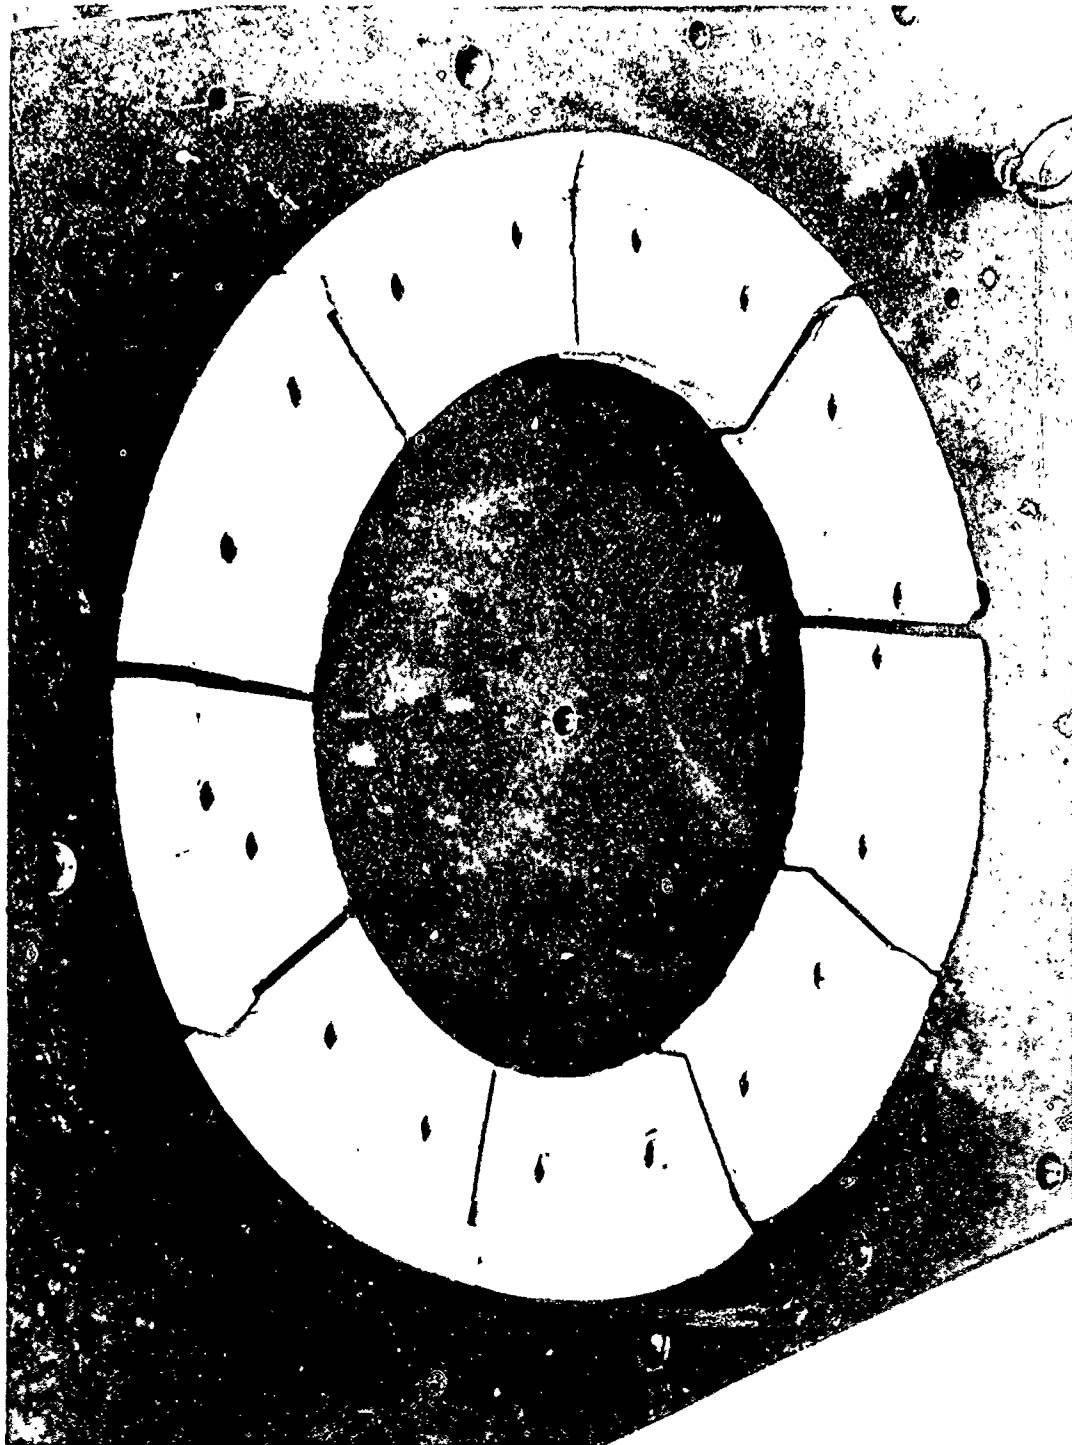
Finally, Figure 4 reveals some chipping and spalling in the overpour regions (Pad 7, particularly) which occurred when the pads were cut apart. Figure 5 shows the mounting ring and chock pads of Test Structure No. 2 after removal of the circumferential dams, and Figure 6 the top and Figure 7 the bottom surfaces of the chock pads after disassembly and separation. The general appearance is much the same as that of the pads for Structure No. 1, with slightly less porosity. After inspection and photography, the test assemblies were put back together and the hold-down bolts tightened to the desired torque. The static bearing load on the chock pads due to the weights of the test structures were negligible, only a few psi in either case. A total static load of 700 psi was chosen as the middle of the range of static loads recommended by manufacturer, and the bolt torque required to produce the necessary bolt tension calculated and rounded. For Test Structure No. 1 this torque was 50 ft. lb., and for Test Structure No. 2, it was 150 ft. lb. Calculated total bearing loads were 714 psi and 715 psi respectively. The mounting ring/chock pad was felt likely to be fairly flexible in comparison to the bolt stiffness, so that the total bolt load could approach the sum of the static and dynamic loads. Accordingly, hex-socket cap screws were used for hold-down bolts because of their high strength. The completed assemblies were then transferred to the NRL Shock and Vibration Lab, where the ambient temperature varied from 80 - 90 F during the period of the shock and vibration tests.

Fig. 4 — Chock pads of Test Structure No. 1 after separation. The continuous ring of overpour was cut with a bandsaw. Note the porous structure and occasional voids, as in Pad 1.

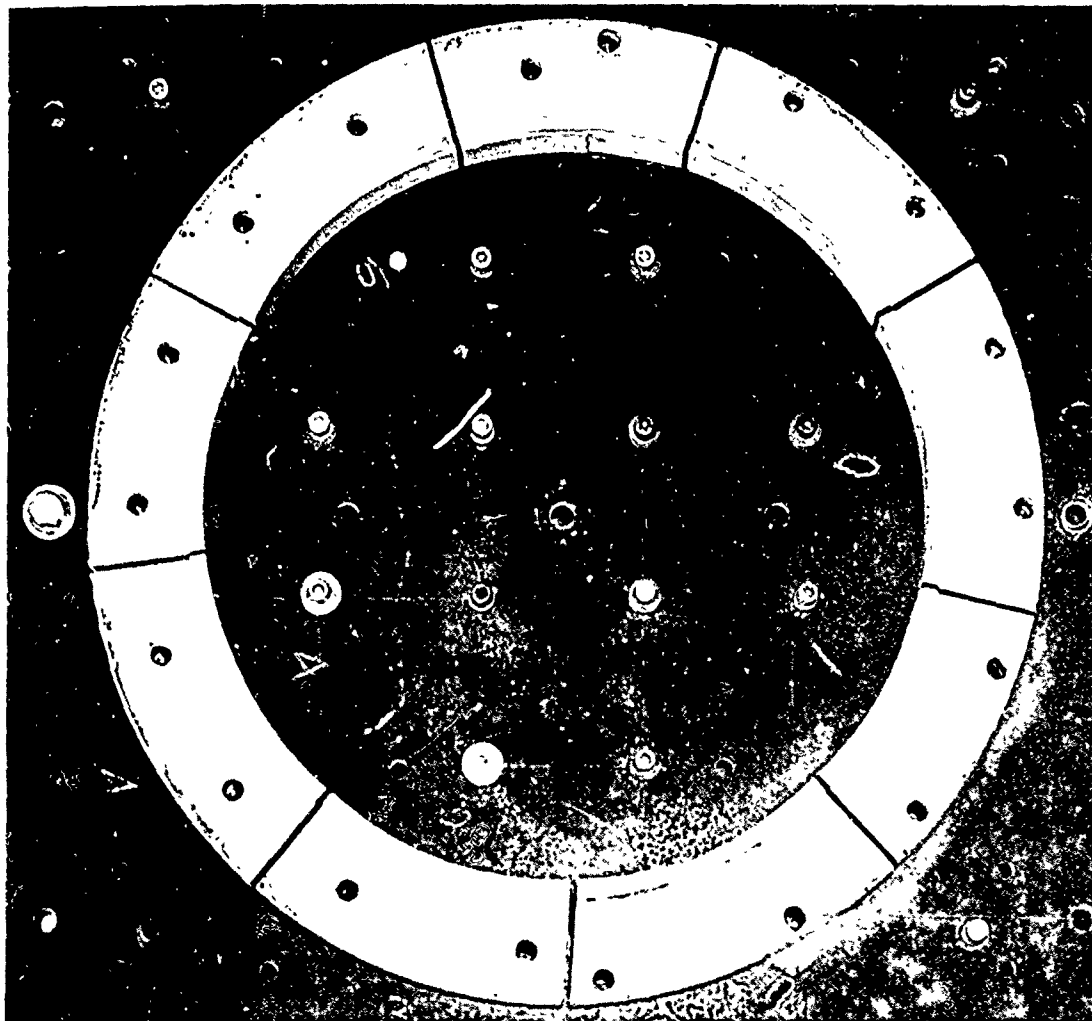
The test structure assembly was disassembled and the chock pads inspected and photographed (Fig. 21). No change in their condition could be seen.

Fig. 21 — The chock pads of Test Structure No. 2 after the standard shock test. The markings visible around the outer edges of Pads (4 & 5, for example) are patchy discoloration rather than abrasions.
