PASSAIC RIVER BASIN
DEN BROOK, MORRIS COUNTY
NEW JERSEY

INDIAN LAKE DAM

PHASE I INSPECTION REPORT
NATIONAL DAM SAFETY PROGRAM

NJ 00167

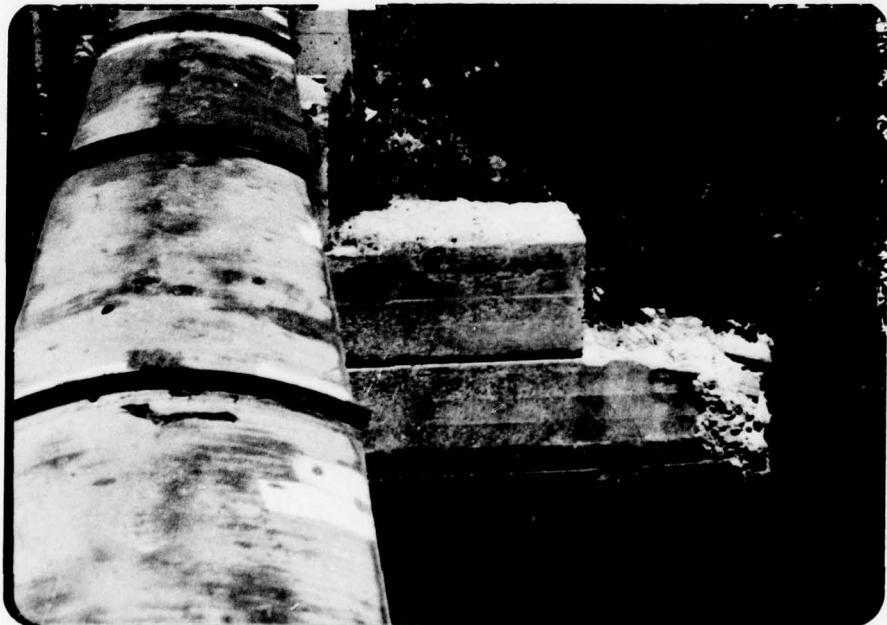
There is some concrete deterioration in the downstream spillway sidewalls and weathering at the spillway construction joints, otherwise the spillway section appears in adequate condition. The concrete bulkhead at the right side of the spillway has cracked and some of the stone facing has fallen out but this is not considered serious.

Deterioration of concrete at left
downstream sidewall of spillway

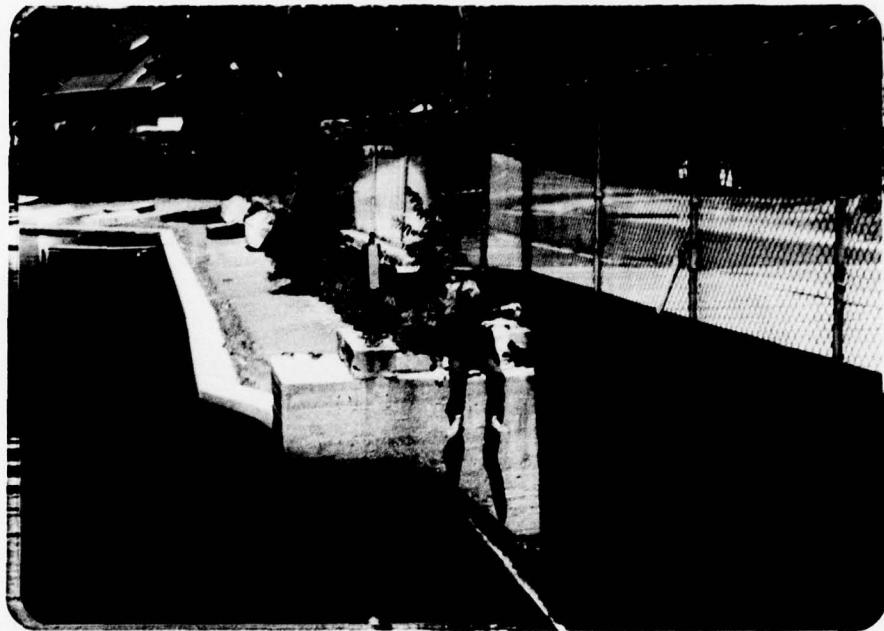
The bottom outlets are in functional condition and the gate valves seem to be in satisfactory condition. They can be easily operated by one man with a ratchet lever handle. The concrete support for the floor stand operator for the control valve at the left side of the spillway has broken up and should be repaired.

Left spillway sidewall and
drawdown control valve

(2) Within one year repair the concrete support for the floor stand gate operator and the bulkhead.

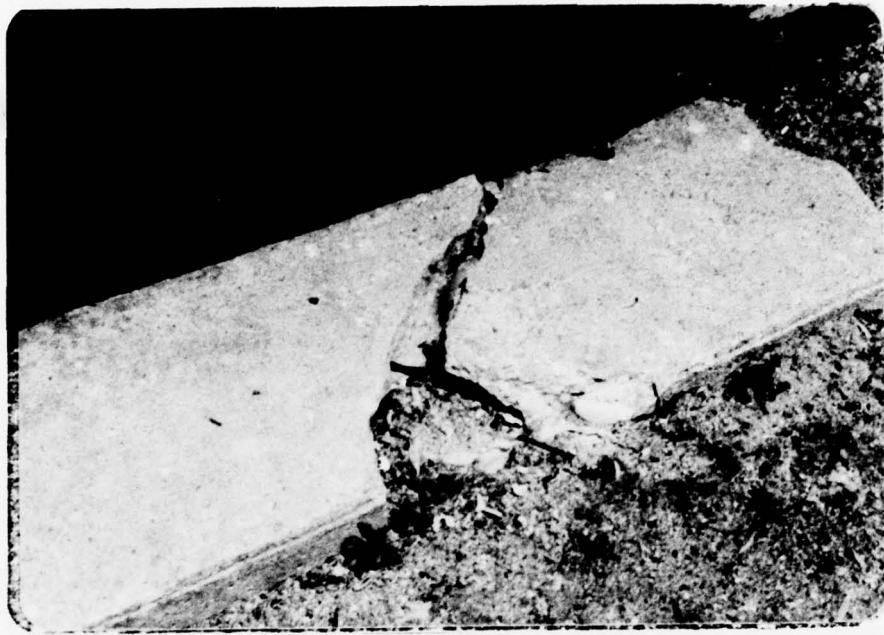
Crack in concrete bulkhead of right upstream section of embankment 5 July 1978

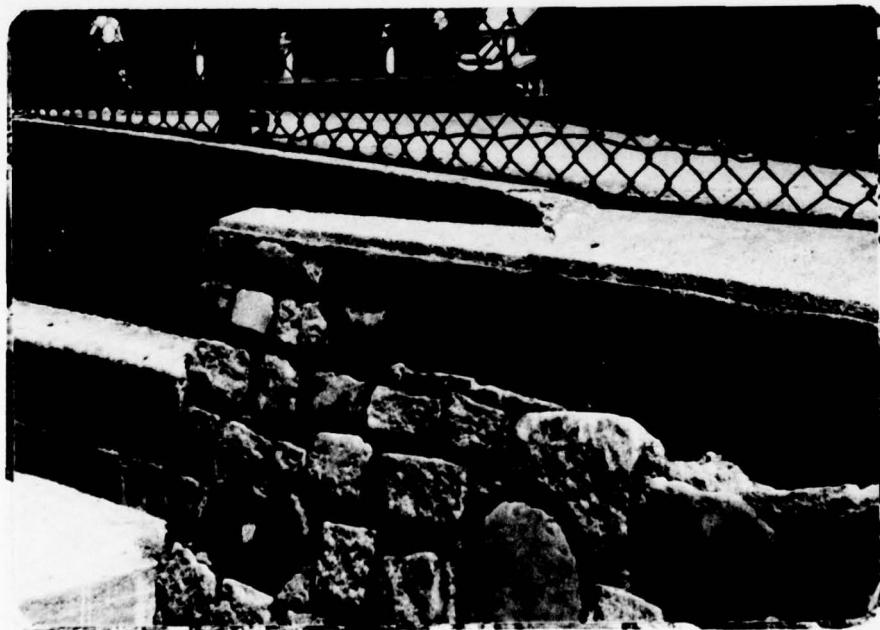
Deterioration of upstream facing of right embankment 5 July 1978

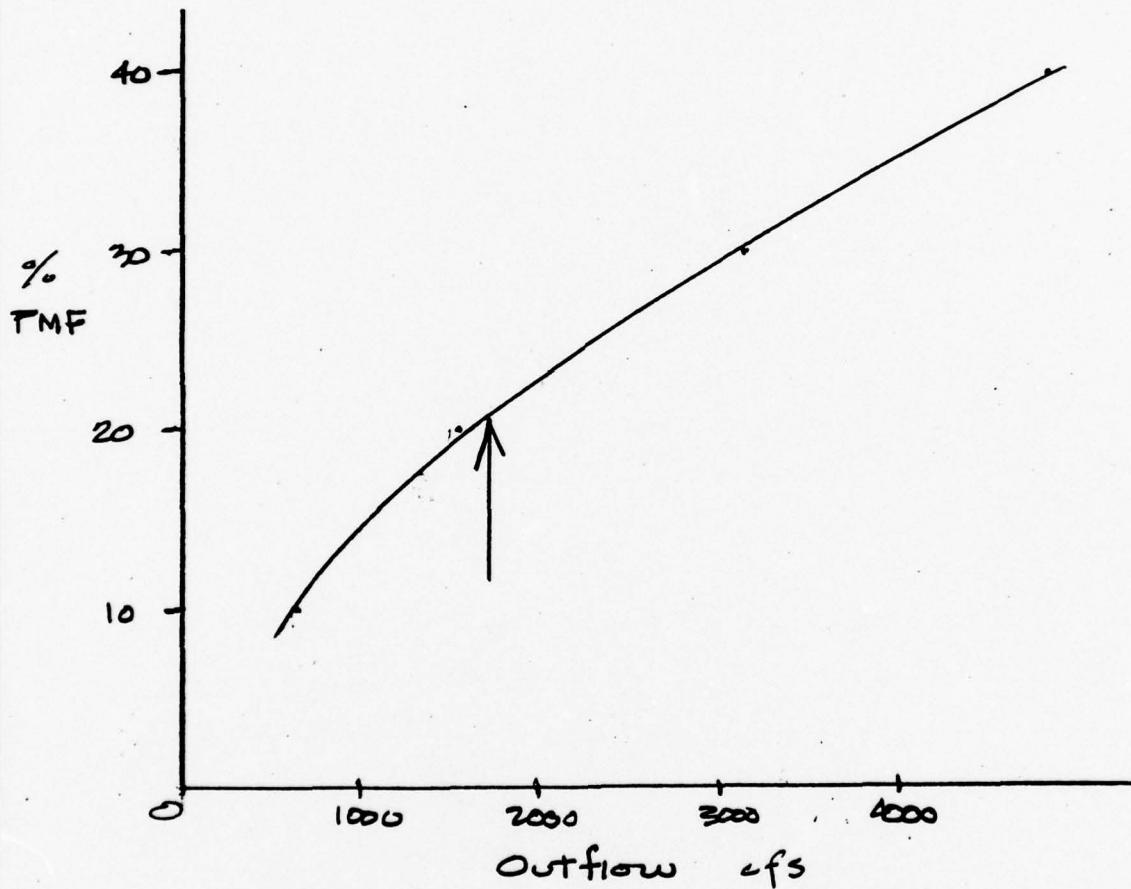
OVERTOPPING POTENTIAL

3. Dam overtops at approx el 513.5 with $Q = 1702 \text{ cfs}$
- \therefore dam can pass 20% PMF
