National Dam Safety Program.
Echo Lake Intake Dam. (NJ-008167).
Echo Lake Spill Way Dam. (NJ-00558)
Passaic River Basin Macopin River.
Passaic County, New Jersey.
Phase I Inspection Report.

ECHO LAKE INTAKE DAM ECHO LAKE SPILL WAY DAM

PHASE I INSPECTION REPORT

4. TITLE (and Subtitle) Phase I Inspection Report National Dam Safety Program Echo Lake Intake Dam & Echo Lake Spillway Dam Passaic County, N.J.		5. TYPE OF REPORT & PERIOD COVERED FINAL

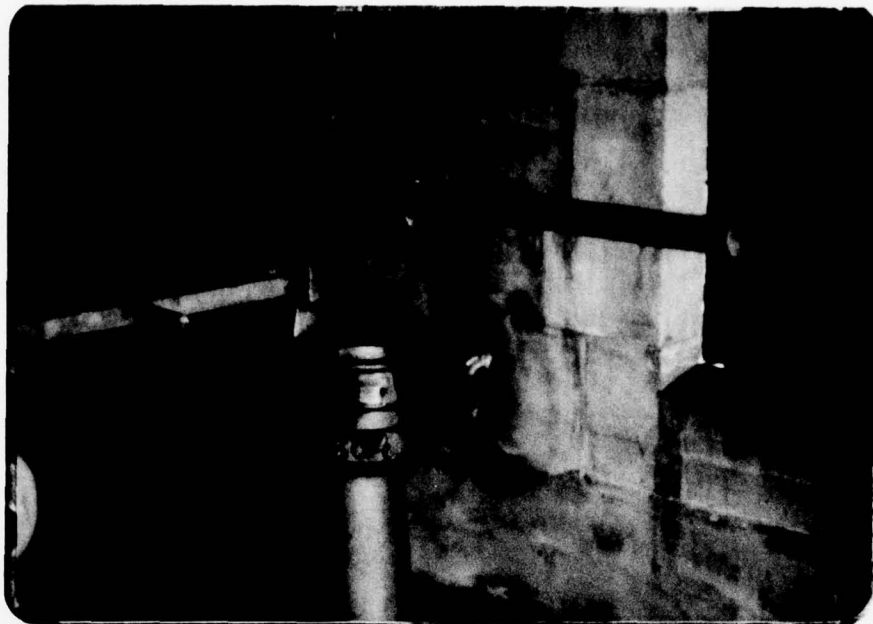
There is a Rodney Hunt control valve at the trash rack intake structure for diversion of make-up water from Echo Lake to Charlotteburg Reservoir or emergency runoff to Macopin. The valve and trash rack structure are in well maintained condition.

One of three Rodney Hunt manually 20 June 1978
operated control valves at intake structure.

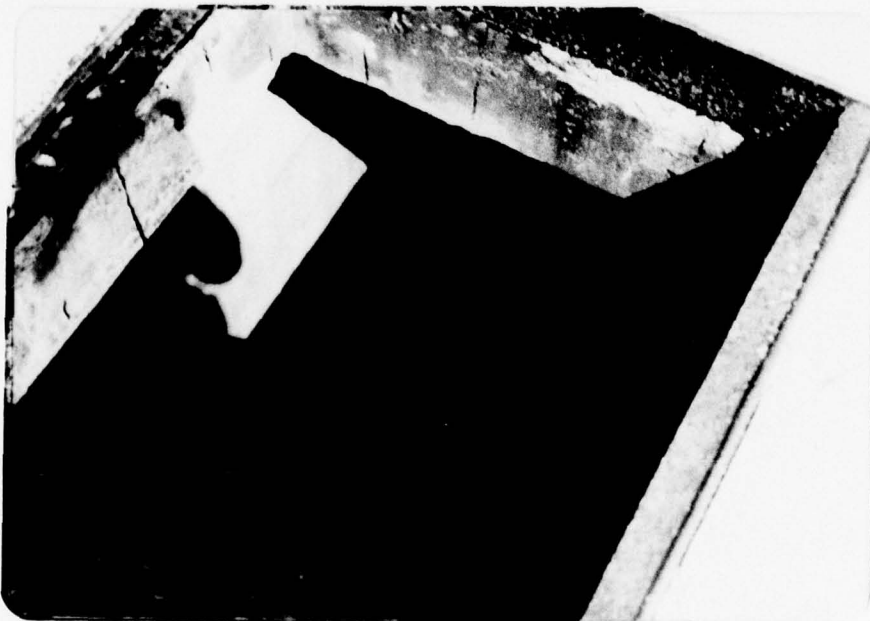
Control valve at right side 20 June 1978
of spillway.
