# LAKE VALHALLA DAM

## PHASE I INSPECTION REPORT

NJ 00330

JULY 1978

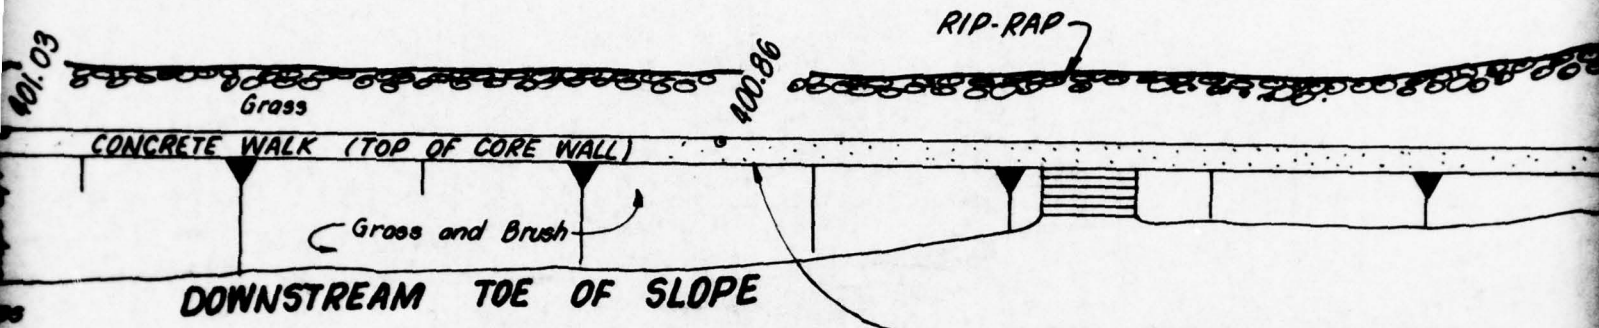
NOTE: EARTH ON BOTH SIDES OF CONC. WALL HAS SETTLED ONE TO THREE INCHES BELOW TOP OF WALL.

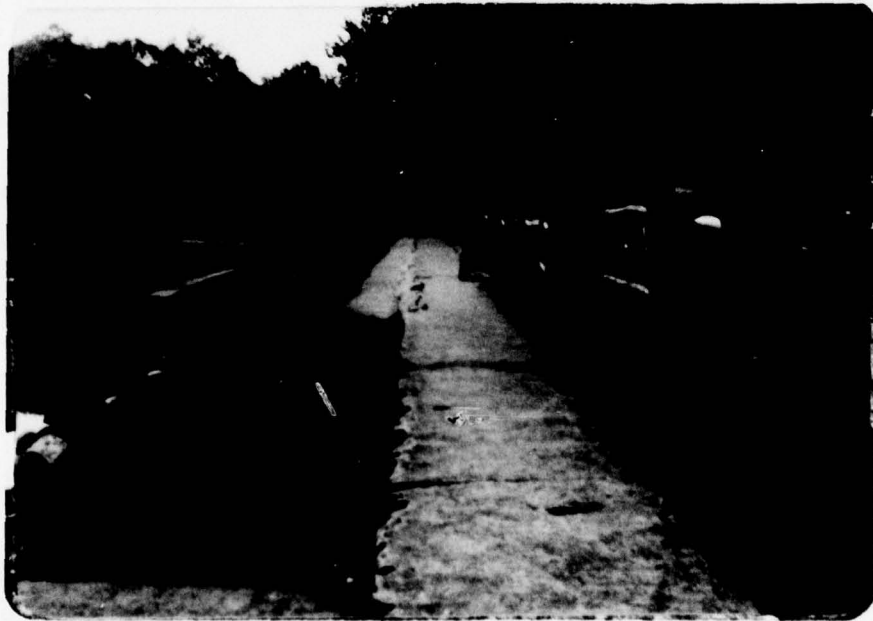
The embankment and spillway appear to be stable with no indications of failure of the dam and appurtenances. The masonry core wall appears intact and without vertical or horizontal deflection. The earth embankment on both sides of the core wall has settled one to three inches below the top of the wall.

Top of core wall in left embankment  
looking east

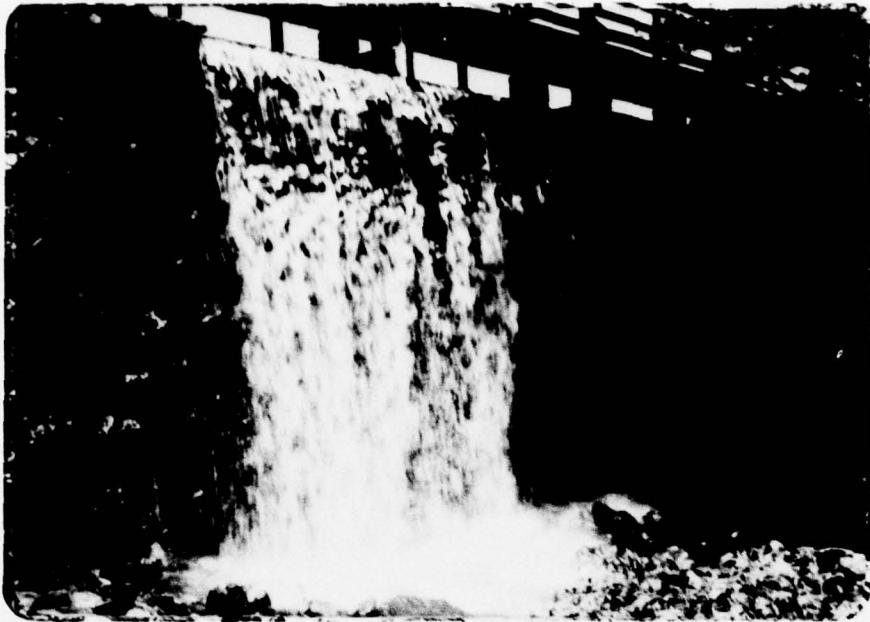
Free Fall Spillway  
Looking Upstream

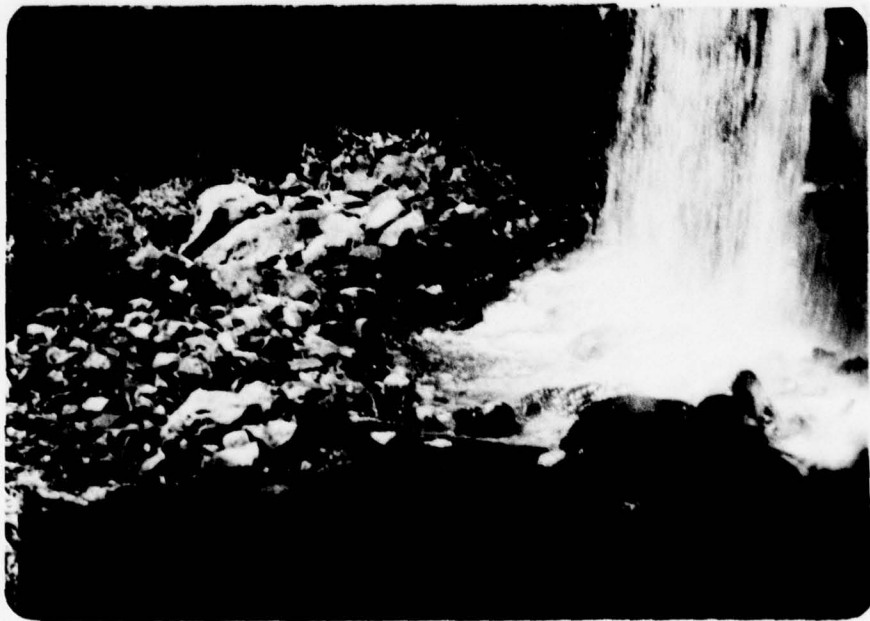
Rocks at bottom of Spillway

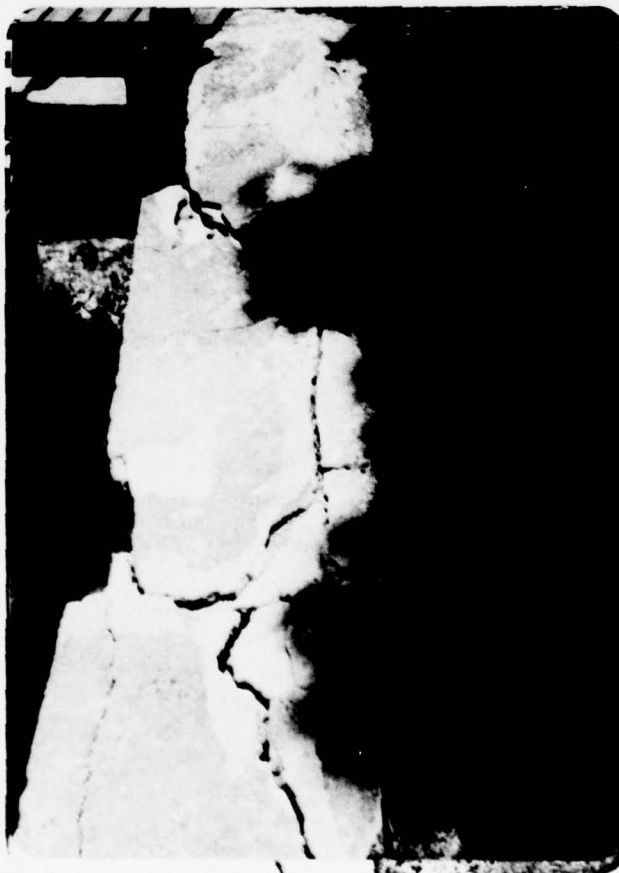
The downstream abutment side walls slope away from the spillway and are in poor condition. They act as retaining walls for the downstream backfilling behind the core wall and there are signs of movement and erosion by rain in that part of the embankment where the height is the greatest.

Deterioration of  
upstream spillway  
right sidewall.

5. Repair and strengthen the side walls of the spillway. This should be done very soon.
6. Provisions should be made to prevent floating debris, boats, etc. from plugging the free space between the bridge and the top of the spillway. This should be done very soon.
